Abandoned roadways aged up to 50 years observed in Kushiro Coal Mine, Japan

ABSTRACT: 95 abandoned old roadways up to 50 years old and 300 m deep were observed at Kushiro Coal Mine. Large plastic deformations as roof deflection and/or floor heave closed most roadways although a few roadways were remain open. Such in-situ measurements as Rayleigh wave velocity, permeability etc. were carried out. Rayleigh wave velocity in the closed roadway was approx. half the virgin rock mass. Permeability of closed roadway was 40 times greater than that for virgin rock mass. This suggests that 1/40 sealability can be expected even a rock cavern in clastic rocks completely collapsed. This would be much better than rock cavern in crystalline rocks in which much less sealability is expected when completely collapsed.

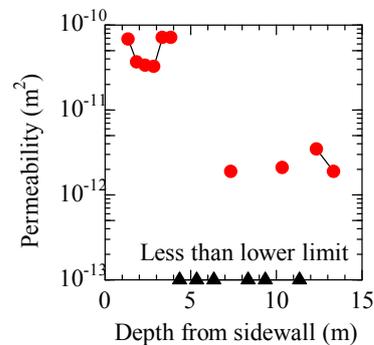
Permeability distribution along a borehole was measured. The instruments were almost the same as Lugeon tests in 2.3, but a double packer was used to divide the pressurized part at 0.5 m. The test was carried out in a 15-m long and 15-degree upward borehole drilled in the sandstone seam at a tailgate before the abutment pressure appeared. Permeability was on the order of 10^{-11} m^2 less than 4 m deep and on the order of 10^{-12} m^2 or less for depths more than 4 m (Fig. 2). It is estimated that the rock mass within 4 m from the sidewall was an EDZ. It was impossible to carry out the test due to borehole collapse when the face reached 5 m to the borehole.

Figure 2. Permeability distribution along a borehole.

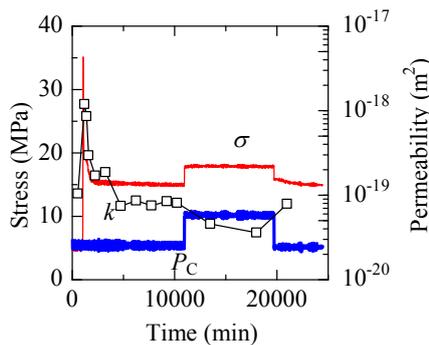
Variation in permeability in triaxial compression was examined for a sandstone core sampled from the roof of one of the sites was carried out. The sample was vacuum-packed at the site, and a 60-mm long, 30-mm diameter cylindrical rock core was taken immediately after unpacking. The core was vacuum-saturated in pure water. End pieces were installed into it, and the core and end pieces were jacketed by heat-shrink tubing. The jacketed specimen was inserted into an ultra-compact triaxial vessel (Fujii & Kondo, 2010). The specimen was consolidated for 10 hours under a hydrostatic pressure of 5 MPa and pore pressures of 2 MPa (upstream) and 1 MPa (downstream). The platen was stopped for 1 week after the specimen was compressed axially to show peak stress and residual state under the drained condition. Slight stress relaxation was observed during the week. The confining pressure was increased to 11 MPa for a week and then decreased to 5 MPa for a week. Permeability increased with specimen failure (Fig. 4); however, it gradually decreased with time in the residual state and reached almost the same level as that for the intact rock specimen. Permeability decreased with the increase in confining pressure and then increased with its decrease. The variation of permeability with confining pressure looked reversible and associated with elastic deformation of the rupture plane. Similar results on Kimachi sandstone can be seen in Takada & Fujii (2009). Fracture closures and poorly connected tortuous fractures were observed in the thin section (Fig. 5). These were likely the causes of the decrease in permeability with time in the residual state. Fracture closure occurred mainly by crushing of the mineral particles and visco-elastic deformation around the rupture plane and not by the pressure solution.

Figure 4 Axial stress (σ), confining pressure (P_C) and permeability (k) versus time obtained under the triaxial compression test using sandstone.

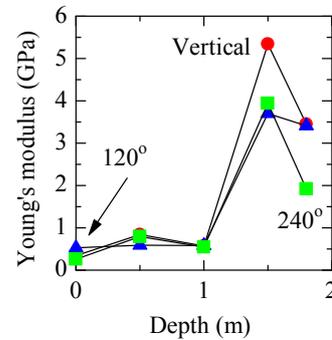
Distribution of Young's modulus along boreholes was measured with a Goodman jack. Tests were carried out at a tailgate. The first test was carried out for a horizontal borehole drilled from the sidewall into the virgin field of siliceous rock. The UCS and the Young's modulus of the intact saturated specimen were 52 MPa and 12 GPa, respectively. Loading was carried out in three directions: vertical and 120 degrees and 240 degrees from vertical. A significant anisotropy was not observed in this plane (Fig. 3). Young's modulus for rock mass within 1 m from the sidewall was much smaller than that for rock mass deeper than 1.5 m. The EDZ boundary was estimated to be between 1 m and 1.5 m from the sidewall. The second test was carried out in the sandstone borehole for a Lugeon test by air for measuring a permeability distribution, when the face approached 5 m to the borehole. Loading was carried out only in the EDZ. Small values of Young's moduli were obtained showing yielding of rock mass around the tailgate.

Figure 3. Distribution of Young's modulus along the borehole in siliceous rock.

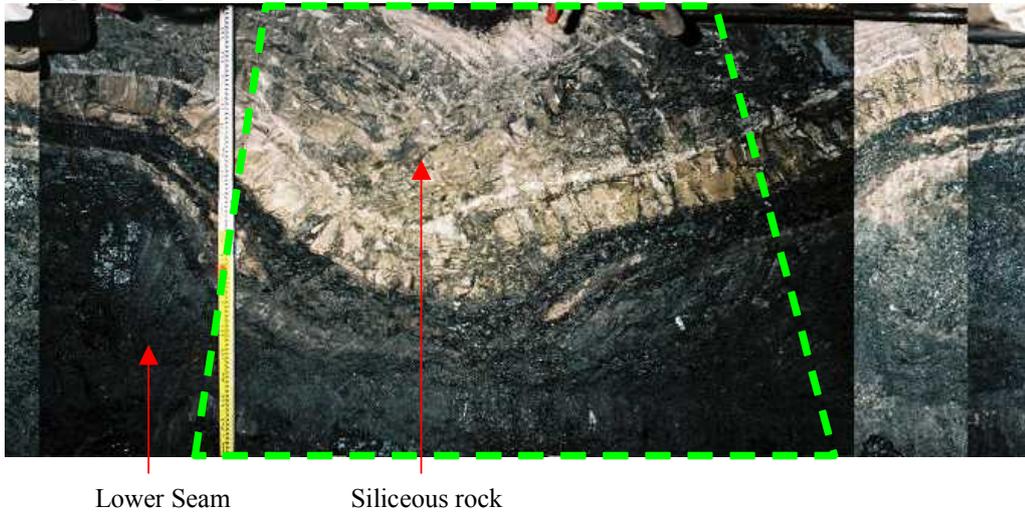
From the observation of closed roadway, it was clarified that most roadways were completely closed by deflection of roof (Fig. 1, see the last page) and/or floor heave due to plastic deformation of clay and siliceous rock. There observed no significant fractures in the closed parts. On the other hand, a few roadways were left open by the wooden support. No back filling was reached to the open roadways.

Main reason for roadway closure can be considered not to be a large stress concentration but large deformation of clastic rocks, which contained smectite, due to water supply by slurry filling under stress which is similar to the overburden pressure from the observation of closed and open roadways, steel arch removing tests and stress recovery test.

Figure 1. Old roadway observed in Kushiro Coal Mine. Roadway which is denoted by the green line was closed by the deflected and sagged roof. Height of old roadways is approx. 2.5 m.

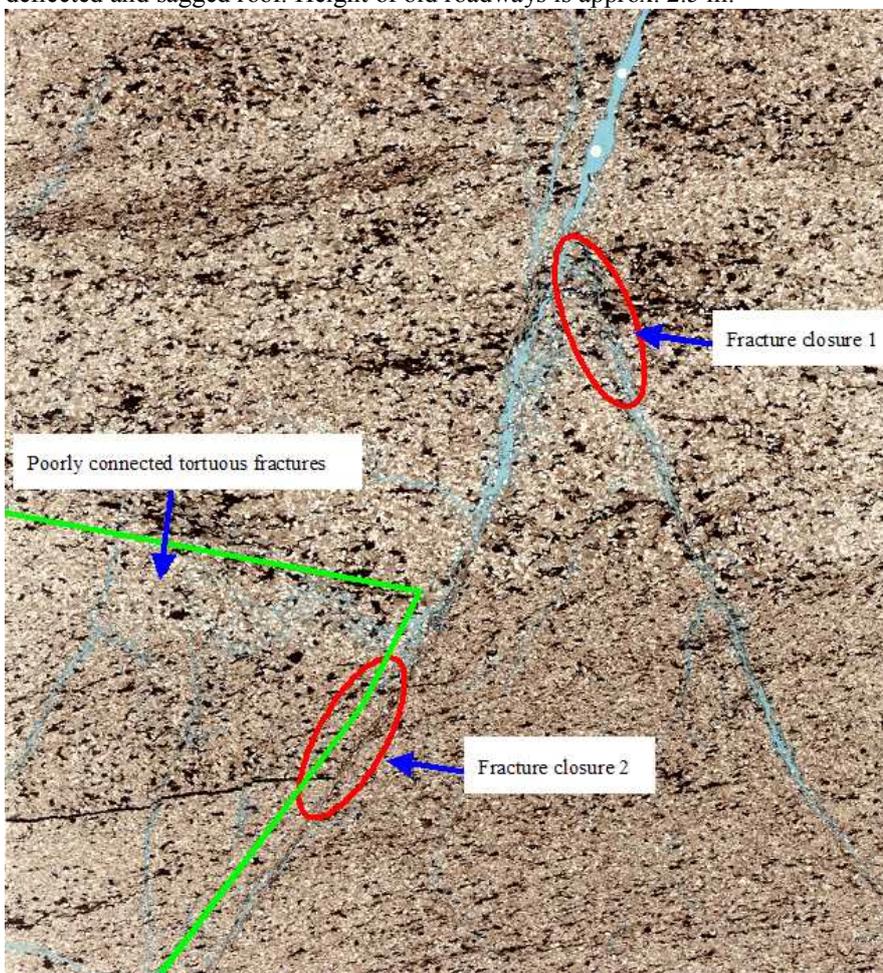
Figure 5. Micrograph of the thin section prepared from the rock specimen used for the triaxial test. The photo corresponds to the thin section of 23 mm wide. Vertical direction of the photo coincides with the loading axis. Test piece was impregnated with blue resin before preparation of the thin section.
