NON-DESTRUCTIVE TESTS APPLIED DURING REPAIR WORKS OF THE YODOGAWA BRIDGE

Yodogawa Bridge having a total length of 723.3m is composed by 30 spans, 6 of which are simply supported truss bridges with spans of 32.918m. The bridge, completed in 1926, is located on a heavy traffic route and underwent repair works after being severely damaged during the World War II. Some of the repaired members had complex details whose structural components were not clear and, in some cases, their connections and welds to the original structural members were not visible.

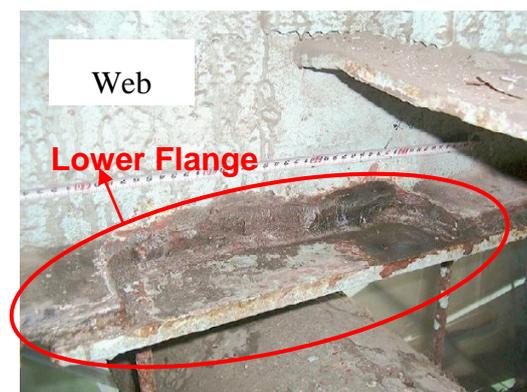
During inspections carried out in previous years, cracks were found at the lower flange of a transverse beam that had been reinforced in the past. In order to execute retrofit works in the damaged area, cracks and superficial flaws had to be removed so as to install new reinforcement plates.

Figure 2: Existing reinforcement plate of transverse beam

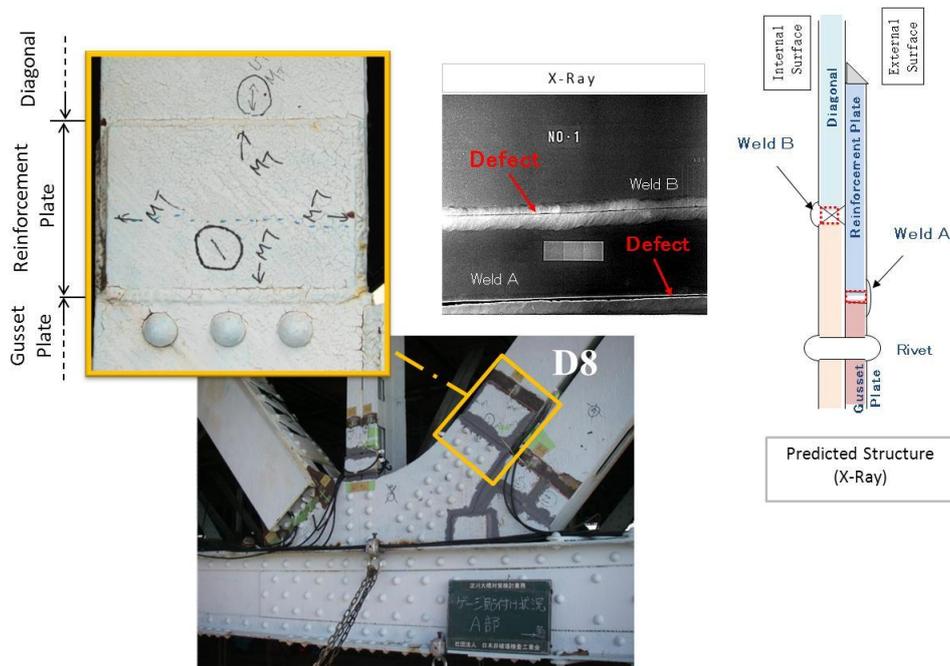
X-Ray test applying digital graphic processing system was applied to find out detailed conditions of butt welds connecting truss members and reinforcement plates that were not visible due to the complex structure of reinforcement works carried out in the past. In addition, an attempt to evaluate the depth of the defect through X-Ray was also made.

Figure 3: Example of existing reinforcement details in truss members

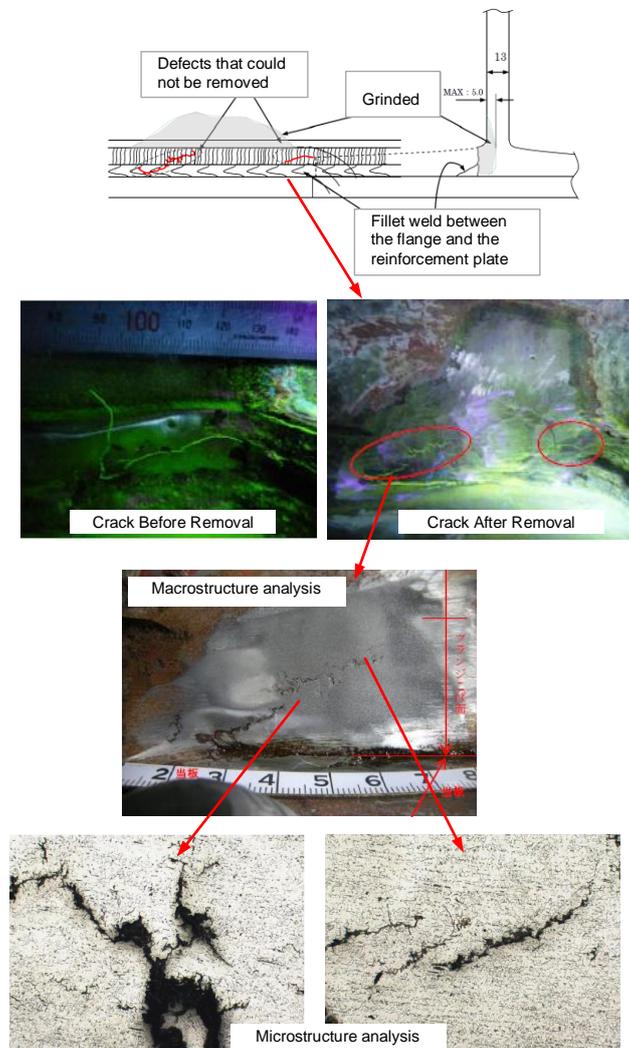
A cracks located at the vicinity of the reinforcement plate of the transverse beam were removed by grinding to a depth of 3mm. However, layers patterns in the steel rolling direction and small cavities could not be completely eliminated, even after grinding to a 5mm depth.

Figure 5: Conditions of the weld at the transverse beam after crack removal

The results of the macro- and microstructure analysis revealed that these flaws were probably originated during the fabrication process of the steel. The magnetic particle test patterns and macro- and microstructure images are shown in Figure 5.

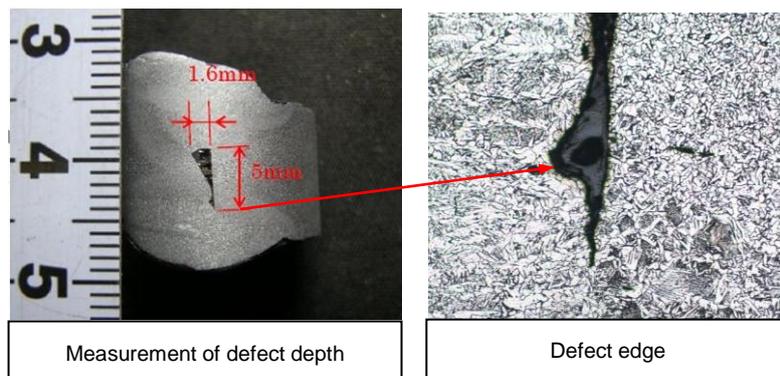
Figure 5: Macro- microstructure analysis

During the repair works on the lower flange of the transverse beam it was found that cracks in the vicinity of the welds could not be completely removed and defects in the form of layers remained in the thickness direction. Further investigations through macro- microstructure analysis proved that the defects found in the rolling direction of the steel were probably originated during the fabrication process of the steel.
