Damage to Steel Buildings Observed After the 2011 Tohoku Earthquake

Taichiro Okazaki,^{a)} Dimitrios G. Lignos,^{b)} M.EERI, Mitsumasa Midorikawa,^{c)} M.EERI, James M. Ricles,^{d)} M.EERI, and Jay Love,^{e)} M.EERI

A joint U.S.-Japan reconnaissance team examined the damage to steel building structures caused by the 2011 off the Pacific Coast of Tohoku Earthquake. In the city of Sendai, where the peak horizontal ground acceleration exceeded 1 g, the majority of steel buildings performed well. Buildings that used older cladding systems for external finish sustained damage to their claddings even if their structural performance was excellent. Damage to a few braced frames offer insight into the seismic design of bracing connections. In areas attacked by violent tsunami, many steel buildings stood upright after the tsunami subsided, although these buildings lost much of their external and internal finishes along with their contents. These steel buildings did not provide safe shelter for tsunami evacuation when the building submerged under the tsunami wave. A number of buildings suffered foundation failure, which was likely caused by scouring or liquefaction or the combination of mul

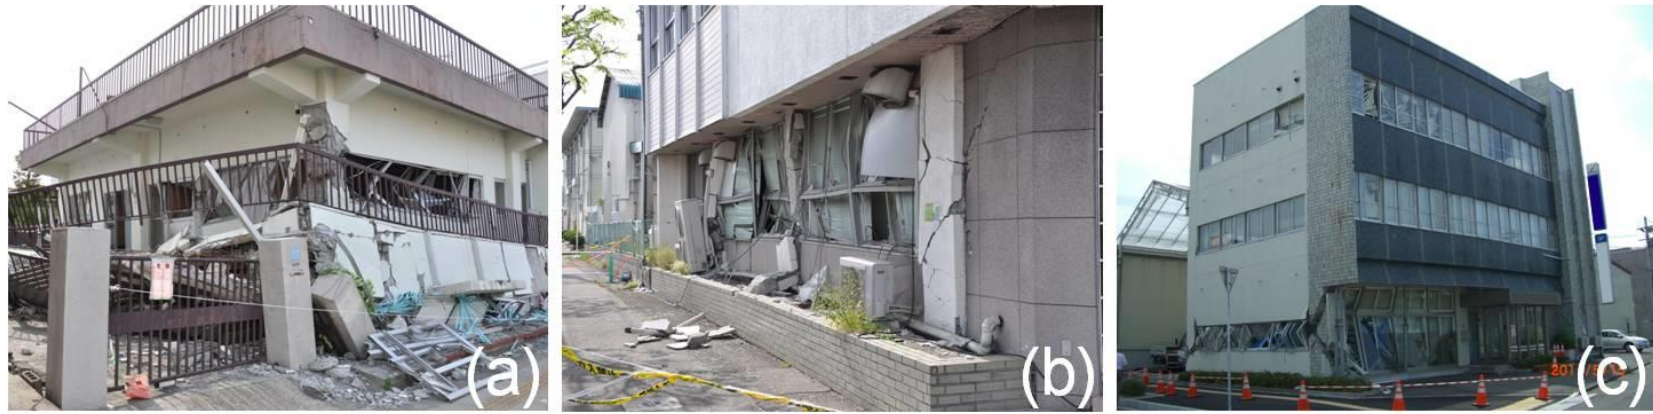
Fig. 5

Within Oroshimachi, one collapsed and three severely damaged RC buildings were noted. Some of these RC buildings are shown in Figure 5 and their locations are indicated in Figure 2 as RC-Buildings A to C. A second collapsed RC building in east Oroshimachi is reported to have been demolished by early May. Limited damage was observed in the large number of single-family residences, old and new, in the area. A large proportion of these residences were constructed with light-gauge steel, which is the material of choice for mass-production construction companies, or timber. Studies of past earthquakes (Sakai et al. 2002) suggest that collapse of Japanese residential structures is caused by strong motion in the 1 to 2 s range.

- Figure 3.** Ground motion records from Oroshimachi
- Figure 4.** Acceleration response spectra for DCRC No. 23
- Figure 5.** Severely damaged RC-Buildings: (a) A; (b) B; and (c) C.

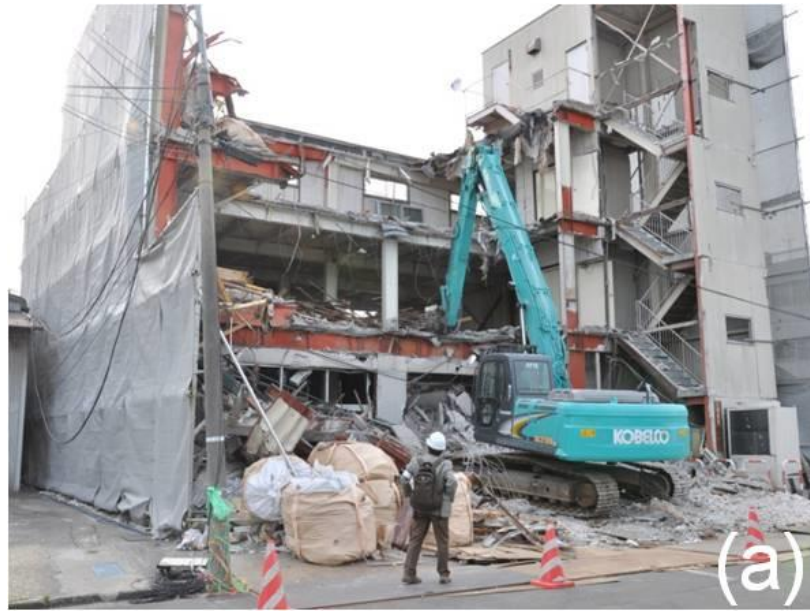
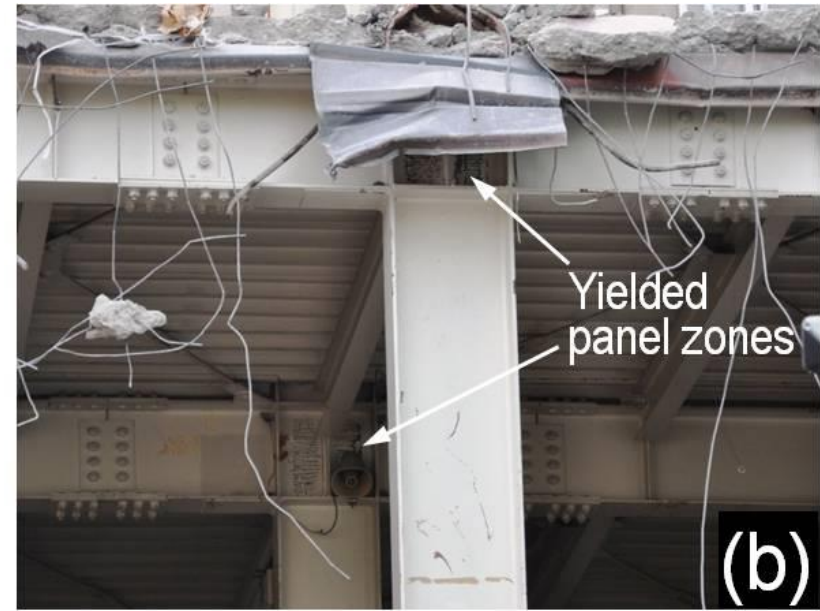
Fig. 6

In Oroshimachi, where one RC building collapsed and three more were severely damaged, there was no report of a severely damaged steel building. A small number of steel buildings were being demolished for unknown reasons in early May, prior to the joint reconnaissance visit. In the example shown in Figure 6, signs of structural damage were limited to mild panel zone yielding in W-shape columns. Many steel buildings were tagged “unsafe” by safety evaluation, but the reason was primarily nonstructural rather than structural damage. Figure 7 shows examples of steel buildings whose external claddings suffered severe damage. The exposed steel framing in these examples showed no sign of structural damage. Consequently, the authors believe that no substantial damage occurred to steel buildings in Oroshimachi.

- Figure 6.** (a) Steel building in Oroshimachi under demolition; and (b) sign of panel zone yielding.
- Figure 7.** Steel structures damaged in the exterior: (a) Warehouse A; and (b) S-Building A.

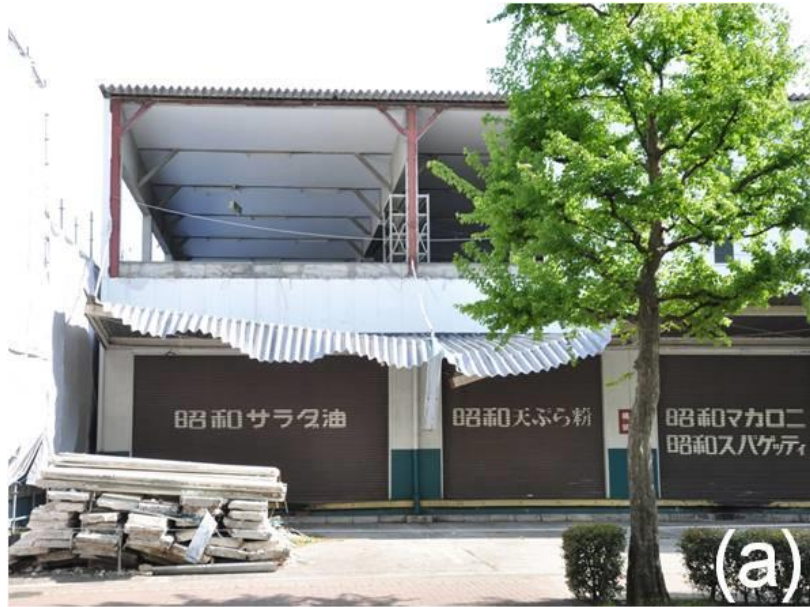
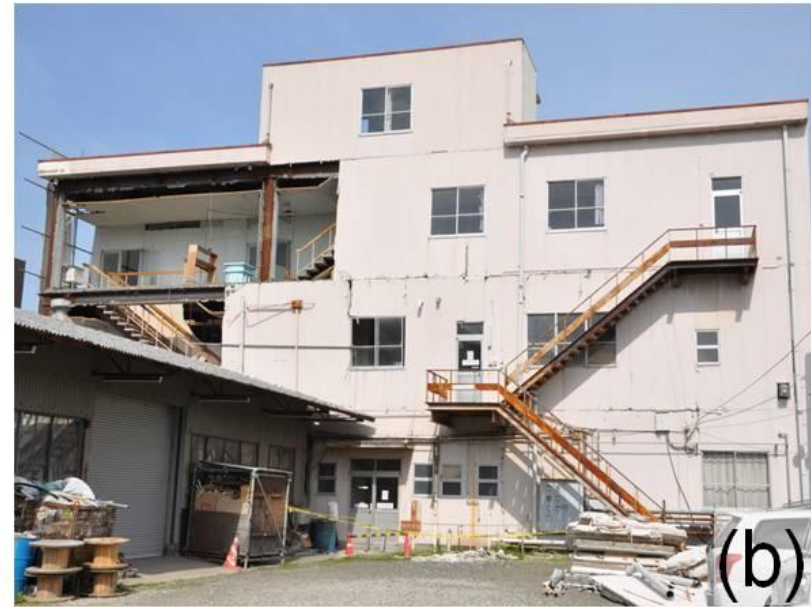
Fig. 7

Widespread damage to all types of external finishes was observed in Oroshimachi. Figure 15 shows damage to older structures where blocks of mortar fell over an extended area. Figure 7(a) shows a warehouse building where ALC panels fell from the second story. Figure 7(b) shows a three-story office building where ALC panels fell off a steel moment frame over one quarter of the perimeter, and where the remaining ALC panels show extensive damage along the panel boundaries. These are few examples of the widespread damage to ALC panels in office buildings, warehouses, and factory buildings. These buildings were two- to three-story high, and believed to be at least ten years old. Figure 16 illustrates the typical method of ALC panel installation that was used until ten years ago. This method, which rigidly connects the ALC panels to each other and to the structural frame, led to extensive damage to ALC panels during the 1995 Kobe earthquake. Over the last decade, an improved ALC panel installation method has been in use, which accommodates drifts up to 0.02 rad (Okazaki et al. 2007). All ALC panel damage observed by the investigation team, including those shown in Figure 7, used the older method shown in Figure 16. As noted earlier, despite the severe damage to ALC panels, few evidence of structural damage was found. A possible exception was the braced frame building shown in Figure 8. Therefore, the observed damage

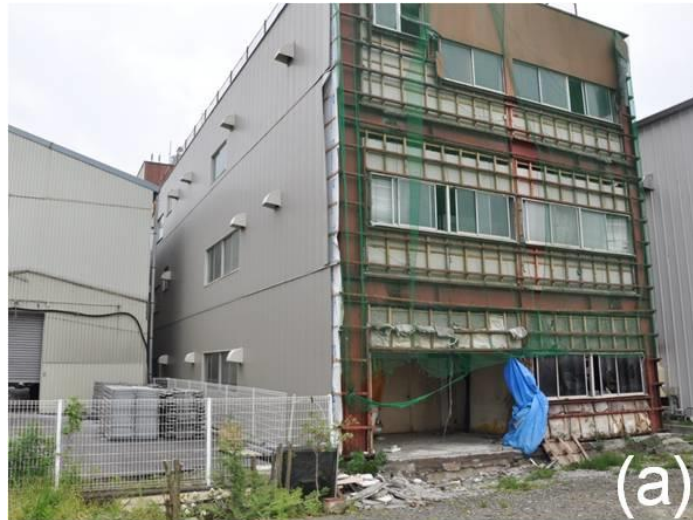
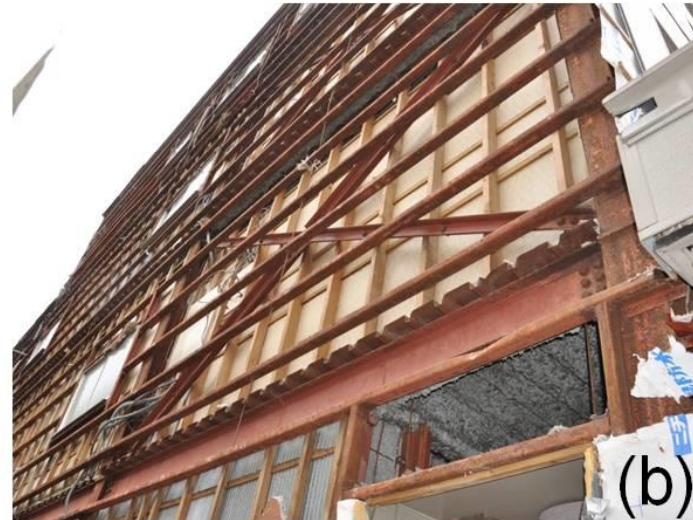
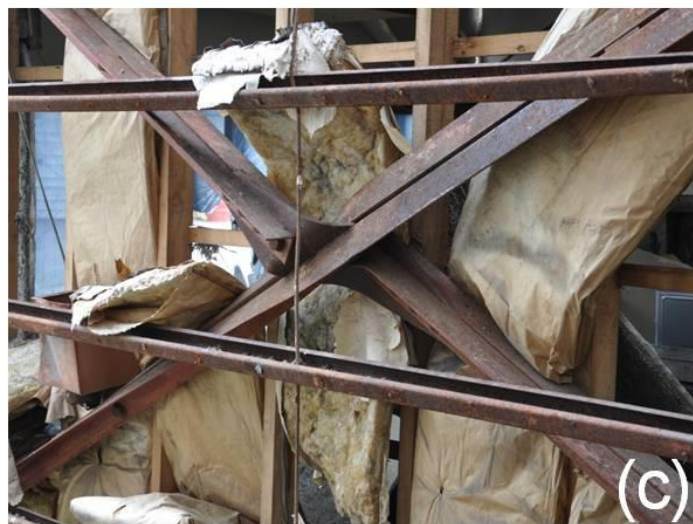
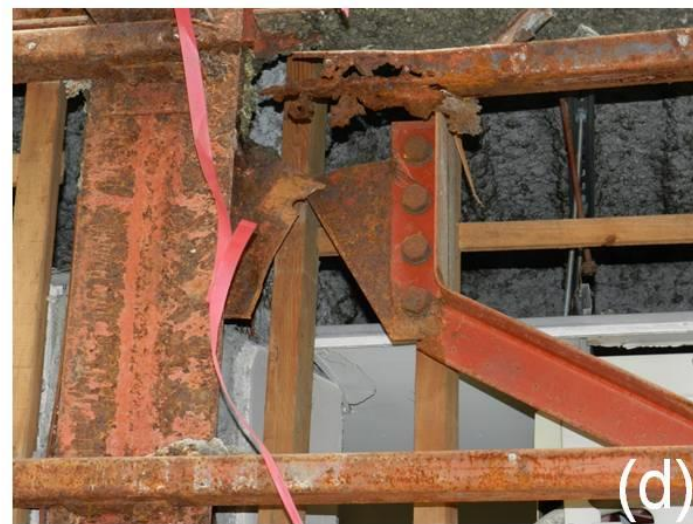
Fig. 8

Meanwhile, notable damage was observed in some CBF structures. Figure 8 shows a steel

office building with an 8-span CBF in the NS-direction and a single-span MRF in the EW-direction. The external wall finish was completely removed from the north and west sides (see Figures 8(a) and (b), respectively), while no damage was observed on the south and east walls. According to the owner, the west wall fell entirely and the north wall was severely cracked after the March 11 event. The north and west walls were made of lath and mortar, but the south and east walls had been replaced with steel siding boards after the original wall was damaged by the 2008 Iwate-Miyagi Nairiku Earthquake. Clear evidence of soil deformation was noted along the west end of the building. The NS-frame used small beams that were simply connected to the column web, and hence depended solely on the braces for lateral-load resistance. Figures 8(b) and (c) show X-braces comprising double-angle members. One brace ran continuously through the middle gusset plate, while the other brace comprised two separate double-angle segments bolted to the middle gusset plate and separated by 150 mm. Figure 8(c) shows large bending deformation of the middle gusset plate, which produced misalignment of the discontinuous brace and severe twisting of the continuous brace. Figure 8(d) shows fracture of an end gusset plate and at the reduced section of a continuous brace. There was no evidence that the braces had yielded in tension. It is suspected that the gusset plate fracture was a result of torsional deformation imposed on the gusset plate and eccentricity in the gusset plate geometry. The lack of consideration for post-elastic response suggests that this building was designed prior to 1981.

- Figure 8.** Damaged CBF structure (S-Building B): (a) North side exterior; (b) West side exterior; (c) bending of middle gusset plate in an X-brace; and (d) fractured gusset plate.

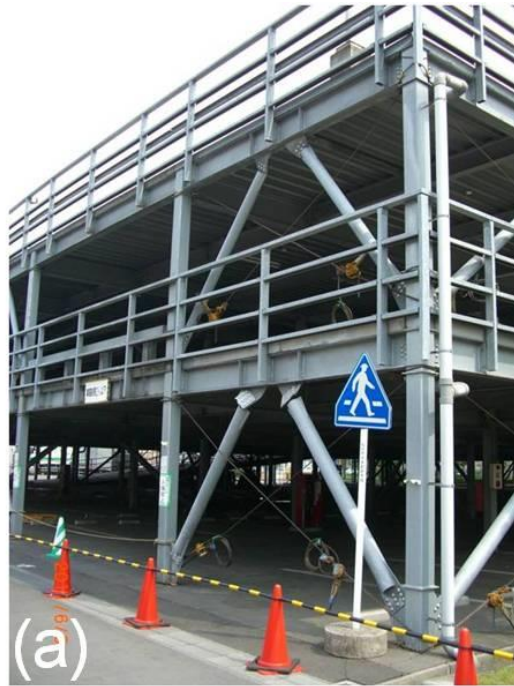
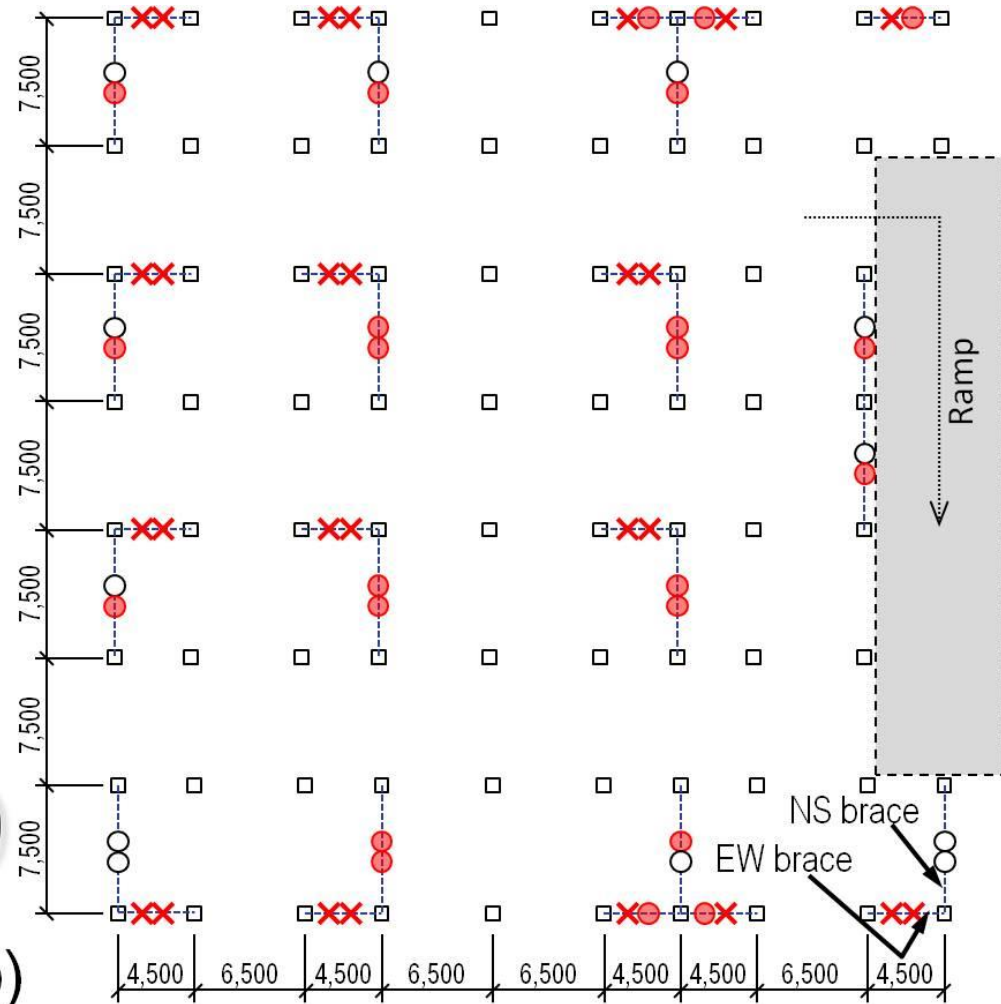
Fig. 9

Figure 9 shows a photo and the floor plan of a parking garage that experienced severe damage to its bracing connections. The garage is a two-story, chevron CBF with 7 spans in the NS-direction and 9 spans in the EW-direction. Because the beams were simply connected to the columns, this structure relied solely on the braces for lateral-load resistance. However, as shown in Figure 9(a), braces in both stories failed by fracture in the upper-end bracing connection. Figure 9(b) indicates the location of bracing connection failure in the first story of this parking garage.

Figure 9(b) indicates the location of gusset plate fracture in the parking garage. Out of the 32 braces in the EW direction, 27 fractured in the upper-end gusset plate and 5 were severely bent in the upper-end gusset plate. Out of the 30 braces in the NS direction, 18 were severely bent and 12 appeared undamaged. The directionality in damage was examined by a three-dimensional linear-elastic analysis. The parking garage was modeled with elastic beam elements for the beams and columns, truss elements for the braces, and rigid diaphragms to represent the reinforced concrete slabs. The gusset plates were modeled by rigid offsets. The fundamental vibration periods in the EW- and NS-directions were computed as 0.26 s and 0.21 s, respectively. Figure 4 suggests that the NS- and EW-components had very similar spectral acceleration amplitudes in the period range of 0.1 to 0.5 s but that the NS component is more prominent at longer periods. Torsional response was negligible.

- Figure 9.** Parking Garage A: (a) photo; and (b) floor plan with indication of gusset plate fracture location in the first story.
- Figure 10.** Damage to Parking Garage A: (a) permanent deformation in the beam due to brace force unbalance; (b) fractured gusset plates; (c) closer view of a fractured gusset plate; and (d) cracking of asphalt covering a column base.

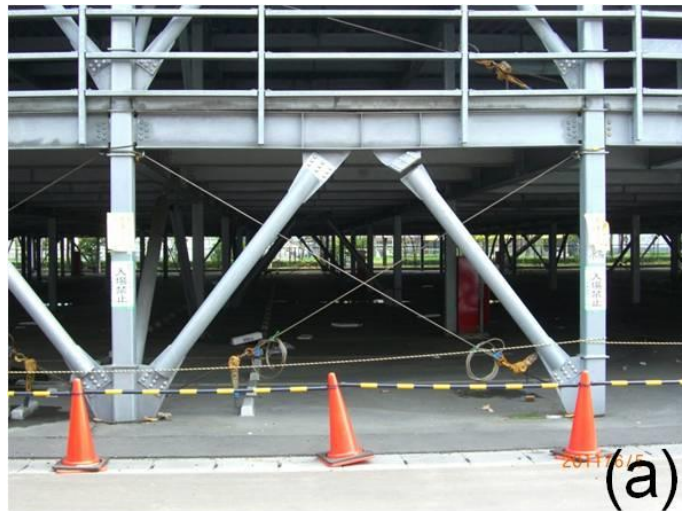
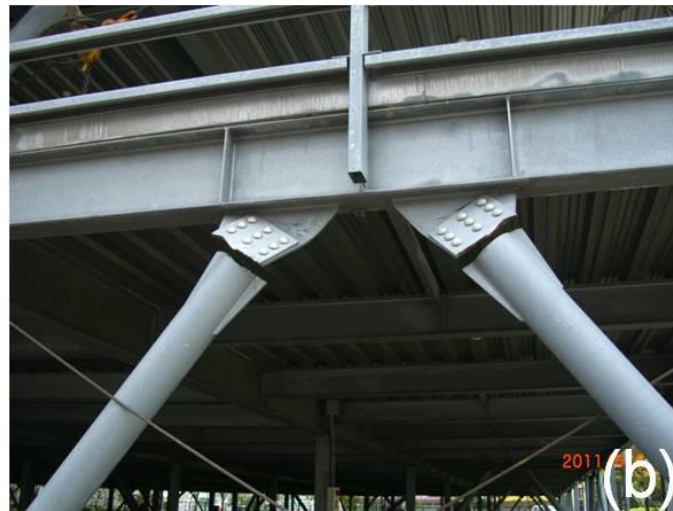
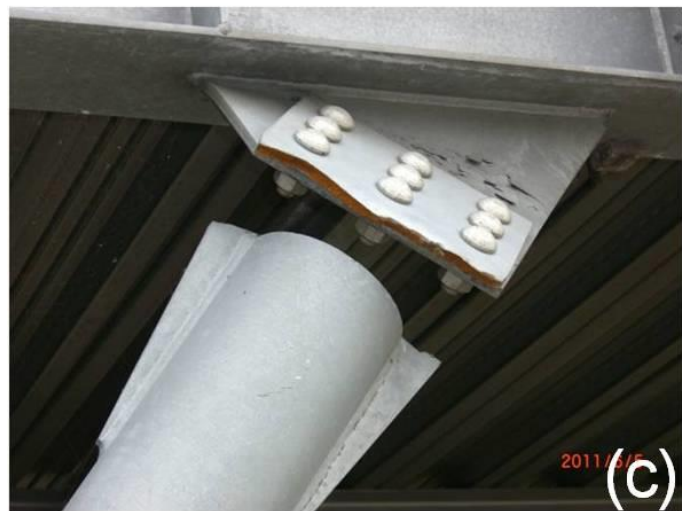
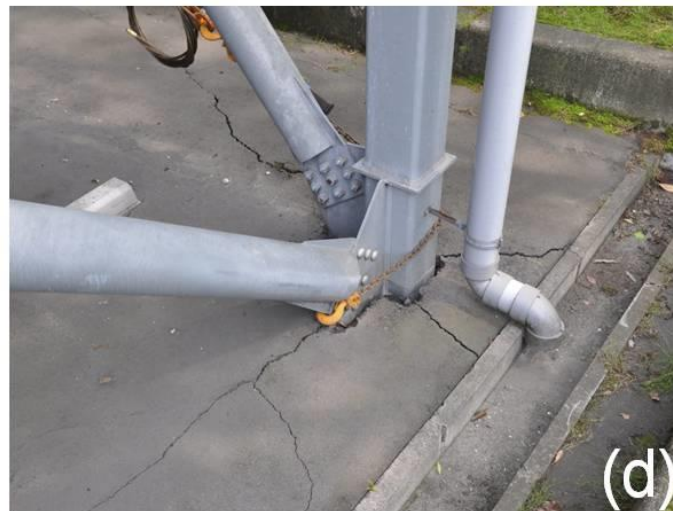
Fig. 10

The pattern of failure was common at all locations. Figure 10 shows some examples. Figure 10(a) shows a beam sagging in the middle after a plastic hinge formed due to force unbalance between the tension and compression braces. Figures 10(b) and (c) show a closer view of fractured gusset plates. The gusset plates on the upper end, which were unsupported along the edges, were clearly more flexible than the gusset plates on the lower end. The difference in out-of-plane flexibility must have caused the fracture to occur only on the

upper-end gusset plate. The common failure pattern indicated that the gusset plate fracture was caused by (i) out-of-plane eccentricity in the bolted connection; (ii) stress concentration between the tube-to-gusset weld and nearest bolt line, and (iii) lack of consideration for an out-of-plane fold line. It is suspected that bending deformation caused by eccentricity was confined in a very small segment of the gusset plate. The location of stress concentration coincided with the region of confined bending. This structure was not detailed for ductile behavior. Because the gusset plates (260×12 mm) had nearly the same cross-sectional area as the braces (Round HSS 165×6 mm), fracture in tension might not be predicted by design calculations.

Figure 10(d) shows a column base where two braces frame in from orthogonal framing directions. The extensive cracking in the asphalt indicate that substantial uplift force acted at this column base when the orthogonal braces simultaneously developed tension.

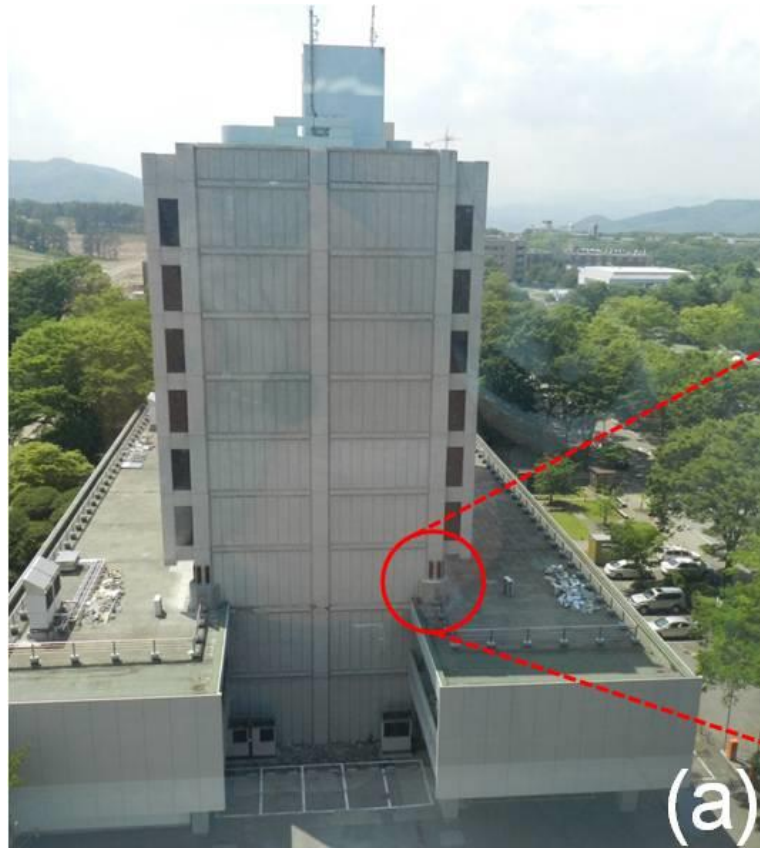
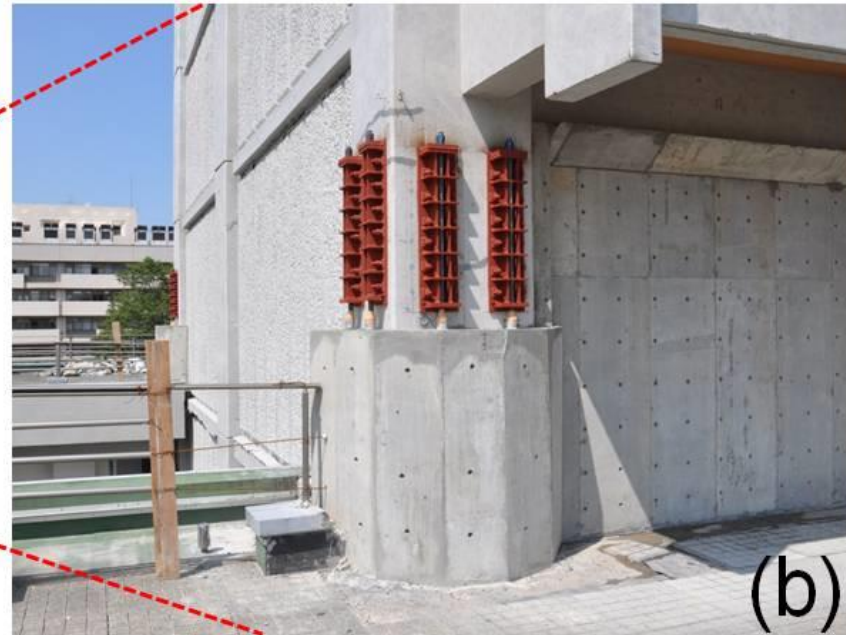
Fig. 12

SRC-Building A, shown in Figure 12, is an older SRC structure located in the Aobayama campus of Tohoku University (see Figure 1) and constructed in 1969. The structure is vertically irregular in mass, stiffness, and strength, since it consists of two podium levels and six tower stories above. This building was damaged by the 1978 Miyagi earthquake and had since been seismically strengthened in two phases (Motosaka et al. 2004). As reported by Motosaka (2012), all corner columns were severely damaged at the transition floor from the tower to the podium level. No evidence of damage was noted in the steel braces implemented in the third story for seismic upgrade. As shown in Figure 12(b), when the team visited the building, the damaged columns had been temporarily repaired with concrete encasement and dywidag bars to provide for safe access. This building is planned to be demolished. Motosaka (2012) noted that, at this site, the ground motion was amplified over the bedrock motion at a period of 1 sec, which happened to coincide with the vibration period of SRC-Building A.

- Figure 11.** Axial force history for (a) NS-brace; and (b) EW-brace.
- Figure 12.** SRC-Building A: (a) Overall view; and (b) repaired corner column.
- Figure 13.** SRC-Building B: (a) Overall view; and (b) cracking in nonstructural walls.

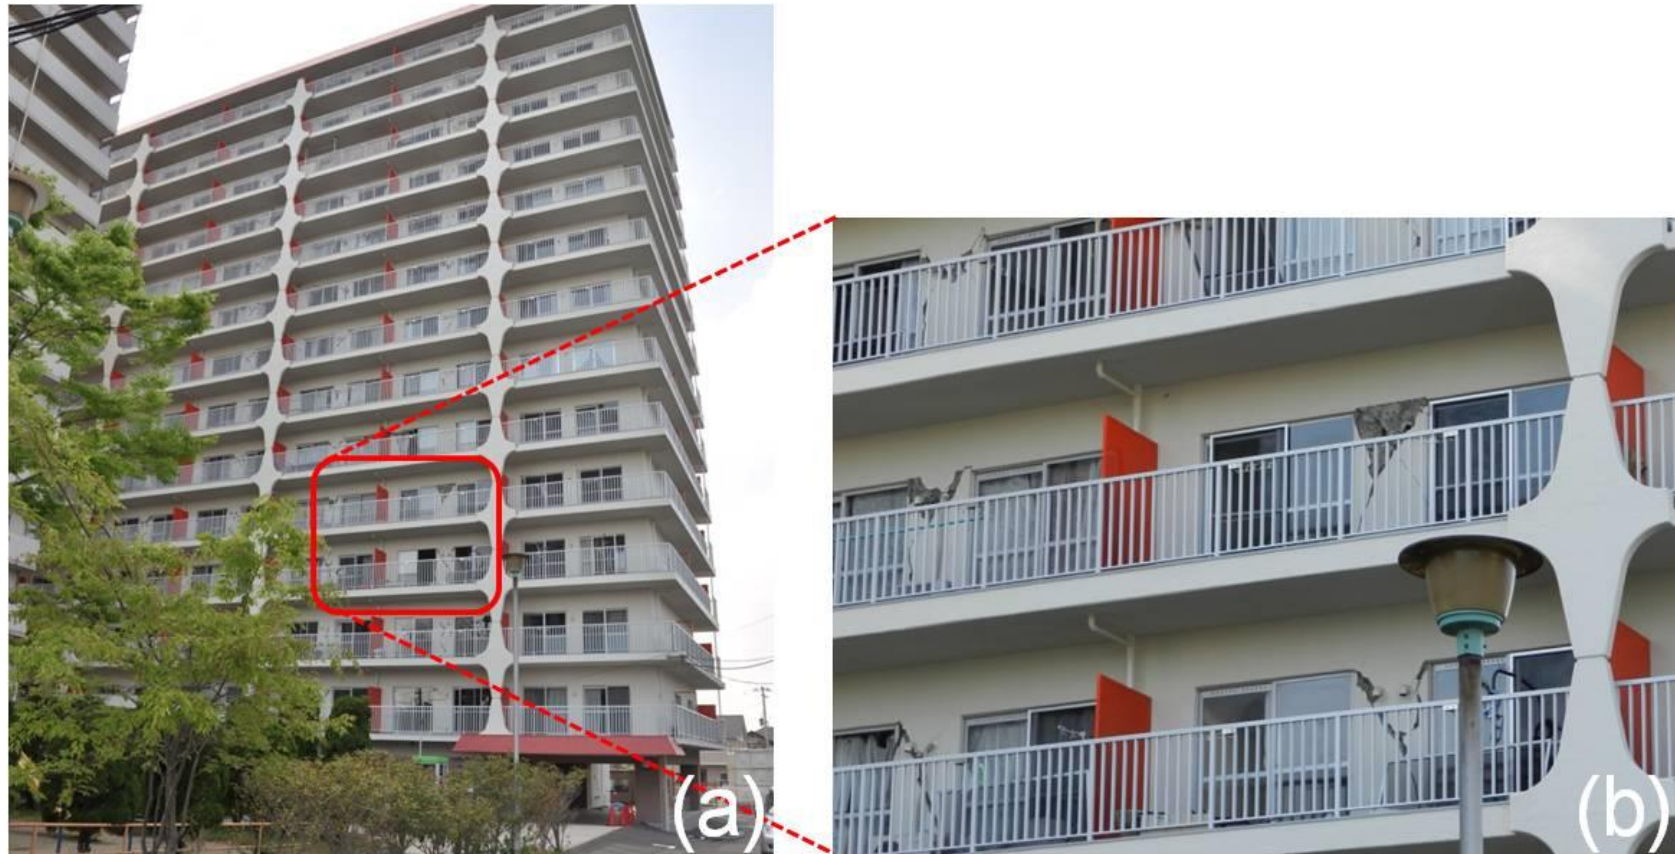
Fig. 13

SRC-Building B, shown in Figure 13, is a condominium building constructed in 1976 in a river delta (see Figure 1) and designed with a pile foundation. Motosaka (2012) measured the residual roof drift ratio of this building after the main event and April 7 aftershock to be 1/45, and attribute the cause to be damage in the piles resulting from soil liquefaction. In fact, evidence of liquefaction surrounding the building was clearly observed. While little damage was noted in the superstructure, cracking in the nonstructural walls, an example of which is shown in Figure 13(b), was widespread. This building experienced very similar damage from the 1978 Miyagi Earthquake. Since then, the building had been resided after the piles were repaired and nonstructural damage was repaired. By the time the team visited, the owners had decided to demolish the building.

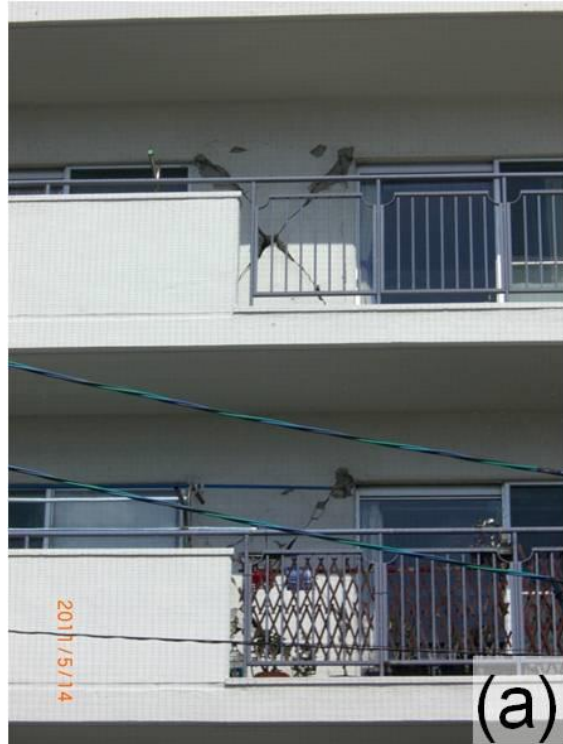
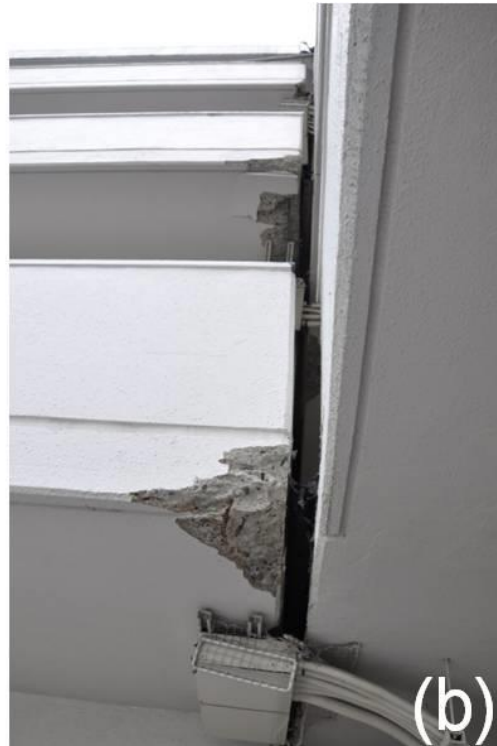
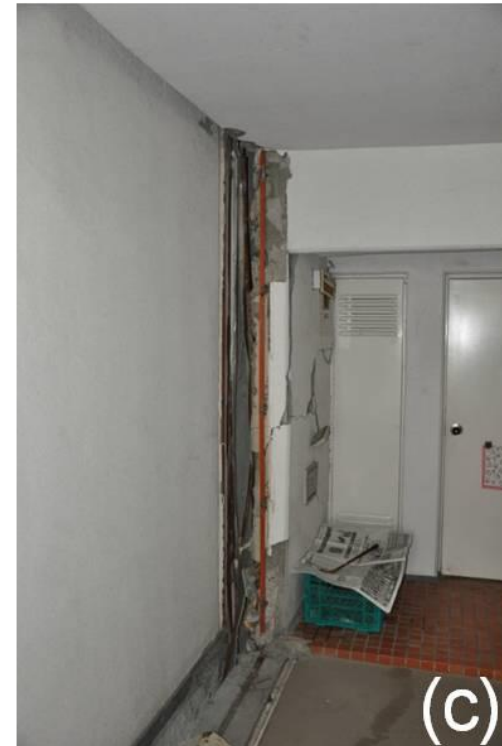
Fig. 14

SRC-Building C, shown in Figure 14, is a residence complex in Oroshimachi (see Figure 2) composed of three, 11-story SRC buildings. The cracks in nonstructural walls, such as those shown in Figure 14(a), were observed along the entire height of the three buildings. Figures 14(b) and (c) show one corner of the complex where a 10-cm gap was left between adjoining buildings. Spalling of concrete at this location suggested that the two buildings pounded against each other. Despite the cosmetic damage, the SRC buildings seemed to have suffered minimal structural damage. At the time of investigation, many residents had returned to occupy the building.

- Figure 14.** SRC-Building C: (a) Cracking in nonstructural wall; (b) cracking in hallway slab; and (c) hallway framed by two buildings.

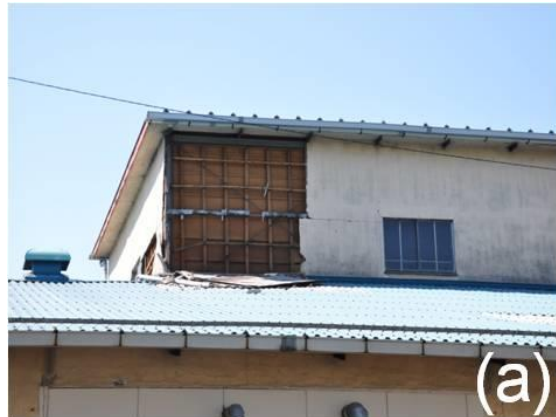
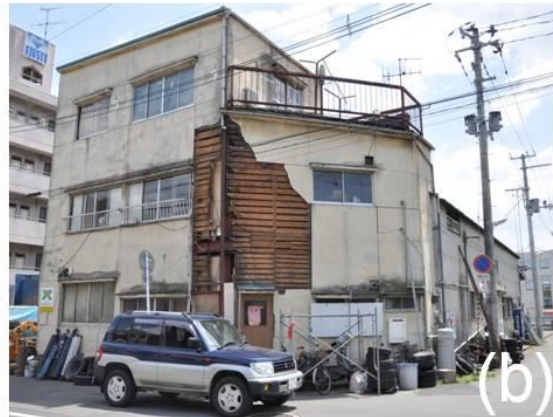
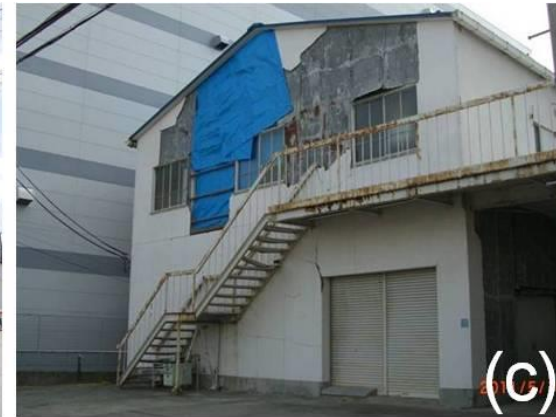
Fig. 15

Figure 15. External damage: (a) penthouse of a single-story factory; (b) two-story residence; and (c) factory with lath-and-mortar over corrugated metal cladding.

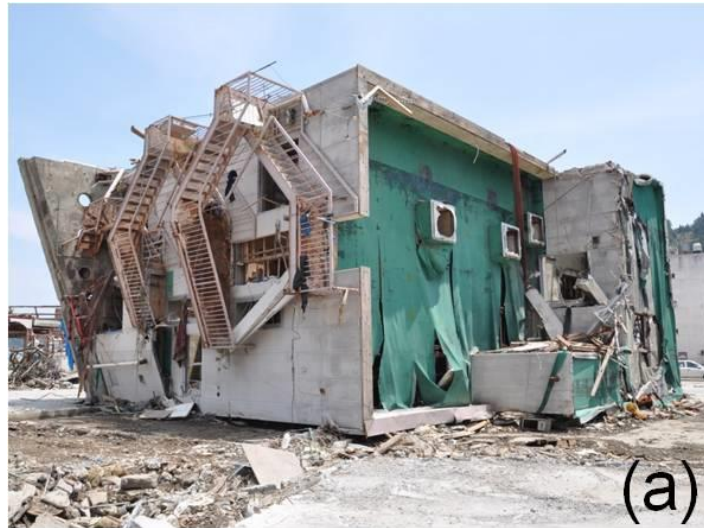
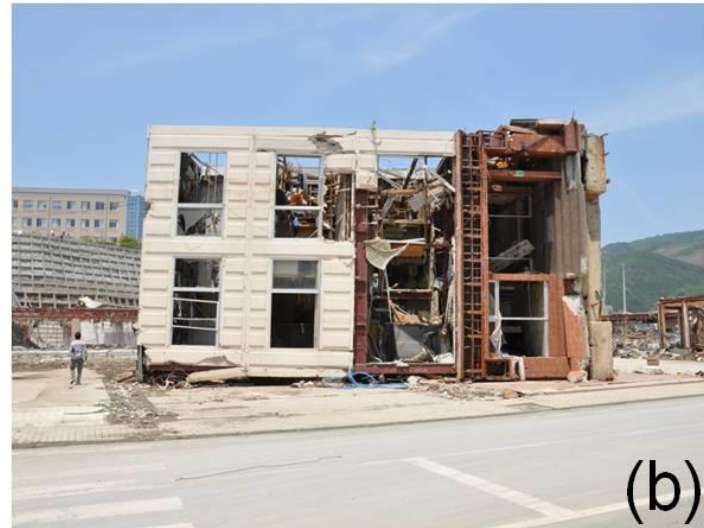
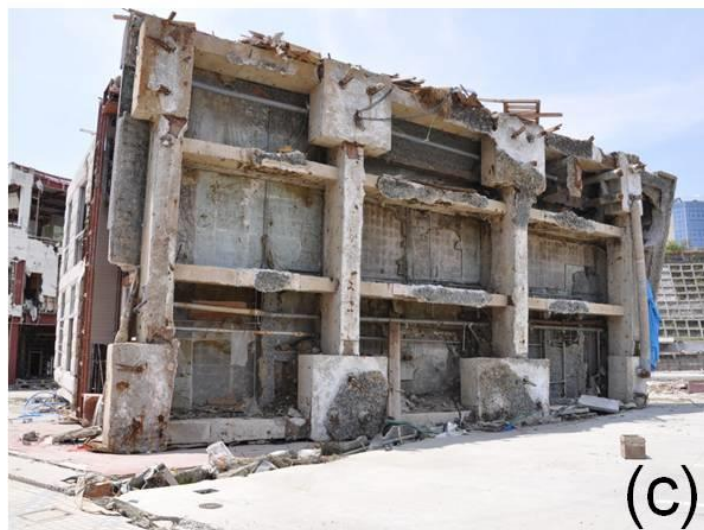
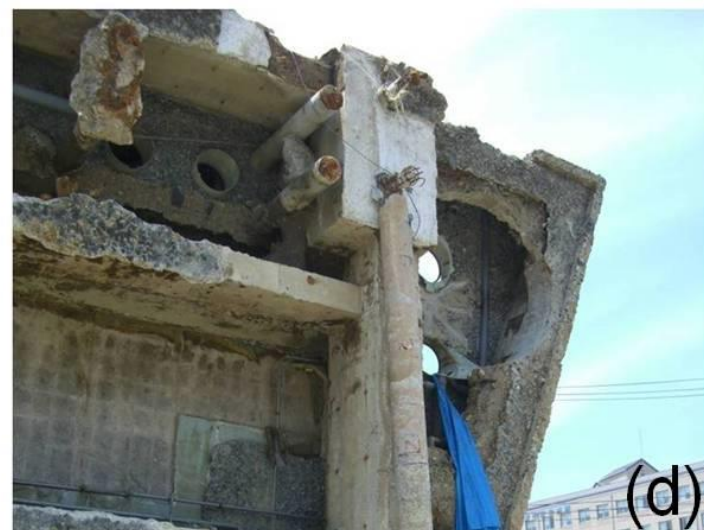
Fig. 19

Figure 19 shows a three-story office building that stood in the middle of downtown Onagawa and 100 m from the shore. This building had traveled 15 m inland from its original location, and lied overturned. Figure 19(a) shows the roof on the right end and the footing on the left end. Minimal structural damage was observed in the 1-bay by 3-bay, steel MRF superstructure partly visible in Figure 19(b). Figure 19(c) shows the foundation, viewing the building from the shore side. The footing foundation suffered minimal damage. However, as Figure 19(d) shows, some of the piles were pulled out with damage concentrated at the connection to the cap. This building had the external ALC panels intact. Therefore, unlike other steel buildings in this area, substantial buoyancy force must have acted when this building submerged in tsunami to the roof (BRI 2011; 2012). The authors suspect that the piles, damaged by ground motion and soil liquefaction, and further loosened by scouring, were pulled out by the tension produced by overturning moment and buoyancy.

Figure 19. Overturned steel building (1 by 3-bay, 3-story MRF/MRF) in Onagawa: (a) side view; (b) side view of opposite side; (c) exposed foundation; and (d) a pulled out foundation pile.

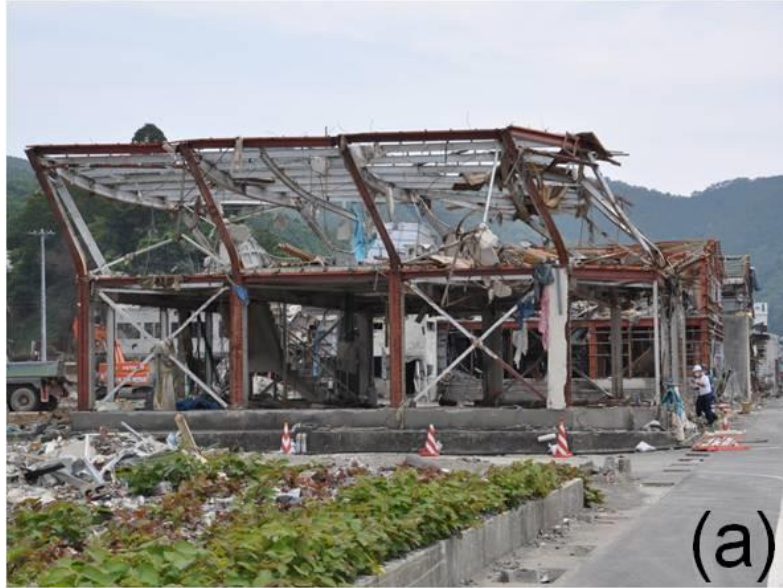
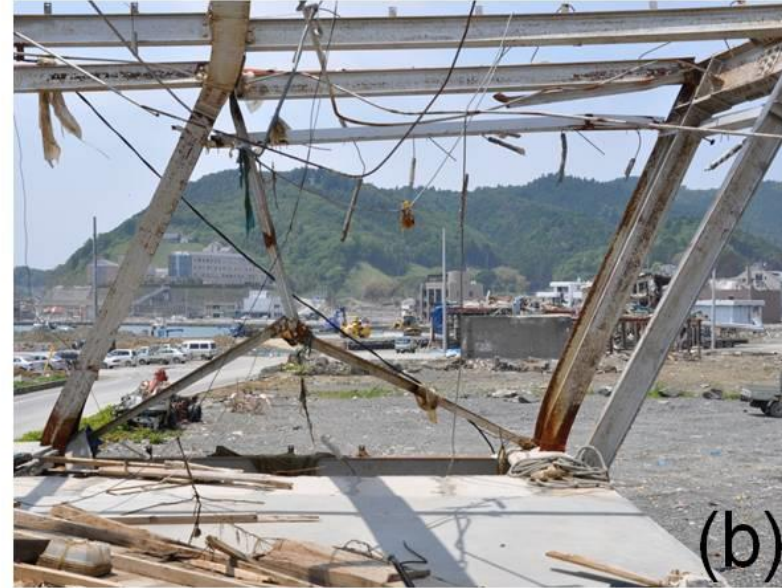
Fig. 20

Figure 20 shows a two-story steel structure, located 100 m from the shoreline, and which entirely lost its exterior and interior finishes. The 1-bay by 3-bay structure employs X-braces in two of the three bays perpendicular to the shoreline, and an MRF in the other direction. A second-story collapse mechanism formed in the direction perpendicular to the shoreline, presumably after all X-braces in the second story failed. Based on this failure mechanism, Hayashi and Tamura (2012) estimated that the tsunami force applied to the shore side façade of this structure to be 24 kN/m^2 or greater.

Figure 20. Deformed steel building (1 by 3-bay, 2-story, MRF/CBF) in Onagawa: (a) side view showing the story drift of the second story; and (b) fractured X-brace and plastic hinging at the base of the 2-story W-columns.

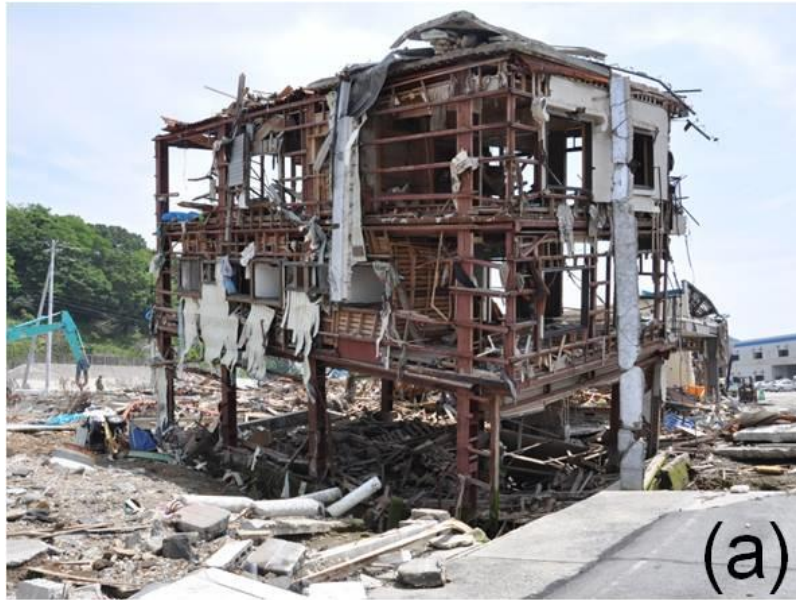
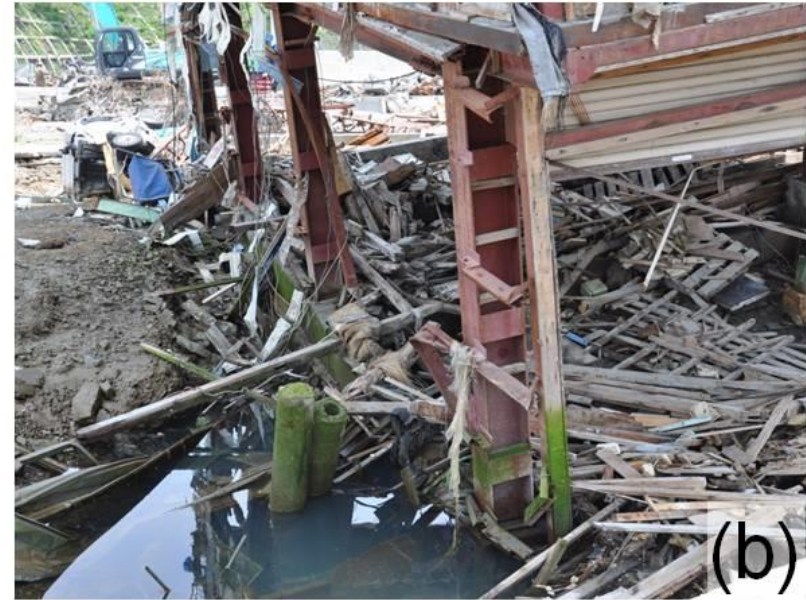
Fig. 21

Figure 21 shows a small three-story building that stood inclined due to foundation

settlement. Figure 21(a) shows the extreme inclination. The external and internal finishes and the roof were completely washed away. As shown in Figure 21(b), one corner of the building sunk into a pocket in the ground that was presumably produced by scouring.

Figure 21. Steel building (1 by 3-bay, 3-story, MRF/CBF) with foundation damage caused by scouring: (a) view of extreme inclination; and (b) scoured foundation.

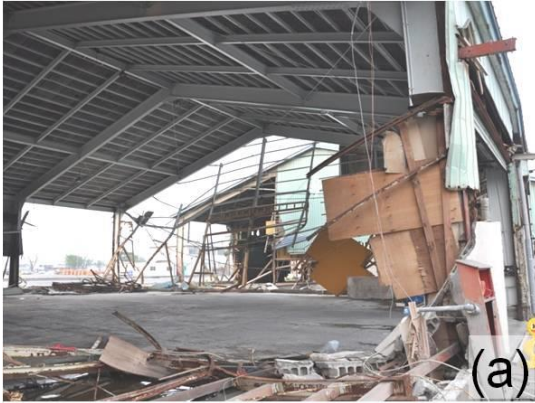
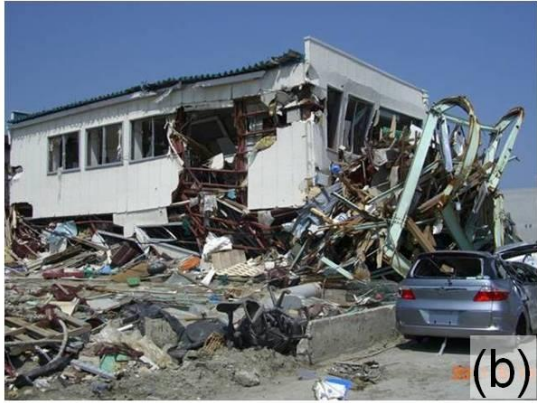
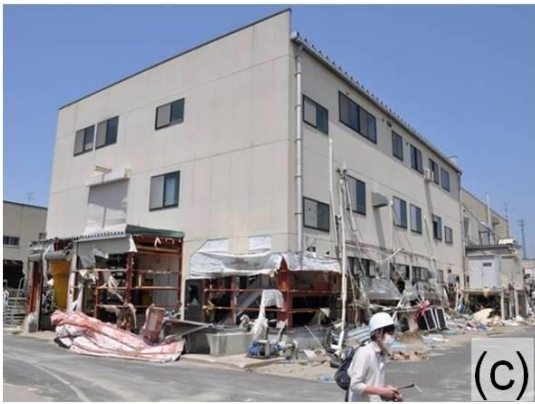
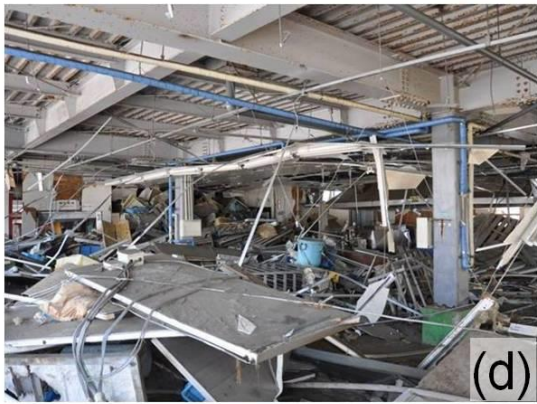
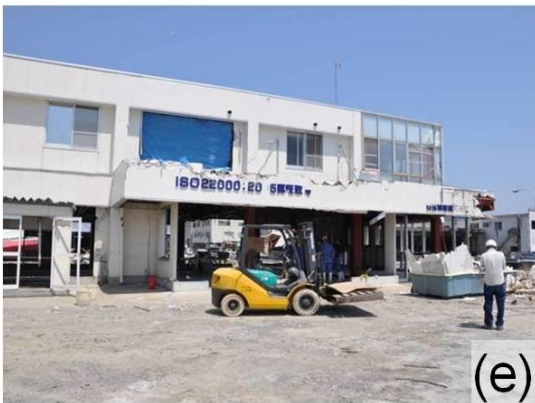
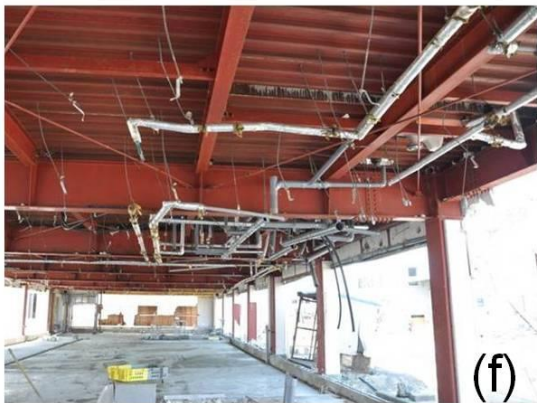
Fig. 22

Although the reported peak tsunami height of 5 m may appear unimpressive compared to the 15 m in Onagawa, the damage at Ishinomaki was substantial. Ishinomaki lost more lives than any other location. Examples of damaged steel buildings near the main port and fishing port are shown in Figure 22. Figure 22(a) shows a port facility adjacent to the shoreline with structural and nonstructural damage. Figure 22(b) shows one of many collapsed buildings in the fishing port. Meanwhile, Figure 22(c) shows a three-story office building with substantial nonstructural damage in the first story, but minimal structural damage. Figure 22(d) is an interior view of the first story, which was filled with debris, but which showed no indication of structural damage. Figure 22(e) shows another example of a structure with substantial nonstructural damage in the first story but minimal structural damage. Figure 22(f) shows the first story of the same factory building, where the external and internal finish was lost but no sign of structural damage was observed.

Figure 22. Damaged steel buildings in Ishinomaki: (a) port facility (two identical structures, 7 by 1-bay, single-story, MRF/Gable frame); (b) collapsed building (2-story, further details unknown); (c) office building (3 by 2-bay, 3-story, MRF/MRF) with nonstructural damage in the first story; (d) inside the office building; (e) factory (8 by 1-bay, 2-story, MRF/MRF); and (f) inside the factory. The port facility in (a) is located in the main port, while the three buildings in (b) through (f) are located in the fishing port.

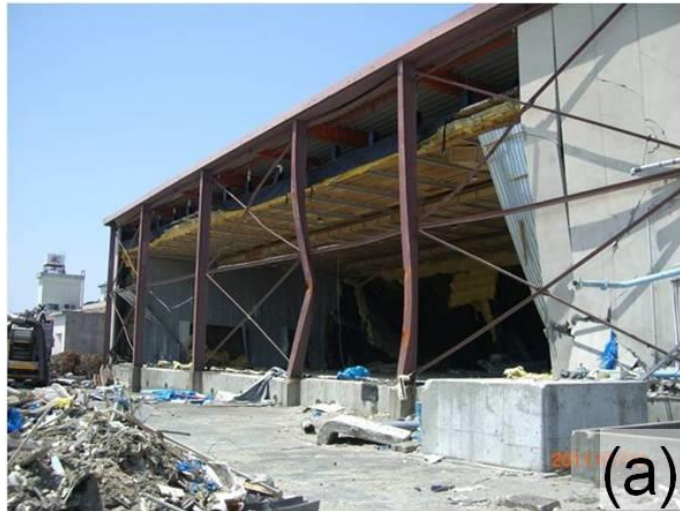
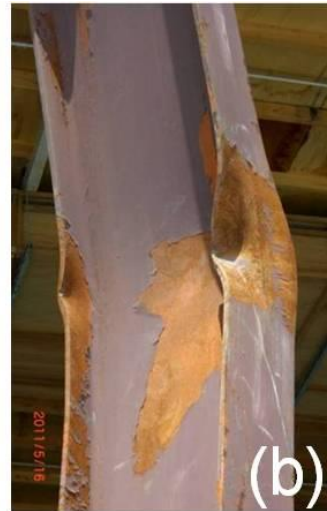
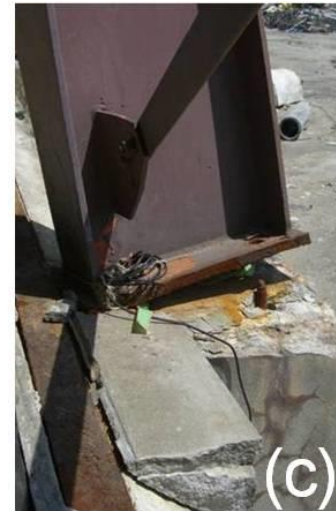
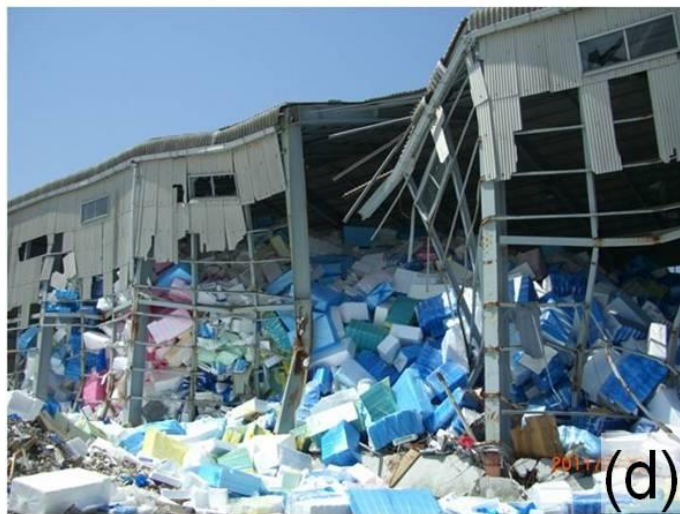
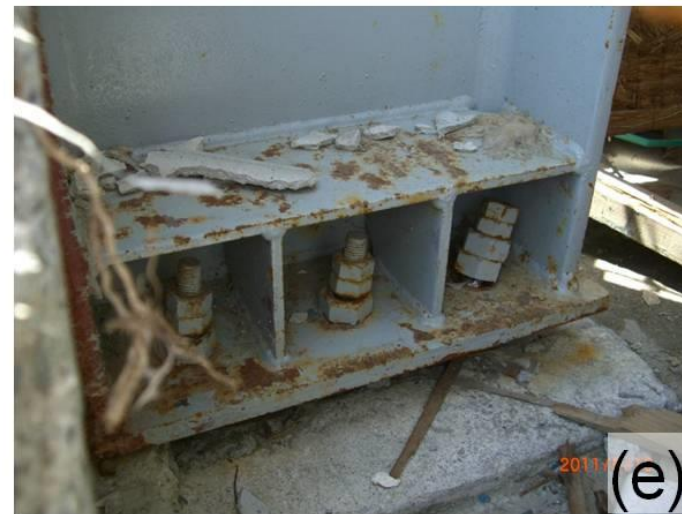
Fig. 23

Evidence of debris impact was noted in some structures including the two large facilities shown in Figure 23. Both facilities are located in the fishing port of Ishinomaki, within 200 m from the shoreline. Figure 23(a) shows a refrigeration facility that lost its exterior finish on the side facing the shore. The fourth column from the left end is kinked in the middle and twisted. Figure 23(b) shows a close-up view of the kink, while Figure 23(c) shows the base of this column. The localized flange deformation in the kink and fracture of all four anchor bolts at the base indicates that the damage is the consequence of a large concentrated force. Figure 23(d) shows another facility that stored Styrofoam for fish packaging. Aerial photos taken within days from the earthquake show large debris piled up on the shore side of each of these two facilities. Therefore, the localized damage shown in Figure 23 was likely caused by the impact of adjacent structures.

bay, single-story, CBF/CBF); (b) close-up view of the kink in the fourth column; (c) anchor bolt fracture in base of the impacted column; (d) front view of storage facility (6 by 1-bay, single-story, CBF/CBF); and (e) anchor bolt elongation at the base of the impacted column.
