Damage to Steel Buildings Observed After the 2011 Tohoku Earthquake

Taichiro Okazaki,^{a)} Dimitrios G. Lignos,^{b)} M.EERI, Mitsumasa Midorikawa,^{c)} M.EERI, James M. Ricles,^{d)} M.EERI, and Jay Love,^{e)} M.EERI

A joint U.S.-Japan reconnaissance team examined the damage to steel building structures caused by the 2011 off the Pacific Coast of Tohoku Earthquake. In the city of Sendai, where the peak horizontal ground acceleration exceeded 1 g, the majority of steel buildings performed well. Buildings that used older cladding systems for external finish sustained damage to their claddings even if their structural performance was excellent. Damage to a few braced frames offer insight into the seismic design of bracing connections. In areas attacked by violent tsunami, many steel buildings stood upright after the tsunami subsided, although these buildings lost much of their external and internal finishes along with their contents. These steel buildings did not provide safe shelter for tsunami evacuation when the building submerged under the tsunami wave. A number of buildings suffered foundation failure, which was likely caused by scouring or liquefaction or the combination of mul

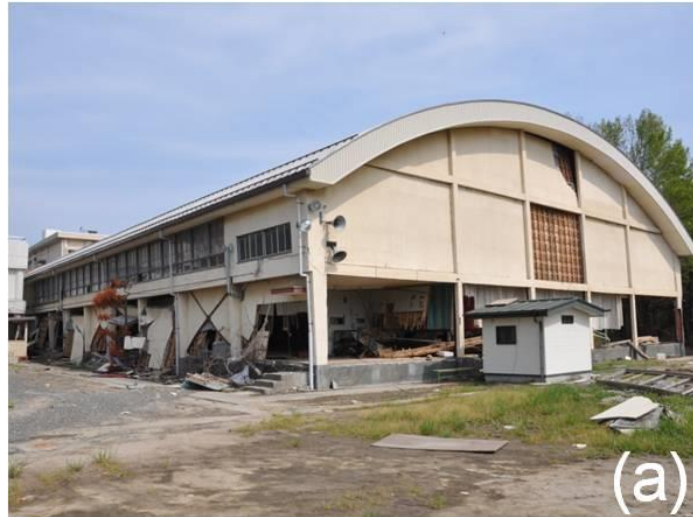
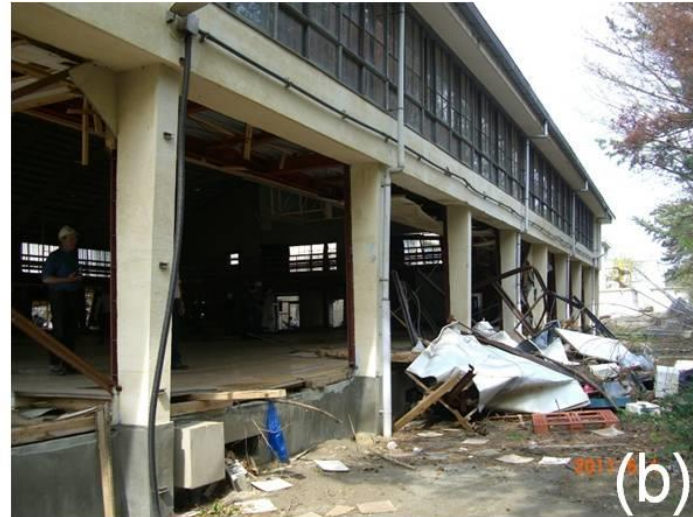
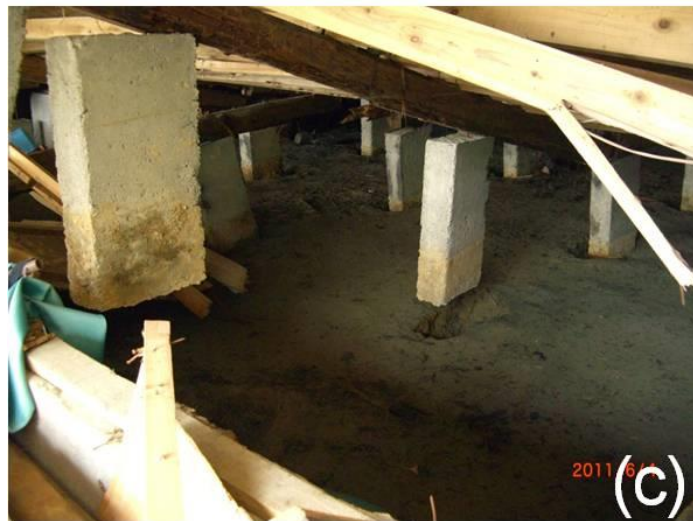
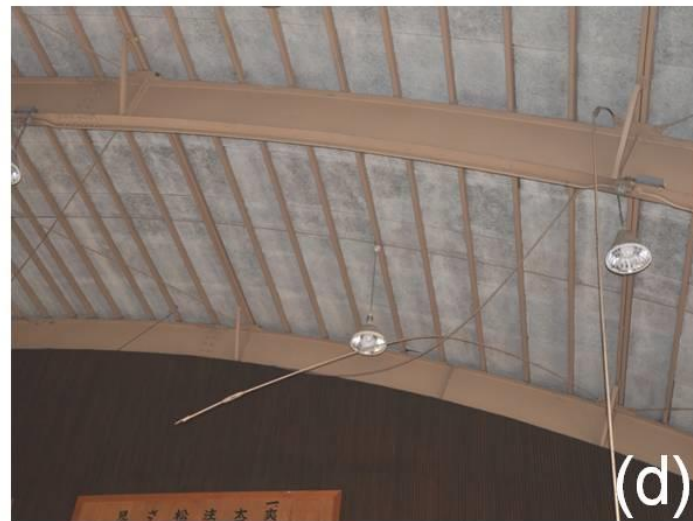
Fig. 24

Figure 24 shows a two story school gymnasium near the fishing port and 250 m from the shoreline. The building was separated from the shore by a pine tree forest that remained after the tsunami subsided. As in typical elementary to high school gymnasiums, this gymnasium was constructed as a Gable moment frame in one direction and a braced frame in the other

direction. The exterior wall was lost at the first floor, and the floor was damaged (see Figure 24(b)). Figure 24(c) shows the bottom side of the damaged floor where the deformed floor panels lifted the stone footings off the soil. While minimal damage was observed in the vertical frame, as shown in Figure 24(d), many of the roof bracing had failed by fracture of the bolts connecting the turn-buckle braces to gusset plates. Because it is unlikely that tsunami could produce substantial forces in the roof, and because this is a typical damage observed in school gymnasiums after earthquakes, the authors suspect that the brace failure was caused by ground motion rather than tsunami.

Figure 24. School gymnasium (9 by 1-bay, single-story, CBF/Gable frame) near Ishinomaki fishing port: (a) view from North-West; (b) South side facing the shore (c) stone footing no longer supporting the floor; and (d) fractured turn-buckle roof braces.

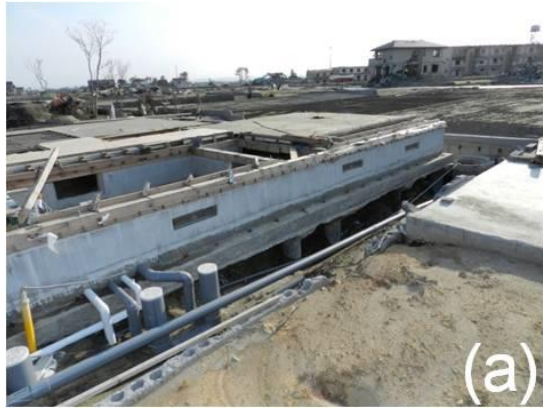
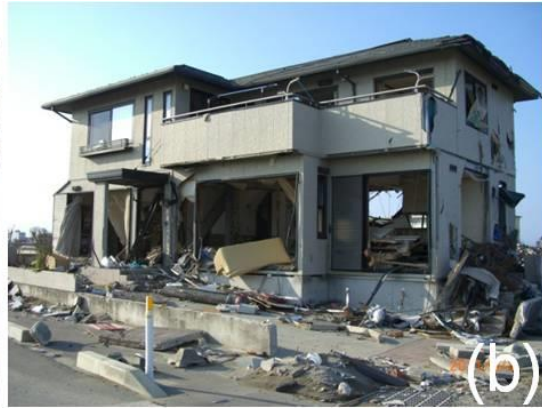
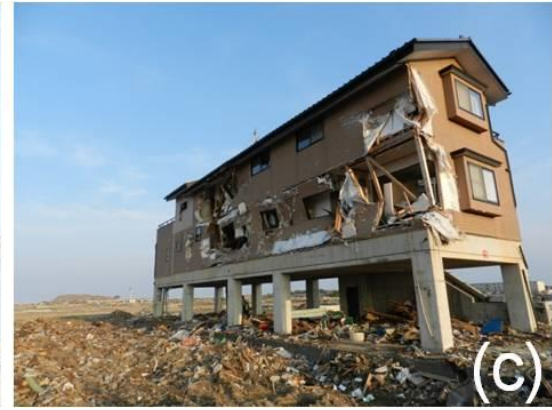
Fig. 25

The Yuriage District of Natori is a residential area near Sendai that was completely destroyed by the tsunami. The area was densely populated with timber and light-gauge steel residences, low-rise RC apartments, schools, and a small number of factories and office buildings constructed with steel. Figure 25 shows the remains of residences. Figure 25(a) shows the concrete foundation of a residence and evidence of scouring surrounding the foundation. Figure 25(b) is an example of a light-gauge steel residence that stood upright but suffered extensive damage to its exterior and contents. Figure 25(c) shows a three-story residence constructed with RC in the first story and timber in the upper stories. This example suggests that the elevation added by the RC portion helped the structure survive the tsunami.

Figure 25. Damage to residences in Natori: (a) foundation of a timber residence; (b) light-gauge steel residence; (c) timber residence over first story with RC.

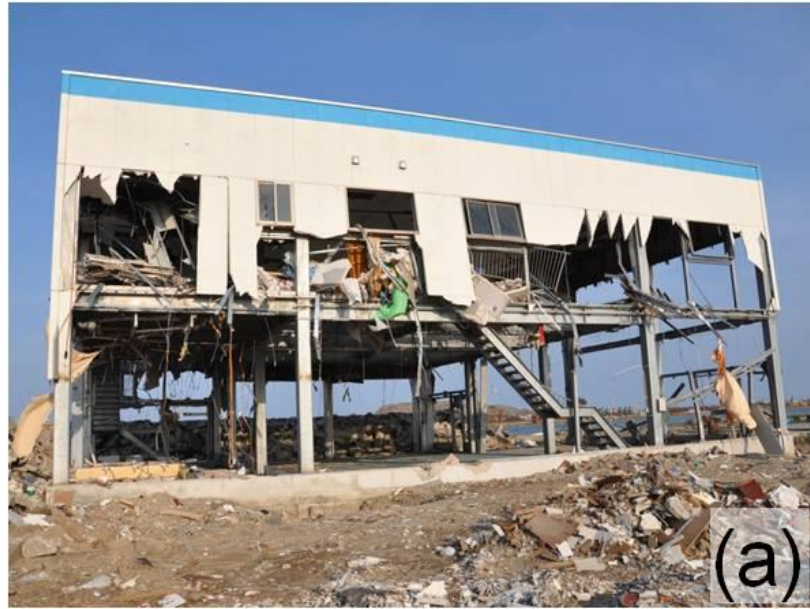
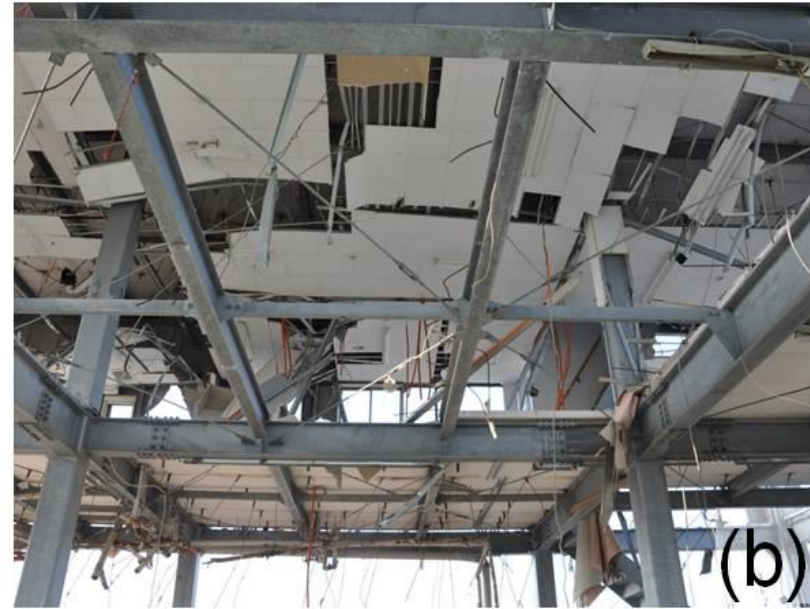
Fig. 26

Figure 26 shows a university boat club facility located within 50 m from the shore. The structure is a 3 by 3-bay, two-story MRF with galvanized steel members. Although no structural damage was noted, the structure was inclined by 0.01 rad. The exterior and interior claddings were ruined up to the second floor, and the ALC floor panels were severely damaged.

Figure 26. Boat Club (3 by 3-bay, 2-story, MRF/MRF) in Natori: (a) exterior view; and (b) damaged floor and ceiling.

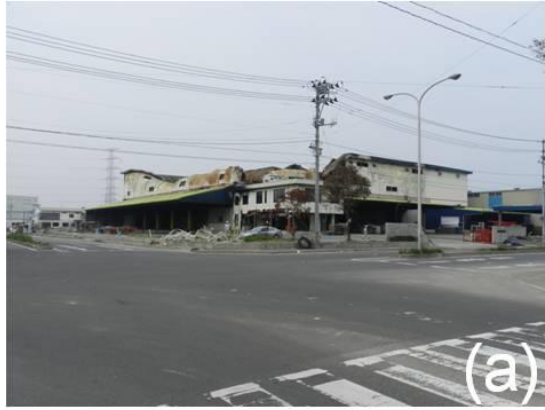
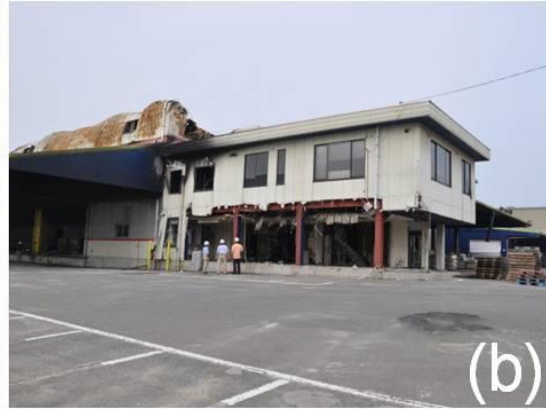
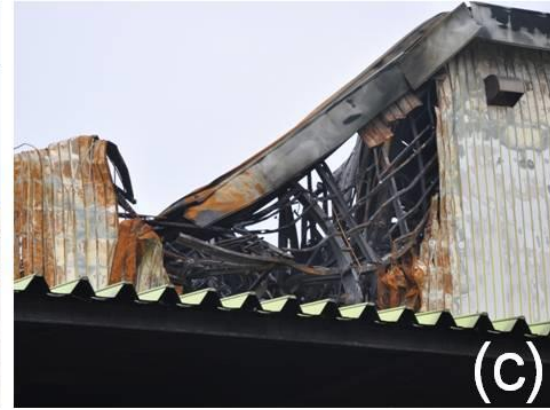
Fig. 27

Figure 27 shows a distribution center located one block away from the shoreline of Sendai Port. This is one of many facilities in the port that were destroyed by tsunami. The damage to external cladding in the office building shown in Figure 27(b) indicates that the first story level was washed by tsunami. A report by BRI (2011) concludes that a vehicle carried by tsunami hit the freight dock and caught fire, and independently, another fire started from within the large-bay area. Figure 27(c) shows a close-up view of the burned roof.

Figure 27. Distribution center and office in Sendai Port: (a) View of entire facility; (b) office portion; and (c) burned roof.
