Strong-Motion Characteristics and Visual Damage Assessment Around Seismic Stations in Kathmandu after the 2015 Gorkha, Nepal, Earthquake

Subeg Bijukchhen,^{a)} Nobuo Takai,^{a)} M.EERI, Michiko Shigefuji,^{b)} Masayoshi Ichiyanagi,^{c)} and Tsutomu Sasatani^{a)}

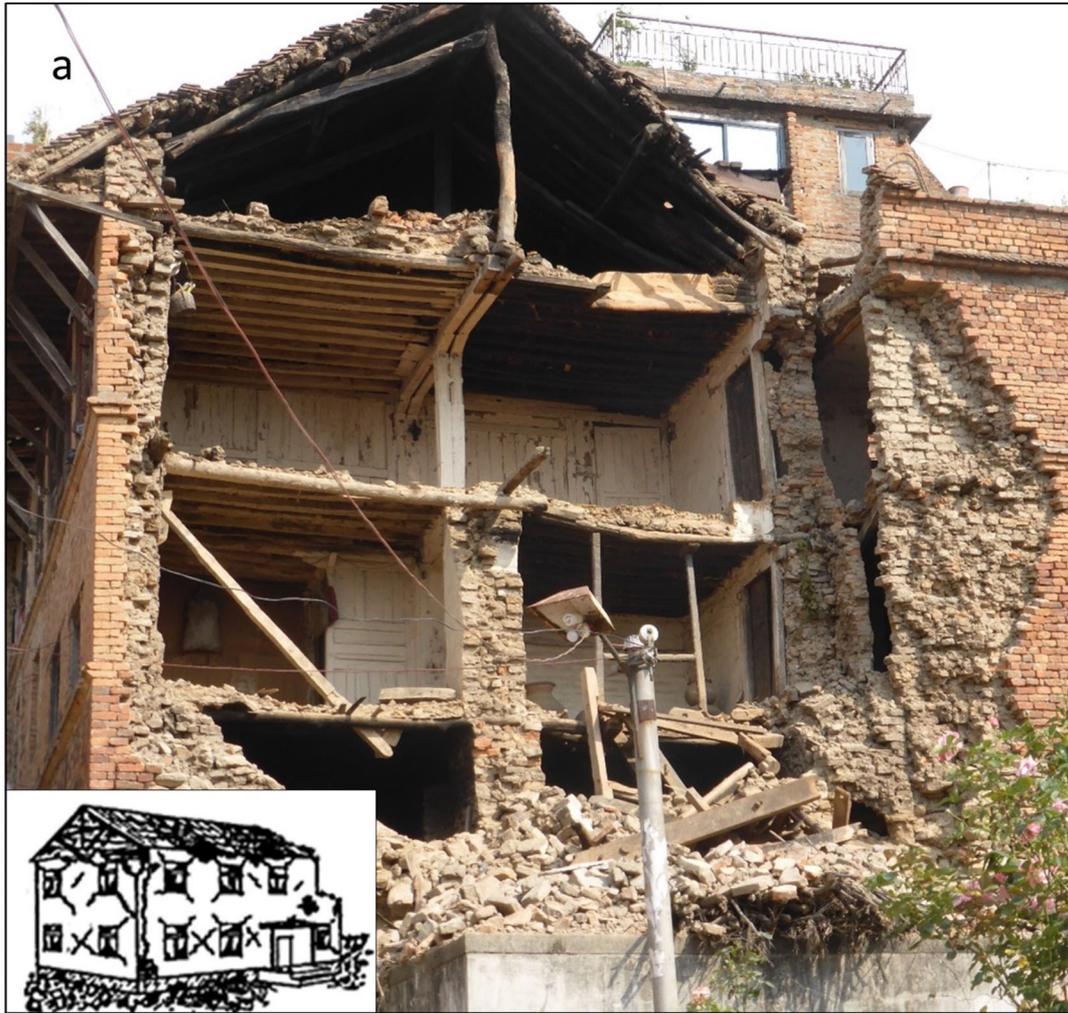
Though all RC infill frame buildings remained unscathed, one masonry mud-mortar building was heavily damaged. The three-story building built on a steep topography suffered

the collapse of the façade facing the slope (Figure 4a). Apart from this, instances of cracks in the inner walls (Figures 4b) were observed in few masonry buildings. We also found fallen roof tiles from some of these houses nevertheless, only less than 6% of total buildings suffered moderate to heavy damage during the earthquake.

Figure 4. (a) Heavily Damaged building with a façade collapse and, (b) cracks in wall inside of a Slightly Damaged building around KTP. The inset shows the diagram of corresponding damage grade (EMS 98).

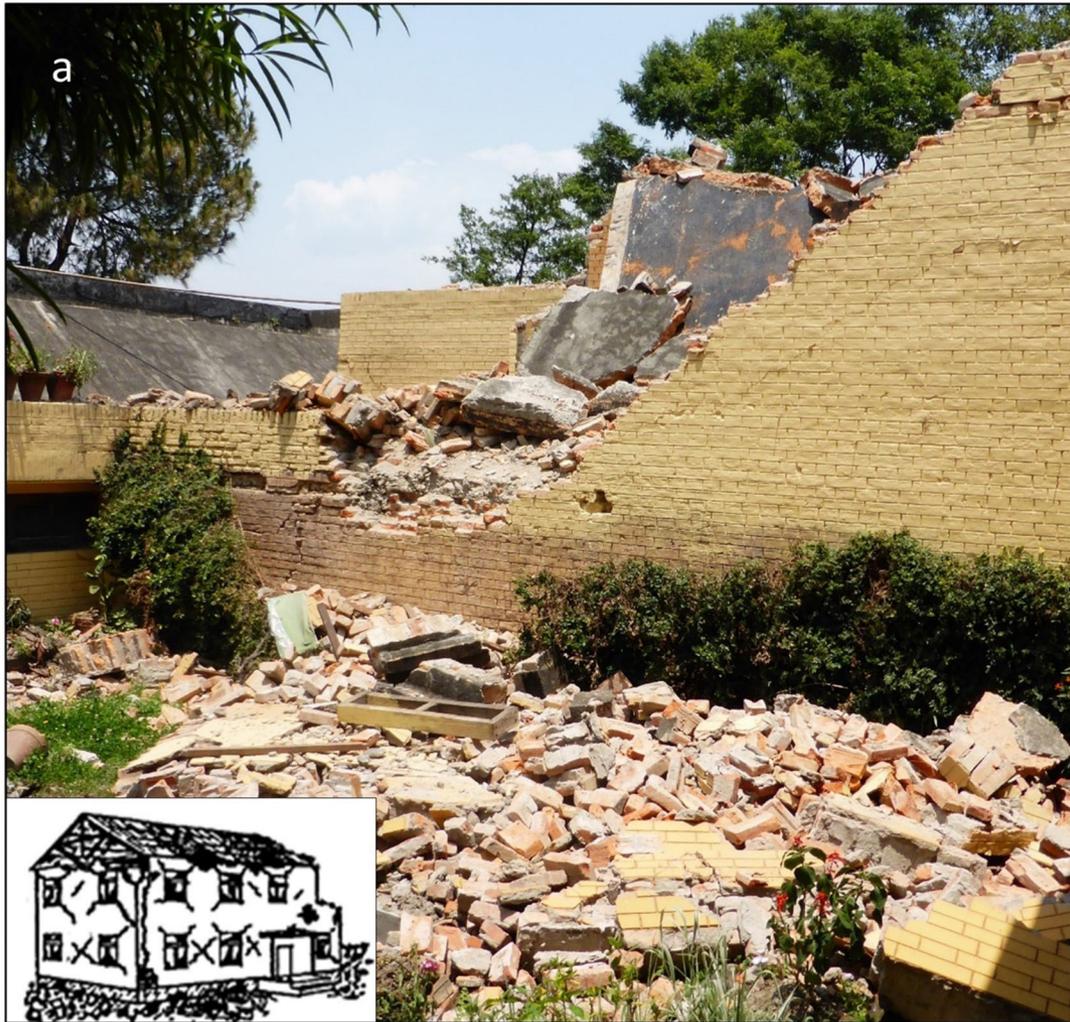
The station TVU is in the premises of the Tribhuvan University and is installed on the ground floor of a two-story RC infill frame building of the Central Department of Geology. There are only 19 buildings around it (Figures 5a) with none more than 2 stories tall. Statistically speaking, this site suffered the most damage (~10%) with slight damage observed in RC buildings as well (Figures 5a). A single story load bearing masonry cement mortar building built in late 1960s was heavily damaged. The walls and ceiling of the building collapsed making the building unsuitable for use (Figure 6a). Though most of the buildings around TVU are RC infill frame structures, slight damage like broken window panes and slight cracks on the ground floor was observed. There was damage to foundation and columns (Figure 6b) in some of the RC structures and a compound wall around one of the department buildings completely collapsed.

Figure 6. (a) Heavily Damaged masonry building and, (b) damage to foundation of Moderately Damaged RC building around TVU.

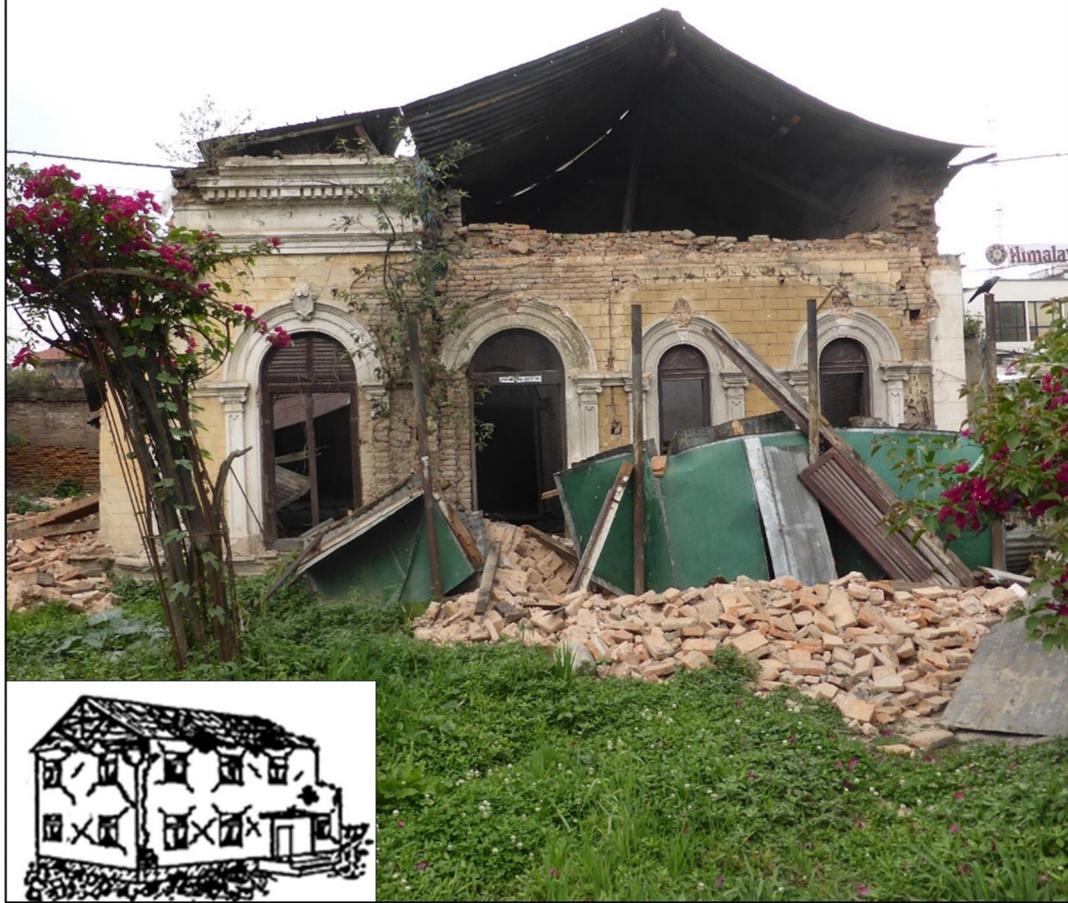
The majority of buildings inside the Institute of Engineering, Pulchowk Campus premises where PTN is installed, are predominantly load bearing masonry-cement mortar structures (Figure 7a). The station itself is set inside a single-story load bearing masonry cement mortar building. The buildings outside the campus premises are predominantly RC infill frame structures. Almost 9% of total buildings considered for the study, suffered moderate to heavy damage (Figure 7b). Two of the buildings that suffered damage were built with brick and lime mortar '*bajra*'. One of them being used as office suffered cracks in the walls and was evacuated following the earthquake. Another one story lime mortar building was heavily damaged (Figure 8a). Some of the RC infill frame buildings in the study area suffered cracks on the outer walls and beams. We observed a multi-story RC infill frame building with shear cracks on the outer façade (Figure 8b).

Figure 8. (a) Heavily Damaged masonry building with lime mortar and, (b) shear cracks developed in Moderately Damaged RC building around PTN.

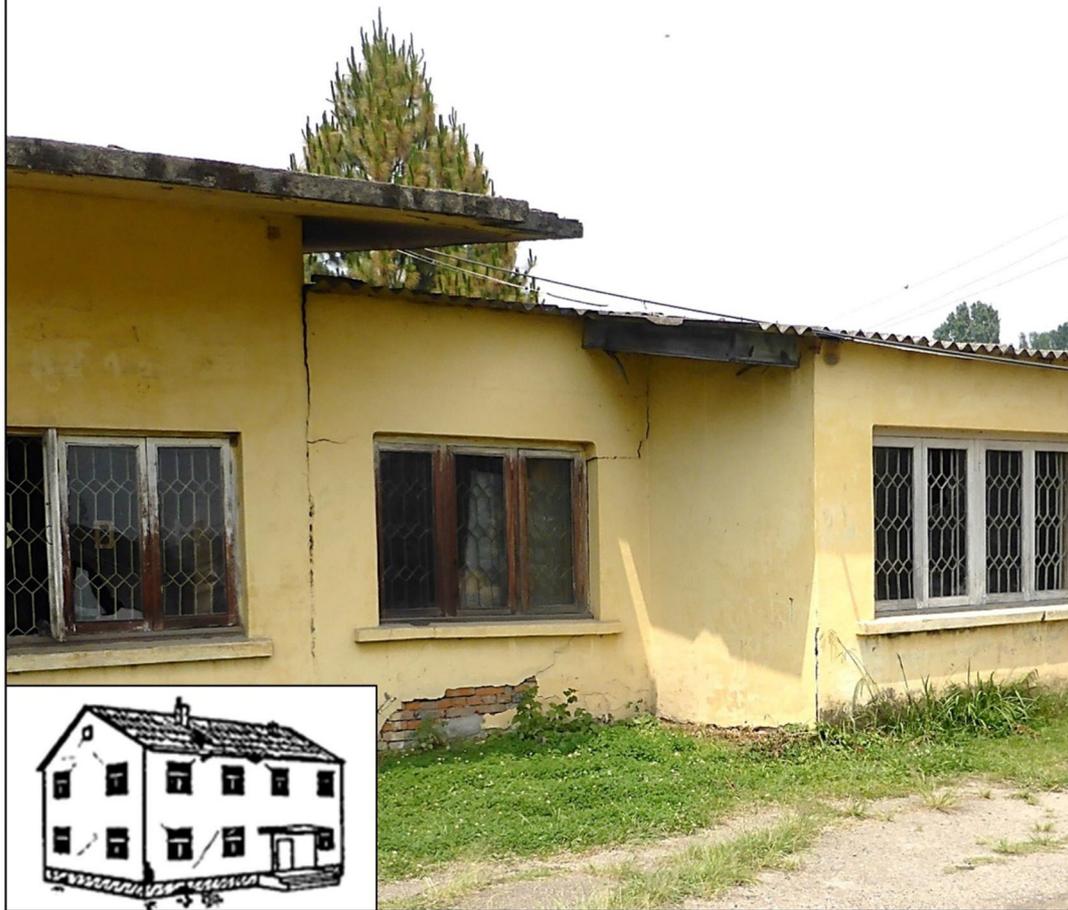
settlement, most of the buildings are RC structures but there are public buildings which are masonry structures (Figure 9a). This site suffered the least damage (Figure 9b) when compared to the other sites. A masonry school building suffered moderate damage and wall cracks (Figure 10a) were clearly visible. A few fallen tiles from the roof were also observed in another building of the same school. The compound walls around the school (Figure 10b) and around a government office collapsed after the earthquake.

Figure 10. Damage around THM, (a) Moderately Damaged masonry building and corresponding damage classification according to EMS98 in inset and, (b) collapsed masonry compound wall.

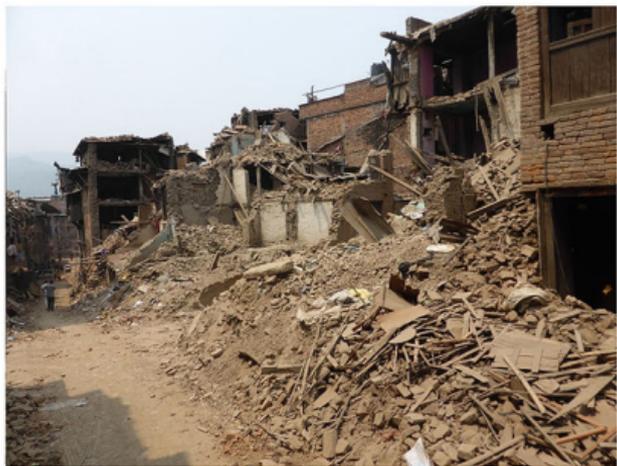
a

Many buildings in different parts of the Kathmandu Valley, like Bhaktapur, Gongabu, Sitapila, and Ramkot suffered heavy damage (Figure 14) due to the Gorkha Earthquake.

Figure 141. Damage to building in other parts of the Kathmandu Valley (a) Damage to masonry structures in Bhaktapur, (b) Tilted and damaged RC infill frame building in Gongabu, (c) Damaged RC infill frame structure in Sitapaila and, (d) collapse of RC infill frame structure in Ramkot.

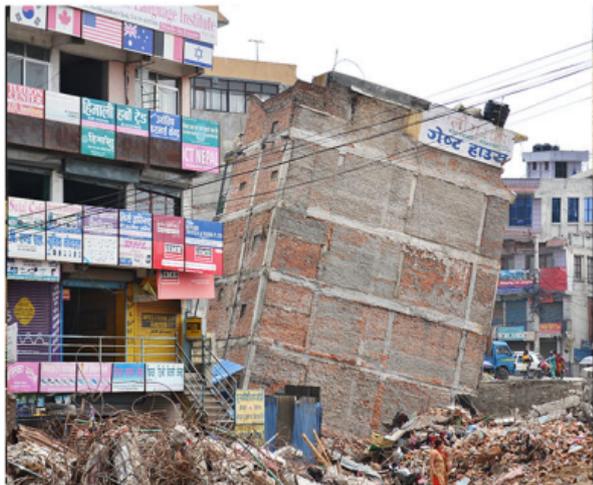
**b**

Several buildings in Gongabu were tilted due to liquefaction and many RC buildings completely collapsed. A team of researchers (Angster et al. 2015) traced an extension of a localized lineament in an area lying south-west of THM and they attributed the origin of the lineament to geological condition and earthquake shaking. These worst-hit areas of Kathmandu unfortunately did not have seismic stations nearby so the assessment on those areas has not been carried out for the present study due to lack of strong-motion data to compare the damage. As basin topography and sediment in the Kathmandu Valley is very heterogeneous, the response of sites merely few hundred meters apart vary a lot, so generalizing the response might not produce accurate results.
