Title	平成29年度の活動 国際交流 : ニュージーランド・カイコウラ地震に関する調査
Author(s)	Yamakawa, Yosuke; Tsutsumi, Daizo; Shimada, Toru; Rosser, Brenda; Dellow, Sally; Massey, Chris; Sakurai, Wataru; Takayama, Syoki; Kito, Kazuki; Marutani, Tomomi
Citation	北海道大学突発災害防災・減災共同プロジェクト拠点平成29年度報告書, 29, 98-99 Extended abstracts of Interpraevent 2018 in the Pacific Rim -Large scale sediment disasters in orogenic zones and countermeasures p260-261
Issue Date	2018-03-31
Doc URL	http://hdl.handle.net/2115/73931
Rights	本稿はインタープリメント2018実行委員会事務局の了解を得て掲載しています。
Type	report part
Note	"Landslide dams caused by the M7.8 Kaikoura Earthquake"INTERPRAEVENT2018. 平成30年10月1～4日. 富山国際会議場, 富山県.
File Information	14-IP2018.pdf

Landslide dams caused by the M7.8 Kaikoura Earthquake

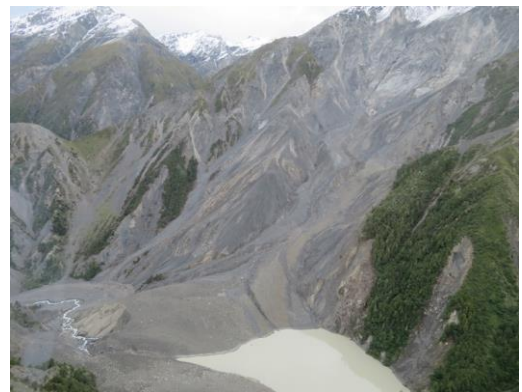
The landslide dam on the Hapuku River (Fig. 1) was the highest (about 150 m high) of the dams triggered by the M7.8 Kaikoura earthquake and covered an estimated 656,430 m², with 12,000,000 m³ of collapsed rock (Rosser, 2017). The landslide was a rock avalanche. The bedrock geology of the watershed is dominated by greywacke (a variety of sandstone). Numerous shallow landslides also occurred along the Hapuku River. The main dam crest, which was monitored by a live camera installed by Kaikoura District Council, overtopped on 6 April 2017, after which the water level of the lake behind the dam decreased rapidly, although it did not empty. Rapid increases in flow depth due to the overtopping were observed about 11 km downstream from the dam, at State Highway 1, on a water level recorder installed and operated by NZTA.

Fig. 1 Landslide dam on the Hapuku River
