Geo-Disaster Report

Reconnaissance report on geotechnical damage caused by 2018 Hokkaido Eastern Iburi earthquake with JMA seismic intensity 7

Tatsuya Ishikawa^{a,*}, Masayuki Yoshimi^b, Koichi Isobe^a, Shoji Yokohama^a

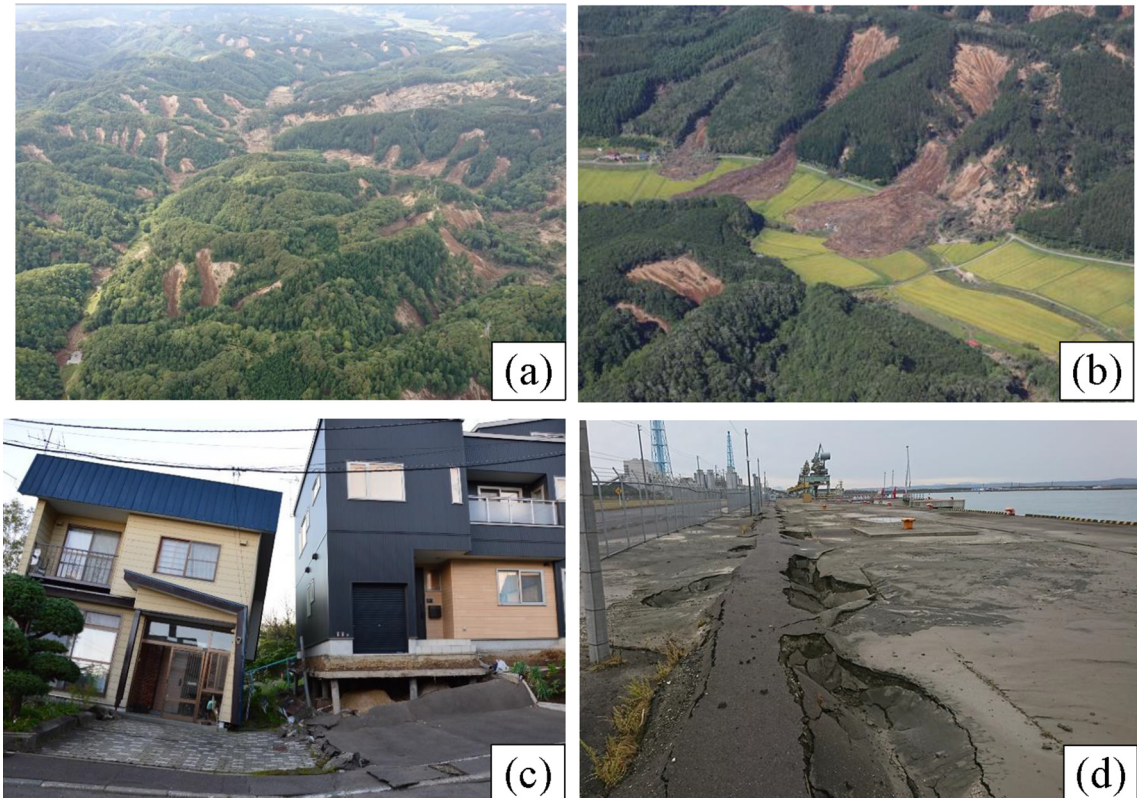
2018 Hokkaido Eastern Iburu earthquake can be found in Watabe and Nishimura (2020) and Kawamura et al. (2019). This section introduces another major geo-disaster where the JGS survey team conducted a detailed investigation into the causes and mechanisms.

Fig. 12. Geotechnical damage caused by the 2018 Hokkaido Eastern Iwate Earthquake: (a) slope failures in Atsuma (Fig. 5), (b) slope failures with sediment flow in Atsuma (Fig. 5), (c) tilted house on the belt-shape depressed area due to liquefaction without sand boiling in Sapporo (Fig. 1), (d) uneven subsidence of road due to liquefaction with sand boiling in Tomakomai (Fig. 1); (a), (c), and (d) taken by Watabe, Y., Hokkaido Univ.; (b) provided from Japan Asia Group, PASC Corporation.

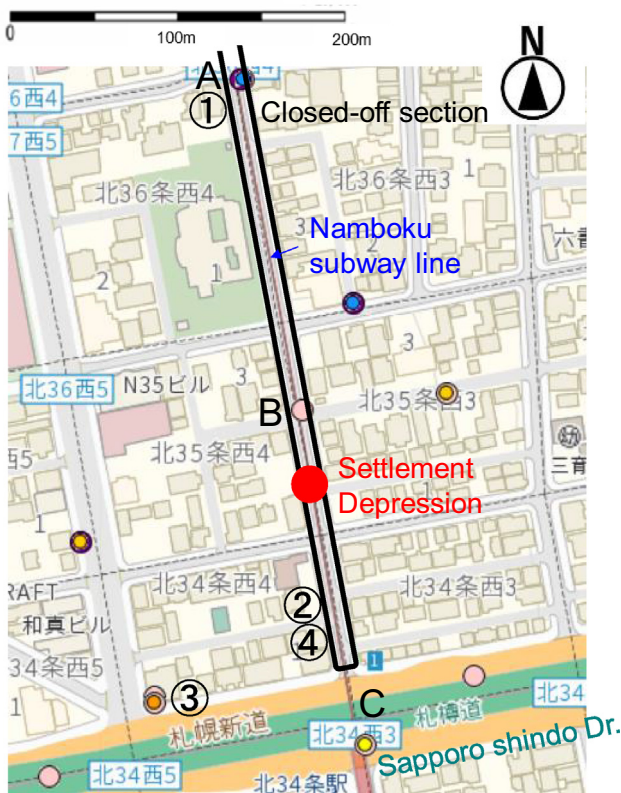
Severe liquefaction induced settlement of the road above the subway line was observed in the area around Kita 34 Station of the Namboku line in Kita-ward and the Higashi 15-chome Tonden street in Sapporo City after the earthquake, as shown in Fig. 13. A field investigation was conducted on September 8–9th 2018 corresponding to 2–3 after the earthquake.

Fig. 14 shows the closed-off sections near Kita 34 Station and the locations where settlement and depressions after the earthquakes were observed. Fig. 15 shows the situation after the earthquake, taken from the location of the numbers shown in Fig. 14. Two days after the occurrence of the earthquake, repair work had already started on the road above the Namboku subway line, and a prompt response was being implemented for emergency restoration. On the other hand, as shown in the picture taken from No. 3, although slight deformation was seen on the foundation tiles of the building facing Sapporo Shindo drive, no noticeable damage was seen in Sapporo Shindo drive or

to the sidewalks. Thus, it was found that the damage was concentrated on the road above the Namboku subway line.

Fig. 14. Closed-off section and damage situation around Kita 34 station of Namboku subway line in Kita ward, Sapporo with the map by G-Space II.

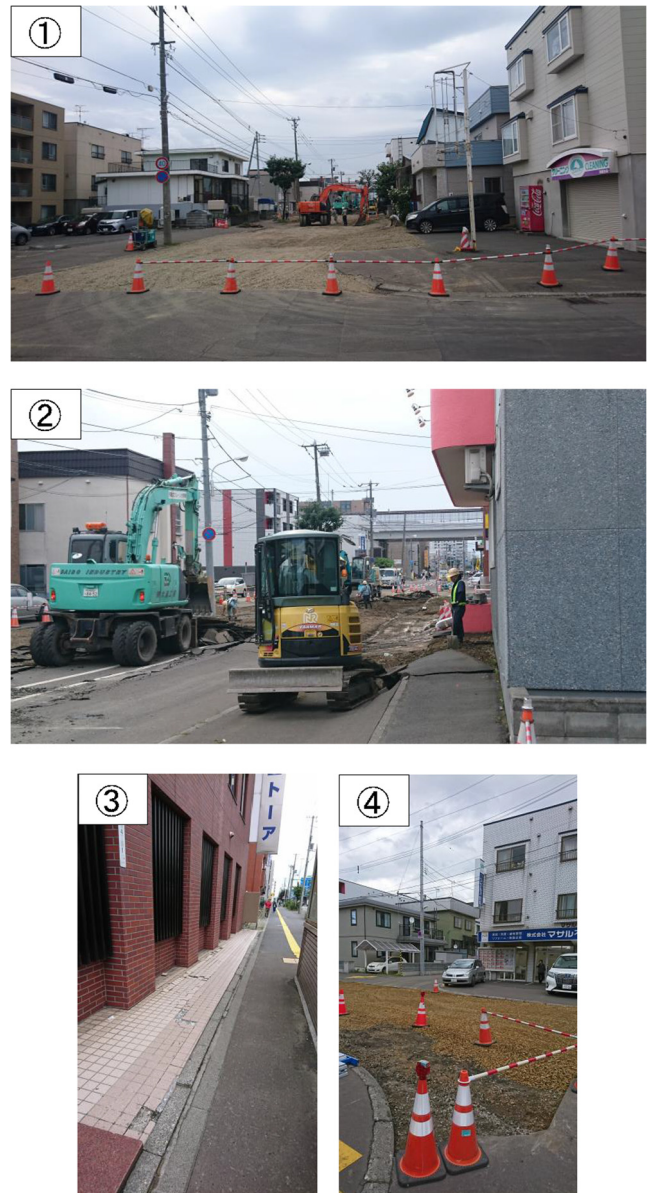
Fig. 15. Damage situation near Kita 34 Station two days after the earthquake (photo locations referred to Fig. 14).

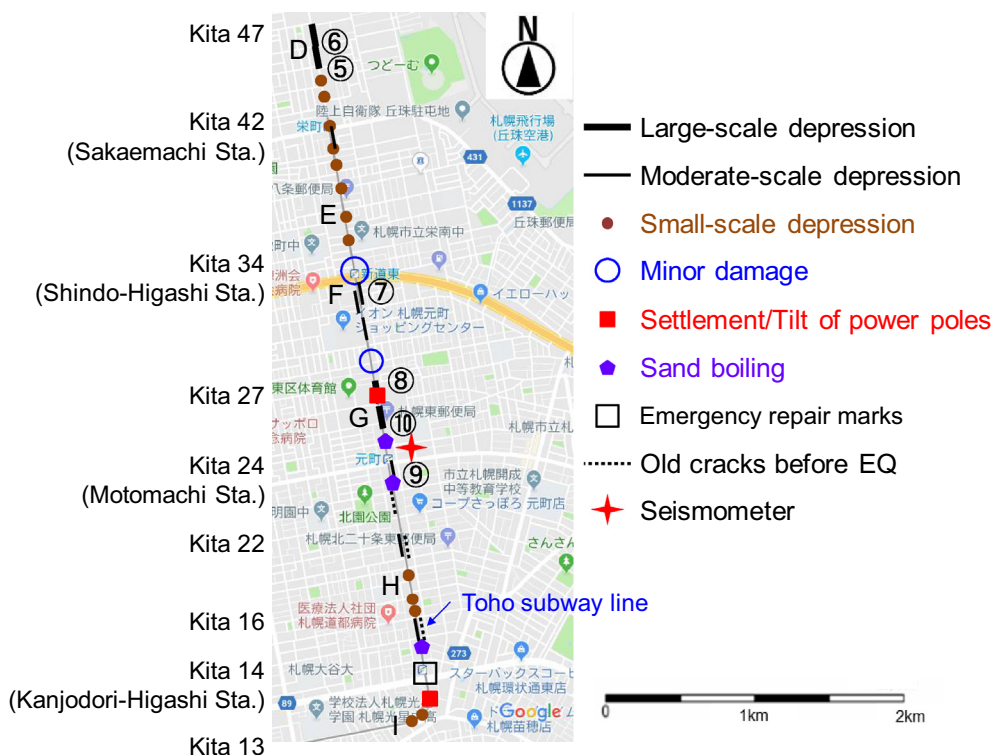
The damage situation in Higashi 15-chome Tonden Street above Toho subway line is shown in Fig. 17. In Higashi 15-chome Tonden Street, the road was damaged by liquefaction-induced settlement over about 4.4 km north to south around Kita 13 to Kita 47, and was closed except for some intersections. Temporary restoration started on the 7th of Sep. which is the day after the earthquake, and traffic was resumed sequentially as the temporary restoration was completed for each section, and full passage was possible around 5 pm on the 17th of Sep.

Fig. 17. Damage to Higashi 15-Chome Tonden Street with the map by Google.

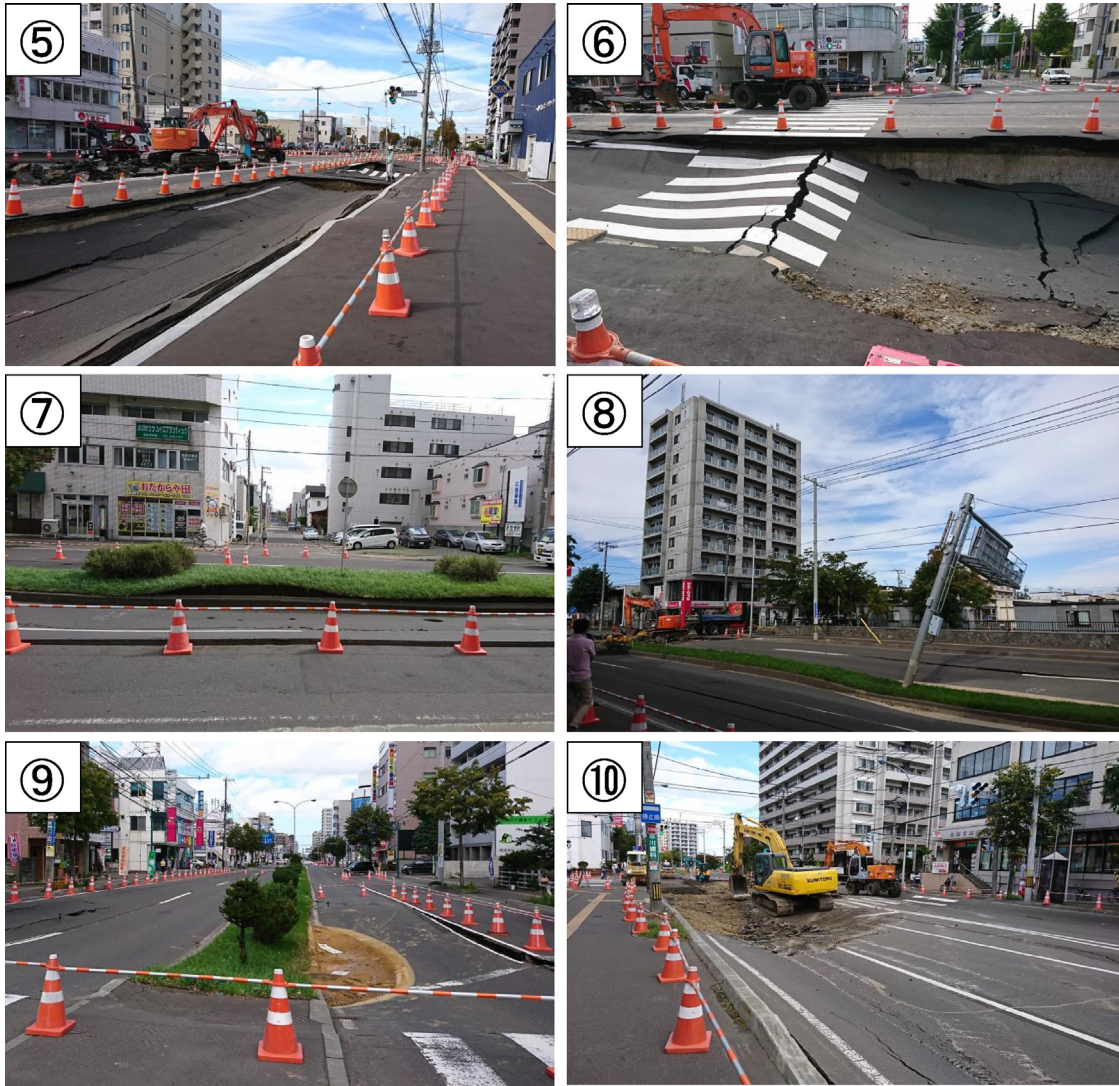
Fig. 18 shows the situation after the disaster at the location of the numbers shown in Fig. 17. Kita 47 to Kita 42 (Sakaemachi Station), which is the northernmost point in the damaged area of Higashi 15-chome Tonden street, experienced the most significant damage, with large-scale road settlement. As shown in Fig. 18 ⑤ and ⑥, up to about 1 m of road settlement and exposure of the buried structure were observed. In addition, the settlement and depressions of not only the driveway but also the sidewalk could be confirmed. The road depressions were concen-

Fig. 18. Damage situation along Higashi 15-Chome Tonden Street two days after the earthquake (photo locations referred to Fig. 17).

trated on the Toho subway line, since the location corresponds to the location of the sidetrack of the Toho subway line.

From Kita 42 (Sakaemachi Station) to Kita 35 a small-scale road settlement occurred. Traffic was controlled at the intersection of Kita 42 (Sakaemachi Station) ~~was out of traffic control~~, but the scale of damage was less than the situation of the northern area.

From Kita 34 (Shindo Higashi Station) to Kita 27, settlement of the road occurred near the median, and long cracks occurred along the settlement along the road as shown in Fig. 18 ⑦.

From Kita 27 to Kita 22 including Motomachi station, the occurrence of large-scale road collapse and the inclination of road signs was observed along with sand boiling, suggesting that liquefaction occurred. Also in the area, a seismic intensity of 6 or less was observed with a seismo-

From Kita 22 to Kita 16, the occurrence of small-scale road settlement and sand boiling were observed, suggesting that liquefaction occurred. Repair marks for old cracks were found in the area, and it is considered that road deformation had occurred before the earthquake.

From Kita 16 to Kita 13 including Kanjodori-Higashi station, along the Toho subway line alignment, the occurrence of settlement or deformation of the road was observed from north-south direction to east-west direction. In addition, it was confirmed that emergency restoration was already completed on the sidewalk near Kanjodori-Higashi Station.

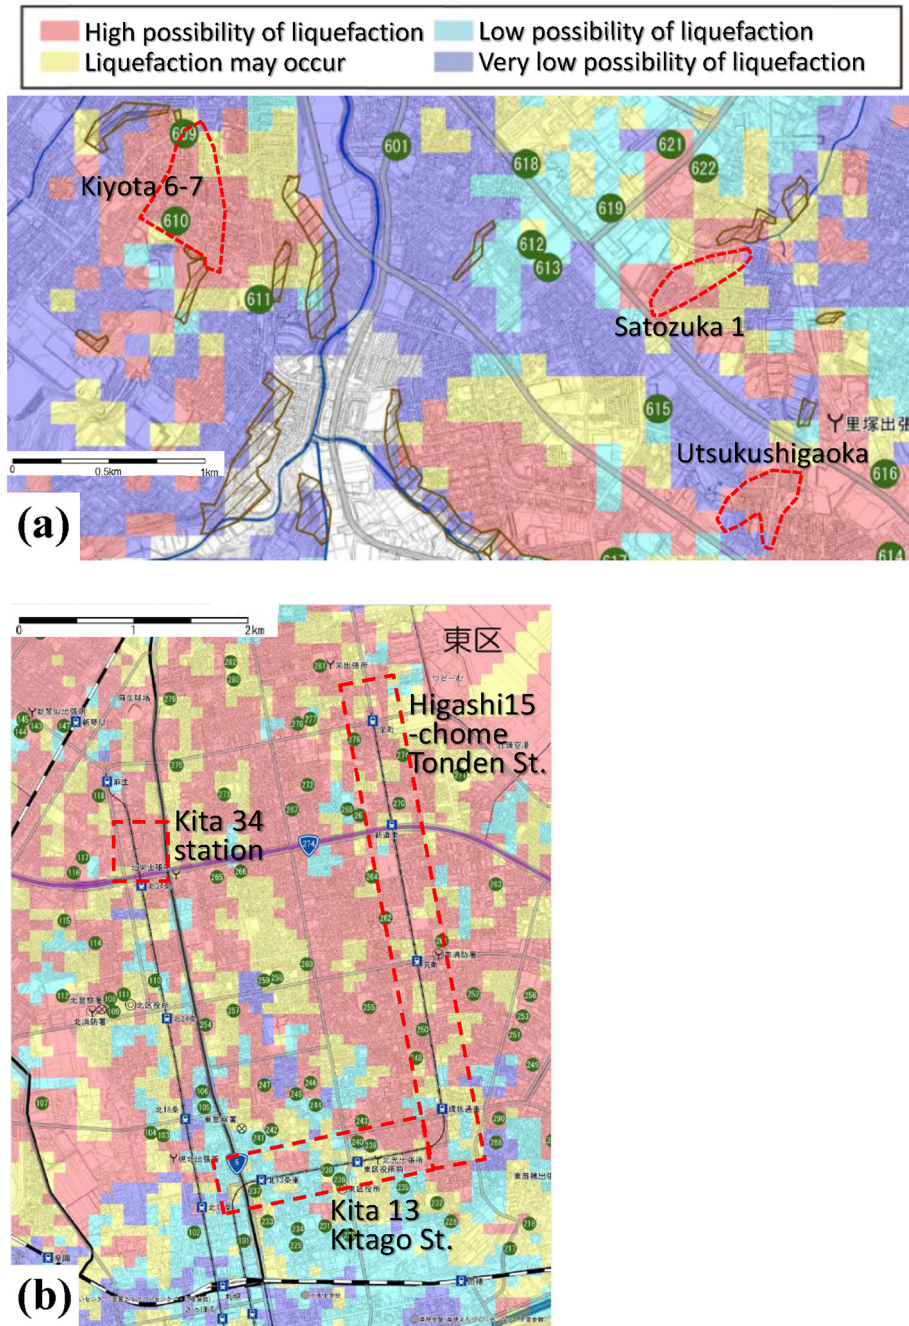
Fig. 22. Liquefaction hazard map for Sapporo City (Sapporo, 2018) with liquefaction-damaged areas by the 2018 Hokkaido Eastern Iburi earthquake: (a) Kiyota ward, (b) Kita ward and Higashi ward.

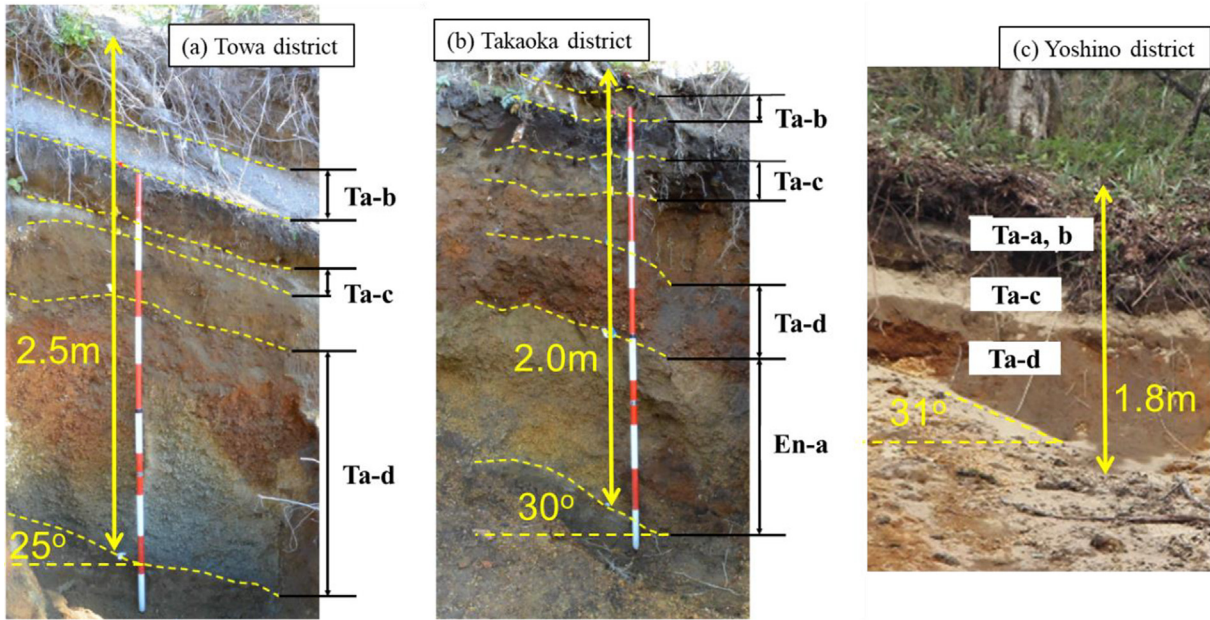
At the mountains and hills in the Atsuma River basin where a large number of slope failures and landslides occurred, multiple layers of volcanic pumice fall deposits with different eruption periods mainly originating from Tarumae volcano, Eniwa volcano, and Shikotsu volcano are widely distributed on sedimentary rocks. Among these, the Shikotsu pumice fall deposit (Spfa-1) erupted from the Shikotsu caldera about 46,000 years ago, and the Eniwa

pumice fall deposit (En-a) erupted from the Eniwa volcano about 20,000 years ago. Four kinds of pyroclastic fall deposits erupted from the Tarumae volcano (Ta-d, Ta-c, Ta-b, and Ta-a) about 9000 years ago, about 2000 years ago, in 1667 CE, and in 1739 CE, respectively. By observing the stratigraphic structures at many slope failure sites (Fig. 23), little disorder of the strata due to crustal movement and landslides was observed. This means that slope failures due to large earthquakes with the same magnitude

Fig. 23. Stratigraphic situations at slope failure sites in Atsuma: (a) Towa district, (b) Takaoka district, (c) Yoshino district (locations of each district referred to Fig. 24).

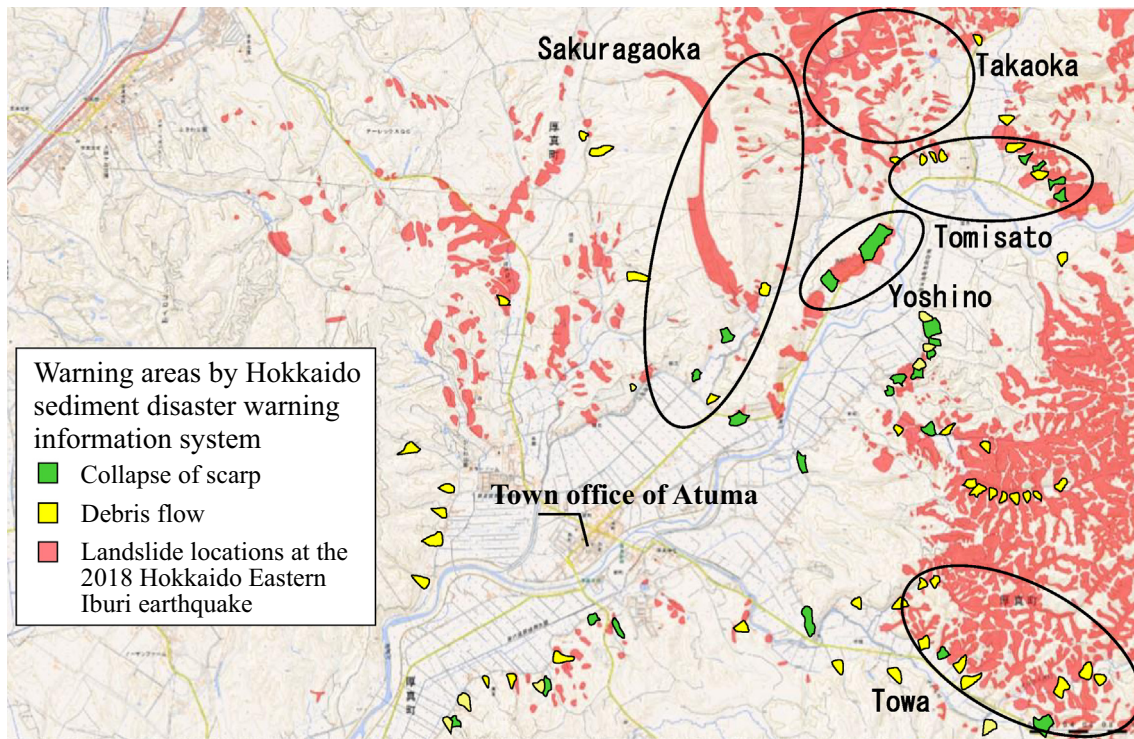
as the 2018 Hokkaido Eastern Iburi earthquake have not occurred for a long time. Fig. 24 compares the slope collapse locations at the 2018 Hokkaido Eastern Iburi earthquake and the sediment disaster warning areas due to heavy rainfall in Atsuma. Though the latter partly overlap with the former, regrettably it is not appropriate to use the map for sediment disaster warning areas as the risk assessment of slope failure during an earthquake. Therefore, it is necessary to discuss and to propose new prevention and

Fig. 24. Comparison the landslide locations at the 2018 Hokkaido Eastern Iburi earthquake (GSI, 2018) with the sediment disaster warning areas in Atsuma (Hokkaido, 2018b).

mitigation measures for geo-disasters against earthquake motion beyond expectations keeping in mind that past experiences are not useful indicators.

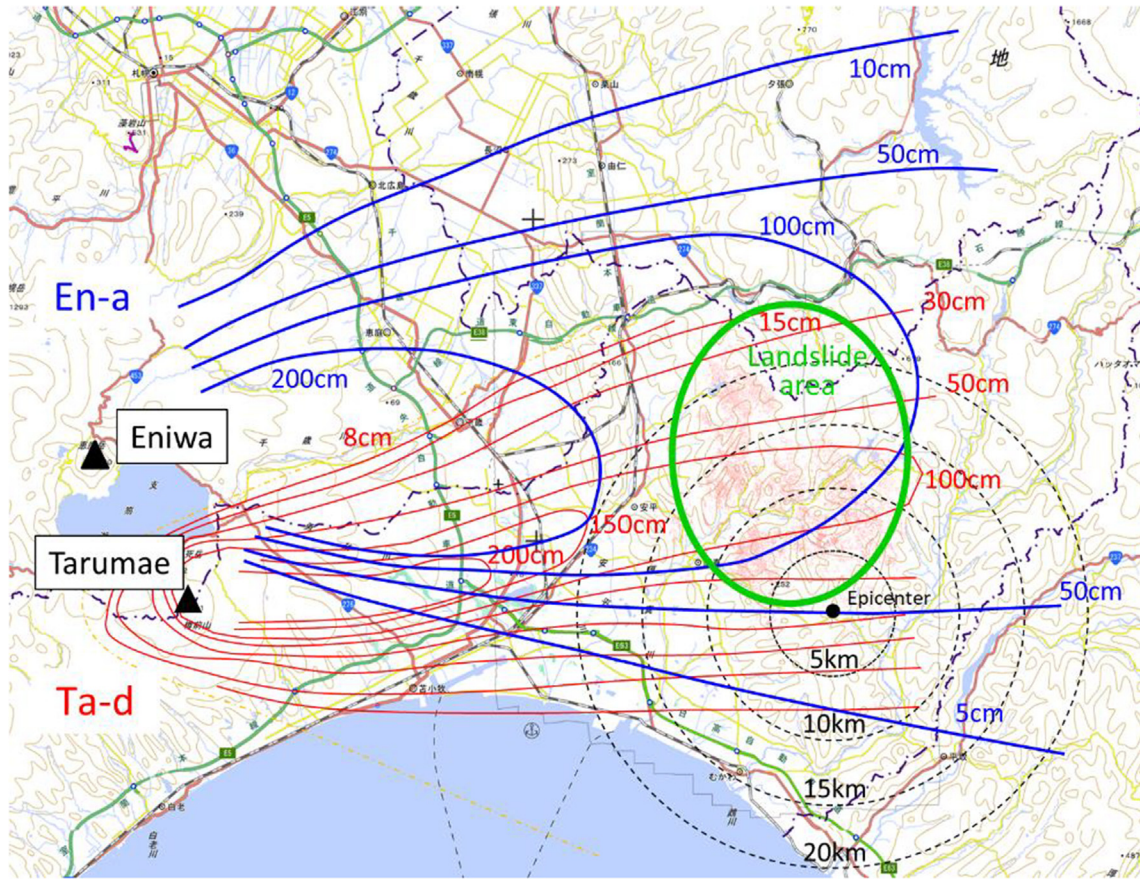
Fig. 25. Distribution area and thickness of pyroclastic fall deposits from Tarumae and Eniwa volcanos with landslide distribution (GSI, 2018).

The other factor is the difference in the deposition status of volcanic pumice fall deposits depending on the distance and direction from the eruption source. Fig. 25 shows the distribution area and thickness for two kinds of the pumice fall deposits which erupted from the Tarumae volcano (Ta-d) and the Eniwa volcano (En-a), respectively. The total thickness of En-a and Ta-d is approximate 100–200 cm at the slope failure locations in Atsuma town, while the thick-

ness is thinner at the area where little slope failure was seen. From these facts, it is obvious that many slope failures occurred in the distribution area with thick pyroclastic deposits. When conducting the slope stability analysis under the assumed calculation conditions shown in Fig. 26 by referring to Amemiya (2019), the depth of the slip surface of the collapsed slope with a 25–35 deg range in the slope angle, which were frequently observed in Atsuma town, is between 1.5 m and 3.5 m. According to an estimation by the Ministry of Land, Infrastructure, Transport and Tourism (MLIT, 2018), the scale of slope collapses due to the 2018 Hokkaido Eastern Iburi earthquake was as follows: (a) the amount of collapsed sediment: 30.0 million m^3 ; (b) the collapsed area 13.4 km^2 . The average collapse depth estimated from the amount of collapsed sediment and the collapse area is about 2.2 m. In addition, according to the results of field investigation, though the slip surface position varied depending on the location, in most cases the collapse depth was approximately 2–3 m in places where Ta-d and En-a are deposited. From these results, it is recognized that the depths of all the slip surfaces was similar, indicating that the slope failures seen around Atsuma town were strongly influenced by the geological structures. Therefore, it is necessary to discuss and to propose prevention and mitigation measures

for earthquake-induced slope failures by considering both the amplification-attenuation characteristics of the local site and the geological structures.
