ON THE DAMAGE TO THE HAKODATE COLLEGE BY  
THE TOKACHIOKI EARTHQUAKE, 1968

Kazuo OHNO\*  
Takuji SHIBATA\*\*

2. Structure of the destroyed school-building of the Hakodate College

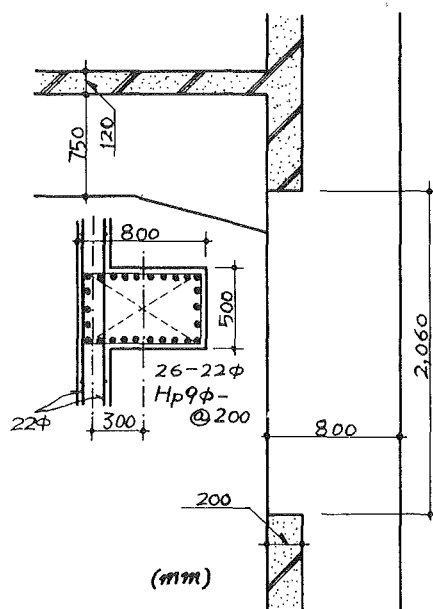
Fig. 4. Details of the first story column

The wall girders in the long direction of the building were 20 cm in thickness and 150 cm in depth, to which the floor slabs were connected at the middle of the girder depth. These girders were connected to the columns so that the insides of girder and column were flush as is shown in Fig. 4. The eccentricity between the axes of girder and column was 30 cm. The footing girders in the same direction had a cross-section of  $20 \text{ cm} \times 180 \text{ cm}$  and the eccentricity between girder and column was the same as those in the upper floors.

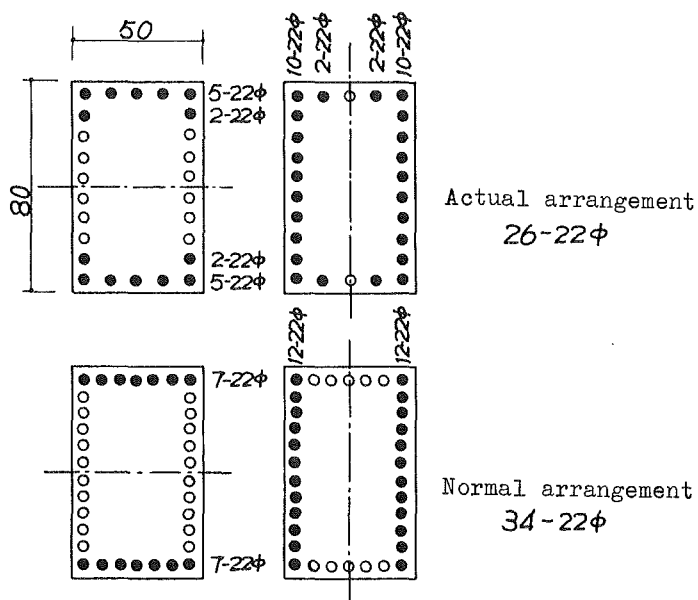
Fig. 5. Saving the axial reinforcement in the columns

The axial reinforcement of column was saved about 20 % by taking the adjacent reinforcement into consideration as is shown in Fig. 5. In the normal calculation, the reinforcement should be  $34-22\phi$  instead of  $26-22\phi$  which was specified in the blue-print. It had been already clarified by the authors that those kinds of saving of axial reinforcement would derive a pretty amount of decrease in column strength in case of bi-axial bending moment.

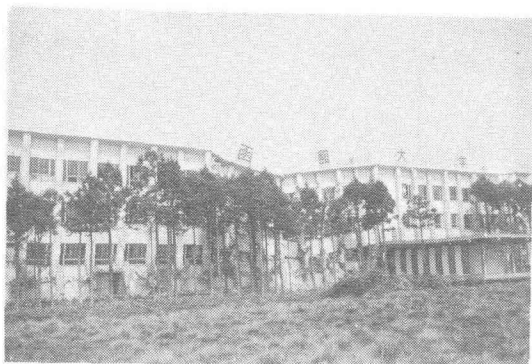
Fig. 6. South-side view of North-west Wing

Newspapers reported immediately after the earthquake that the four-storied building collapsed into three-storied one in a moment (Fig. 6). Almost all of the columns and walls in the first story were exhaustively destroyed. These damages were considerably intensified by the aftershock which attacked the building in the evening on the same day.

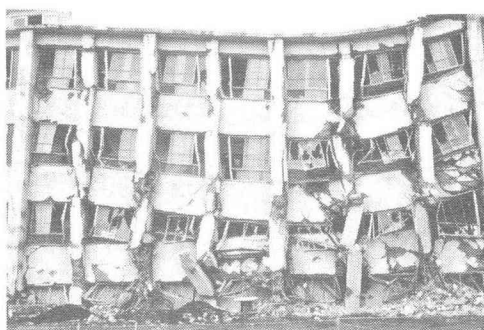
Fig. 9. North-side view of North-west Wing

The walls with the thickness of 12 cm, which were located at the both sides of the staircase in the middle of the north-west wing, were badly damaged in the first story, so that the staircase from the first floor to the second floor was destroyed (Fig. 9).

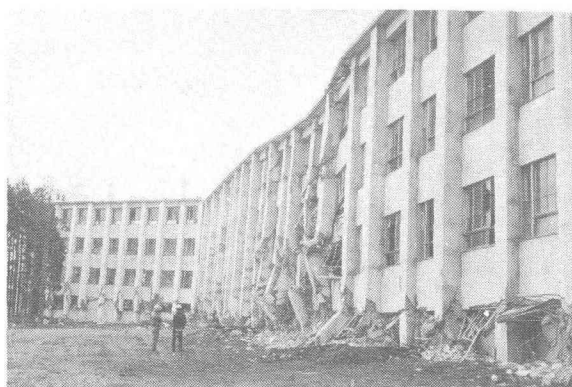
Fig. 7. North-side view

There was some difference of damages between the north-west wing block and the east wing block of the building. In the former, the skeleton upper than the second story fell down so that the bottom of wall-girders of the second floor touched the top of the first floor wall-girders, because all of the columns in the first story were destroyed into pieces (Fig. 7). Regarding the upper stories, the columns and wall-girders in the middle one-third of the north-west wing were severely damaged (Fig. 9). Especially, the girder-column joints were destroyed and the pilasters fell down separated from the wall-girder (Fig. 10). In the east wing, the damages of columns of the first story were somewhat less and the columns at the east end of the building kept almost their original forms, though many severe cracks were observed on them (Fig. 8). These crack patterns

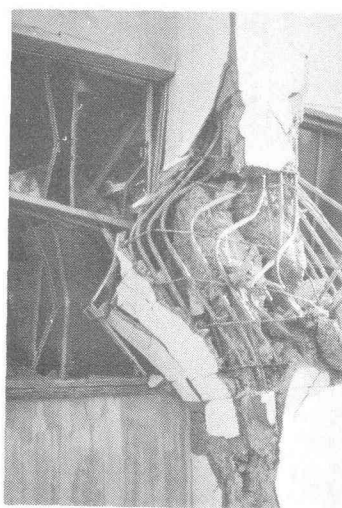
Fig. 11. First story column in East Wing

suggested that the column would be subjected to a large shearing force in the long direction of the building (Fig. 11).

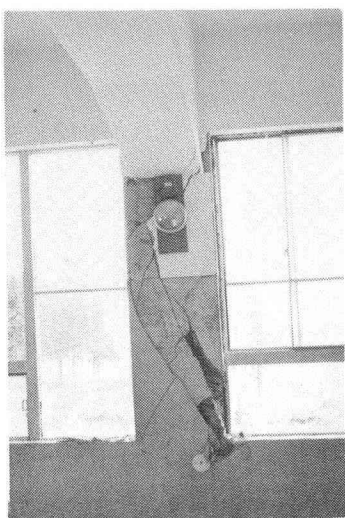
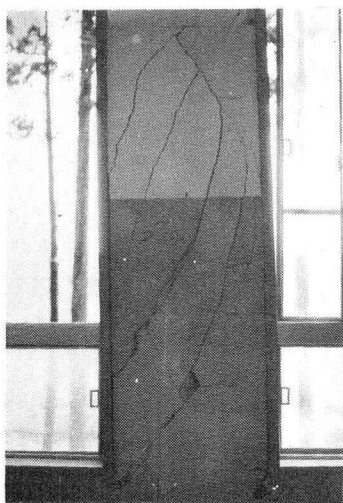
Almost all of the columns in the upper stories of the whole building also had many shear cracks of the same kind (Fig. 12, 13). Some spiral cracks which spread on the surfaces of columns were also observed. This feature of cracks suggested that the columns would be subjected to considerably large torsional moments (Fig. 14).

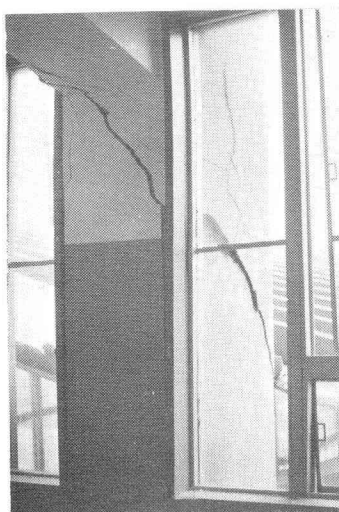
Fig. 14. Second story column in  
North-west Wing

- (1) The connecting joint of column and wall-girder.
  - a) The eccentricity between the axes of wall-girder and column would cause a torsional moment in the column (Fig. 14). However, the effect of this eccentricity had been neglected.
  - b) There was no consideration to secure the anchorage of the reinforcement of wall-girder to the column. Moreover, some of the reinforcement of wall-girder was arranged outside the reinforcement of the column (Fig. 4).
  - c) The effect of rigid zone of joint panel was neglected in the stress analysis. It would derive unsafe error for the estimation of bending moments of the members.
- (2) The axial reinforcement of column

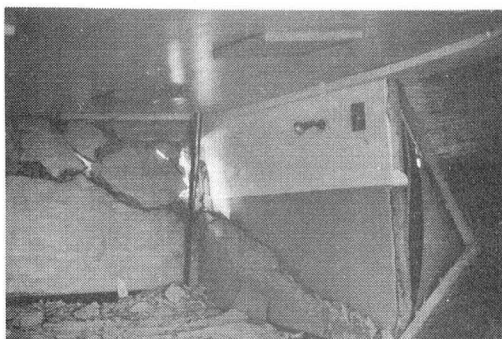
Fig. 15. First story wall in East Wing

Of course, all of the walls in the first story were damaged. The walls with a thickness of 10 cm around the main entrance, which was situated in the center of the east wing, were obliquely shorn into two parts and fell down overlapping each other (Fig. 15).

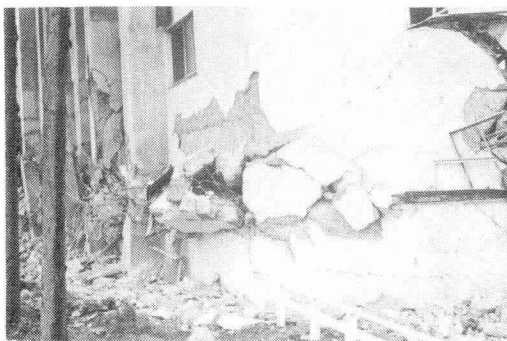
Fig. 16. External wall in the bend

The external wall with thickness of 20 cm which was located at the bent corner of the building was broken as will be seen in Fig. 16.
