| Title | Mechanical Properties of Abandoned and Closed Roadways in the Kushiro Coal Mine, Japan |
| Author(s) | Yoshiaki, Fujii; Yoji, Ishijima; Yoshihisa, Ichihara et al. |

## Mechanical Properties of Abandoned and Closed Roadways in the Kushiro Coal Mine, Japan

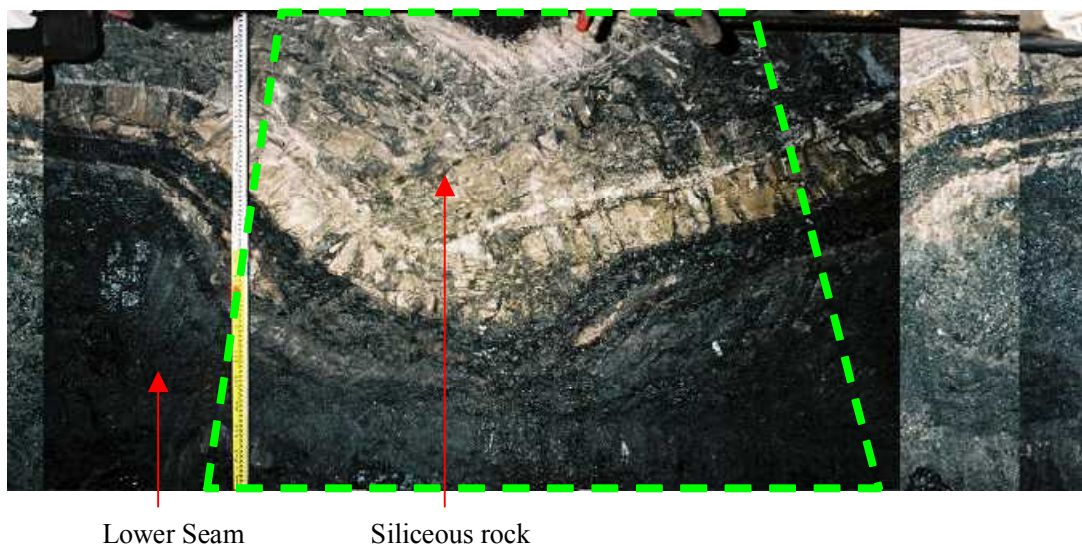
Old roadways in this mining panel were level roadways with a square or trapezoid cross section and were supported by 3-part wooden frame. They were excavated by continuous miners, used for approximately three years, and sealed when abandoned. Then the roadway was back filled by the mound method. The main seam was excavated in 2003 (Table 2). Most old roadways were completely closed by significant roof deflections (Figs. 4 and 5). Siliceous rock and clay exhibited large plastic deformations and filled the

space between the almost-unfractured roof and floor.

Fig. 4 Old roadway observed in Jobu Hidari Lower Seam No. 1 SD. Roadway which is denoted by the broken line is closed by the deflected and sagged roof. Heights of all photos of old roadways in Figs. 4 to 14 are approx. 2.5 m.

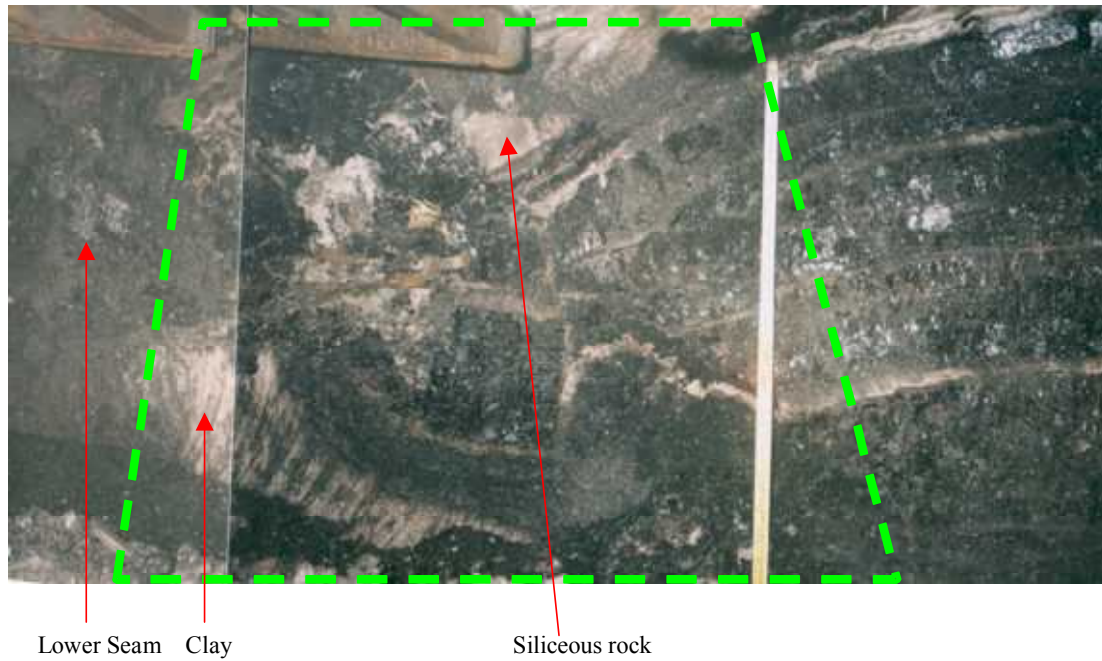
Fig. 5      Old roadway observed in Jobu Hidari Lower Seam No. 1 SD. Right part of the roof kept deflected shape. Left part was crushed by compression.

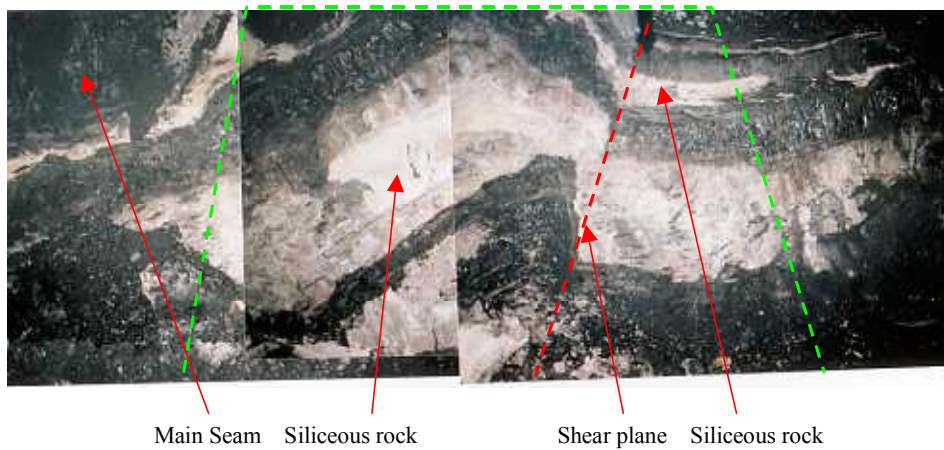
Fig. 6      Old roadway observed in Jobu Hidari No. 6 SD. The deflected floor was sheared. Variation in width of siliceous rock can be seen.

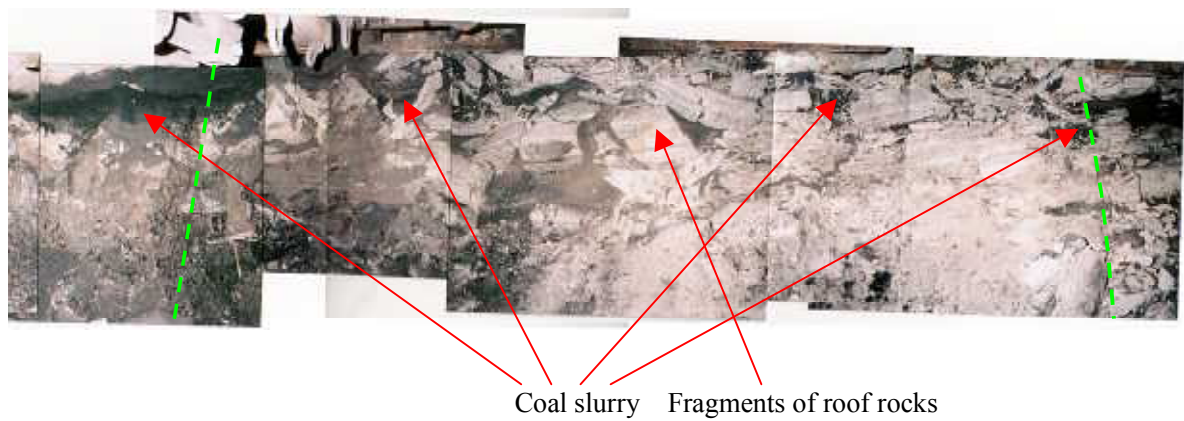
Old roadways in this mining panel were another level roadway. Sections, support, excavation methods and filling conditions were the same as stated above. The Main seam was excavated in 2002 (Table 2). Most old roadways were completely closed. Some were closed by significant floor heaving (Fig. 6), and some were closed by fragments of the roof and the filling-material mixture of fine coal powder produced during coal processing (Fig. 7).

Fig. 7 Old roadway observed in Jobu Hidari No. 6 SD. Fragments of roof rock distributed in coal slurry (gray part seen around the top of the old roadway), the mixture of water and fine coal powder produced in coal processing.

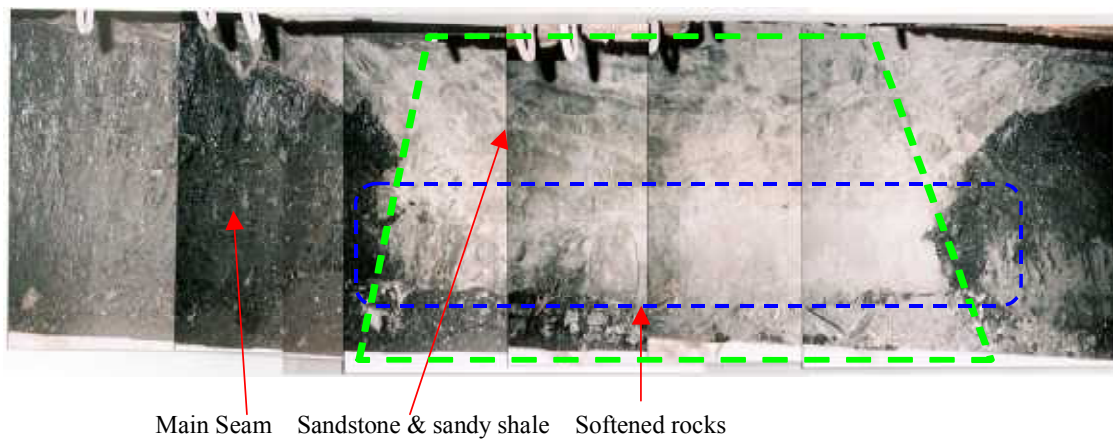
Fig. 8 Old roadway observed in Jobu Hidari No. 5 SD. Old roadway was closed by the deflected and sagged roof. Rocks below the deflected roof were softened.

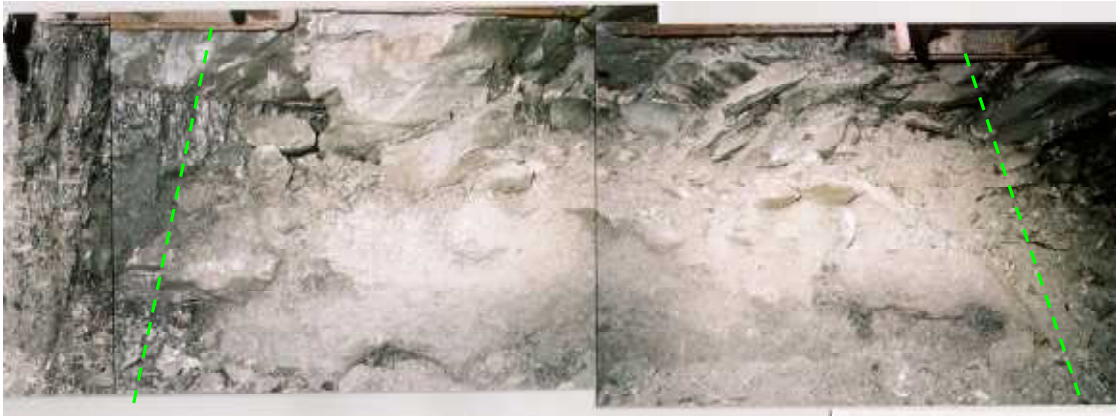
Fig. 9 Old roadway observed in Jobu Hidari No. 5 SD. Old roadway was closed by the deflected and sagged roof. Rocks below the deflected roof were softened.

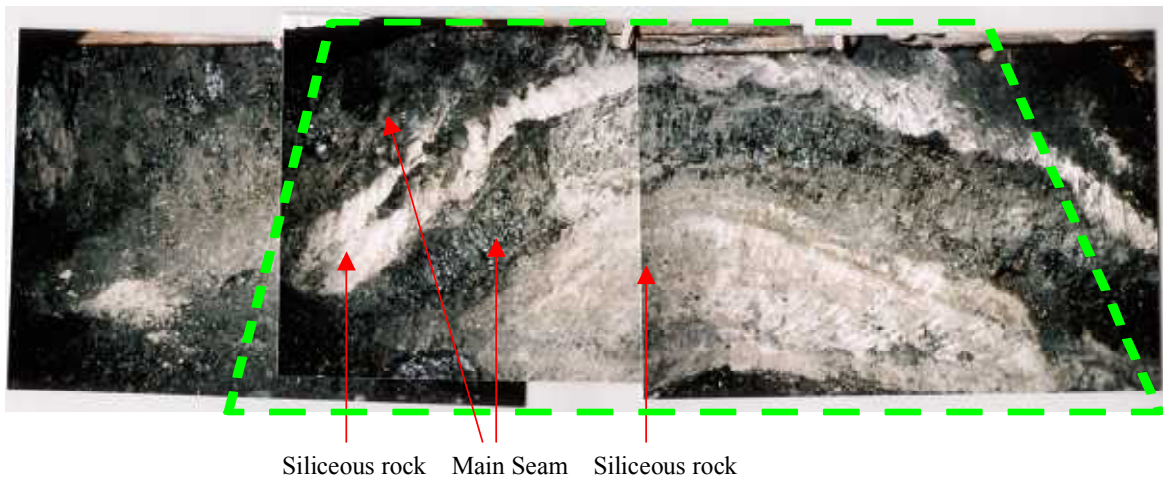
Fig. 10 Old roadway observed in Jobu Hidari No. 5 SD. Roadway was closed by deflected and heaved floor.

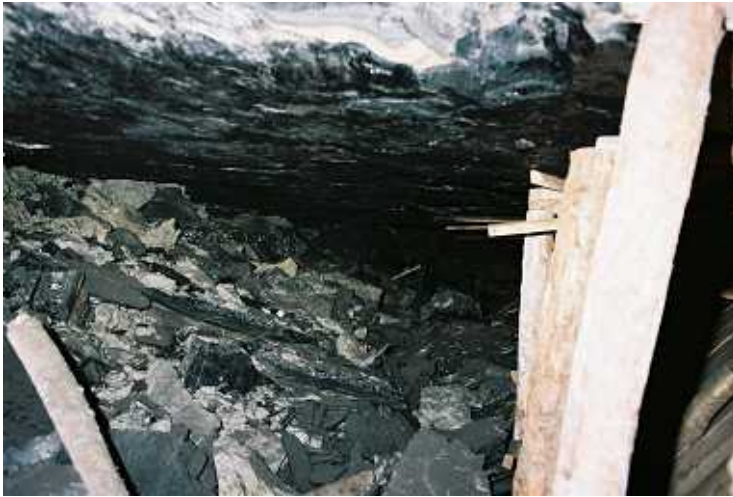
Old roadways in this mining panel were roadways of the room method. Sections, supports, mining equipment and filling methods were substantially the same as those above. Some completely open old roadways were still observed (Fig. 11). Piles of thin slabs of roof shale were observed.

Fig. 11 Old roadway observed in Jobu Chuo No. 0 SD tailgate. Fallen rock slabs piled up on the heaved floor.

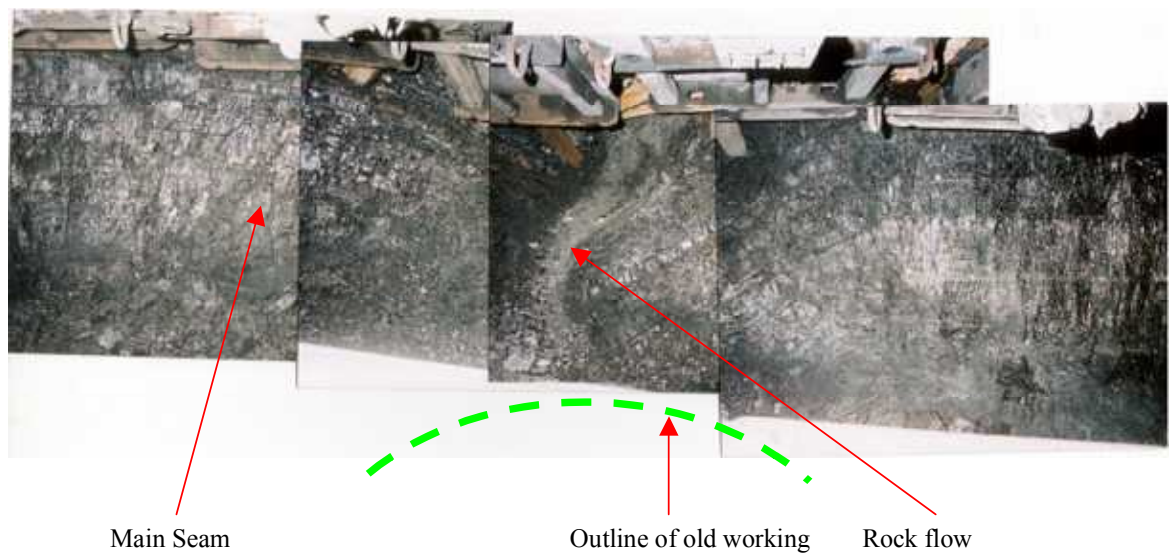
When the old roadway was below the face, significant roof deformations were observed (Fig. 12). Shear fractures in the sidewalls were also observed when the roadways were almost in the working coal seam (Fig. 13). Significant floor deformations were observed for old roadways located above the working coal seam, even though the distance between the coal seam and the roadway was 6 m (Fig. 14).

Fig. 12 Roof just above an old roadway observed in Jobu Chuo No. 1 SD. Crushed roof rocks flowed into the gape of the deflected coal seam.

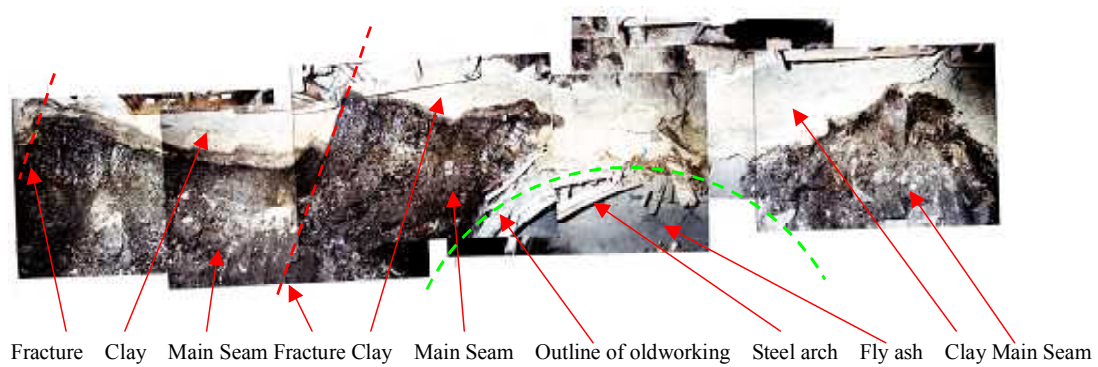
Fig. 13 Old roadway observed in Jobu Chuo No. 1 SD. Shear fractures and variation of clay thickness can be seen.

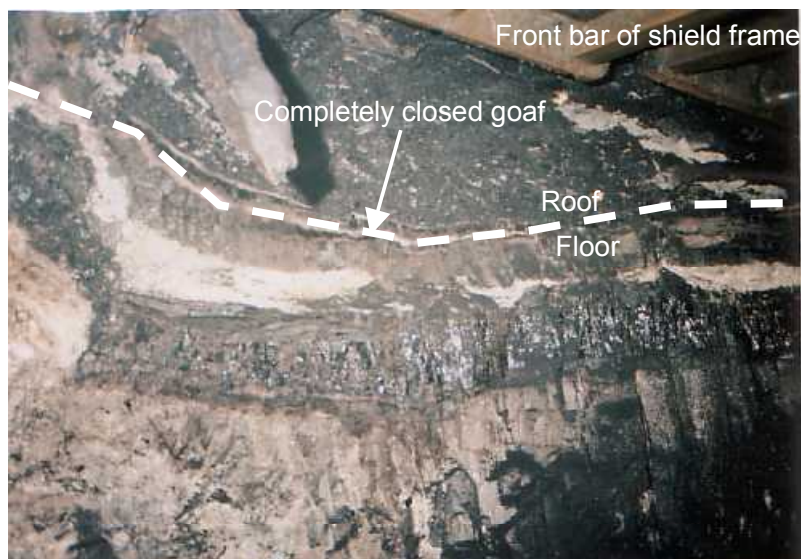
The Lower seam was first mined at Jobu Hidari No. 6 SD; the face moved to the Main seam because the Main seam near the starting point had already been mined 52 years ago. The 52-year-old longwall goaf in the Main seam was observed when the face switched from the Lower seam to the Main seam. The longwall goaf was completely closed, and there was no aperture between the sandy shale seam and the thin sandy shale seam that formed the immediate roof and the floor of the Main seam, respectively (Fig. 15).

Longwall goafs are generally filled by rock blocks of various sizes, an effect which was also confirmed in this mine. The excavation of the Lower seam was carried out several months to several years after the excavation of the Main seam in this mine. There were several experiences in other mining panels in which rock blocks from the longwall goaf of the Main seam fell into the face of the Lower seam. However, there was no such accident during mining of the Lower seam in Jobu Hidari No. 6 SD. The observed longwall goaf was considered to be consolidated for 52 years and was strong.

Fig. 15 A goaf of the Main seam mined in 1954, appeared at the working face of Jobu Hidari No.6 SD. The white broken line indicates the boundary between the roof and the floor of the excavated Main seam.

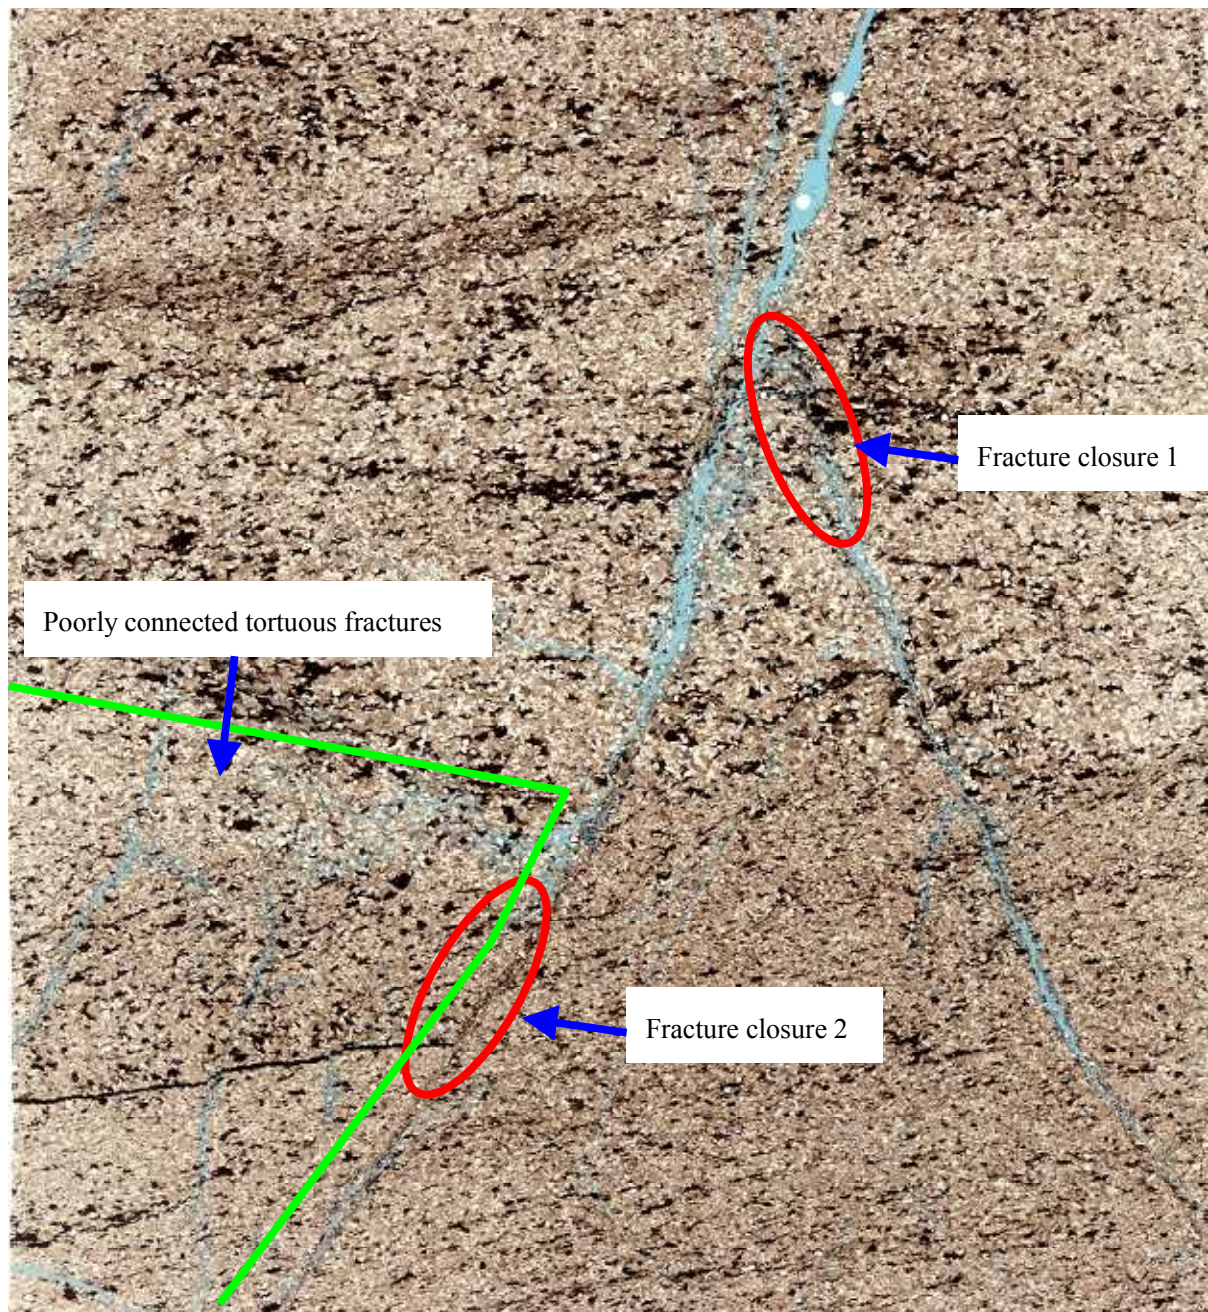
The specimen was immersed into blue resin, and a thin section was made after the resin hardened. Fracture closures and poorly connected tortuous fractures were observed in the thin section (Fig. 20). These were likely the causes of the decrease in hydraulic conductivity with time in the residual state. The mechanism of the fracture closure should be considered further. The authors, however, think that the fracture closure occurred mainly by crushing of the mineral particles and visco-elastic deformation around the rupture plane and not by the pressure solution because the duration and temperature were much shorter and lower than those deep underground where the pressure solution dominates.

Fig. 20 Micrograph of the thin section prepared from the rock specimen used for the triaxial test shown in Fig. 19. The photo corresponds to the thin section of 23 mm wide. Vertical direction of the photo coincides with the loading axis. Test piece was impregnated with blue resin before preparation of the thin section.
