| Title | NON-DESTRUCTIVE TESTS APPLIED DURING REPAIR WORKS OF THE YODOGAWA BRIDGE |
| Description | The Thirteenth East Asia-Pacific Conference on Structural Engineering and Construction (EASEC-13), September 11-13, 2013, Sapporo, Japan. |

# NON-DESTRUCTIVE TESTS APPLIED DURING REPAIR WORKS OF THE YODOGAWA BRIDGE

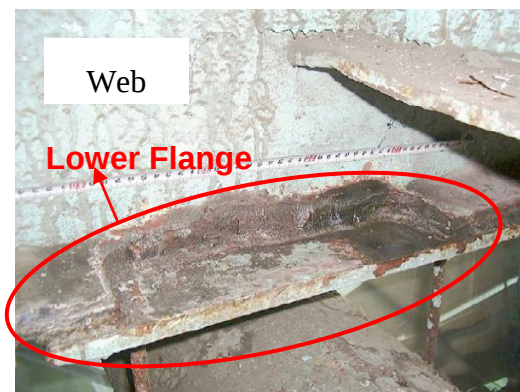
During inspections carried out in previous years, cracks were found at the lower flange of a transverse beam that had been reinforced in the past. In order to execute retrofit works in the damaged area, cracks and superficial flaws had to be removed so as to install new reinforcement plates.

**Figure 2: Existing reinforcement plate of transverse beam**

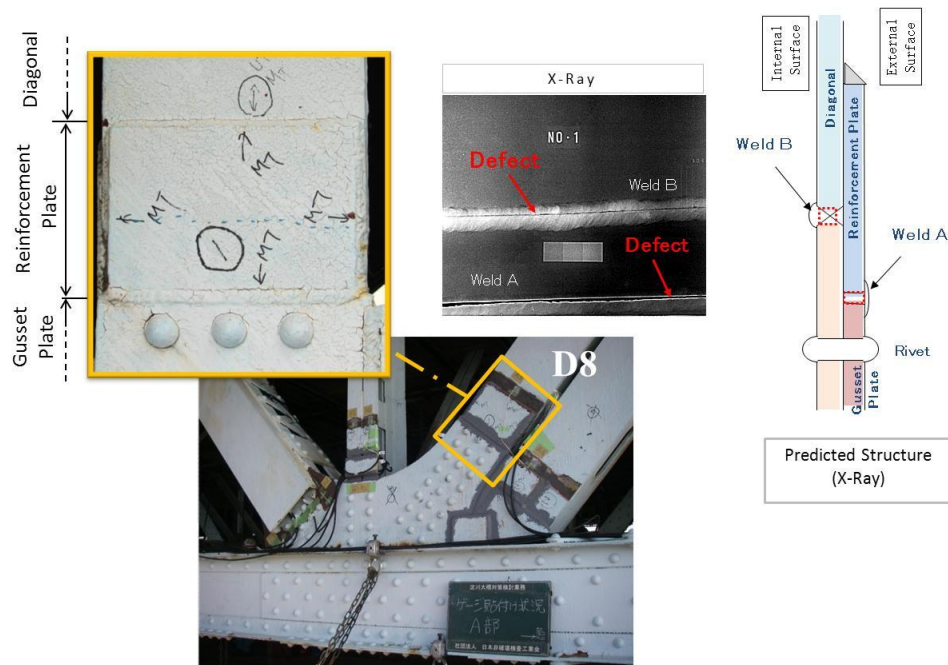
X-Ray test applying digital graphic processing system was applied to find out detailed conditions of butt welds connecting truss members and reinforcement plates that were not visible due to the complex structure of reinforcement works carried out in the past. In addition, an attempt to evaluate the depth of the defect through X-Ray was also made.

Figure 3: Example of existing reinforcement details in truss members

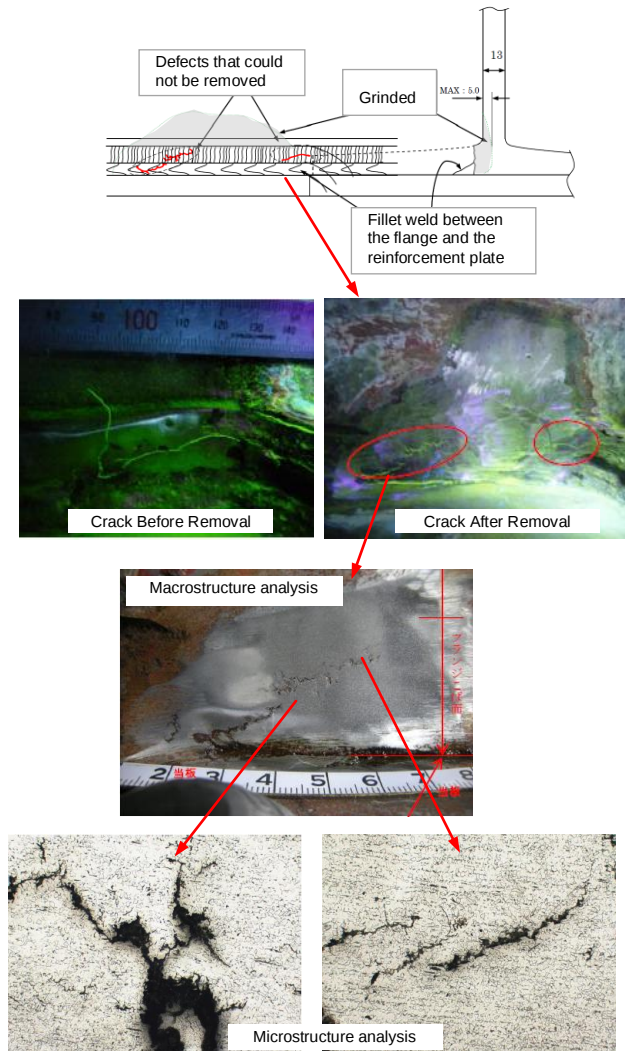
A cracks located at the vicinity of the reinforcement plate of the transverse beam were removed by grinding to a depth of 3mm. However, layers patterns in the steel rolling direction and small cavities could not be completely eliminated, even after grinding to a 5mm depth.

**Figure 5: Conditions of the weld at the transverse beam after crack removal**

The results of the macro- and microstructure analysis revealed that these flaws were probably originated during the fabrication process of the steel. The magnetic particle test patterns and macro- and microstructure images are shown in Figure 5.

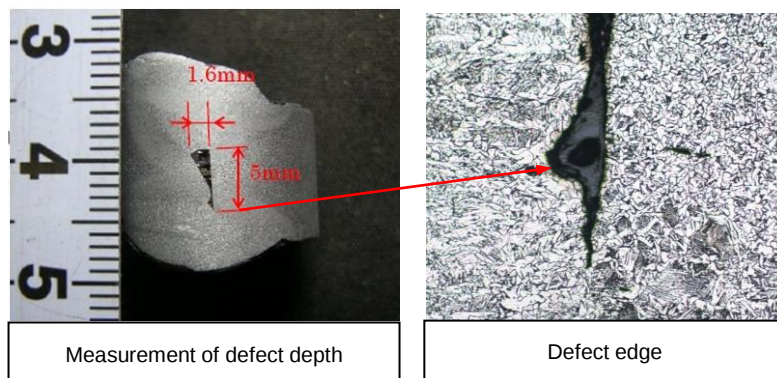
**Figure 5: Macro- microstructure analysis**

During the repair works on the lower flange of the transverse beam it was found that cracks in the vicinity of the welds could not be completely removed and defects in the form of layers remained in the thickness direction. Further investigations through macro- microstructure analysis proved that the defects found in the rolling direction of the steel were probably originated during the fabrication process of the steel.
