| Title | Strong-Motion Characteristics and Visual Damage Assessment Around Seismic Stations in Kathmandu After the 2015 Gorkha, Nepal, Earthquake |
| Author(s) | Bijukchhen, Subeg; Takai, Nobuo; Shigefuji, Michiko et al. |
| Citation | Earthquake Spectra, 33(S1), S219-S242<br><a href="https://doi.org/10.1193/042916EQS074M">https://doi.org/10.1193/042916EQS074M</a> |

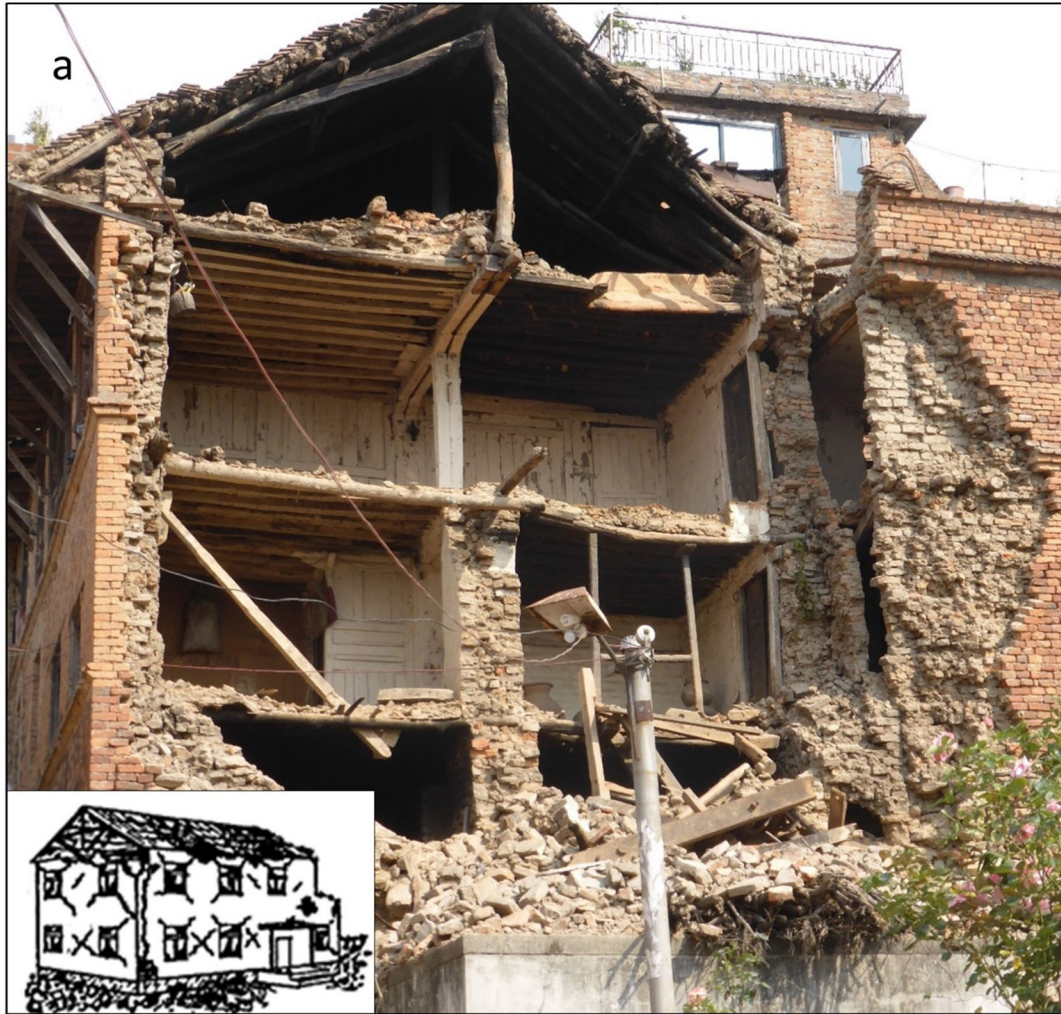
Though all RC infill frame buildings remained unscathed, one masonry mud-mortar building was heavily damaged. The three-story building built on a steep topography suffered

the collapse of the façade facing the slope (Figure 4a). Apart from this, instances of cracks in the inner walls (Figures 4b) were observed in few masonry buildings. We also found fallen roof tiles from some of these houses nevertheless, only less than 6% of total buildings suffered moderate to heavy damage during the earthquake.

**Figure 4.** (a) Heavily Damaged building with a façade collapse and, (b) cracks in wall inside of a Slightly Damaged building around KTP. The inset shows the diagram of corresponding damage grade (EMS 98).

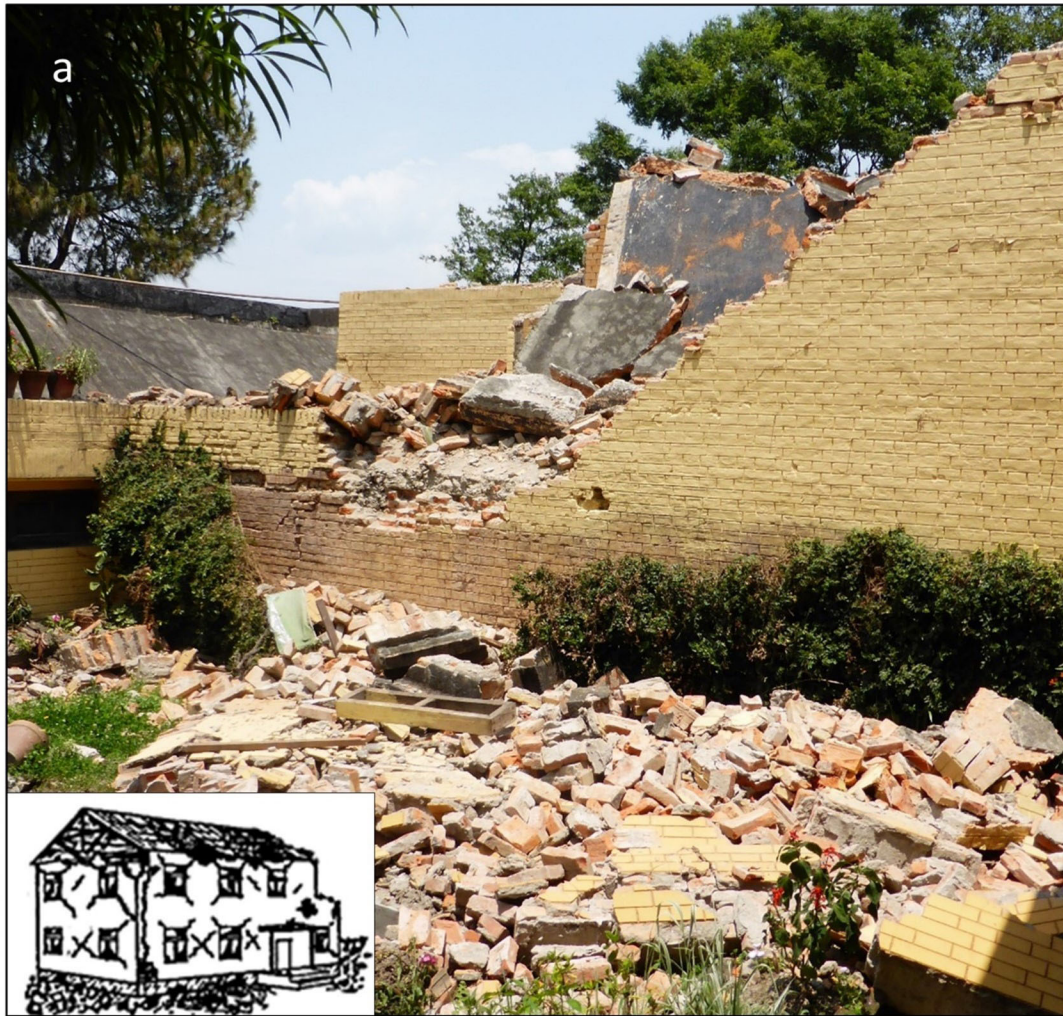
The station TVU is in the premises of the Tribhuvan University and is installed on the ground floor of a two-story RC infill frame building of the Central Department of Geology. There are only 19 buildings around it (Figures 5a) with none more than 2 stories tall. Statistically speaking, this site suffered the most damage (~10%) with slight damage observed in RC buildings as well (Figures 5a). A single story load bearing masonry cement mortar building built in late 1960s was heavily damaged. The walls and ceiling of the building collapsed making the building unsuitable for use (Figure 6a). Though most of the buildings around TVU are RC infill frame structures, slight damage like broken window panes and slight cracks on the ground floor was observed. There was damage to foundation and columns (Figure 6b) in some of the RC structures and a compound wall around one of the department buildings completely collapsed.

**Figure 6.** (a) Heavily Damaged masonry building and, (b) damage to foundation of Moderately Damaged RC building around TVU.

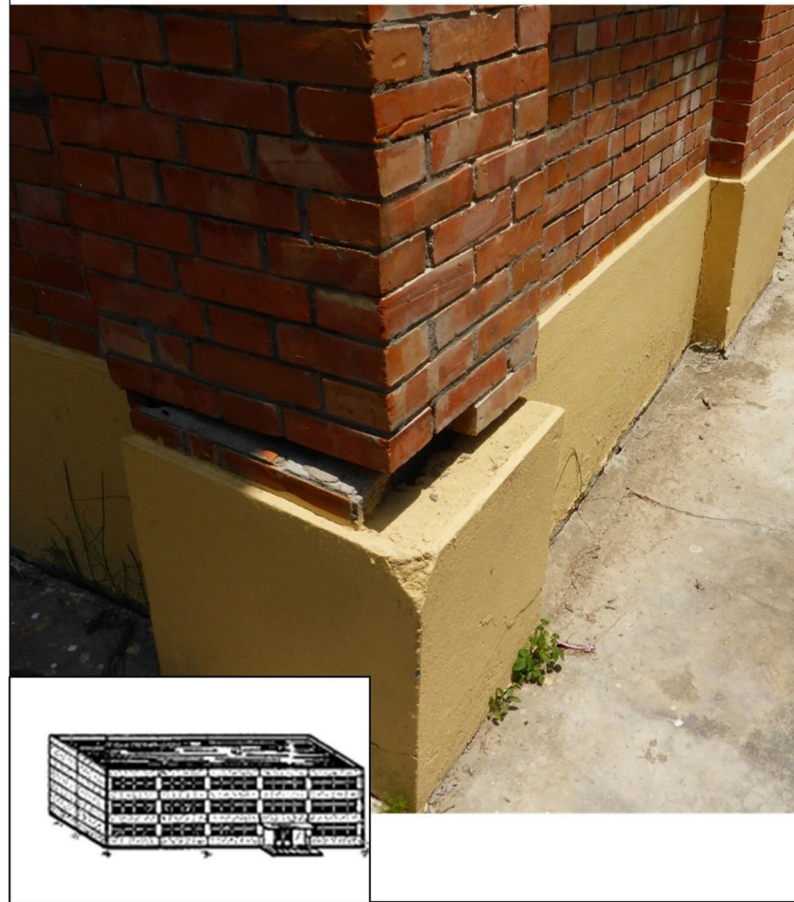
b

| Site | $I^*$<br>(1-2s) | $I_H$<br>(1-2s) | PGA<br>(cm/s <sup>2</sup> ) | Damage situation | No of<br>buildings | Damage<br>Ratio<br>(%) |
|---|---|---|---|---|---|---|
| TVU | 5.54 | 34.14 | 238 | Cracks in RC infill frame building foundations, one load bearing masonry building completely collapsed | 19 | 10.52 |

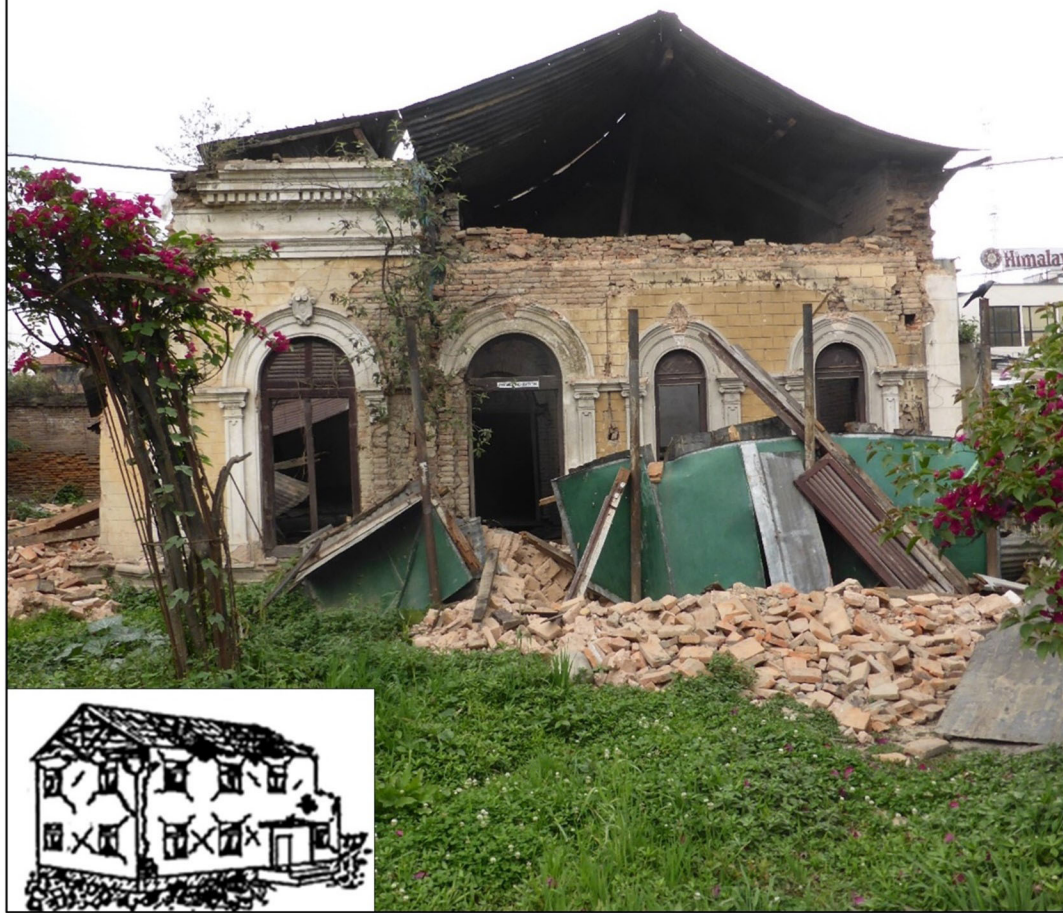
The majority of buildings inside the Institute of Engineering, Pulchowk Campus premises where PTN is installed, are predominantly load bearing masonry-cement mortar structures (Figure 7a). The station itself is set inside a single-story load bearing masonry cement mortar building. The buildings outside the campus premises are predominantly RC infill frame structures. Almost 9% of total buildings considered for the study, suffered moderate to heavy damage (Figure 7b). Two of the buildings that suffered damage were built with brick and lime mortar '*bajra*'. One of them being used as office suffered cracks in the walls and was evacuated following the earthquake. Another one story lime mortar building was heavily damaged (Figure 8a). Some of the RC infill frame buildings in the study area suffered cracks on the outer walls and beams. We observed a multi-story RC infill frame building with shear cracks on the outer façade (Figure 8b).

**Figure 8.** (a) Heavily Damaged masonry building with lime mortar and, (b) shear cracks developed in Moderately Damaged RC building around PTN.

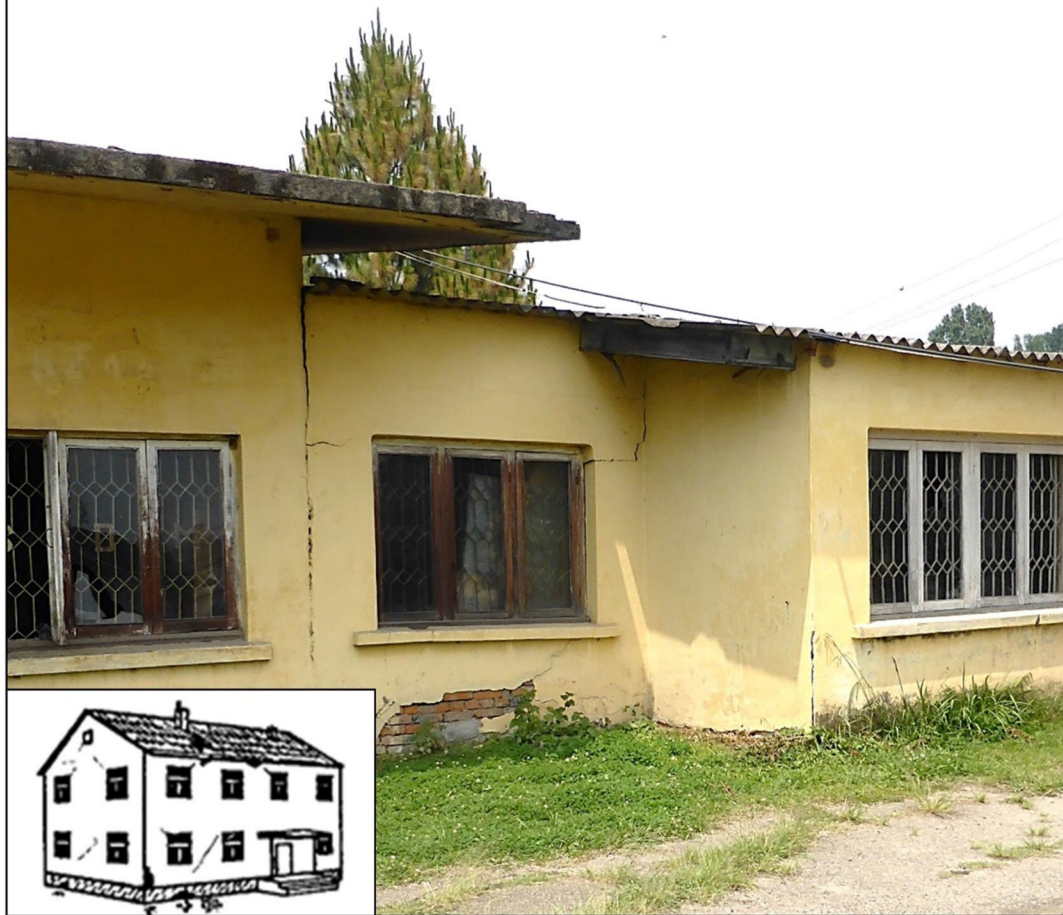
settlement, most of the buildings are RC structures but there are public buildings which are masonry structures (Figure 9a). This site suffered the least damage (Figure 9b) when compared to the other sites. A masonry school building suffered moderate damage and wall cracks (Figure 10a) were clearly visible. A few fallen tiles from the roof were also observed in another building of the same school. The compound walls around the school (Figure 10b) and around a government office collapsed after the earthquake.

**Figure 10.** Damage around THM, (a) Moderately Damaged masonry building and corresponding damage classification according to EMS98 in inset and, (b) collapsed masonry compound wall.

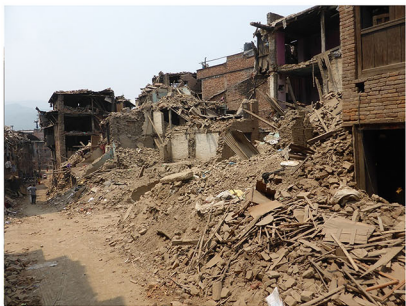
**a**

Many buildings in different parts of the Kathmandu Valley, like Bhaktapur, Gongabu, Sitapila, and Ramkot suffered heavy damage (Figure 14) due to the Gorkha Earthquake.

**Figure 141.** Damage to building in other parts of the Kathmandu Valley (a) Damage to masonry structures in Bhaktapur, (b) Tilted and damaged RC infill frame building in Gongabu, (c) Damaged RC infill frame structure in Sitapaila and, (d) collapse of RC infill frame structure in Ramkot.

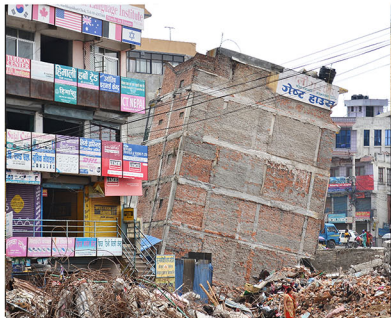
**b**

Several buildings in Gongabu were tilted due to liquefaction and many RC buildings completely collapsed. A team of researchers (Angster et al. 2015) traced an extension of a localized lineament in an area lying south-west of THM and they attributed the origin of the lineament to geological condition and earthquake shaking. These worst-hit areas of Kathmandu unfortunately did not have seismic stations nearby so the assessment on those areas has not been carried out for the present study due to lack of strong-motion data to compare the damage. As basin topography and sediment in the Kathmandu Valley is very heterogeneous, the response of sites merely few hundred meters apart vary a lot, so generalizing the response might not produce accurate results.
