| Title | 平成29年度の活動 国際交流：ニュージーランド・カイクウラ地震に関する調査 |

## Landslide dams caused by the M7.8 Kaikoura Earthquake

### 1. Hapuku (42°14.636'S, 173°40.192'E)

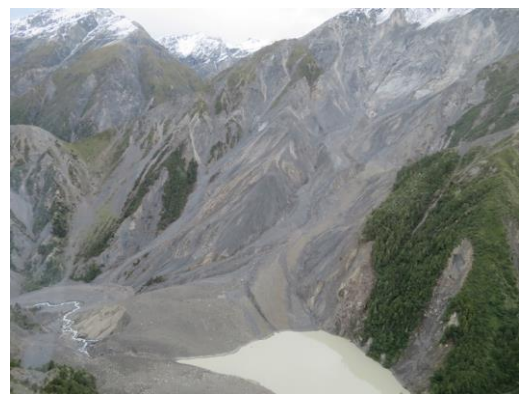
The landslide dam on the Hapuku River (Fig. 1) was the highest (about 150 m high) of the dams triggered by the M7.8 Kaikoura earthquake and covered an estimated 656,430 m<sup>2</sup>, with 12,000,000 m<sup>3</sup> of collapsed rock (Rosser, 2017). The landslide was a rock avalanche. The bedrock geology of the watershed is dominated by greywacke (a variety of sandstone). Numerous shallow landslides also occurred along the Hapuku River. The main dam crest, which was monitored by a live camera installed by Kaikoura District Council, overtopped on 6 April 2017, after which the water level of the lake behind the dam decreased rapidly, although it did not empty. Rapid increases in flow depth due to the overtopping were observed about 11 km downstream from the dam, at State Highway 1, on a water level recorder installed and operated by NZTA.

Fig. 1 Landslide dam on the Hapuku River
