Geo-Disaster Report

# Reconnaissance report on geotechnical damage caused by 2018 Hokkaido Eastern Iburi earthquake with JMA seismic intensity 7

Tatsuya Ishikawa<sup>a,\*</sup>, Masayuki Yoshimi<sup>b</sup>, Koichi Isobe<sup>a</sup>, Shoji Yokohama<sup>a</sup>

<sup>a</sup> Faculty of Engineering, Hokkaido University, Japan

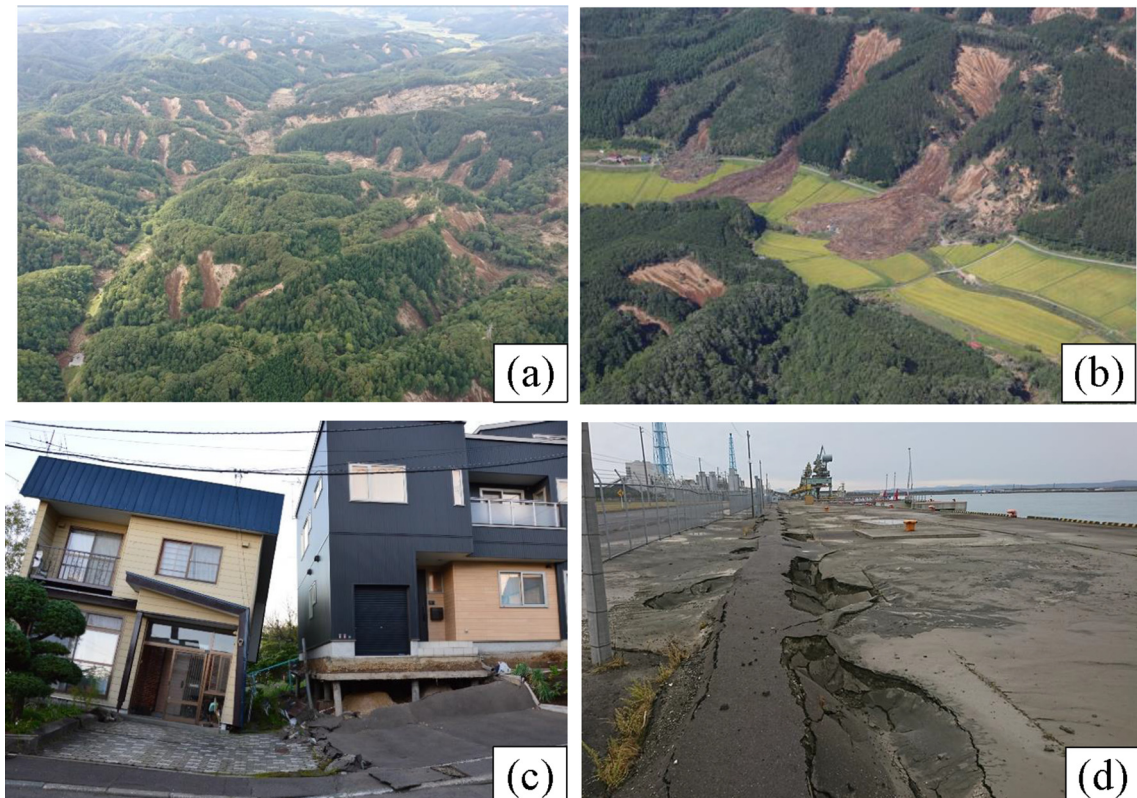
Fig. 12. Geotechnical damage caused by the 2018 Hokkaido Eastern Iburi Earthquake: (a) slope failures in Atsuma (Fig. 5), (b) slope failures with sediment flow in Atsuma (Fig. 5), (c) tilted house on the belt-shape depressed area due to liquefaction without sand boiling in Sapporo (Fig. 1), (d) uneven subsidence of road due to liquefaction with sand boiling in Tomakomai (Fig. 1): (a), (c), and (d) taken by Watabe, Y., Hokkaido Univ.; (b) provided from Japan Asia Group, PASCO Corporation.

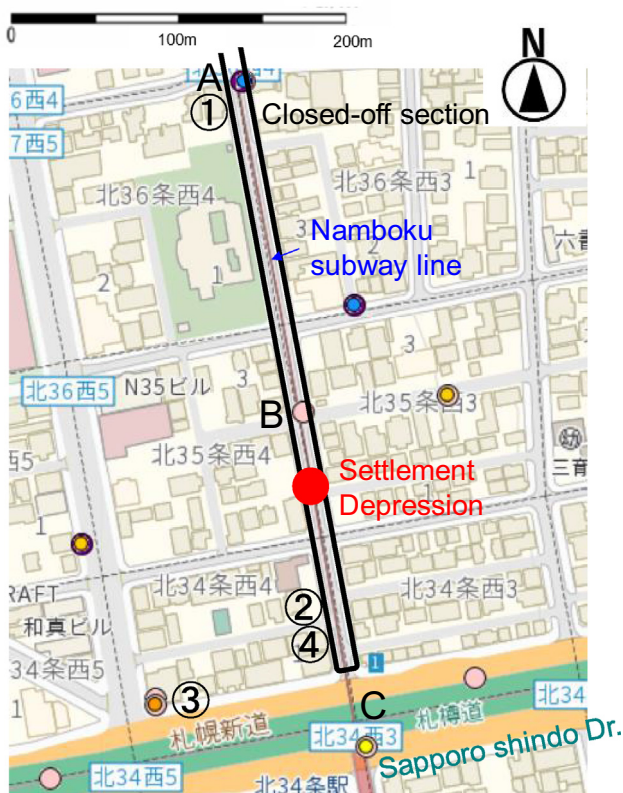
Severe liquefaction induced settlement of the road above the subway line was observed in the area around Kita 34 Station of the Namboku line in Kita-ward and the Higashi 15-chome Tonden street in Sapporo City after the earthquake, as shown in Fig. 13. A field investigation was conducted on September 8–9th 2018 corresponding to 2–3 after the earthquake.

Fig. 14. Closed-off section and damage situation around Kita 34 station of Namboku subway line in Kita ward, Sapporo with the map by G-Space II.

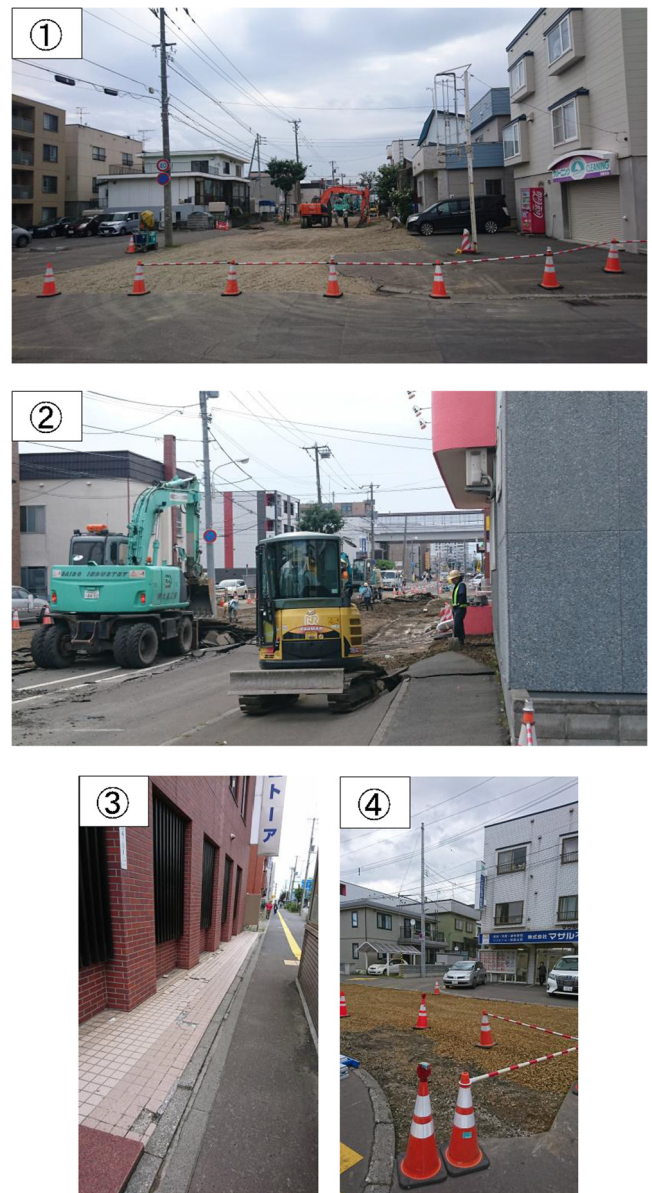
Fig. 14 shows the closed-off sections near Kita 34 Station and the locations where settlement and depressions after the earthquakes were observed. Fig. 15 shows the situation after the earthquake, taken from the location of the numbers shown in Fig. 14. Two days after the occurrence of the earthquake, repair work had already started on the road above the Namboku subway line, and a prompt response was being implemented for emergency restoration. On the other hand, as shown in the picture taken from No. 3, although slight deformation was seen on the foundation tiles of the building facing Sapporo Shindo drive, no noticeable damage was seen in Sapporo Shindo drive or

to the sidewalks. Thus, it was found that the damage was concentrated on the road above the Namboku subway line.

Fig. 15. Damage situation near Kita 34 Station two days after the earthquake (photo locations referred to Fig. 14).

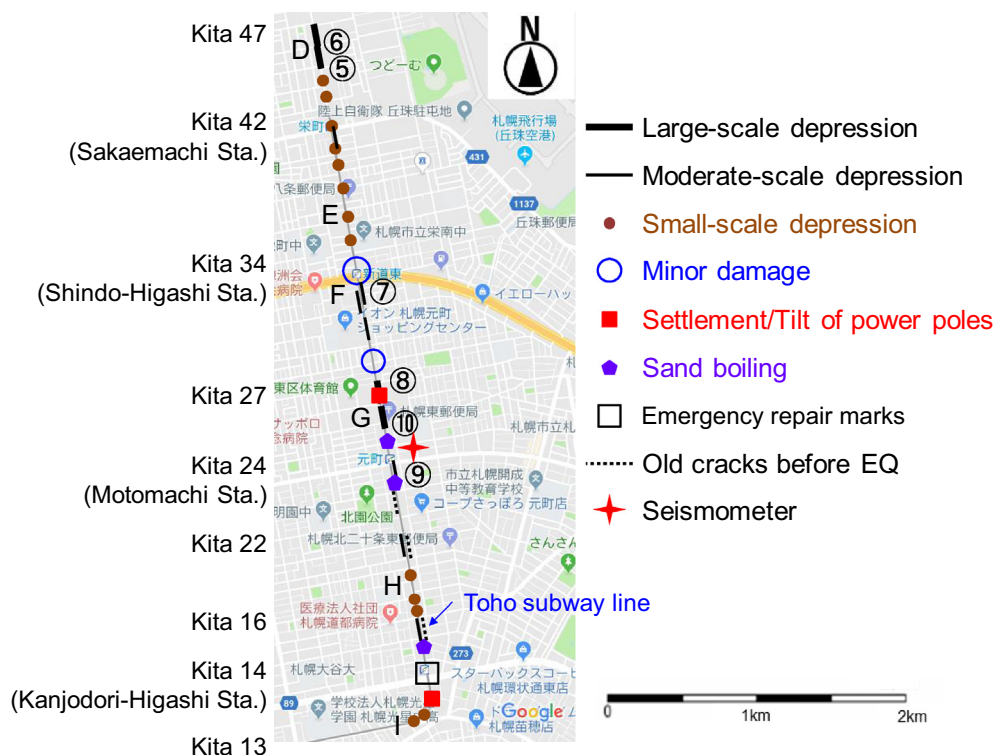
The damage situation in Higashi 15-chome Tonden Street above Toho subway line is shown in Fig. 17. In Higashi 15-chome Tonden Street, the road was damaged by liquefaction-induced settlement over about 4.4 km north to south around Kita 13 to Kita 47, and was closed except for some intersections. Temporary restoration started on the 7th of Sep. which is the day after the earthquake, and traffic was resumed sequentially as the temporary restoration was completed for each section, and full passage was possible around 5 pm on the 17th of Sep.

Fig. 17. Damage to Higashi 15-Chome Tonden Street with the map by Google.

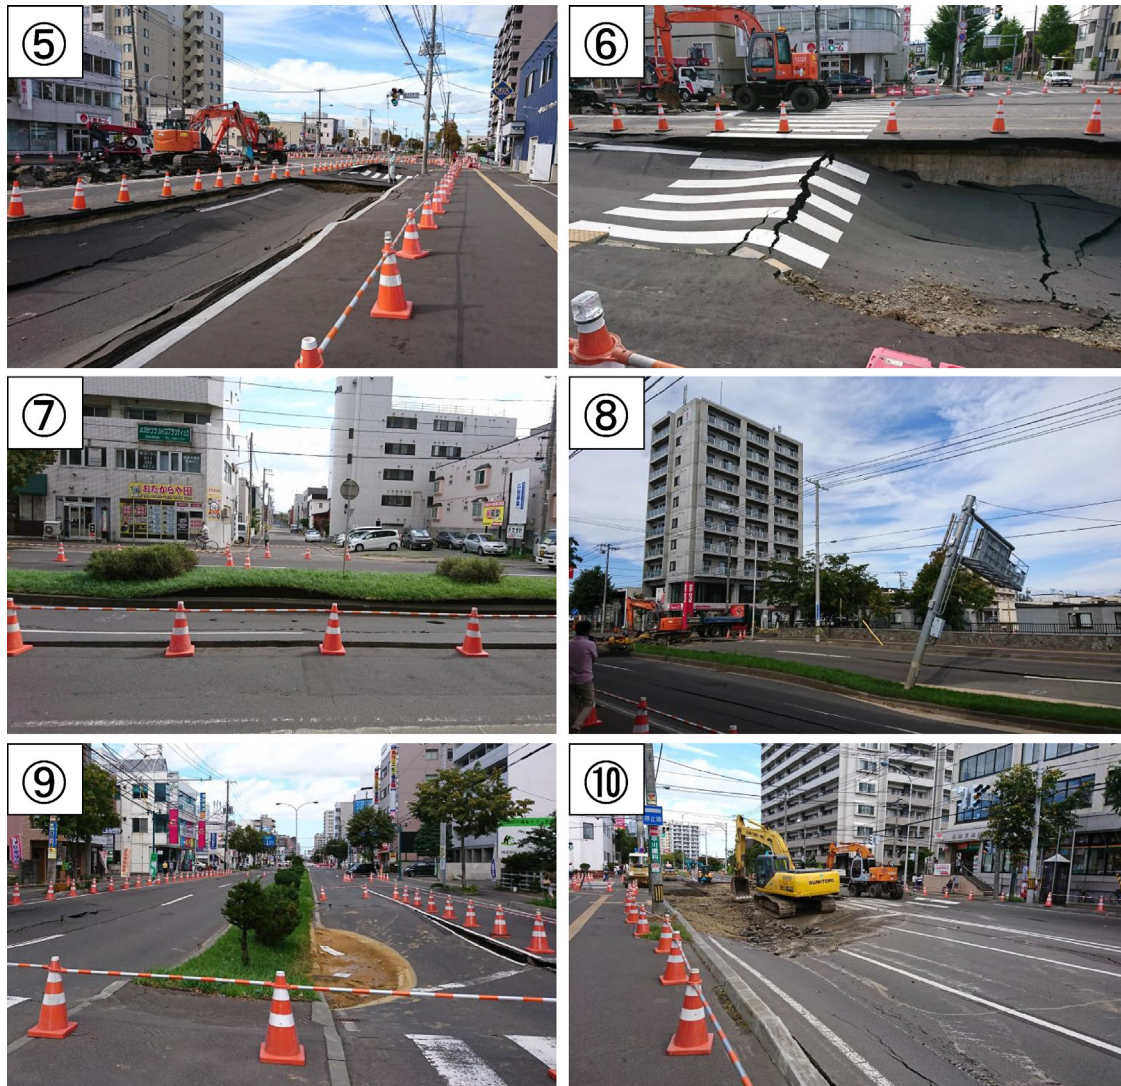
Fig. 18 shows the situation after the disaster at the location of the numbers shown in Fig. 17. Kita 47 to Kita 42 (Sakaemachi Station), which is the northernmost point in the damaged area of Higashi 15-chome Tonden street, experienced the most significant damage, with large-scale road settlement. As shown in Fig. 18 ⑤ and ⑥, up to about 1 m of road settlement and exposure of the buried structure were observed. In addition, the settlement and depressions of not only the driveway but also the sidewalk could be confirmed. The road depressions were concen-

Fig. 18. Damage situation along Higashi 15-Chome Tonden Street two days after the earthquake (photo locations referred to Fig. 17).

trated on the Toho subway line, since the location corresponds to the location of the sidetrack of the Toho subway line.

From Kita 34 (Shindo Higashi Station) to Kita 27, settlement of the road occurred near the median, and long cracks occurred along the settlement along the road as shown in Fig. 18 ⑦.

From Kita 27 to Kita 22 including Motomachi station, the occurrence of large-scale road collapse and the inclination of road signs was observed along with sand boiling, suggesting that liquefaction occurred. Also in the area, a seismic intensity of 6 or less was observed with a seismo-

From Kita 22 to Kita 16, the occurrence of small-scale road settlement and sand boiling were observed, suggesting that liquefaction occurred. Repair marks for old cracks were found in the area, and it is considered that road deformation had occurred before the earthquake.

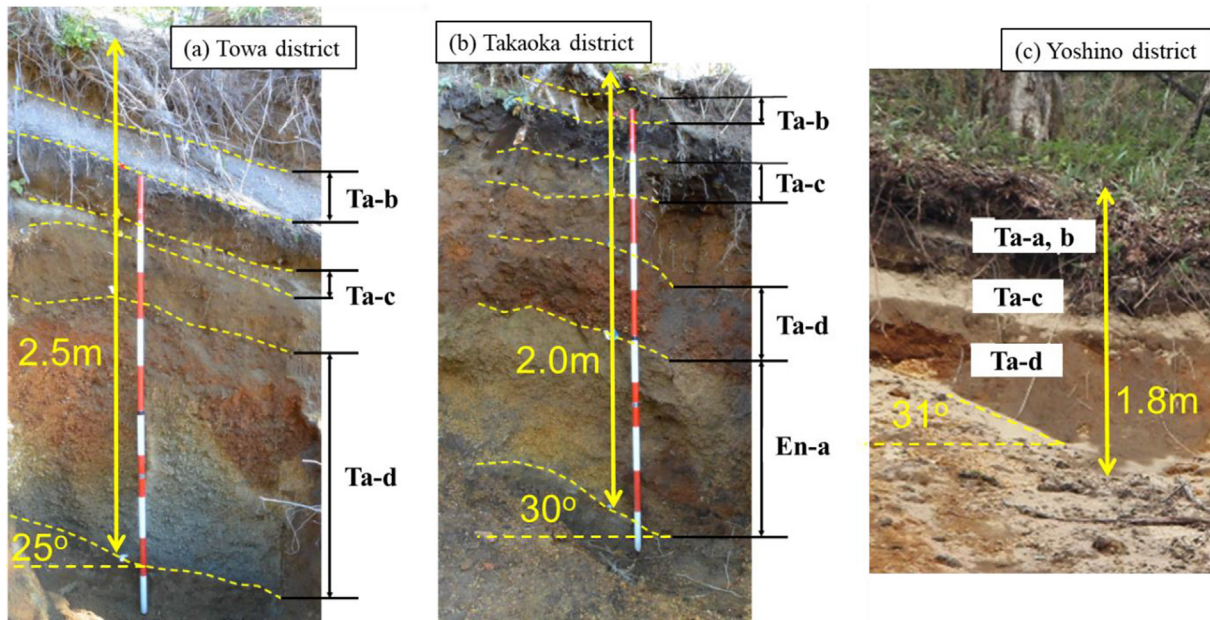
At the mountains and hills in the Atsuma River basin where a large number of slope failures and landslides occurred, multiple layers of volcanic pumice fall deposits with different eruption periods mainly originating from Tarumae volcano, Eniwa volcano, and Shikotsu volcano are widely distributed on sedimentary rocks. Among these, the Shikotsu pumice fall deposit (Spfa-1) erupted from the Shikotsu caldera about 46,000 years ago, and the Eniwa

pumice fall deposit (En-a) erupted from the Eniwa volcano about 20,000 years ago. Four kinds of pyroclastic fall deposits erupted from the Tarumae volcano (Ta-d, Ta-c, Ta-b, and Ta-a) about 9000 years ago, about 2000 years ago, in 1667 CE, and in 1739 CE, respectively. By observing the stratigraphic structures at many slope failure sites (Fig. 23), little disorder of the strata due to crustal movement and landslides was observed. This means that slope failures due to large earthquakes with the same magnitude

Fig. 23. Stratigraphic situations at slope failure sites in Atsuma: (a) Towa district, (b) Takaoka district, (c) Yoshino district (locations of each district referred to Fig. 24).

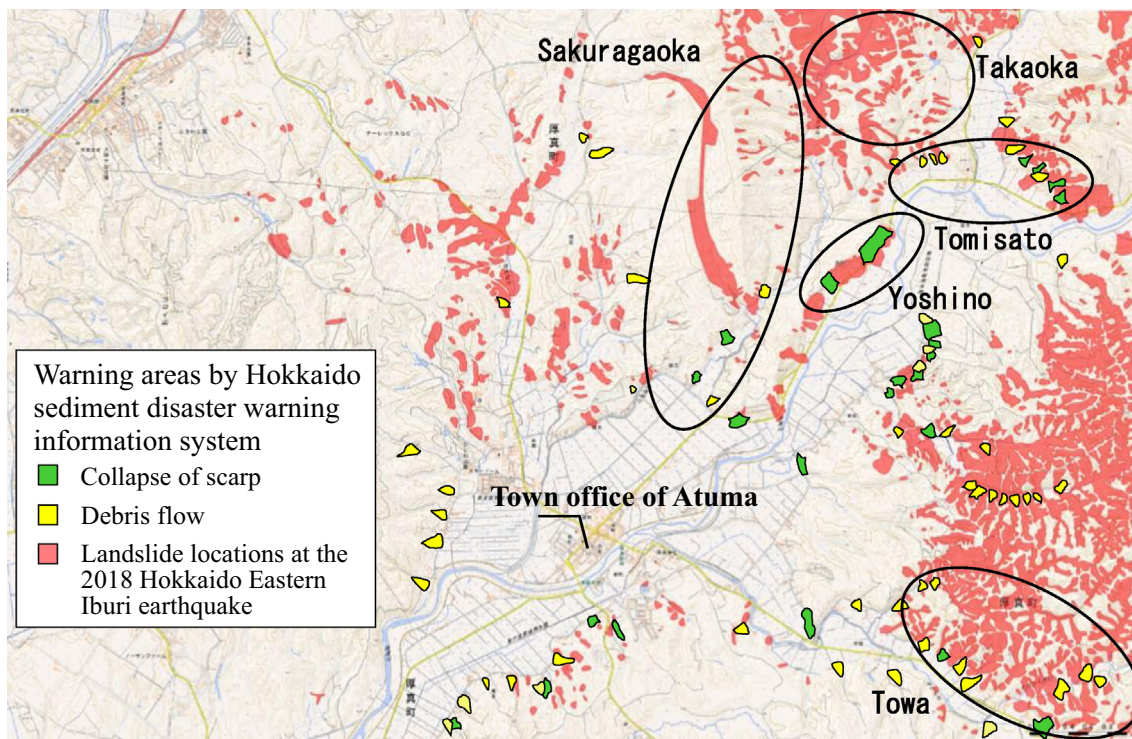
as the 2018 Hokkaido Eastern Iburi earthquake have not occurred for a long time. Fig. 24 compares the slope collapse locations at the 2018 Hokkaido Eastern Iburi earthquake and the sediment disaster warning areas due to heavy rainfall in Atsuma. Though the latter partly overlap with the former, regrettably it is not appropriate to use the map for sediment disaster warning areas as the risk assessment of slope failure during an earthquake. Therefore, it is necessary to discuss and to propose new prevention and

Fig. 24. Comparison the landslide locations at the 2018 Hokkaido Eastern Iburi earthquake (GSI, 2018) with the sediment disaster warning areas in Atsuma (Hokkaido, 2018b).

mitigation measures for geo-disasters against earthquake motion beyond expectations keeping in mind that past experiences are not useful indicators.

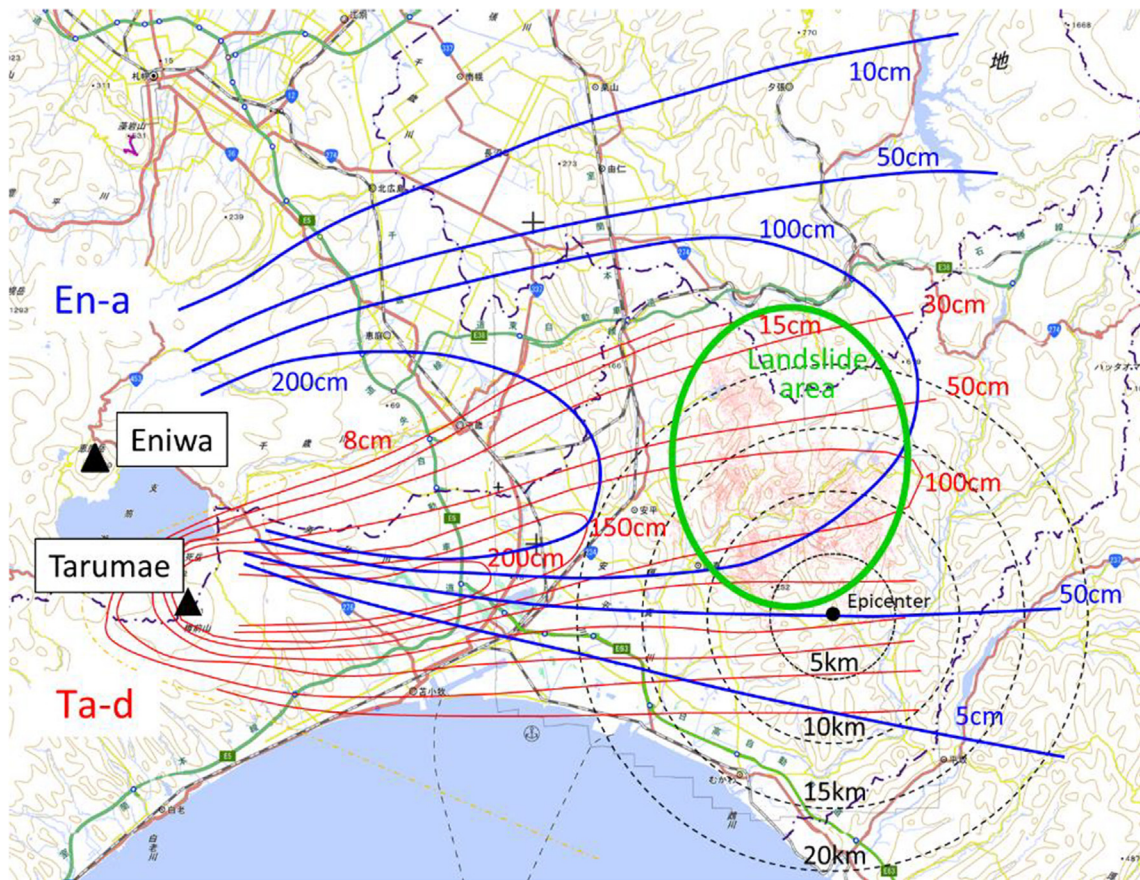
Fig. 25. Distribution area and thickness of pyroclastic fall deposits from Tarumae and Eniwa volcanos with landslide distribution (GSI, 2018).

The other factor is the difference in the deposition status of volcanic pumice fall deposits depending on the distance and direction from the eruption source. Fig. 25 shows the distribution area and thickness for two kinds of the pumice fall deposits which erupted from the Tarumae volcano (Ta-d) and the Eniwa volcano (En-a), respectively. The total thickness of En-a and Ta-d is approximate 100–200 cm at the slope failure locations in Atsuma town, while the thick-

ness is thinner at the area where little slope failure was seen. From these facts, it is obvious that many slope failures occurred in the distribution area with thick pyroclastic deposits. When conducting the slope stability analysis under the assumed calculation conditions shown in Fig. 26 by referring to Amemiya (2019), the depth of the slip surface of the collapsed slope with a 25–35 deg range in the slope angle, which were frequently observed in Atsuma town, is between 1.5 m and 3.5 m. According to an estimation by the Ministry of Land, Infrastructure, Transport and Tourism (MLIT, 2018), the scale of slope collapses due to the 2018 Hokkaido Eastern Iburi earthquake was as follows: (a) the amount of collapsed sediment: 30.0 million  $\text{m}^3$ ; (b) the collapsed area 13.4  $\text{km}^2$ . The average collapse depth estimated from the amount of collapsed sediment and the collapse area is about 2.2 m. In addition, according to the results of field investigation, though the slip surface position varied depending on the location, in most cases the collapse depth was approximately 2–3 m in places where Ta-d and En-a are deposited. From these results, it is recognized that the depths of all the slip surfaces was similar, indicating that the slope failures seen around Atsuma town were strongly influenced by the geological structures. Therefore, it is necessary to discuss and to propose prevention and mitigation measures

for earthquake-induced slope failures by considering both the amplification-attenuation characteristics of the local site and the geological structures.
