Report on the 2014 Winter Cyclone Storm Surge in Nemuro, Japan

From Tuesday, December 16, 2014, until Thursday, December 18, Hokkaido was battered by strong winds and high sea waves caused by a passing low pressure system intensified to typhoon levels. In the city of Nemuro, a rise in sea level influenced by the storm surge which exceeded quay height in port areas was observed from predawn Wednesday, December 17, 2014. Flooding was experienced in areas of central Nemuro, the Nemuro Port and estuaries of rivers. This technical note provides a comprehensive meteorological analysis and the results of a local flood survey carried out by the authors from December 19 to 21, 2014, and summarizes the characteristics of the 2014 Nemuro storm surge disaster.

Keywords: 2014 Nemuro storm surge, inundation, river flooding

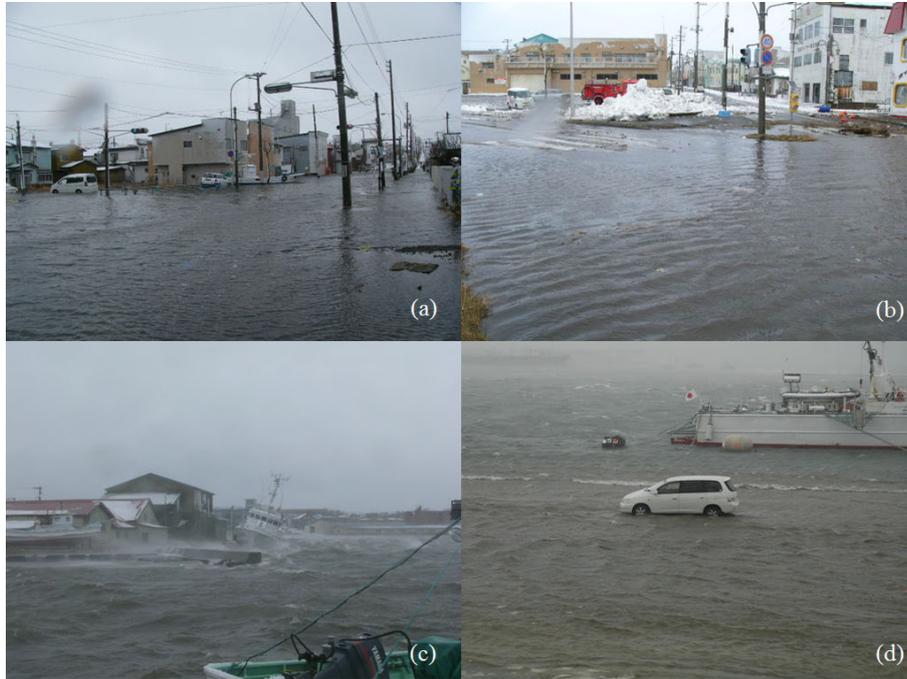
Fig. 2. Photographs of (a)–(b) inundated streets in central Nemuro (locations indicated in Fig. 10), and (c)–(d) inundated quays in the Nemuro Port (locations indicated in Fig. 9). Fishing boats and cars were drifted by the flood. All photos were taken by the Hokkaido Regional Development Bureau during the flood event on December 17, 2014.

towns), causing about \$20 million damage to ports and harbors, fishery facilities, commercial buildings, fishing boats, residences and vehicles (Fig. 2). An overview of the flood damages was reported by the Hokkaido Regional Development Bureau [Hokkaido Regional Development Bureau, 2015].

Fig. 10 shows the runup area and inundation heights in urban areas of Nemuro (Yayoi and Midori towns) where significant flood damage to houses and shops occurred. Seawater flew and spread through sloping streets (see Fig. 2 a and b), causing

above floor and underground inundation, damage to fishing boats and equipment (Fig. 2), and sewage blockage. We estimated a 1.8-2.1 m deep (T.P.) flood covering approximately 7 ha over streets with a relatively low ground level (Fig. 10).

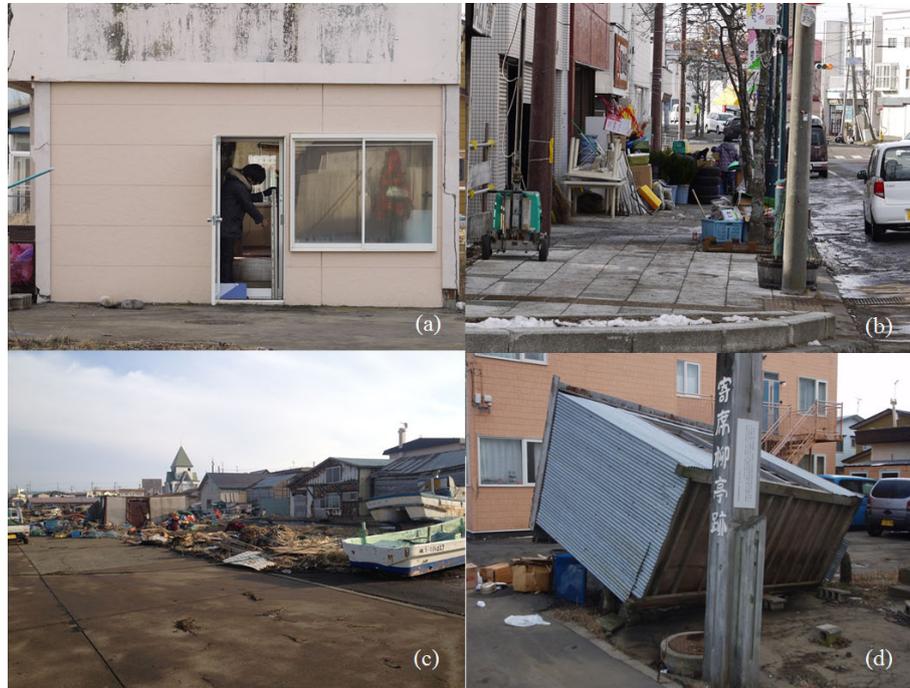
Fig. 7. Photographs of streets in central Nemuro after the disaster: (a)–(b) inundated houses and shops, (c) debris and a fishing boat brought ashore, (d) fallen shed (locations shown in the photos in Fig. 10). All photos were taken during the survey on December 20, 2014.

because the cleaning works of the affected areas were not sufficiently advanced, large amounts of debris carried inland by the storm surge remained untouched (see Fig. 7 and Fig. 8). Additionally, watermarks in buildings, indicated by locals who witnessed the event, were still visible (Fig. 7 a). There were, thus, a number of traces of flooding. For instance, lines of debris from which no debris were observed further upstream were clear vestiges of the extent of the runup (Fig. 8 a and b).

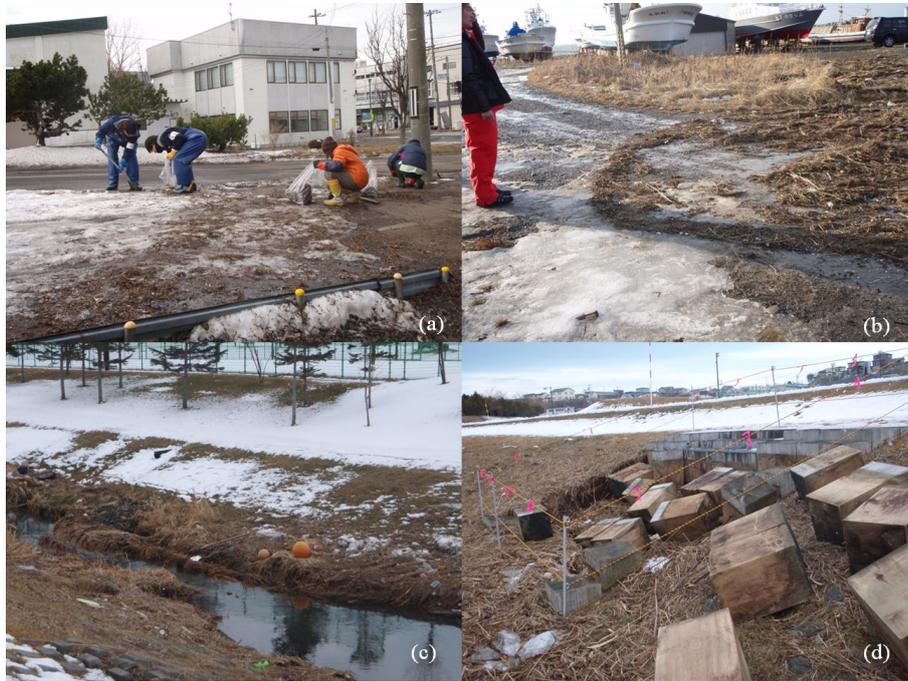
Fig. 8. Debris brought ashore by (a) high tide at Site 4 (see map in Fig. 9) and (b) by wave overtopping at Site 8 (see map in Fig. 10), (c) debris and buoys transported through Hattari River and (d) wooden river-side benches plucked out due to buoyancy (see map in Fig. 11). All photos were taken during the survey on December 20, 2014.

Flooding was also observed around the mouth and downstream areas of Hattari River, which flows through Misaki and Nishihama towns (Fig. 8 c and d). Since the hourly precipitation (snowfall) during the storm surge was less than 1.5 mm, river swelling was not significant. Increased seawater level due to the storm surge spread upstream (Fig. 11) and caused the flood. The inland runup possibly reached approximately 1 km. As in general tropical cyclones accompany heavy rain and cause river flood ([Dietrich et al., 2010; Fritz et al., 2010]), river propagation of the tide had yet to be explicitly observed. A storm tide propagation in the river, which potentially extends the flood area inland away from the coast, is a disaster scenario which should be taken into account for warning and evacuation in future storm surge events.

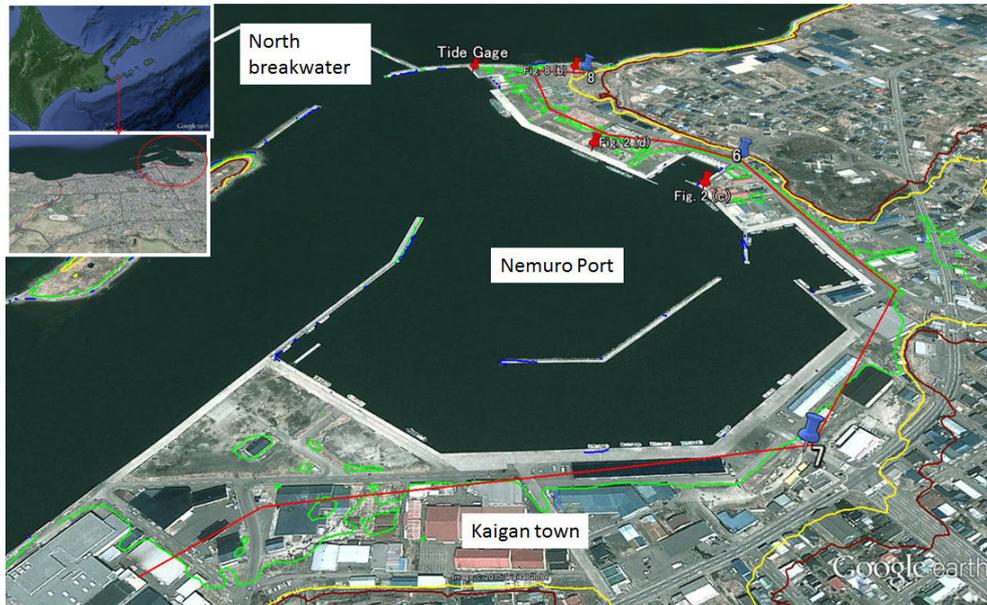
component of approximately 1.8 m (T.P.), Fig. 9) covering approximately 15 ha took place in the pier and other areas surrounding the Nemuro Port, which is located at the lowest ground level of the city. In the present survey, debris from the flood were found at T.P. 3.55 m at site 8, which is located behind the north seawall of the Nemuro Port (Fig. 9 and also Fig. 8 b). Since the traces at site 8 were more than 1 m higher than the highest inundation level of TP 2.24 m observed among the other surveyed sites at Nemuro Port (sites 6 and 7 in Table 1), the flooding at site 8 is attributed to high overtopping waves which developed outside of the port. Seawater influx overtopping the seawall crest (height of 3.13 m) above the sea level rise during the storm surge was found to have inundated areas adjacent to the seawall. No other place affected by overtopping was observed, as the multiple breakwaters surrounding the port, shown in Fig. 9, intercepted the northerly ocean waves from propagating to the affected areas. Thus overtopping waves were effectively reduced and extra damage may have been minimized.

Fig. 9. Estimated runup limits (indicated by a red line) and surveyed sites at Nemuro Port. Flood heights at Sites 6–8 are listed in Table 1. The locations where the photographs of Fig. 2 (c–d) and Fig. 8 (b) were taken and the location of the tide gage (Fig. 3) are indicated in the map. The ground elevation estimated from 5-m topographic data of the Geospatial Information Authority of Japan (GSI) is indicated by the blue (1 m), green (2 m), yellow (4 m) and brown (6 m) contours.

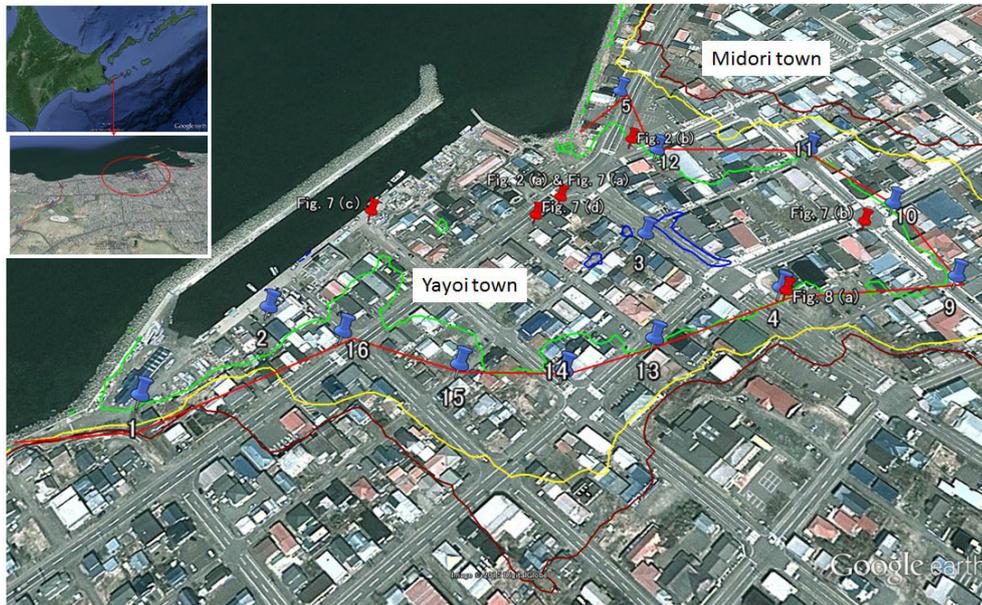
Fig. 10. Estimated runup limits (indicated by a red line) and surveyed sites at central Nemuro. Flood heights at sites 1 - 5 are listed in Table 1, and the locations of the runup limit sites are shown in Table 2. The locations where the photographs were taken (Fig. 2 a, b, Fig. 7 and Fig. 8 a) are indicated in the map. The ground elevation estimated from 5-m topographic data of GSI is indicated by the blue (1 m), green (2 m), yellow (4 m) and brown (6 m) contours.

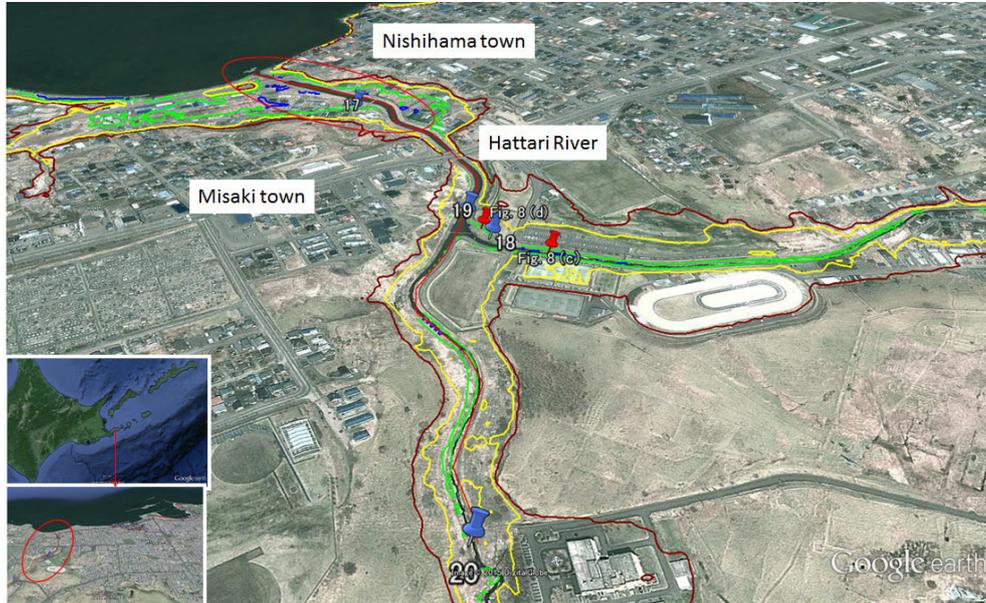
Fig. 11. Location of the survey (red line) and survey sites along Hattari River. The inundated area is marked by a circle. Site locations where debris were observed are shown in Table 2. The locations where the photographs were taken (Fig. 8 c, d) are indicated in the map. The ground elevation estimated from 5-m topographic data of GSI is indicated by the blue (1 m), green (2 m), yellow (4 m) and brown (6 m) contours.
