Geomorphic Process and Natural Revegetation on Landslide Scars in Teshio Experiment Forest, Hokkaido University

Marlon AIPASSA* and Osamu SHIMIZU*

Abstract

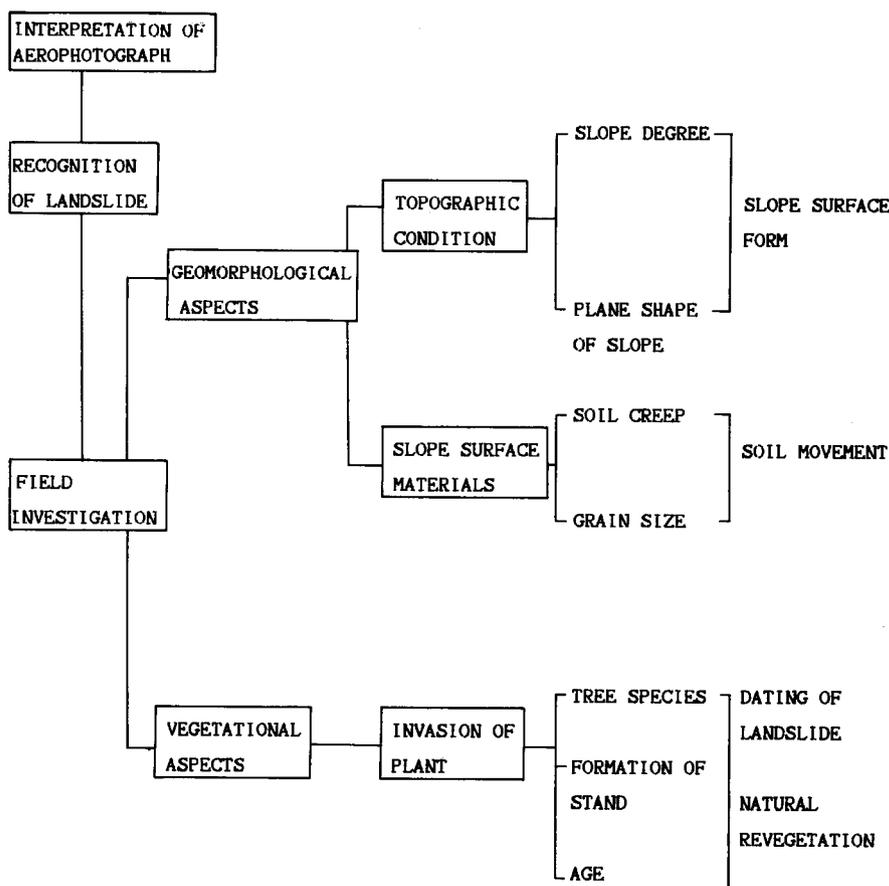
Fig. 1. Study method.

geomorphology condition such as the rupture of slope, main scarp, cliff, longitudinal slope surface form, deposited slope debris etc., and vegetational condition including the formation of natural revegetation, the curvature of trunk etc. was undertaken (Fig. 1).

Geomorphological investigation consists mainly of two works, namely the observation of topographical characteristics and the analysis of the nature of soil movement. In order to recognize slope surface forms, the measurement of microtopography, involving the degree of slopes, and the plane shape of slope including the length and width of slopes, was carried out. Besides the characteristics of topographical condition, the slope surface materials were also analyzed. Other elements observed in the analysis of soil movement were soil creep measurement and the analysis of grain size distribution of slope materials. The soil creep measurement was only applied in serpentine area and was used in the examination of the slope degree and the water content in soil. Since the soil consists mostly of coarse particles which is somewhat deep, pegs for measuring soil creep could not be firmly embedded consequently no soil creep measurement was performed in the investigated site of mudstone area.

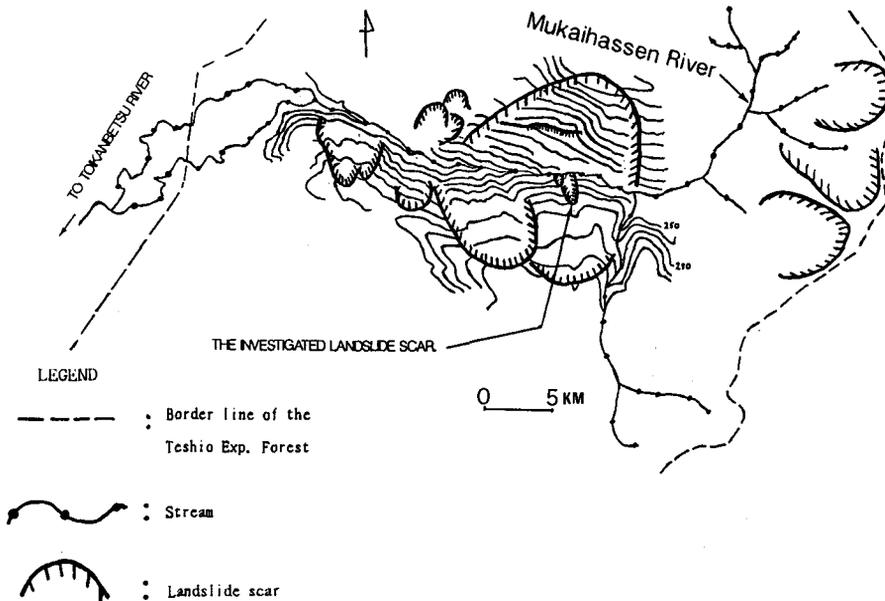
Fig. 3. Map of the investigated landslide scar in the serpentine area (S).

Figures 3 and 4 show the maps of the investigated landslide in serpentine and mudstone areas. The Mukaihassen River flows from the east side of the Teshio Experiment Forest passing a numerous landslide sites of various dimensions and finally ends in the

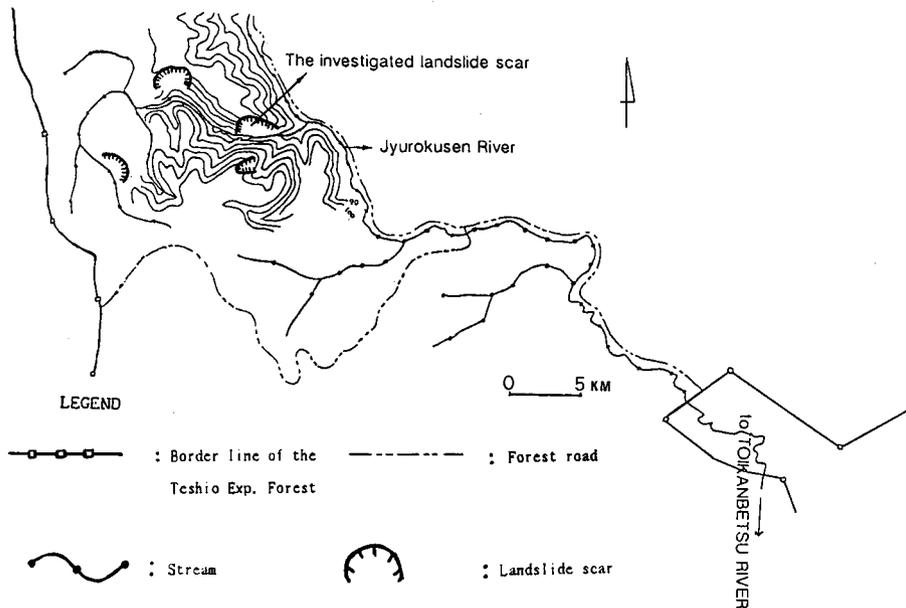
Fig. 4. Map of the investigated landslide scar in the mudstone area (M).

Toikanbetsu River. The right side of this river is largely covered by grassland and shrub, and most likely these are remains of burnt forest. Unlike in the Mukaihassen River, Jyurokusen River landslide sites are confined in number and are small in scale. This placid river flows from the west side of Teshio Experiment Forest to the east side and ends in the Toikanbetsu River.

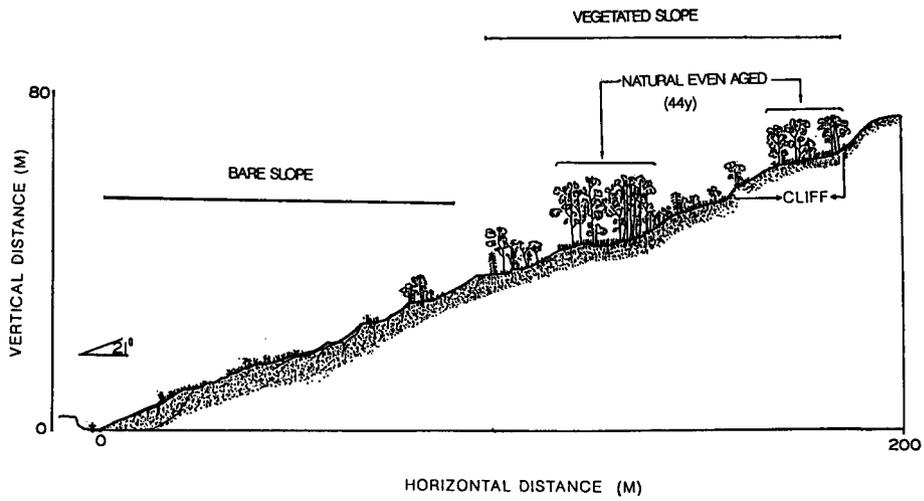
Fig. 5. Longitudinal profile of the landslide scar, investigated in the serpentine area.

Figure 5 shows the longitudinal profile of landslide scar investigated in serpentine area. Generally, the slope degree is more gentle than that landslide investigated in mudstone area. The mean slope degree is 21° . The extensive length of landslide scar slope was found to be around 190 meters and is composed of complex slope forms, such as concave, convex, and rectilinear forms. Besides these forms, cliff was found situated among them. The total dimension area of landslide is estimated to be approximately $14,000 \text{ m}^2$.

Through the longitudinal profile measured on the landslide scar at the vegetated slope site, there are at least two forms of terraced plane (Fig. 5) which exhibits gentle slope. On these sites invaded trees densely occupied and tend to form a uniformity of height, diameter and age which is usually termed as natural even-aged stand. The distribution of the natural even-aged is not uniform on the whole slope but it is concentrated in a contour belt. The composition is dominated by *Betula ermanii* (44y) which shows high value either in diameter or height toward the other invaded trees, while *Sasa spp.* (about 2 m in height) was also densely found in the vegetated slope as the forest floor plant. The distribution of invaded trees seems to expand from the dense vegetated site to surrounding sites gradually as time passes by. The distribution of those pioneer trees is most likely promoted by the favorable land surface. A number of the seeds of anemophilous plant might reach the bare slope after landsliding on the relatively gentle slope, where the erosional forces seem to be not active, they were successful in the germination process. Besides *Betula ermanii* and other broadleaved trees, *Picea sp.* were also found in the vegetated slope site. However, they were limited in number although the surrounding mother trees are mostly consist of *Picea sp.* Perhaps, they were unable to compete in taking nutrient, light, and living space, just after landsliding when they began to invade together with those pioneer plants and

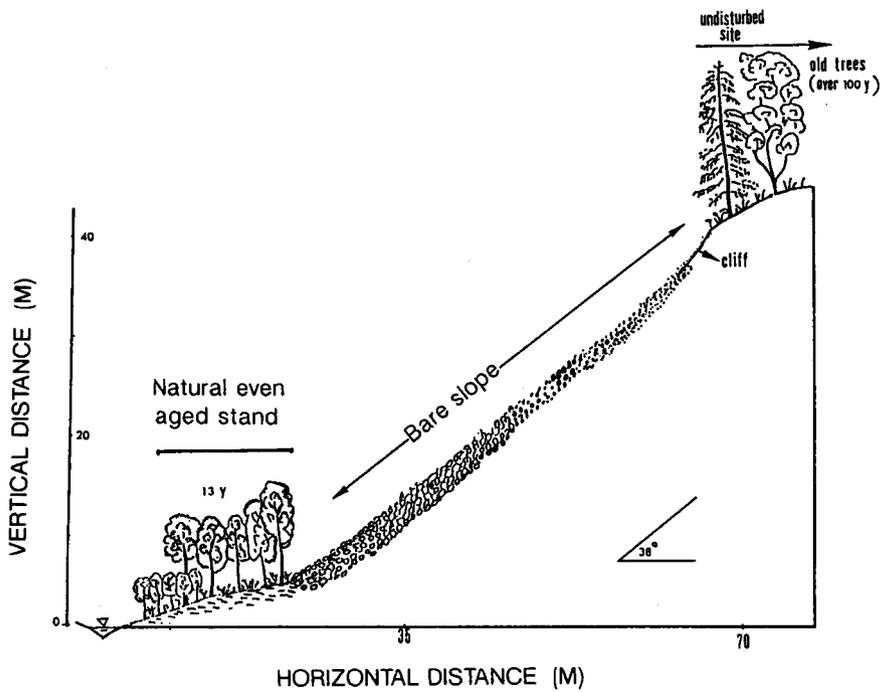
Fig. 6. Longitudinal profile of the landslide scar, investigated in the mudstone area.

Figure 6 shows the longitudinal profile of the landslide scar investigated in mudstone area. The total dimension area of landslide scar is smaller than that in serpentine area. It is estimated to be approximately $5,500 \text{ m}^2$ while the horizontal distance is estimated to be about 70 meters and exhibits steeper slope (38°) than that in serpentine area. The longitudinal profile is mostly rectilinear.

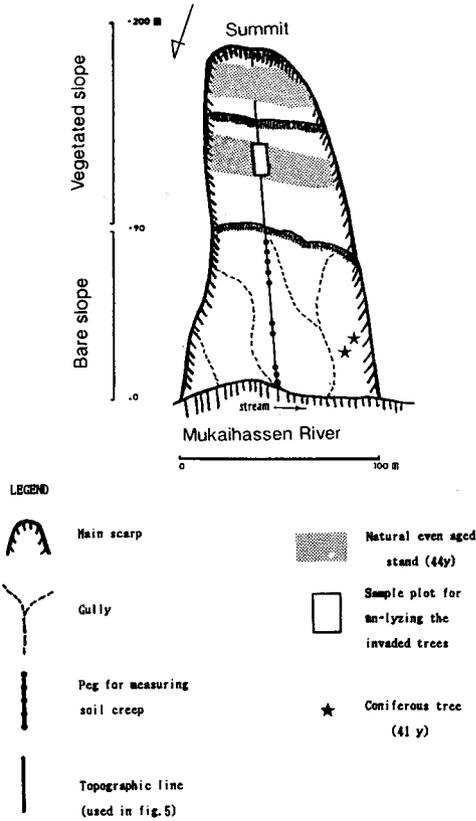
Fig. 7. Vertical view of the landslide scar, investigated in the serpentine area.

Vertical view of landslide scar investigated in serpentine area (Fig. 7) shows the distribution of invaded trees. The middle part to the summit of slope is densely covered by vegetation, while the downward part is almost bare on which small gullies develop from the summit of barren slope channeling to the stream. Based on the vegetational investigation carried out on the vegetated site of landslide scar, the composition of forest mostly consists of natural even-aged stand of *Betula ermanii*. This is the single dominant plant species and is mostly distributed and laterally expanded on the relatively gentle slope.

The natural forests in serpentine area consist of pure forest of *Picea glehnii* distributed along with some special floral communities. In a certain interval after landsliding, however, the composition of forest in landslide scar itself had extensively changed into pioneer tree vegetation. Most likely those pioneer trees began to invade landslide scar years after landsliding. Based on the condition of natural revegetation, landslide scar slope in this area can roughly be classified into two groups. First, the dense vegetated slope site situated on the upper part of slope and second, the bare slope situated on the lower part. The area of each distribution is almost equal (Fig. 7).

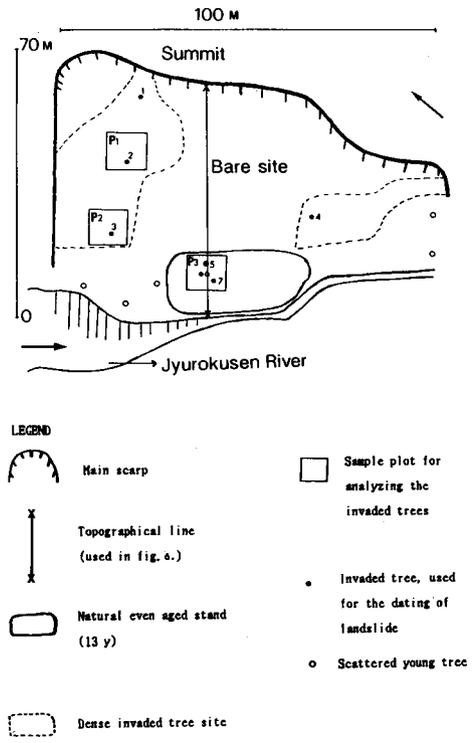
Fig. 8. Vertical view of the landslide scar, investigated in the mudstone area.

Figure 8 shows the distribution of invaded trees on the landslide scar, investigated in mudstone area. The distribution is not uniform. It is concentrated in the lower part of landslide scar slope up to the summit, which is bare in the centre part of the slope. The invaded trees growing on the landslide scar slope is shown in Tables 2 and 3. Deposited slope debris is formed in the downslope site and they partially blocked the stream on which natural even-aged *Salix sp.* was found. The number, diameter, height, average age of invaded tree is listed in Table 4. Some invaded trees on landslide scar were taken for the analysis of annual rings. The list is presented in Table 5.

Note: * The position of sample plot (P1) is presented in Fig. 8.

Note: * The position of sample plot (P2) is presented in Fig. 8.

Note: * The position of sample plot (P3) is presented in Fig. 8.

Note: The position of sample trees is presented in Fig. 8 (marked by code number).

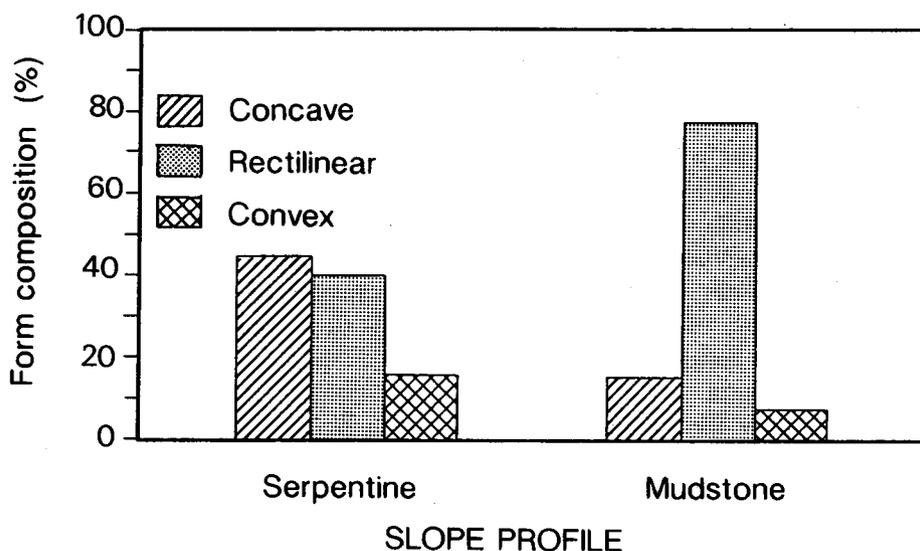
Fig. 9. Slope forms of the investigated landslide scars.

The coarse and consolidated particles are assumed to be the strong factor promoting the rectilinear slope form. The concavity, and convexity sections are conversely displayed at minimum since the downslope transportation of slope materials becomes more increased and so the slope load is moved downward straight without making any concave and/or convex slope profiles through the gravitational force. The proportion of slope profiles observed in the investigated sites is presented in Fig. 9.

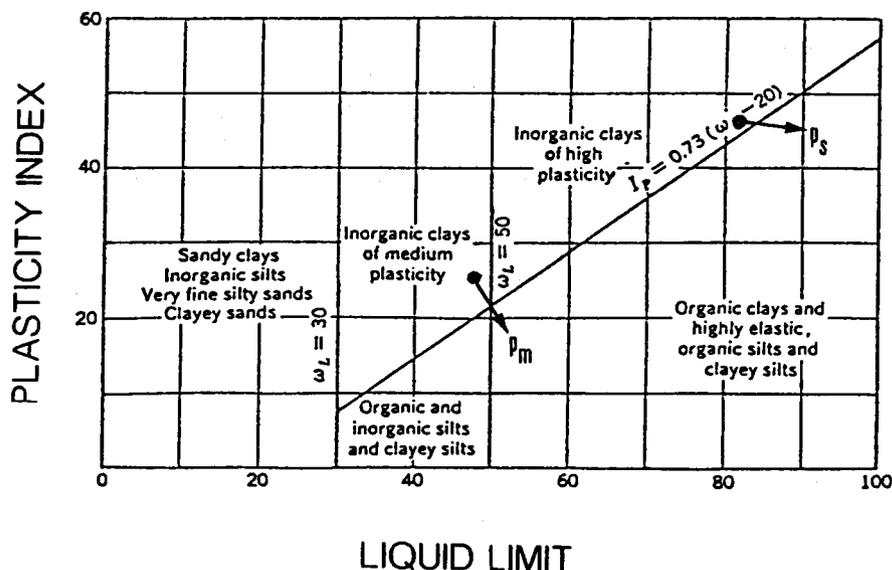
Fig. 10. Casagrande Plasticity Chart (after CASAGRANDE, 1948).

The slope materials of the landslide scar investigated in serpentine area were known to be mostly composed of fine material and somewhat impermeable. Based on the Atterberg Limits shown in Table 6, in serpentine area, plastic limit and both plasticity index and its range show high value. According to the Casagrande Plasticity Chart (Fig. 10), this soil is classified into an inorganic clays of high plasticity. This may indicate the increase of the bounding properties of fine clay and colloidal fraction of material. Accordingly, it may have high consolidation characteristics under stress (KAROL, 1960).

P_s and P_m are referred to the soil plasticity group, investigated in the serpentine and mudstone areas.

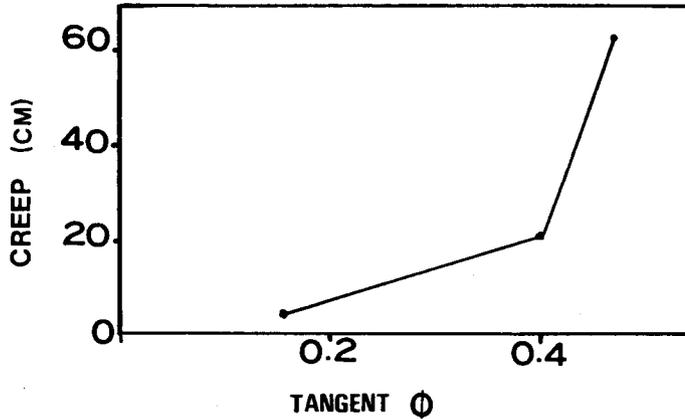
Fig. 11. Correlation of soil creep and slope degree, examined in the serpentine area.

The soil creep was found to vary according to the steepness of slope. In a slope of

more than 22° , soil creep was found to be 20.1 cm to 63.2 cm within a year, and in a slope of around 9° , soil creep was found to be about 5 cm (see Table 8). These values reflect the considerable high potential of slope material movement which is presumed to be due to the factors of slope steepness and water content of soil. SCHULTS and CLEAVES (1955) stated that creep may be caused by a great number of agencies such as the type of material, its physical condition, angle of slope, climate, and vegetation cover. Soil creep tends to vary directly with slope degree (Fig. 11). The steeper the slope degree is, the higher is the magnitude of soil creep. Conversely, the decrease of the magnitude of soil creep is proportional to the decrease of the slope degree. In this phenomena, gravitational force seems to be a factor responsible for the creep. PENCK (1953) proposed that as the slopes

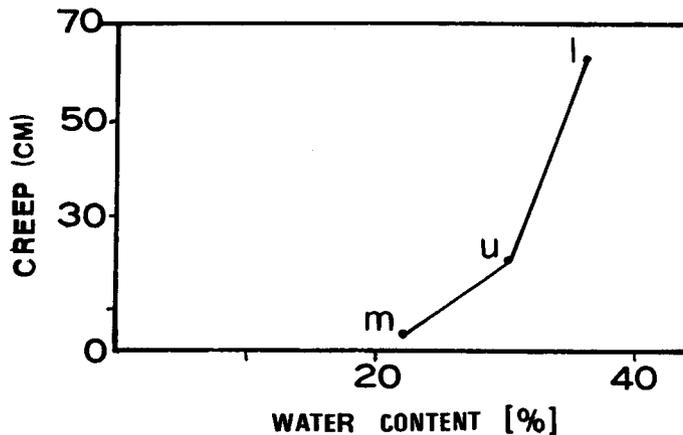
Fig. 12. Trend of soil creep toward the water content of soil, examined in the serpentine area. Each point indicates the position of the measured creep on slope (m: middle part, u: upper part, and l: lower part).

As in the case of slope degree, the magnitude of soil creep also tend to increase with the increase of the amount of water on soil. The higher is the amount of water, the more rapid is the slope surface material moved downward. The trend of the amount of water on soil to the soil creep is presented in Fig. 12. The presence of water is important not only for its lubricating effects, but also because it causes certain clay minerals to swell and move adjacent particles. Water action is intermittent, and is really effective only during and after prolonged or heavy rainfall or when thawing of a snow cover takes place (SMALL, 1970).

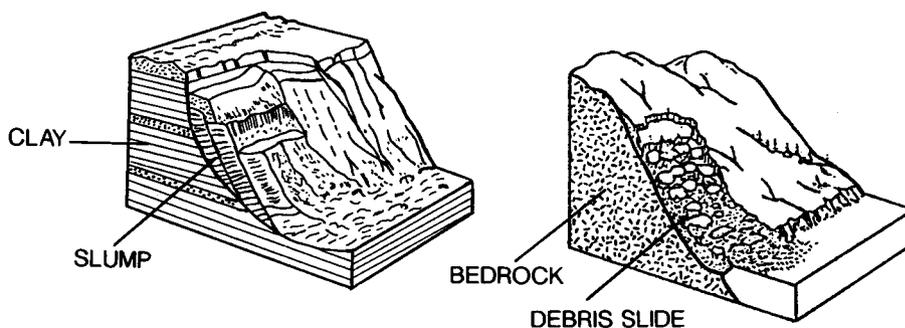
Fig. 13. Types of slope failure (after VARNES, 1958).

Based on the configuration of their recent geomorphic appearances, the type of ancient mass movement in serpentine area is regarded to be "slump". The mass rotates backward so that the slope of the upper surface of the block is diminished or reversed, while the displaced materials form a series of block which slipped down along parallel slip surfaces to the downslope. Slump is known to be the most common type in Hokkaido (CIVIL ENGINEERING ASSOCIATION OF HOKKAIDO, 1985). The landslide investigated in this area showed a main scarp of about 70 meters width, and nearly 200 meters length with a vertical distance of approximately 80 meters.

In the case of large scale mass movement observed in mudstone area, the type is regarded to be as "debris slide". The mass did not slip down by sliding plane, instead it seemed to be moved like some kind of surface failure. In the site near the summit of the slope, the materials were detached so extensively that bedrock was exposed and this led to the formation of small cliff. The rate of this mass movement type can range from feet per year to feet per second depending on the hillslope gradient, the water content, and the existence of special condition, such as the presence of a lubricating cushion of compressed air (DUNNE and LEOPOLD, 1978).

The illustration of slump and debris slide proposed by VARNES (1958) are presented in Fig. 13 in order to provide the clearer type of landslide.

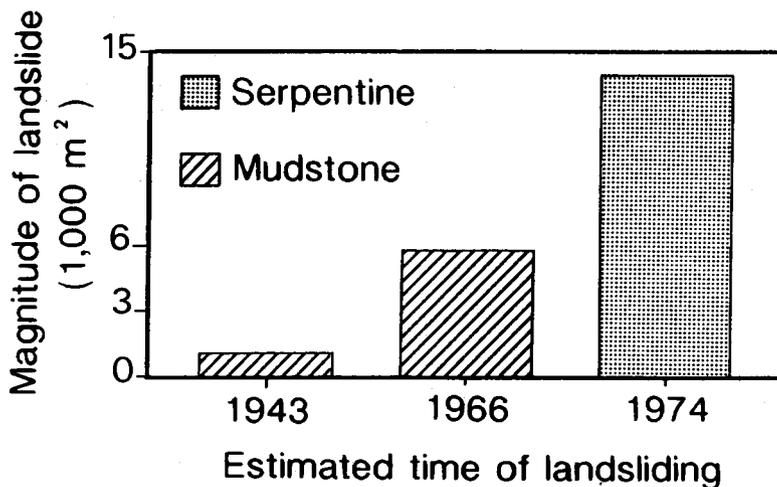
Fig. 14. Chronological landsliding in the investigated sites.

Figure 14 shows the characteristics of the magnitude and frequency of landslide in each investigated area. In the case of landslide investigated in serpentine area huge magnitude was found. However, no significant recurrence of landslide appeared within a long period of time (around 40 years). As for, in the landslide investigated in mudstone area, the magnitude was relatively small. However, it occurred more frequently than that in the serpentine area. At this point, it might be simply said that those characteristics may indicate the degree of stability of landslide site towards the major pursuing disturbance over a certain period of time. Those characteristics may also indicate the natural recovery rate of the landslide scar site particularly by natural revegetation.

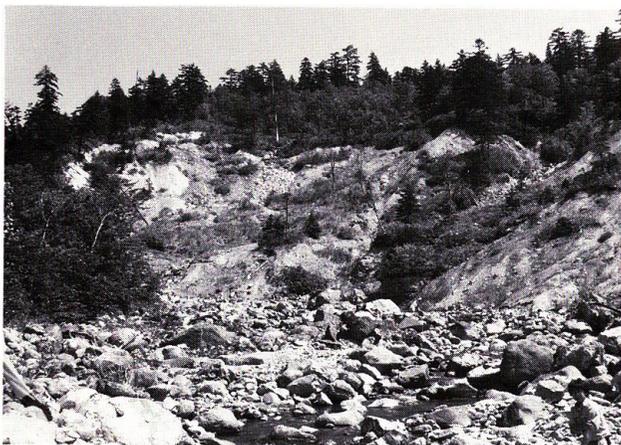
Photo 1. Landslide scar investigated in the serpentine area.

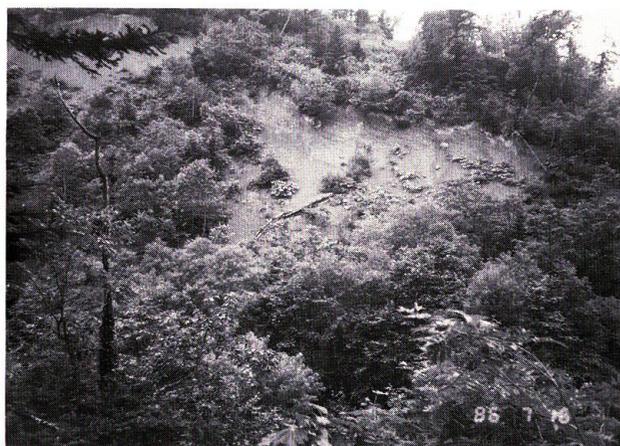
Photo 2. Landslide scar investigated in the mudstone area.

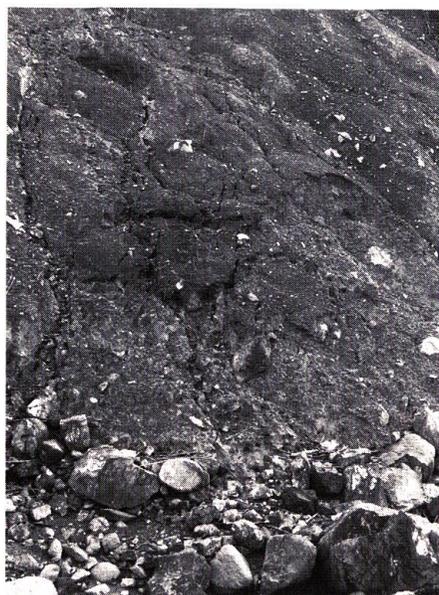
Photo 3. Characteristics of slope materials in the serpentine area.
