Title	1977-1978噴火後の有珠山における侵食と泥流 (1977年8月～1979年12月)
Author(s)	門村, 浩; 山本, 博; 今川, 俊明; 高橋, 英紀; 鈴木, 利吉; 田辺, 隆司; 新井, 健司; 鈴木, 啓助; 田治米, 次郎
Citation	環境科学 : 北海道大学大学院環境科学研究科紀要, 3(2), 155-184
Issue Date	1980-12-22
Doc URL	http://hdl.handle.net/2115/37106
Type	bulletin (article)
File Information	3(2)_155-184.pdf

Erosion and Mudflows at Usu Volcano after the 1977-1978 Eruption : August 1977-December 1979

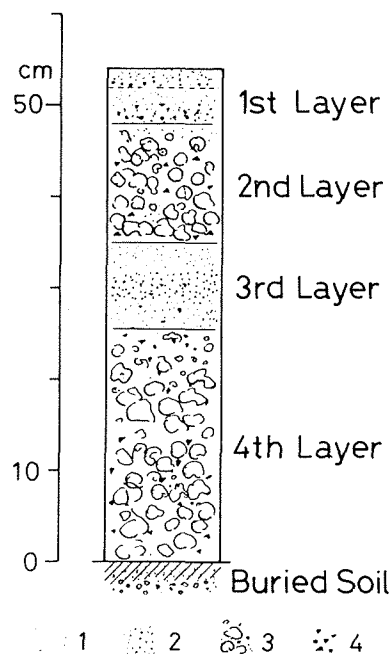
Fig. 4. A typical columnar section of new tephra on the experimental slope in the middle reaches of R. Nishiyama

1: Fine ash, 2: Volcanic sand,
3: Pumice, 4: Lapilli.

A typical columnar section of the new tephra observed in August 1978 in the R. Nishiyama watershed is shown in Fig. 4. Two cycles of coarse and fine textural alternation can be found within the deposits of big eruptions. The new tephra is subdivided into four layers from the textural difference. Mean diameter of the 2nd and the 4th layers composed mainly of pumice is 4-5 mm (Fig. 4; Table. 2), while that of the 1st and the 3rd layers is 0.3-1 mm. The 1st layer contains 13% of silt and clay particles. The ash produced by the eruption of September 12/13, 1978 consists of 57% of silt and clay particles. Owing to the texture of these layers, solid phase ratio of the 1st and the 3rd layers is about 50% and that of the 2nd and the 4th layers is 34% and 40% respectively. Apparent and specific gravities are larger for the finer deposits than the coarser deposits consisting mainly of pumices (Table. 3).

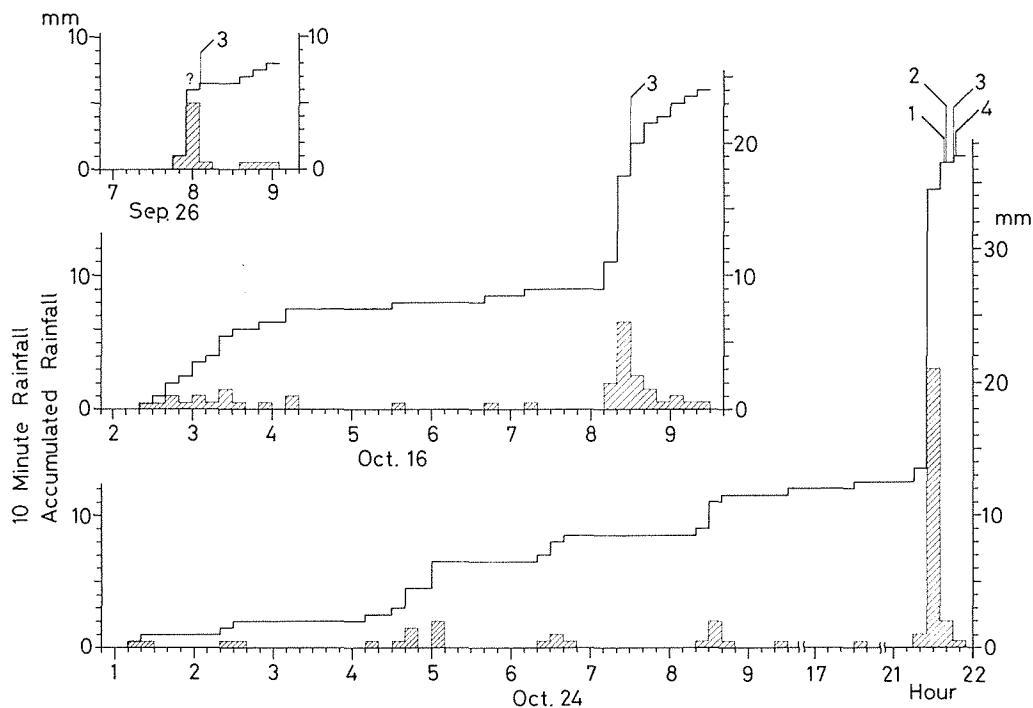
Fig. 7. Rainfall and the occurrence of mudflows of September 26 and October 16 and 24, 1978

Time of triggering for 1: R. Sobetsu-onsen; 2: R. Itaya; 3: R. Nishiyama, 4: R. Ko-Utsu.

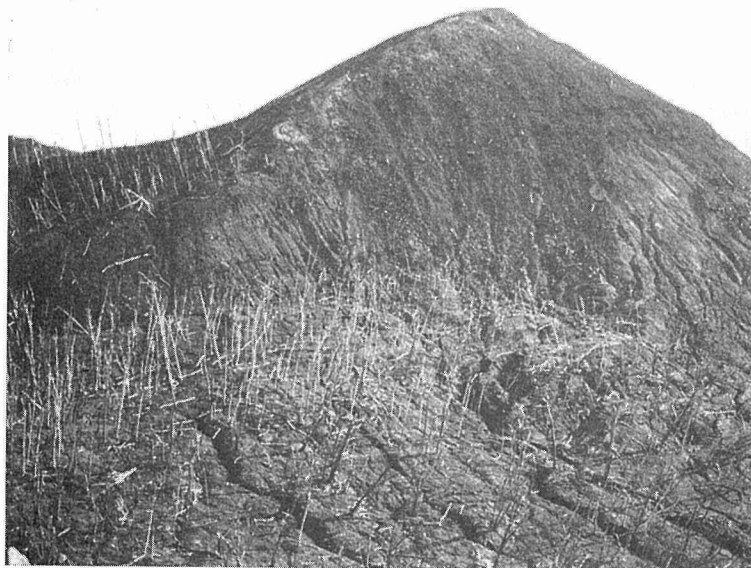
Photo 1. Forest vegetation in the summit atrio was completely destroyed by air-fall pumices and volcanic blocks and bombs ejected during the First Stage eruption in August 1977. Backing hill is a New Mountain (cryptodome) upheaved due to the rise of subsurface magma body underneath the atrio, accumulated upheaval reaching 120 m up to July 1979.

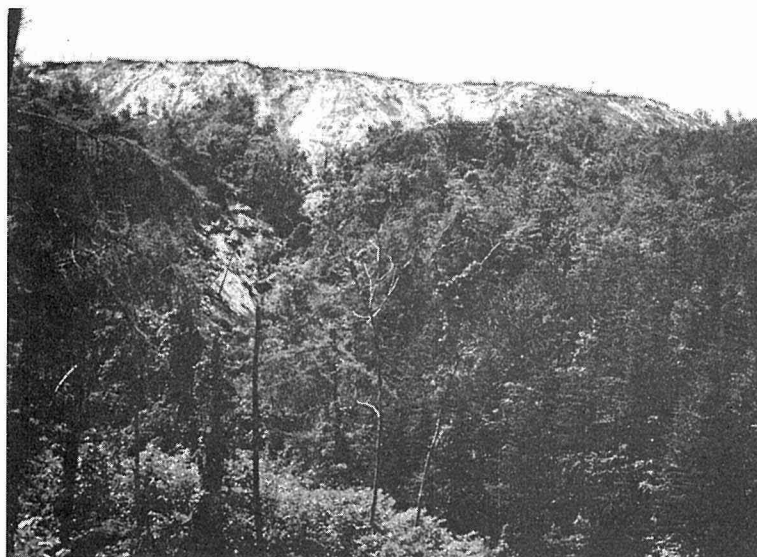
Photo 2. Northeastward thrust of the somma resulted in extremely deformed and devastated upper slopes of the somma. View from north. Landslide and rockfall have been accelerated due to over-steepening and faulting but also the shock of repeated earthquakes.

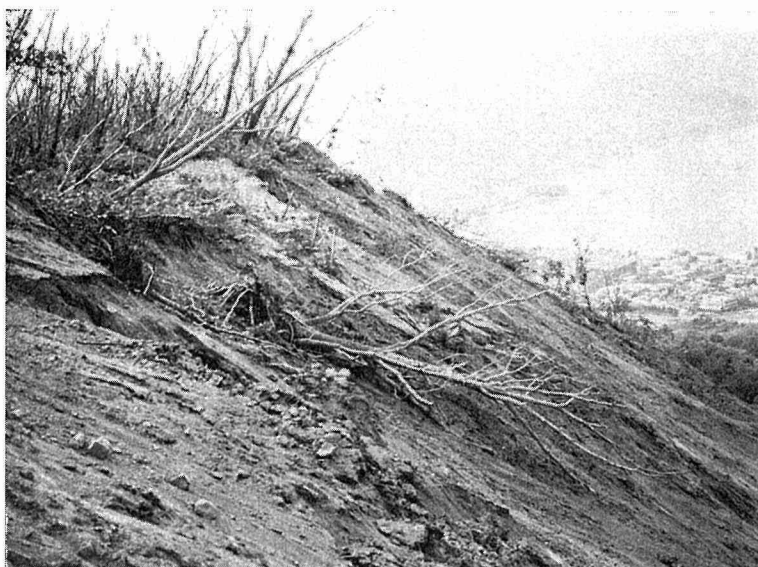
Photo 3. Close up of deformed uppermost slope of the northern somma. On the right are Toyako-onsen spa and Lake Toya.
June 17, 1979. Photo by T. Imagawa.

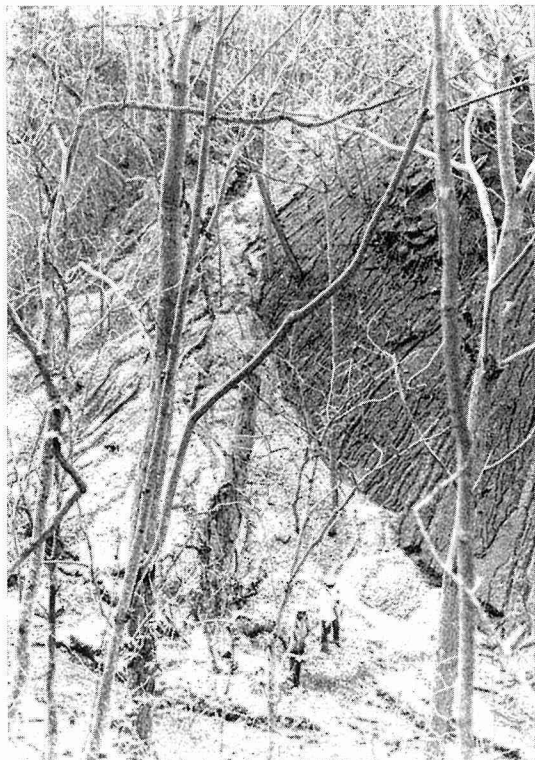
Photo 5. Alluvial cones consisting mainly of redistributed pumices were also formed here and there in the watershed of R. Nishiyamn. Note marks of miniature mudflows with levees and tongue-shaped front. *September 29, 1977. Photo by R. Suzuki.*

formed before that day (Photos 4 and 5). On the upper slopes, especially on the narrow divide, thin (0.5–1 cm), hard crust was formed and Horton's "no erosion belt" was clearly observed everywhere. On the middle and lower parts of hillslopes with a slope of 30°, straight rills dissecting the surface layer of the new tephra were well-developed (Photo 4). Concentration of rills on the concave slopes in plane-profile led to the formation of gullies of 0.3–0.5 m wide and 0.3–0.5 m deep. Numerous talus cones were also formed in the lower steep slopes by the sediment derived from gullying. The volume of the sediment deposited in every talus cone, with a size of 5–15 m high and 0.3–0.5 m deep, was 3 to 20 m³.

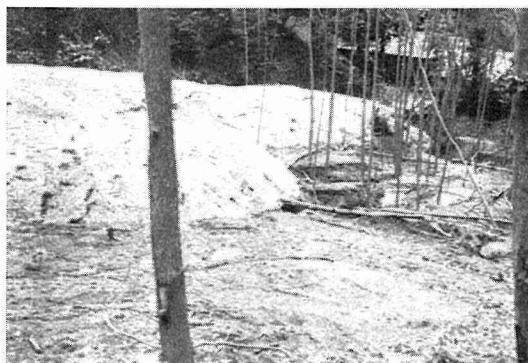
Photo 6. Tongue-shaped front of pumiceous flow issued from a tributary reached the main valley floor of R. Nishiyama in late August 1978. *26 August, 1978. Photo by H. Kadomura.*

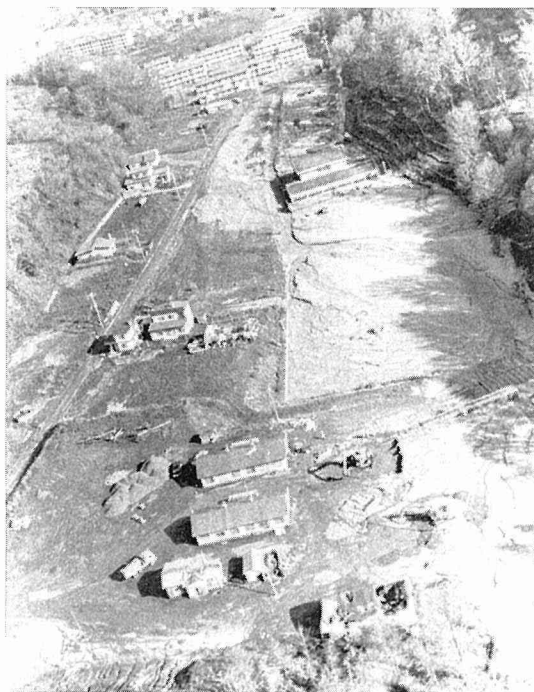
Photo 7. Trace of the mudflow of October 24, 1978, in the valley plain of R. Nishiyama. The mudflow went over a sabo-dam and attacked the filtration plant in the middle and apartment houses in the distant view, with a depth of more than 2 m. Broken roof of a D-shaped hut in the foreground was caused by deposition of the 1977 tephra about 50 cm in deep.

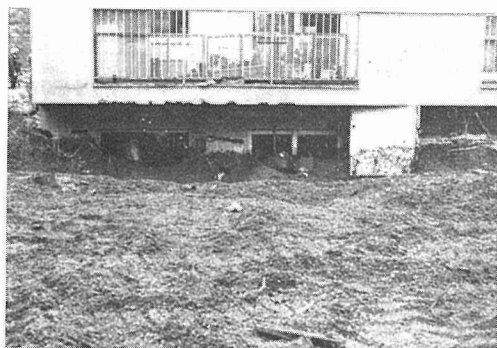
Photo 8. The ground floor of a three-storied apartment house, which is seen in the rearmost right in Photo 7, was penetrated and completely buried by the mudflow of new tephra with a depth of more than 2.5 m.

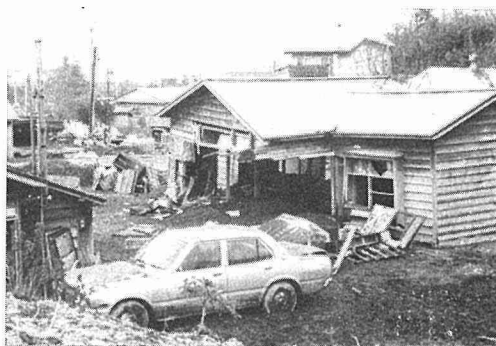
Photo 9. A wooden house almost completely destroyed by the mudflow of October 24, 1978, near the apex of R. Nishiyama alluvial fan.

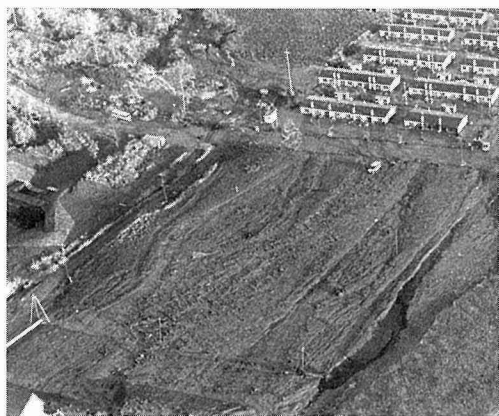
Photo 11. Trace of the rocky mudflow of October 24, 1978 on the upper part of alluvial fan of Sobetsu-onsen. Most of houses in the upper right were inundated by the flood of mud. October 25, 1978. *Curtesy Disaster and Fire Prevention Section of Hokkaido Government.*

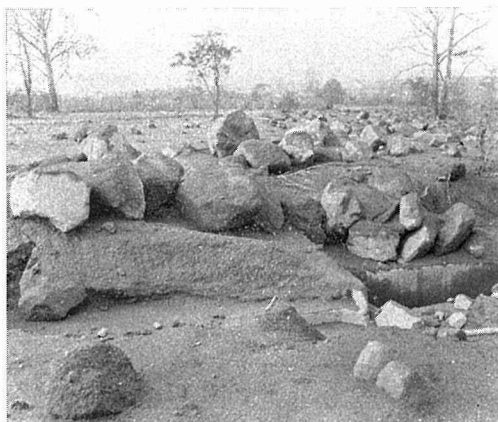
Photo 12. Boulders of lava which were derived from scouring of former valley fill in the upstream spread onto an alluvial fan of R. Izuminosawa, southwest foot of the volcano. October 26, 1978. *Curtesy of Publicity Section of Hokkaido Government.*

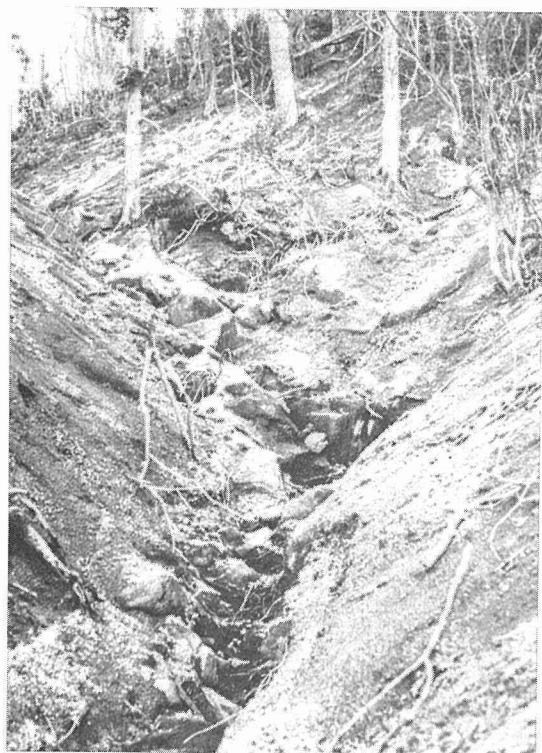
Photo 13. Exhumation of former valley fill resulting from removal of new tephra, on the upper reaches of R. Nishiyama. Only some herbs and shrubs have regenerated in autumn 1979. *September 14, 1979. Photo by T. Imagara.*

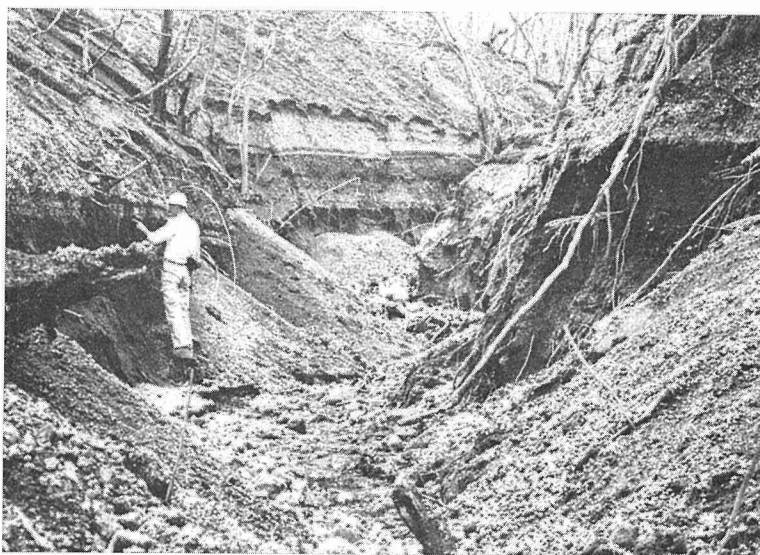
Photo 14. Vigorous channel processes accompanying cut and fill have been operating up to the end of 1979, on the upper reaches of R. Ko-Uzu. The depth of new tephra exceeds 2 m. Former ground surface is pointed with a finger. *September 14, 1979. Photo by T. Imagara.*

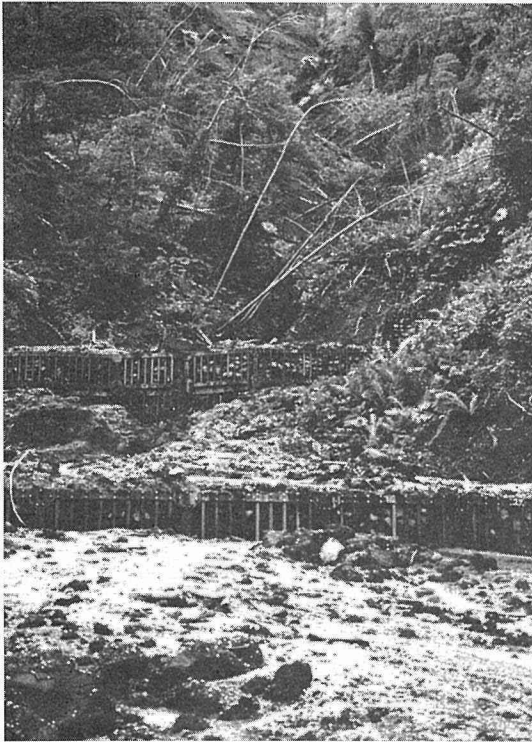
Photo 15. Rocky mudflow of September 5, 1979 went down one of valleys of R. Sobetsu-onsen rising on the extremely devastated northern somma slope. Tilted trees and scars in the background have been caused by faulting, landsliding and the shock of repeated earthquakes. September 15, 1979. Photo by H. Kadomura.

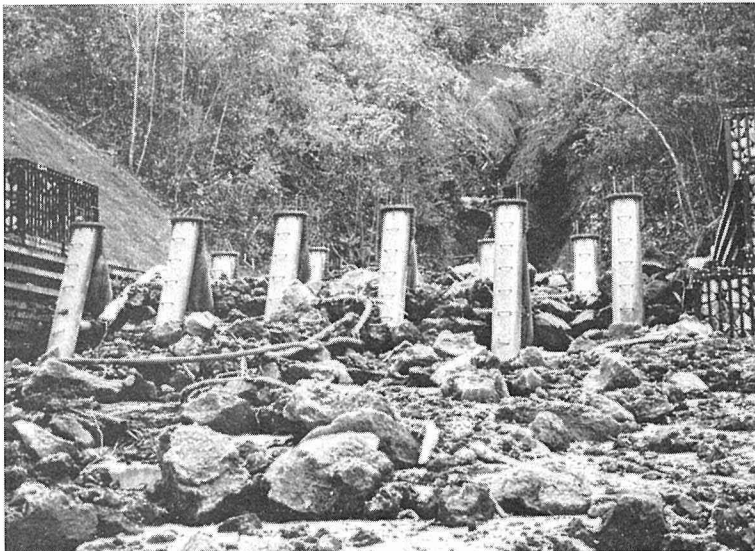
Photo 16. Rock debris flow passed through a "slit-dam" installed in the main valley of R. O-Uso, the most active river during 1979 in terms of sediment yield and frequency of mass transport. The debris flow was triggered by a rainfall of 86 mm/24 h brought about by Typhoon No. 7920 which attacked the region on October 19, 1979. Valley-side slopes in the background have been progressively retreated due to landslide and rockfall, producing a large number of boulders. October 22, 1979. Photo by T. Imagawa.
