Uniaxial tension-compression fatigue behavior and fiber bridging degradation of strain hardening fiber reinforced cementitious composites

Takashi Matsumoto<sup>a\*</sup>, Kavalin Wangsiripaisal<sup>b</sup>, Toshiro Hayashikawa<sup>a</sup>, Xingwen He<sup>a</sup>

<sup>a</sup> Division of Built Environment, Graduate School of Engineering, Hokkaido University, Sapporo, 060-8628, Japan

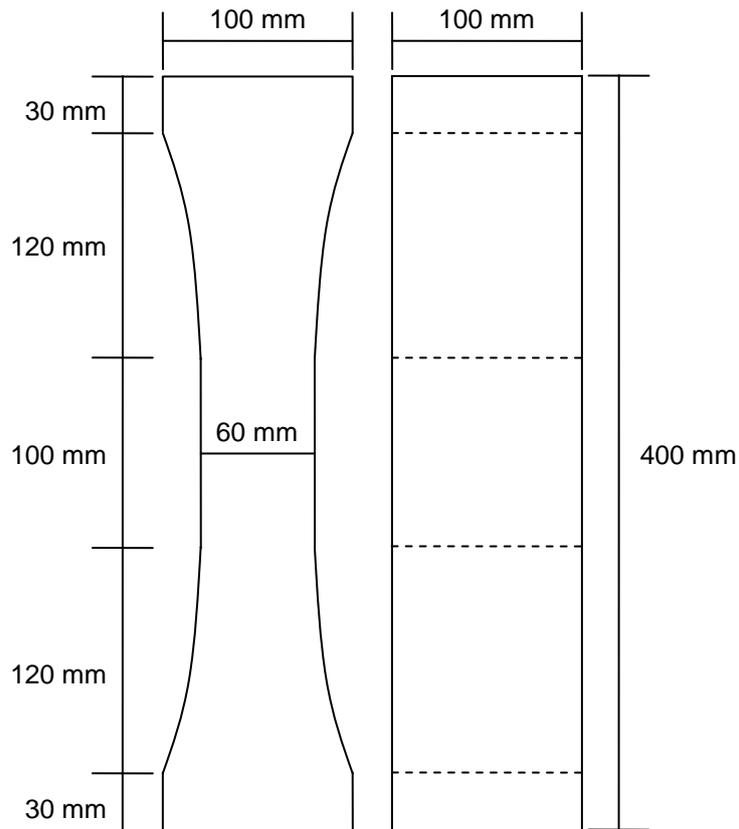
Specimen dimensions are shown in Fig. 1. The specimen dimensions are designed in order to control the initiation of cracks in a specific area and to eliminate the overall failure of a specimen at or near the grip. Namely, the cross sectional area is gradually reduced from 100 mm square at both ends to 100 mm by 60 mm at the center, and it is constant over the central 100 mm length. Within this constant cross sectional zone, multiple cracks are intended to initiate and grow. At both ends, the cross sectional area is also constant in order to have bonding to loading grips. The total length of a specimen is 400 mm.

**Fig. 1. Shape and dimensions of specimens.**

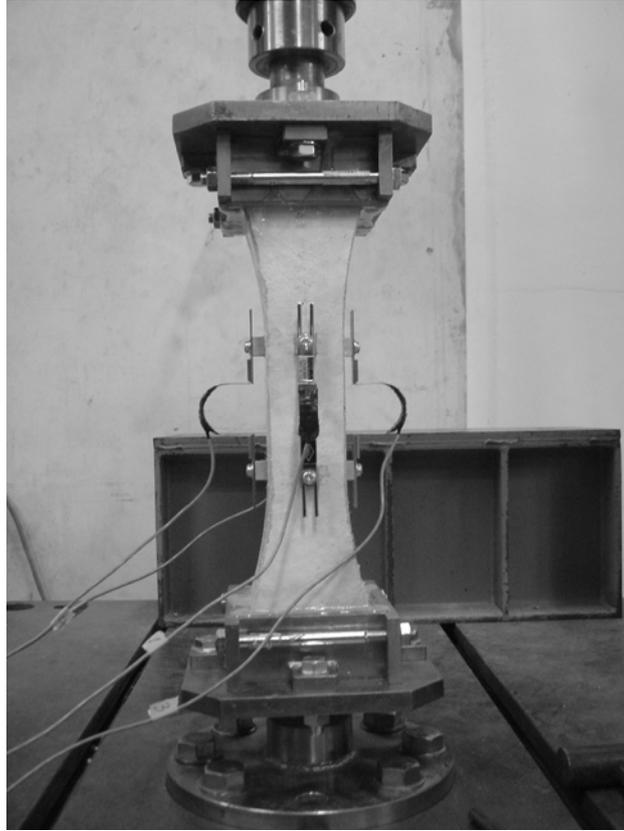
For data acquisition, four strain gauges were carefully attached with accurate alignment on the four side surfaces (Fig. 2). These gauges have 100 mm of gauge length, therefore they have enough length to cover the central constant cross sectional zone. These gauges were attached in order to measure the tensile and compressive strain over the central zone and to control the static and fatigue loading sequences under displacement control. In addition to the four strain gauges, load and stroke displacement were also obtained from the 200 kN capacity feed back controlled loading machine.

**Fig. 2. Experimental set-up. Strain gauge is attached on each of side surfaces.**

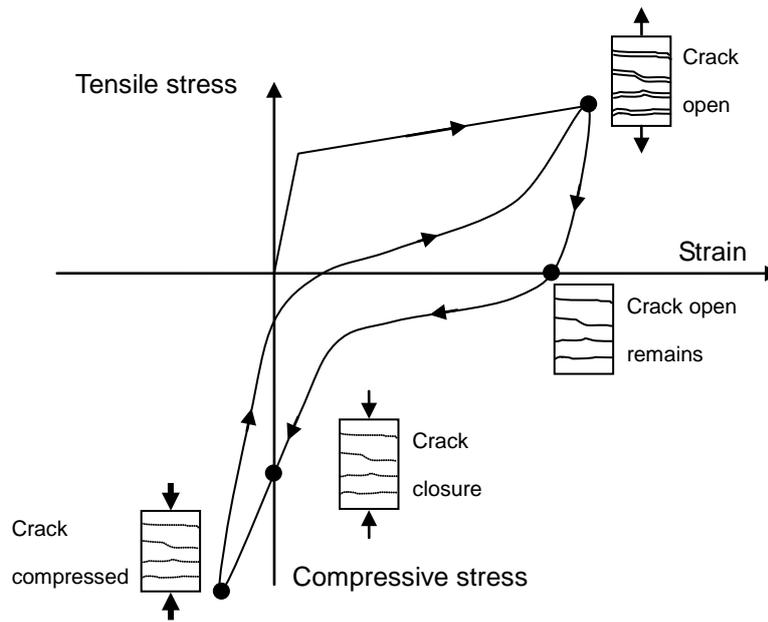
The former strain level of 0 % means that overall the specimens are not in compression, but it means that cracks are enforced to close fully (Fig. 3). As can be exemplified from visible cracks of unloaded fiber composite specimens (Matsumoto and Li [22], Wu et al. [23]), the cracks of unloaded specimens always have some remaining opening. This is because, even at overall zero load level, pulled-out fibers still remain in the crack and resist against the crack closure. Therefore, the maximum compressive strain level of 0 % means that there is no space between crack surfaces and that fibers have to be pushed back into matrix or to be buckled between crack surfaces. The latter strain level of 0.05 % is more severe than the former (Fig. 3). Not only fibers go back into matrix or buckle and crack surfaces are in

Tension-compression fatigue loading was applied as follows (see also Fig. 3). First, a specimen was loaded in tension under displacement control at the rate of 0.005 mm/sec. After reaching the maximum tensile strain level, the specimen was unloaded, and further loaded into the maximum compressive strain level at the same rate of displacement control. From this point on, cyclic fatigue loading was applied at the frequency of 1 Hz under the constant displacement amplitude between the corresponding maximum tensile and compressive strain. Load and the average of four gauges were recorded. The cyclic loading was applied with a sinusoidal wave, and it was stopped when the load decrease ceased or the number of cycles reached 2,000 cycles.

**Fig. 3. Tension-compression loading sequence and crack behaviors.**

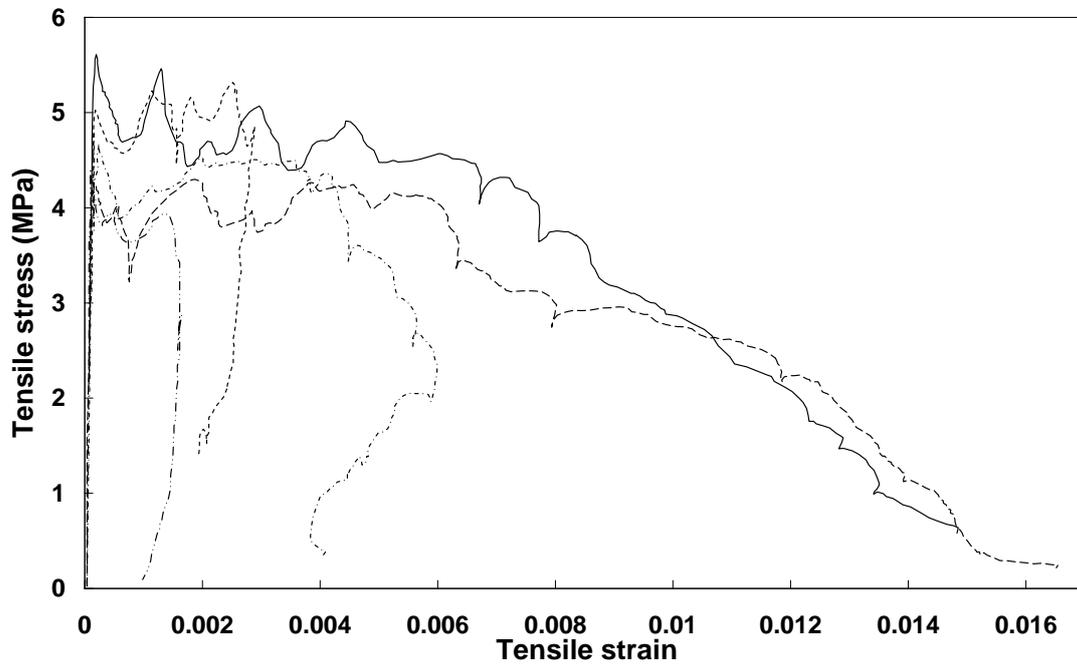
The obtained tensile stress-strain relations of Mix A are shown in Fig. 4, and those of Mix B in Fig. 5.

Tensile stress was observed to linearly increase with tensile strain, until first cracking took place.

Several load drops were observed, although they were recovered. These load drops were associated with

multiple crack occurrences during strain hardening. Finally, one of the cracks became localized, and

Fig. 4. Tensile behaviors of Mix A specimens.

The average tensile strength of Mix A is 4.98 MPa, and Mix B 4.83 MPa. The average tensile strain capacity measured at the first cracking stress level of Mix A is 0.414 %, and Mix B 0.375 %.

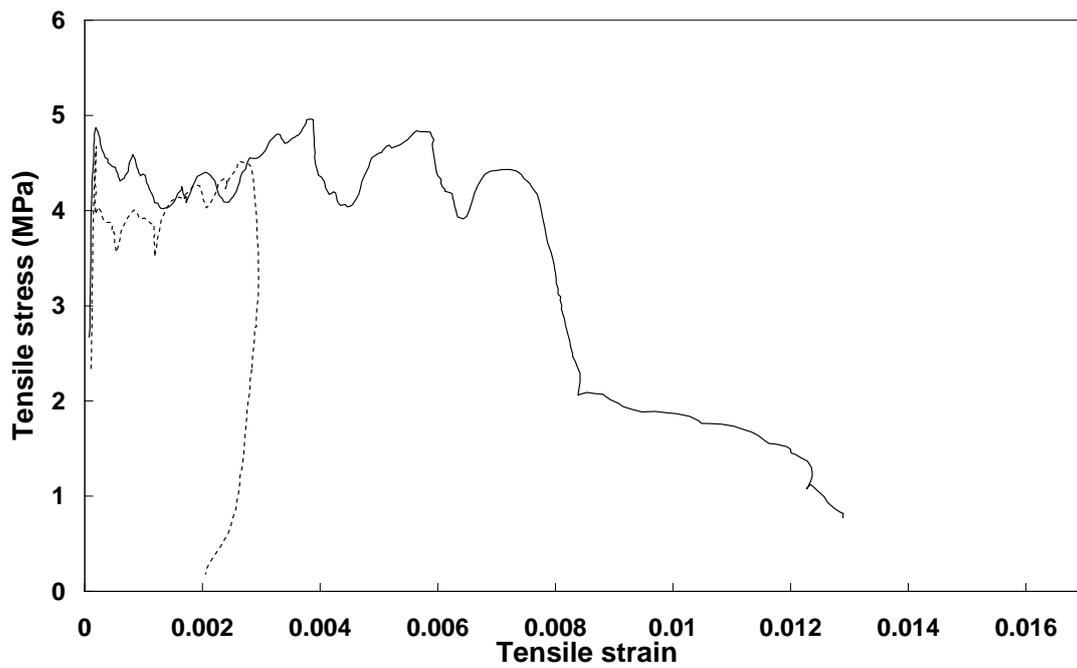
**Fig. 5. Tensile behaviors of Mix B specimens.**

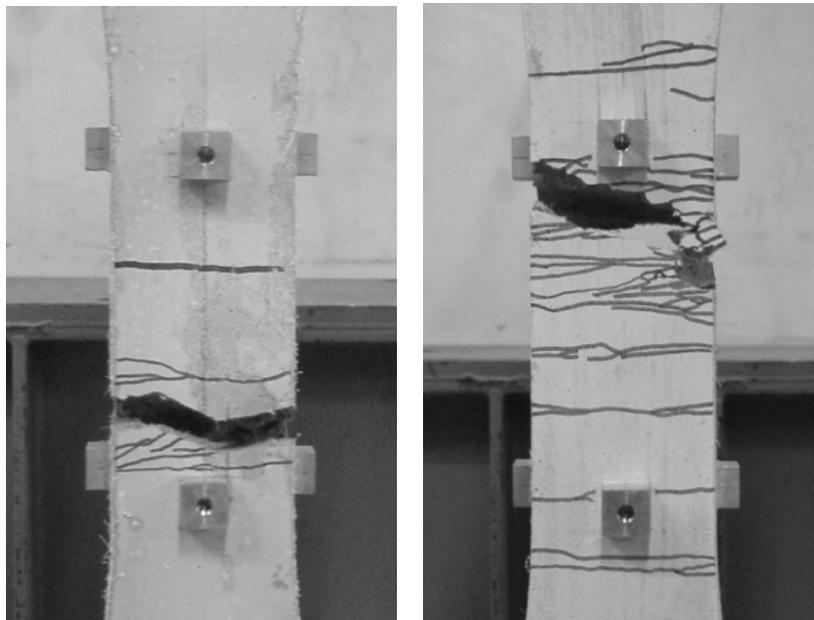
Fig. 6 shows the multiple cracks of Mix A and B, and it shows that these multiple cracks are mostly formed within the central zone. Mix B with light weight aggregates formed more cracks compared to Mix A, supporting the lowering effect of matrix fracture toughness by the light weight aggregates.

**Fig. 6. Multiple cracks of Mix A (left) and Mix B (right). Cracks are visualized with markings.**

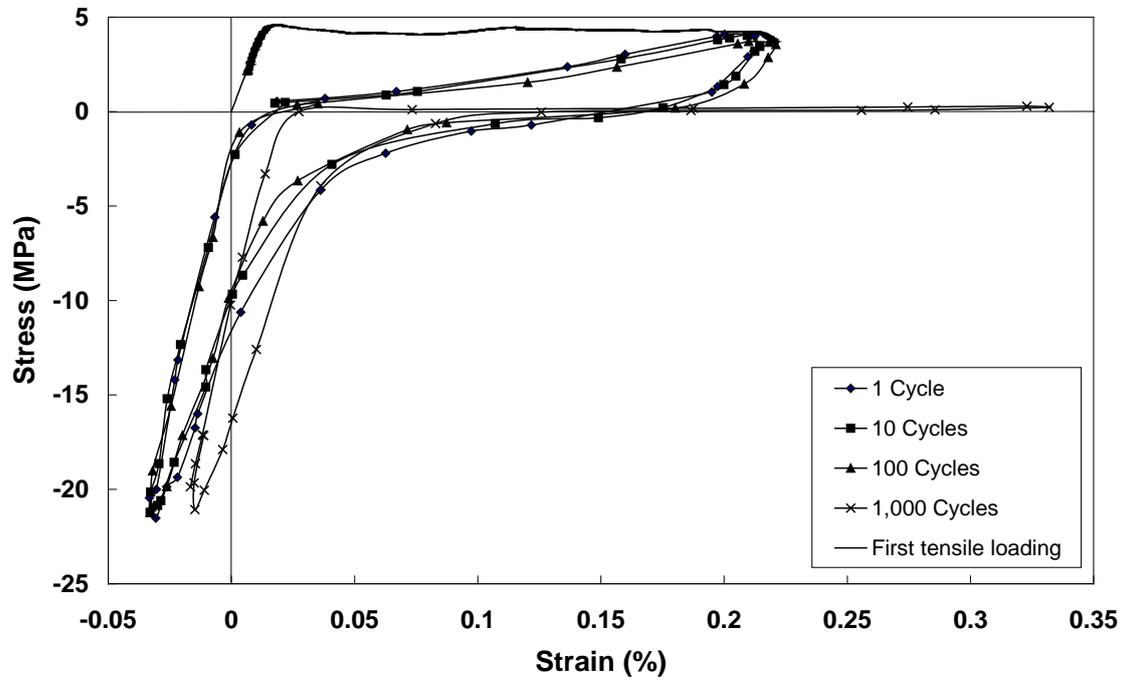
Fig. 7 shows the hysteresis curves of a Case 1 specimen under tension-compression fatigue. The curves are the stress-strain behavior at first tensile loading, 1, 10, 100, and 1,000 cycles. From 1 to 100 cycles, the shapes of curves do not change significantly, and the maximum tensile and compressive stress on the curves decrease slightly. From 100 to 1,000 cycles, the curves change significantly. At 1,000 cycles, the tensile stress is nearly zero, meaning that a crack opens up with no tensile stress transmitted across the crack. The hysteresis curves imply that the bridging stress across the crack has degraded

quickly between 100 and 1,000 cycles.

Fig. 7 Hysteresis curves during tension-compression fatigue of a Case 1 specimen.

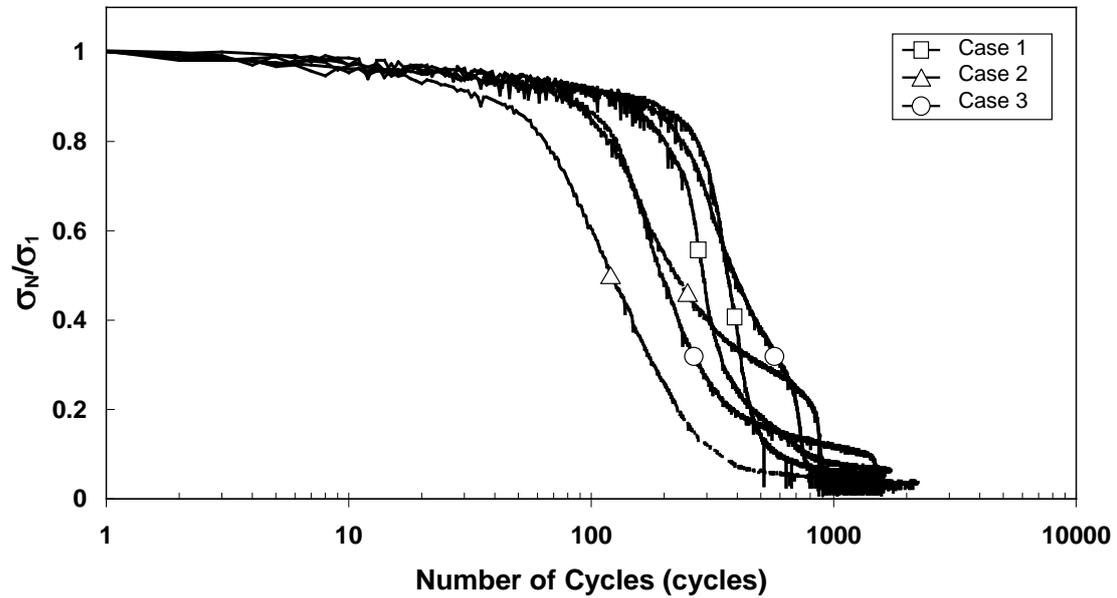
**Fig. 8 Bridging stress degradation curves during tension-compression fatigue.**

In order to observe the bridging stress degradation, the tensile stress corresponding to the preset maximum tensile strain was recorded with the number of cycles. In Fig. 8, the ratio of the tensile stress at the current number of cycles,  $\sigma_N$ , to that at 1 cycle,  $\sigma_1$ , is plotted with the number of cycles for all the specimens. Fig. 8 shows that there are three stages in the bridging stress degradation curves. First, from 1 to 100 cycles, bridging stress gradually decreases roughly to 90 %. Second, from 100 to 1,000 cycles, the bridging stress sharply decreases roughly to 10 %. Some specimens suffer from severe damage, and those specimens exhibit a decrease nearly to 0 %. Finally, after the sharp decrease, the bridging stress decreases gradually again. The tests were terminated, if the final decrease is negligible and the number of cycles is above 1,000 cycles.

The differences among the experimental cases can be seen at the onset of the second stage and during the second stage.

For Case 1 and 2 of Mix A, Case 1 enters the second stage slightly later than Case 2, but Case 1 decays quickly with sharper gradients. This behavior was partially contrary to expectations. It was expected that Case 1 started to decay earlier and decayed quickly, since Case 1 was subjected to more severe loading conditions as explained in section 2.3. At this moment, the reason why Case 1 started to decay later than Case 2 is not clear.

Case 3 of Mix B started to decay earlier than Case 1, but later than Case 2. Also, Case 3 decays less quickly than Case 1, but more than Case 2. When compared to Case 1 under the same loading conditions, Case 3 exhibited more multiple cracks. The increased number of multiple cracks may contribute to the distribution of damages, and the gradient of the second decline stage in Case 3 might be achieved. The reason why Case 3 started to decay earlier than Case 1 is not clear at this moment.

Although there are not enough specimens to discuss the differences among the three cases, all the three cases show that the major bridging stress degradation takes place before 1,000 cycles and that the bridging stress degrades nearly to 10 %. It can be said that the bridging stress degradation under tension-compression fatigue is significantly severe, and that its degradation life on the order of  $10^3$  cycles is quite short compared to engineering design life on the order of  $10^6$  cycles.

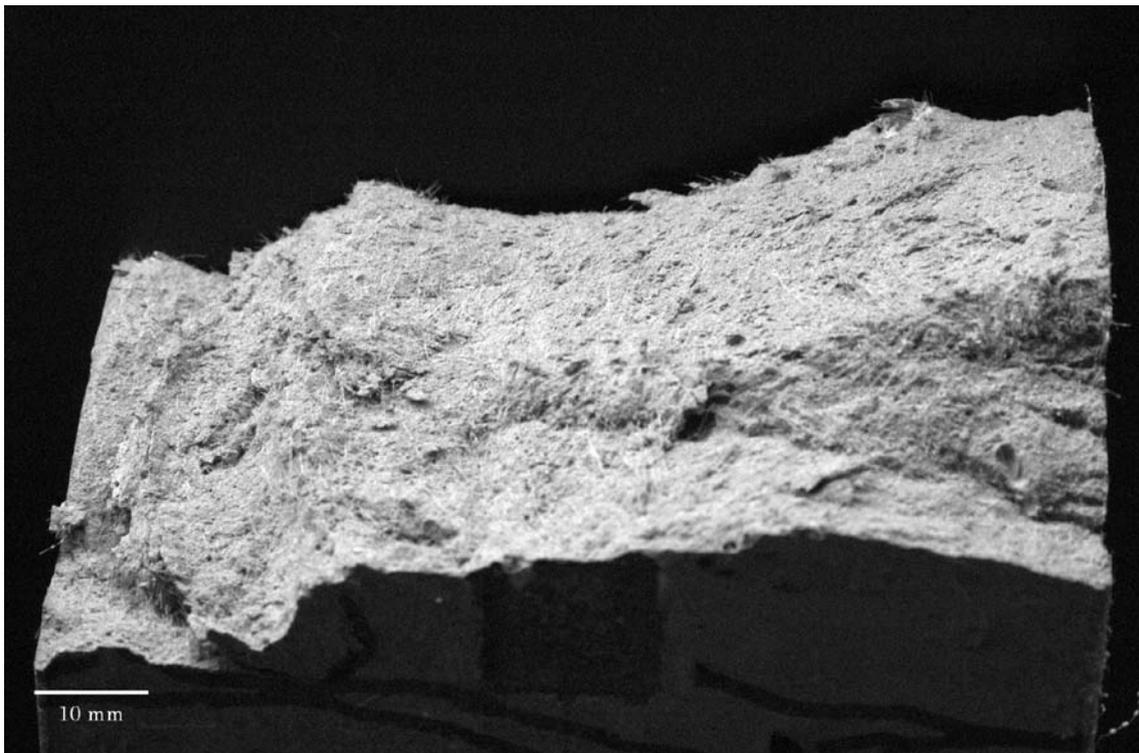
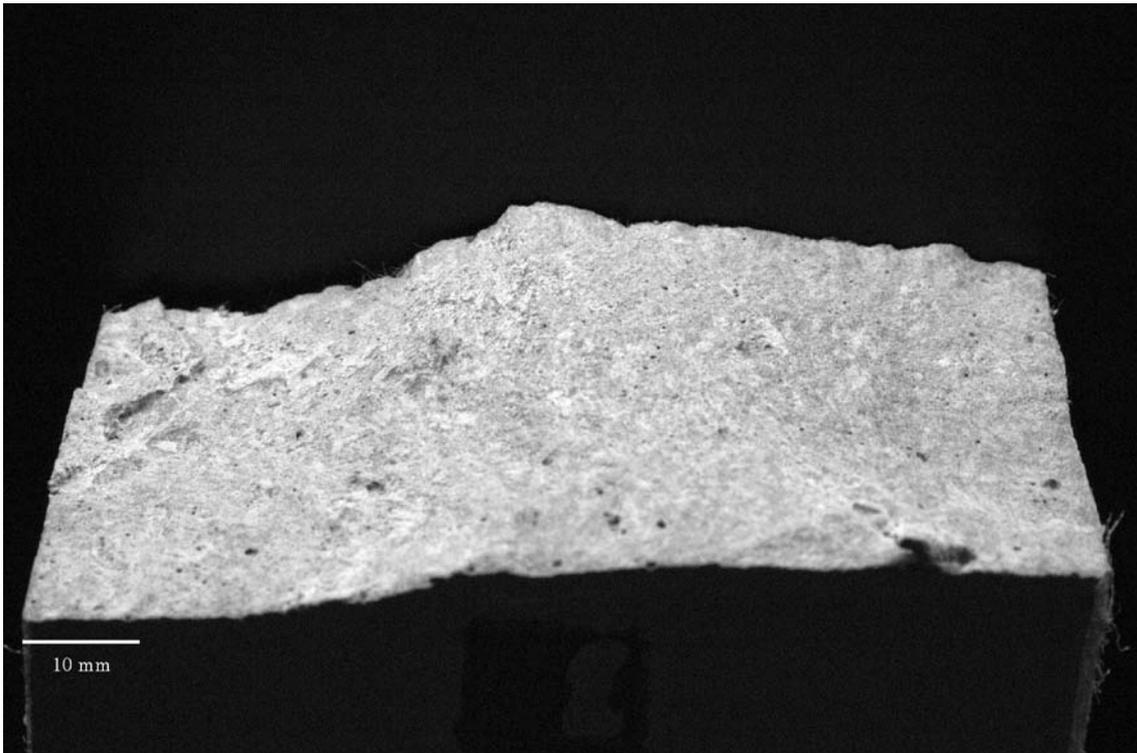
Fig. 9 shows the typical failure surfaces of a static specimen and a tension-compression fatigue (Case 1) specimen. Both specimens are made of Mix A. When the static specimen is compared to the fatigue specimen, it is clearly seen that the failure surface is rougher and that more fibers are protruded on the surface. Also, it was observed that cement powder accumulated on the failure surface of the fatigue specimen. The reason could be as follows. The failure surface in the fatigue specimen was made smooth, after the surface was subjected to cyclic contact and wear during tension-compression fatigue. At the same time, the fibers were damaged between the surfaces, and those fibers were worn out to short protrusion length. For further understanding of fiber damages, it is necessary to observe the fibers in situ under tension-compression fatigue, and detailed image analysis is required to examine the fiber failure mode.

**Fig. 9 Failure surface of a static tensile specimen with protruded fibers (up) and a tension-compression fatigue (Case 1) specimen without protruded fibers (down).**

Fig. 9 and Fig. 10 exemplify the severity of tension-compression fatigue for bridging fibers. The early bridging stress degradation before 1,000 cycles obviously results from the severe damages to bridging fibers.

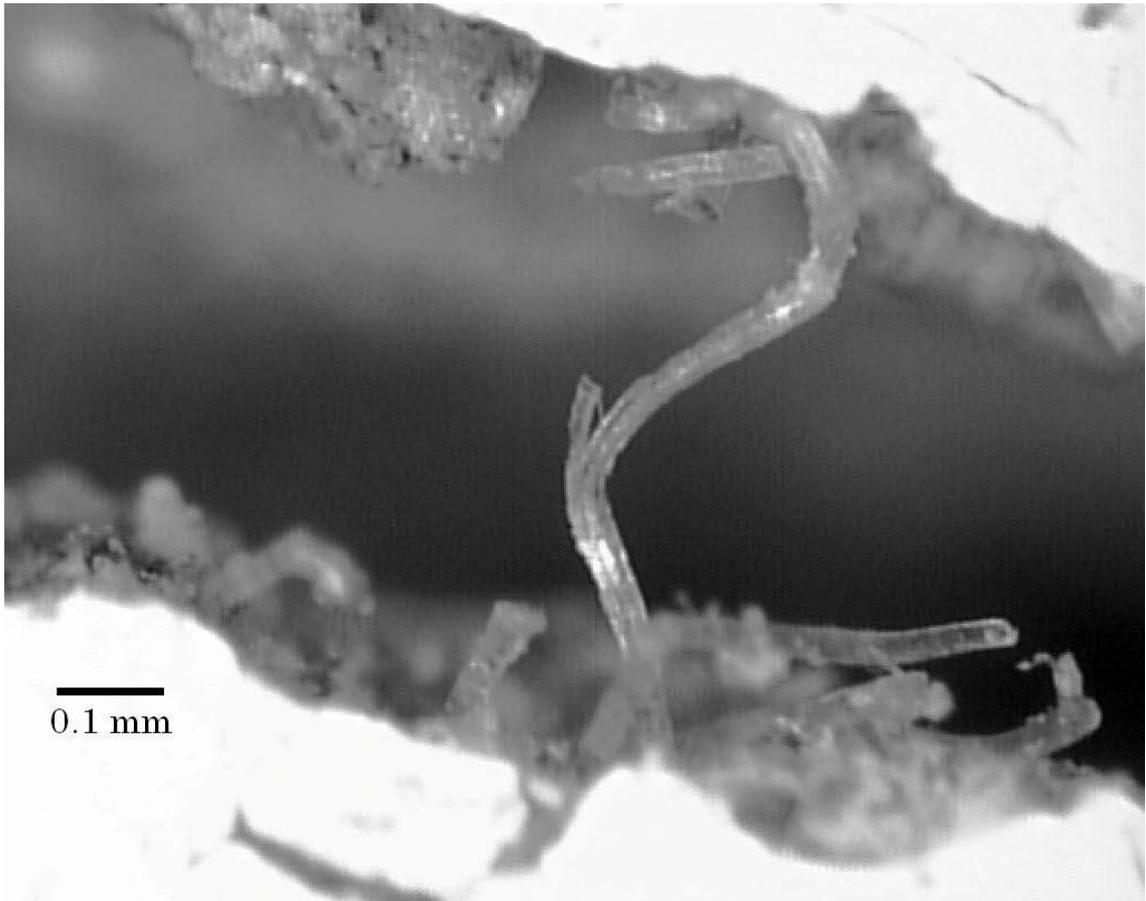
Fig. 10 is a microscopic image of a crack. In the figure, a fiber is buckled, and other fibers are short-protruded on the surface. It is considered that some fibers are buckled between the crack surfaces under tension-compression fatigue, and that this buckling may lead to the rupture of fibers. Yielding is also possible for the rupture of fibers. In either case, it is considered that these ruptured fibers were worn out to the short protrusion length observed on the surface.

**Fig. 10 Buckling of a fiber and short protrusion of fibers.**

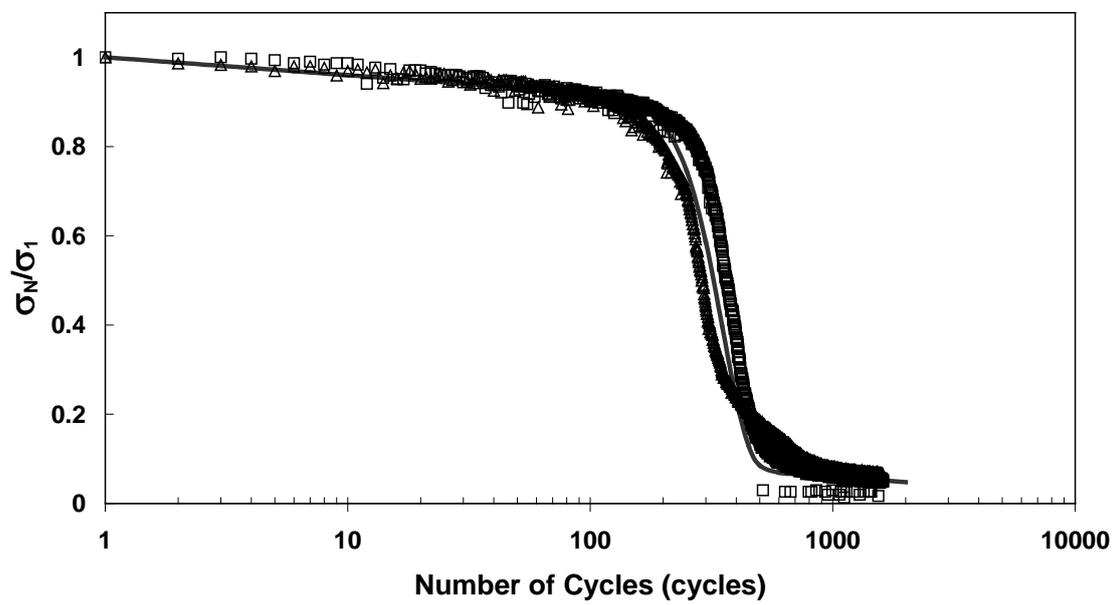
Fitting curves are obtained for the three cases of bridging stress degradation, and they are shown in Fig.

Table 4 shows the parameters of the fitting curves. The shape parameter,  $m$ , of Case 1 is 25, while those of Case 2 and 3 are lower: 9 and 12, respectively. The shape parameter describes the gradient of the second decline stage of a bridging degradation curve. The larger the shape parameter is, the steeper the gradient becomes. Hence, with a large shape parameter like Case 1, the second decline stage can be narrowed down or well-defined. On the other hand, with a small shape parameter like Case 2 and 3, it has some range in two orders of magnitude. Regarding the scale parameter,  $\log N_0$ , it is noted that, when  $N$  is equal to  $N_0$ ,  $w(N)$  becomes  $1/e = 0.37$ , according to Weibull distribution. Namely,  $N_0$  points the number of cycles for the second decline stage.

**Fig. 11** Fitting curve and bridging stress degradation curves of Case 1.

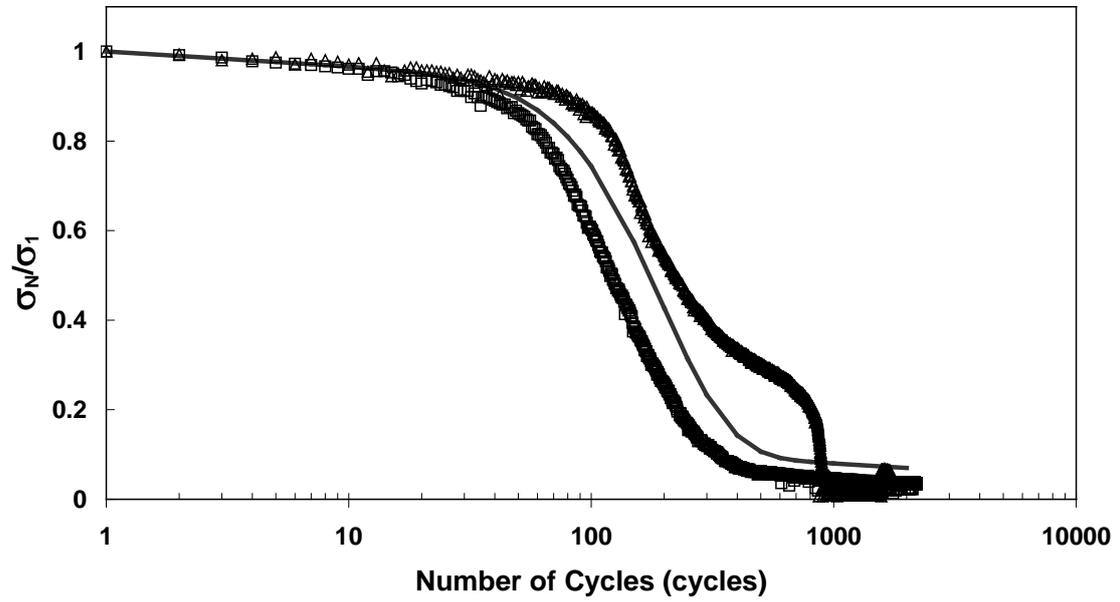
Fig. 12 Fitting curve and bridging stress degradation curves of Case 2.

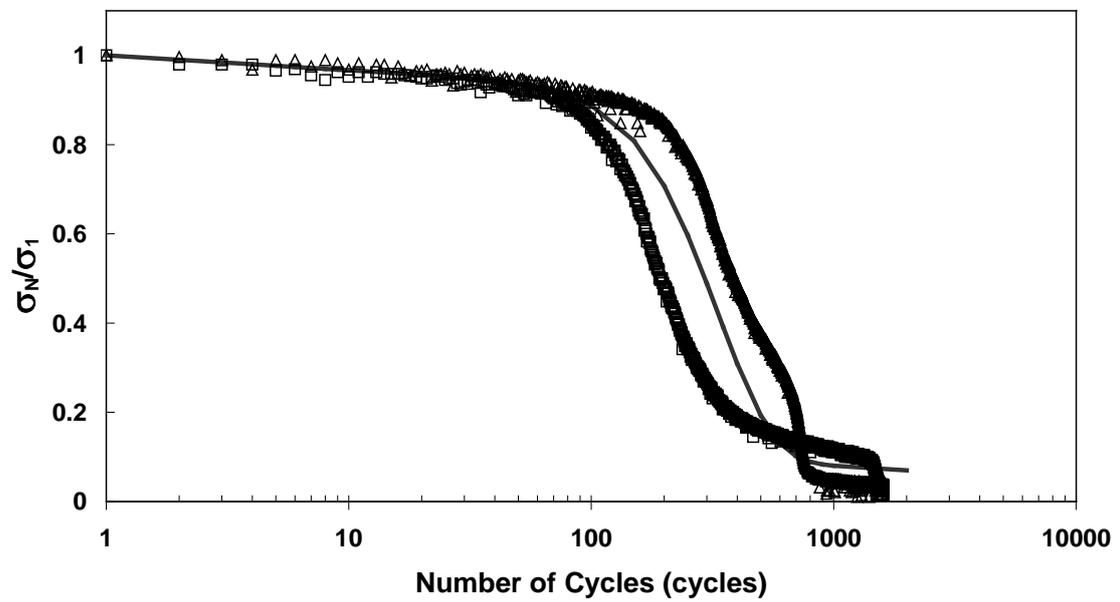
Fig. 13 Fitting curve and bridging stress degradation curves of Case 3.

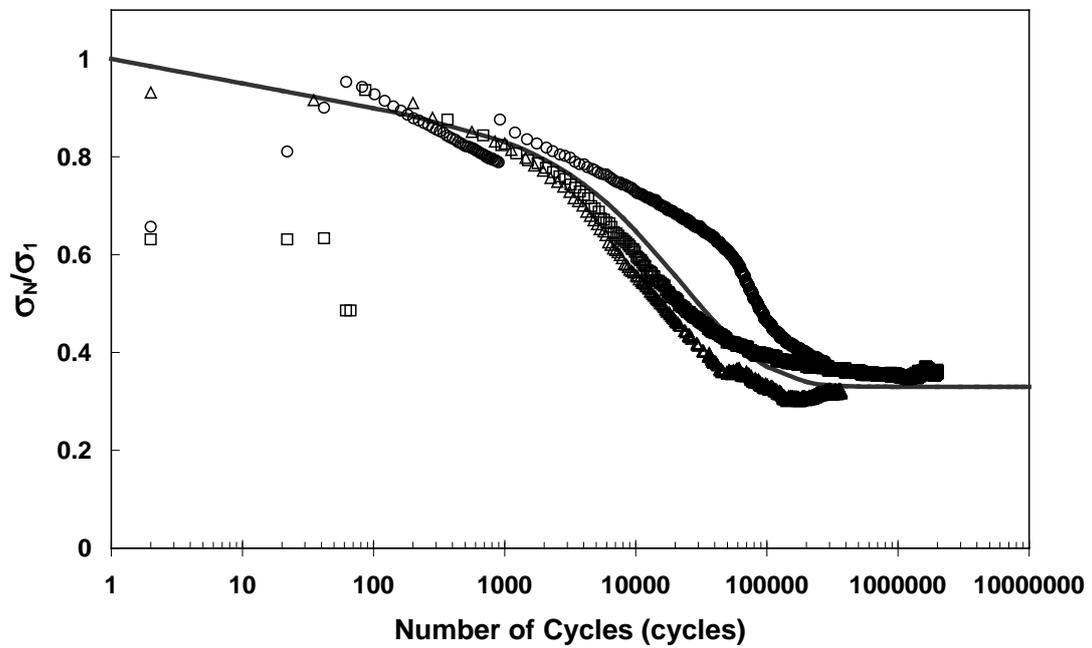
Fig. 14, 15, and 16 show the resulting bridging stress degradation curves under tensile fatigue for the maximum strain level of 0.1, 0.15, and 0.2 %, respectively. The curves have similar behaviors to those presented in the current study. In the same manner, the curves can be divided into three stages.

Fig. 14, 15, and 16 also show the fitting curves obtained in the same way as explained in section 3.3, and Table 5 presents the parameters. The shape parameter,  $m$ , is smaller, meaning that the second decline stage has more range. The scale parameter,  $\log N_0$ , is larger, showing that the number of cycles for the second decline stage is larger. The gradient of the initial slope,  $a_1$ , is slightly steeper, although the loading condition is less severe in the cited study. This is probably because of the lack of measurement points from 1 to 1,000 cycles or the difference in matrix compositions. On the other hand, the gradient of the final slope,  $a_2$ , is set to be zero, based on the behaviors of the degradation curves. Finally, the intercept,  $b_2$ , is larger than that of the current study. This implies that, in the tensile fatigue condition, there are more fibers loaded below fatigue limit.

**Fig. 14 Fitting curve and bridging stress degradation curves during tensile fatigue with maximum tensile strain of 0.1 %.**

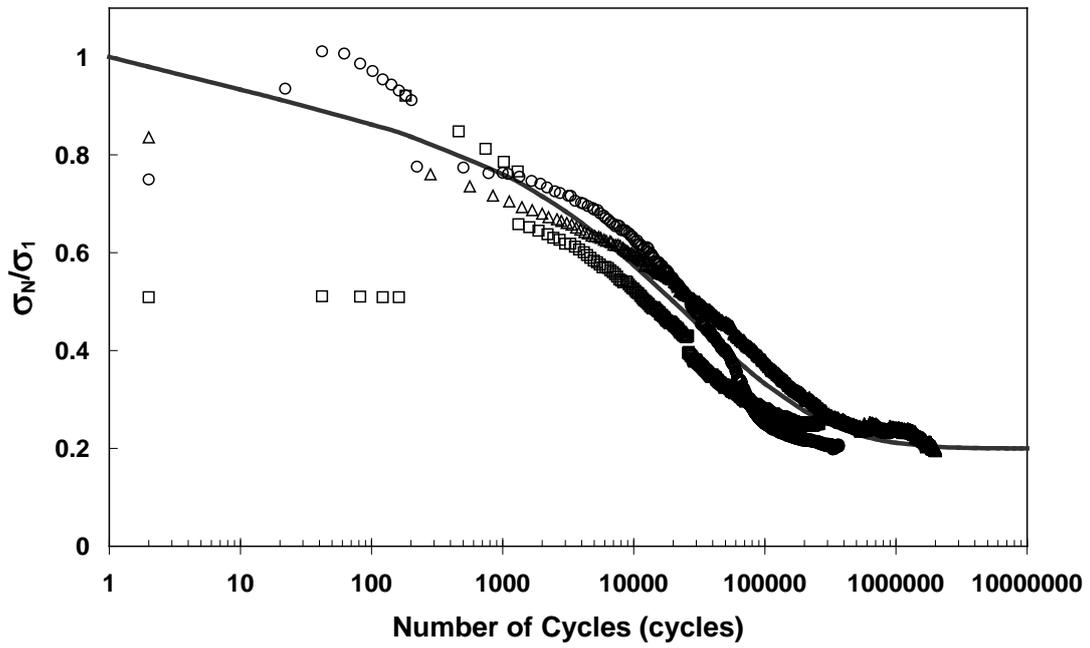
Fig. 15 Fitting curve and bridging stress degradation curves during tensile fatigue with maximum tensile strain of 0.15 %.

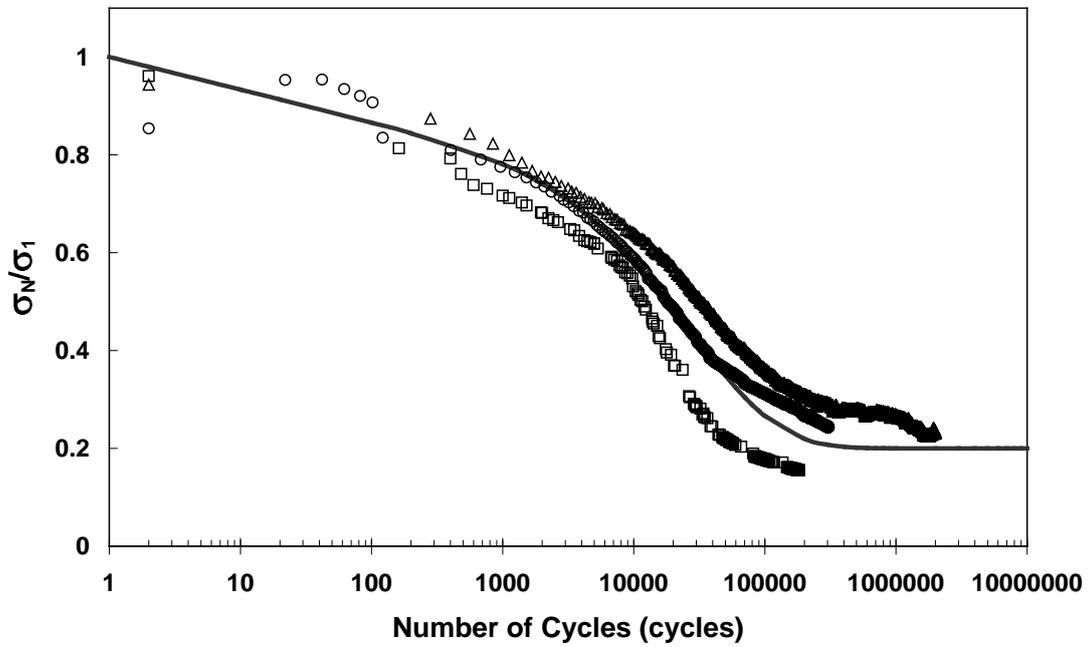
Fig. 16 Fitting curve and bridging stress degradation curves during tensile fatigue with

**maximum tensile strain of 0.2 %.**
