## **[Short Communications]**

### **Evaluation methods for porous asphalt pavement in service for fourteen years**

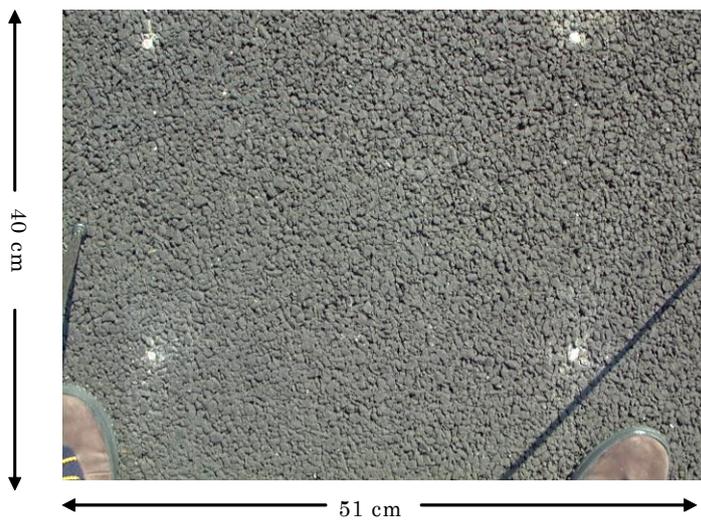
Fig. 2 . The photo of pavement surface including four points of nail

Photography of pavement surface was suggested to examine the movement of aggregate on surface of pavement. This method was very simple, but it can not correctly measure the movement of aggregate in porous asphalt. The movement (0.1 mm) of aggregate on pavement surface at Section A was measured by 35 mm camera, including with the embedded nail of four points (51 x 40 cm) in Fig.2.. Those points were located under the wheel path and it was 20 cm apart from the outer white line and photo was taken at area of 51 cm x 40 cm. Thereafter, the analyses (0.1 mm) of those

images were conducted using the images used film scanner. The four points of nails were used to fit the images.

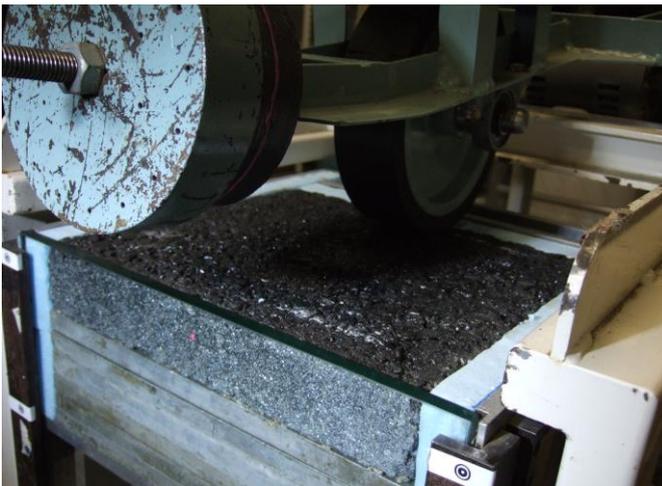
Photo 1. Overview of wheel tracking test of Hokkaido University Type

Wheel tracking test of Hokkaido University Type was performed to measure the movement of aggregate and strain distribution on the end of specimen (5 x 30 cm) at 45 C for one hour (Photo 1.).

The center of wheel in this test was shifted to glass side 5 cm and the nearest wheel of path was 5 mm apart from the glass. One side of specimen in this test consists of transparent glass and the movement of aggregate and asphalt mortar can be measured through the glass by 35 mm camera (Fig.1). The movement (0.01 mm) and rotation (0.01 degree) of aggregate (2 mm or lager) [13] in mixtures were measured for the end of specimen (5 x 30 cm) facing glass by 35 mm camera.
