# **Surface Cracking on $\Sigma 3$ , $\Sigma 9$ CSL and Random Grain Boundaries in Helium Implanted 316L**

## **Austenitic Stainless Steel**

The relationship between surface cracking at grain boundaries and the grain boundary nature in helium implanted 316L austenitic stainless steel was investigated by *in-situ* annealing in a high-voltage electron microscope, and by SEM and TEM observations. The nucleation and growth of helium bubbles at a random grain boundary was observed during annealing up to 973 K. After annealing, surface cracking was observed at the random grain boundaries and some coincidence site lattice (CSL) boundaries because of the formation and rupture of the helium bubbles at these grain boundaries. At the faceted CSL boundaries, surface cracking occurred only on one boundary facet plane. This indicates that the twin boundary and pure tilt  $\Sigma 9$  CSL boundary show the highest resistance to cracking because of their low boundary energies.

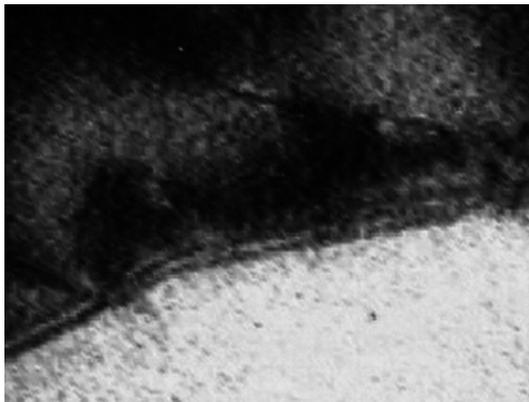
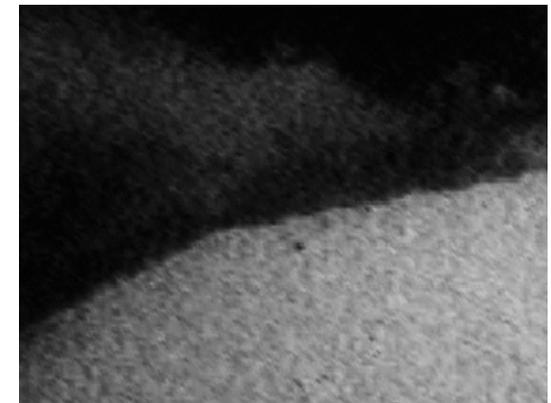
Fig.2 Behavior of helium bubble nucleation and growth on a random grain boundary during *in-situ* annealing in the MBHVEM up to 923 K.

Fig. 2 shows the helium bubble formation behavior in helium ion implanted 316L steel during the *in-situ* heating experiment in the MBHVEM. Before heating, no helium bubbles were seen at the random grain boundary, twin boundary or in the matrix. When the sample temperature reached 773 K, tiny helium bubbles (~10 nm) formed exclusively at the random grain boundary. The bubbles grew slowly upon further heating of the sample to 873 K. Finally, upon heating to 923 K, the bubbles coalesced forming a channel of helium gas along the random grain boundary. No helium bubbles were seen at the twin boundary during this heating experiment.

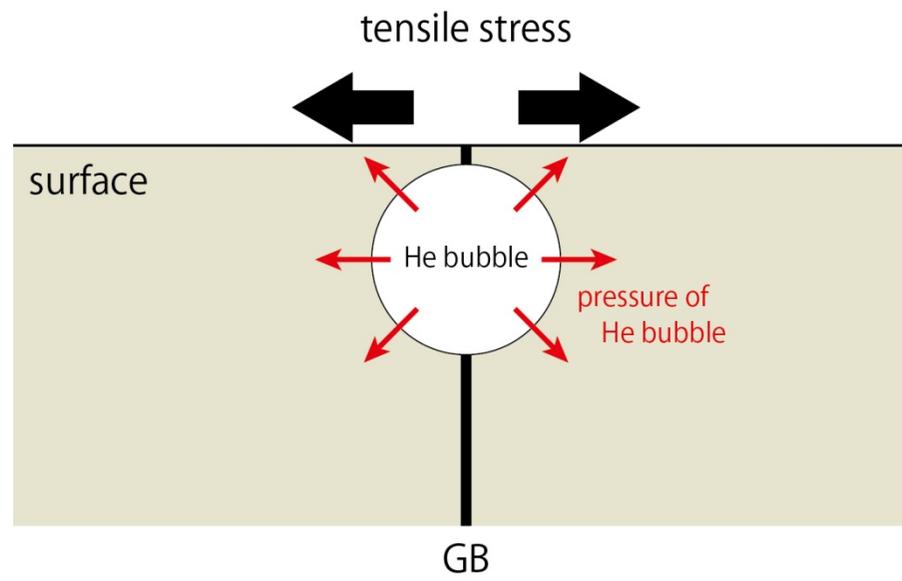
Fig.8 Schematic illustration of the generation of surface stress caused by helium bubble overpressure formed on the grain boundary near the surface.

After annealing of the helium ion implanted 316L stainless steel in the MBHVEM, surface cracking occurred along the random boundary and some CSL boundaries. This is due to the formation and rupture of helium bubbles at the grain boundaries. Helium cracking is known to occur during welding of stainless steel containing helium atoms. In the heat-up period of welding, helium bubbles nucleate at grain boundaries and grow by thermal vacancy absorption because of helium gas overpressure in the bubbles [26]. In the cooling period, the helium bubbles continuously grow by stress-induced vacancy absorption [26] due to the tensile stress associated with the solidification of the melting zone. When the tensile stress exceeds the fracture stress of the grain boundary decorated

by the helium bubbles, surface cracking occurs. It was observed that many helium bubbles nucleated and grew at the grain boundaries during *in-situ* annealing in the MBHVEM, analogous to the heat-up process during welding. However, in our experiment, the cooling rate of the sample was about 10 K/s, which is much slower than that during welding. Furthermore, there was no melting zone near the grain boundaries, hence the effect of external tensile stress can be neglected. As shown in Fig. 1, the distribution of implanted helium atoms is limited to a depth of 300 nm from the surface, resulting in helium bubbles only being nucleated at grain boundaries near the surface. When the helium bubbles grow through the absorption of both thermal vacancies and helium atoms, tensile stress is applied near the surface due to the helium gas overpressure in the bubbles (see Fig. 8). We believe that the surface cracking occurred during the annealing period in the MBHVEM (not during the cooling period) and the surface does not affect the nucleation of helium bubbles at the grain boundaries.
