Dynamic Response of a Chevron Concentrically Braced Frame

Taichiro Okazaki, A.M.ASCE¹; Dimitrios G. Lignos, A.M.ASCE²; Tsuyoshi Hikino³;
and Koichi Kajiwara⁴

Abstract: Large-scale shake table tests were conducted at E-Defense, Japan, to examine the dynamic response of a steel concentrically braced frame. The specimen was a single-bay, single-story frame with a pair of square-HSS braces placed in a chevron arrangement. The gusset plates connecting the brace to the framing elements were provided with an elliptic fold line to accommodate out-of-plane rotation of the brace in compression. The specimen was subjected repeatedly to a unidirectional ground motion with increasing magnitude until the braces buckled and eventually fractured. The bracing connections performed as intended; the gusset plates folded out-of-plane and no crack was observed in the gusset plate or in the critical welds. Consequently, the test results demonstrated excellent performance of the bracing connections. Elastic deformation of the beam prevented the braces from developing their full tensile strength. Yielding in the middle of the beam, which was predicted by monotonic loading analysis, did not occur. The sp

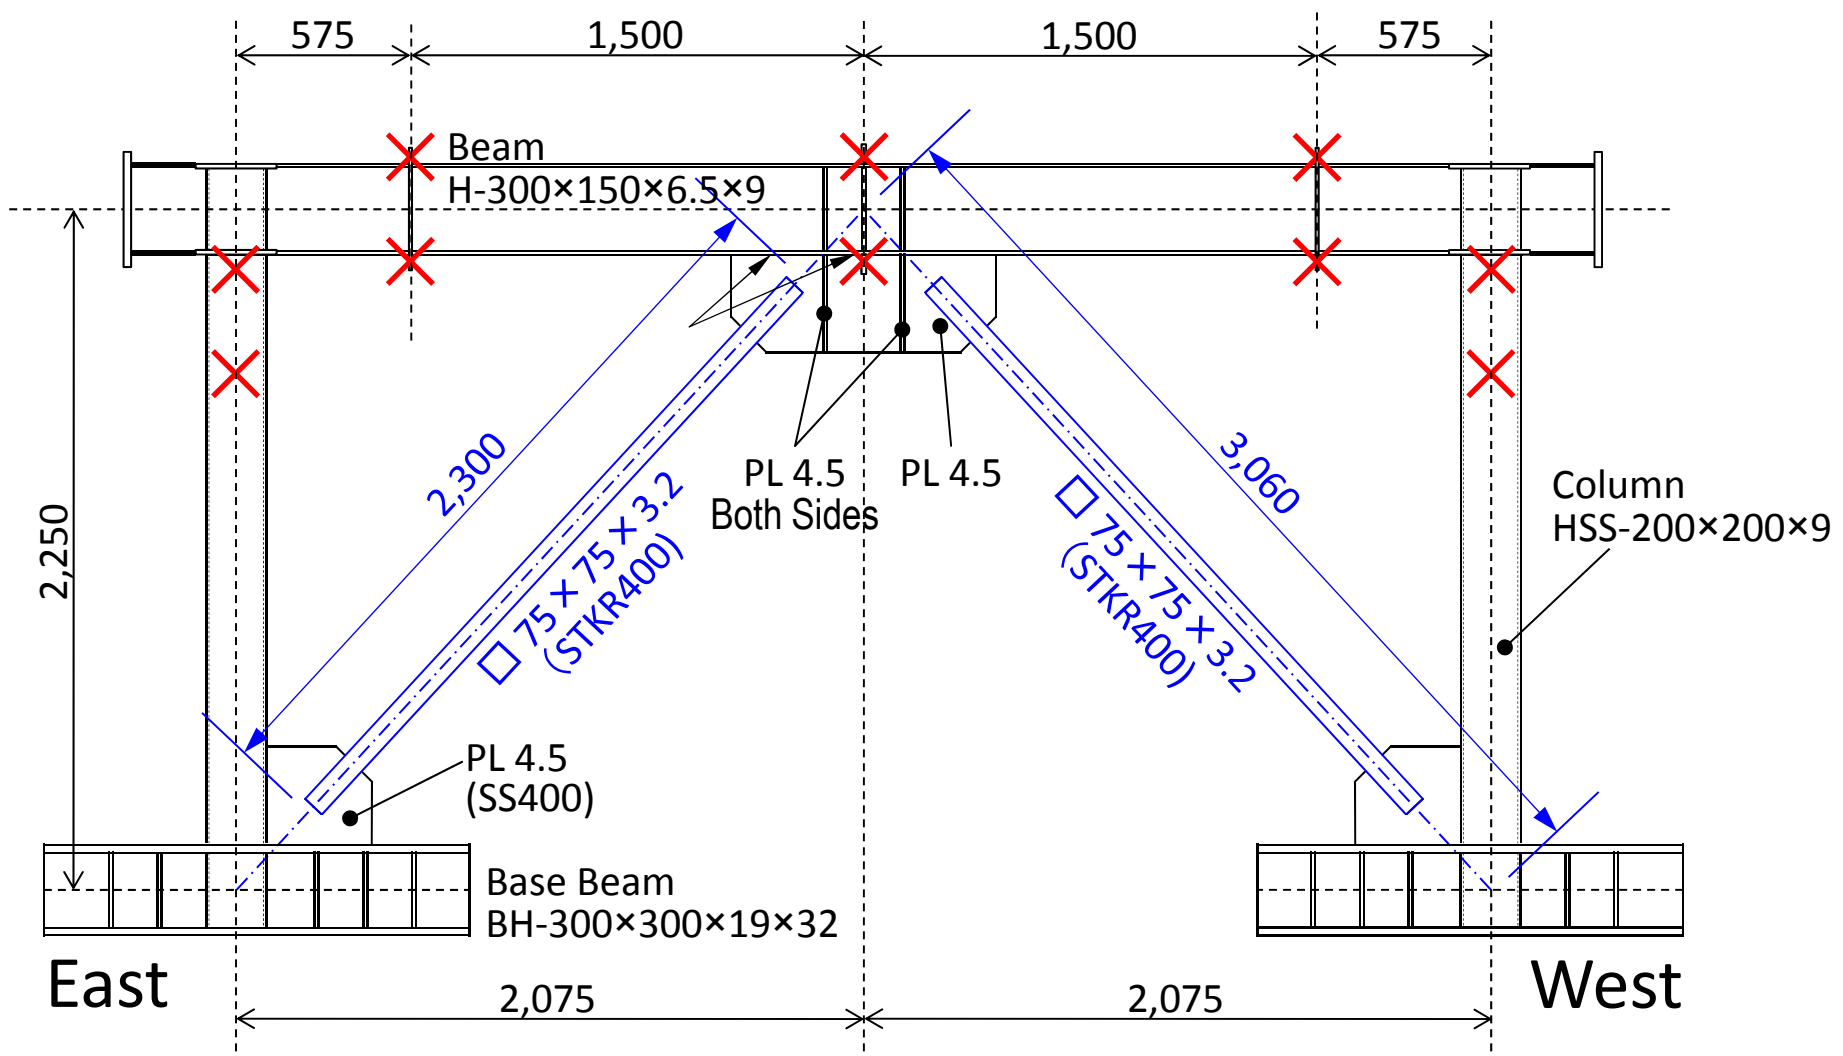
Figure 1

1 Fig. 1 shows an elevation of the CBF specimen. The 4.15-m span and 2.25-m height
2 correspond to 70%-scale of typical building structures. The specimen may represent the bottom
3 story of a 3 to 5-story building in Japan. The frame comprised a built-up wide-flange beam ($d =$
4 300 , $b_f = 150$, $t_w = 6.5$, $t_f = 9$ mm), two cold-formed square-HSS columns ($d = b = 200$, $t = 9$
5 mm), and a pair of square-HSS braces ($d = b = 75$, $t = 3.2$ mm). The braces connected to the
6 beam-to-column joints through 4.5-mm gusset plates. The standard through-diaphragm detail
7 (Nakashima et al. 1998) was used to achieve rigid beam-to-column connections.

1 connected to the test-bed system described later. The specimen was laterally braced along the
2 columns and beam at discrete locations indicated in Fig. 1 by “×” marks.

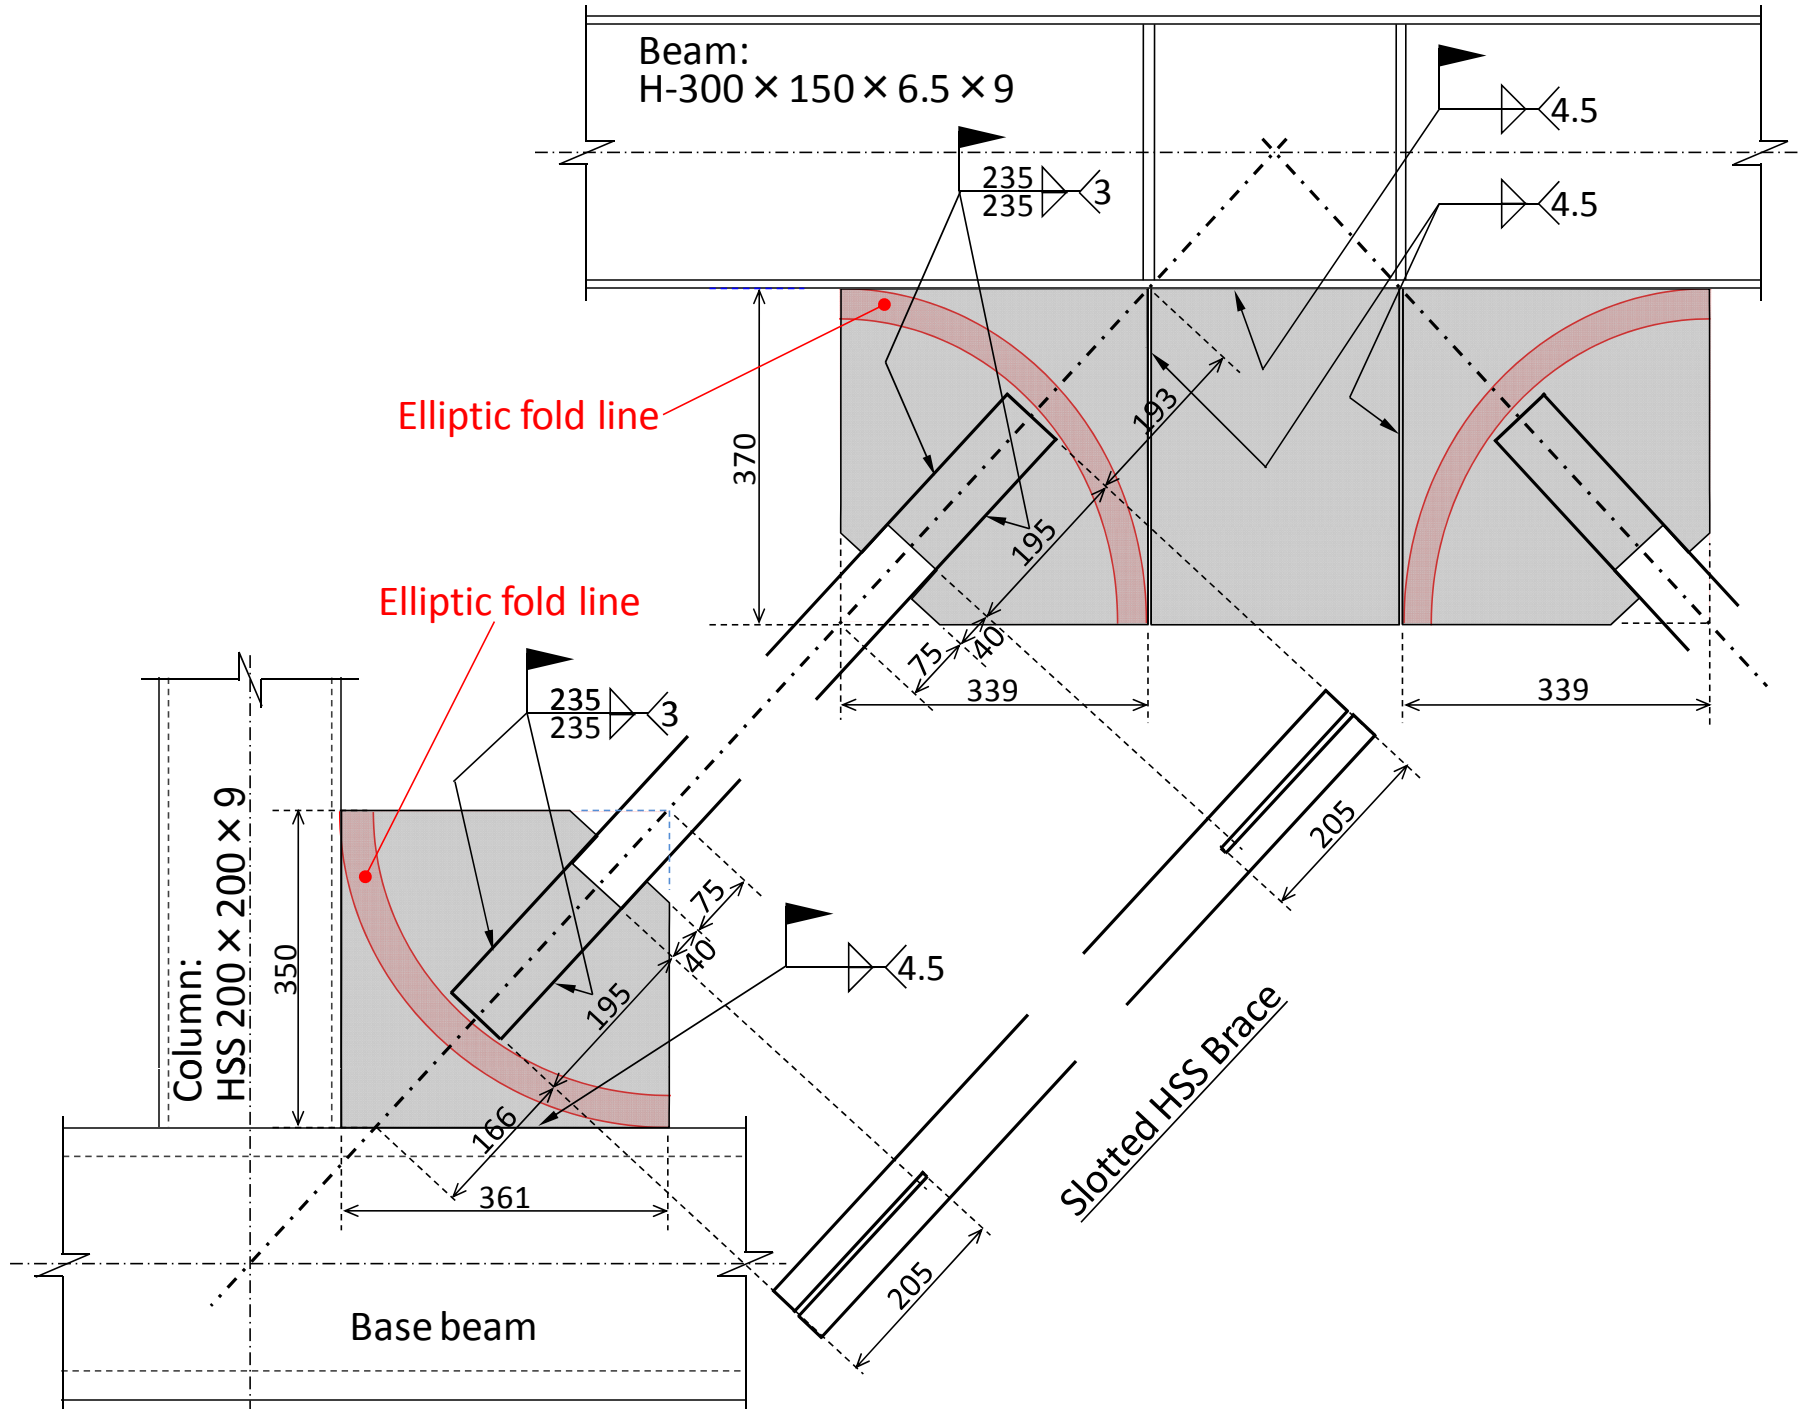
Figure 2

21 The bracing connections shown in Fig. 2 did not represent typical Japanese design. The
22 three gusset plates were designed according to the balanced design proposed by Lehman et al.
23 (2008); by adopting an elliptic clearance distance of eight times the thickness of the gusset plate,

1 the unsupported segment between the brace and the beam and column flanges was shortened,
2 thereby enabling relatively thin, compact gusset plates. The gusset plate at the top end of the
3 braces, connecting the braces to the beam at its mid-span, was provided with a pair of vertical
4 stiffener plates. As indicated in Fig. 2, each end of the brace was welded to a gusset plate along
5 the slotted edges of the brace and clipped portion of the gusset plate. Net section reinforcement is
6 not needed for this detail. The welds between the brace and gusset plate and between the gusset
7 plate and beam and column flanges were placed with the specimen standing in the upright
8 position, and made by a shielded metal arc welding process using a 3.2-mm diameter JIS Z 3211
9 electrode. The welds were sized to develop the full strength of the base material.

14 The bracing connection shown in Fig. 2 was designed to develop the required tensile and
15 compressive strength of the HSS braces using the procedure by Roeder et al. (2011). While
16 Roeder et al. (2011) suggests selectively relaxing the resistance factors in the *AISC Specification*,
17 the designs shown in Fig. 2 fully meet the *2005 AISC Specification* requirements. However,
18 based on the measured yield strength values shown in Table 1, the tensile yield strength of the
19 brace was nearly 10% larger than the yield strength of the Whitmore section of the gusset plates.

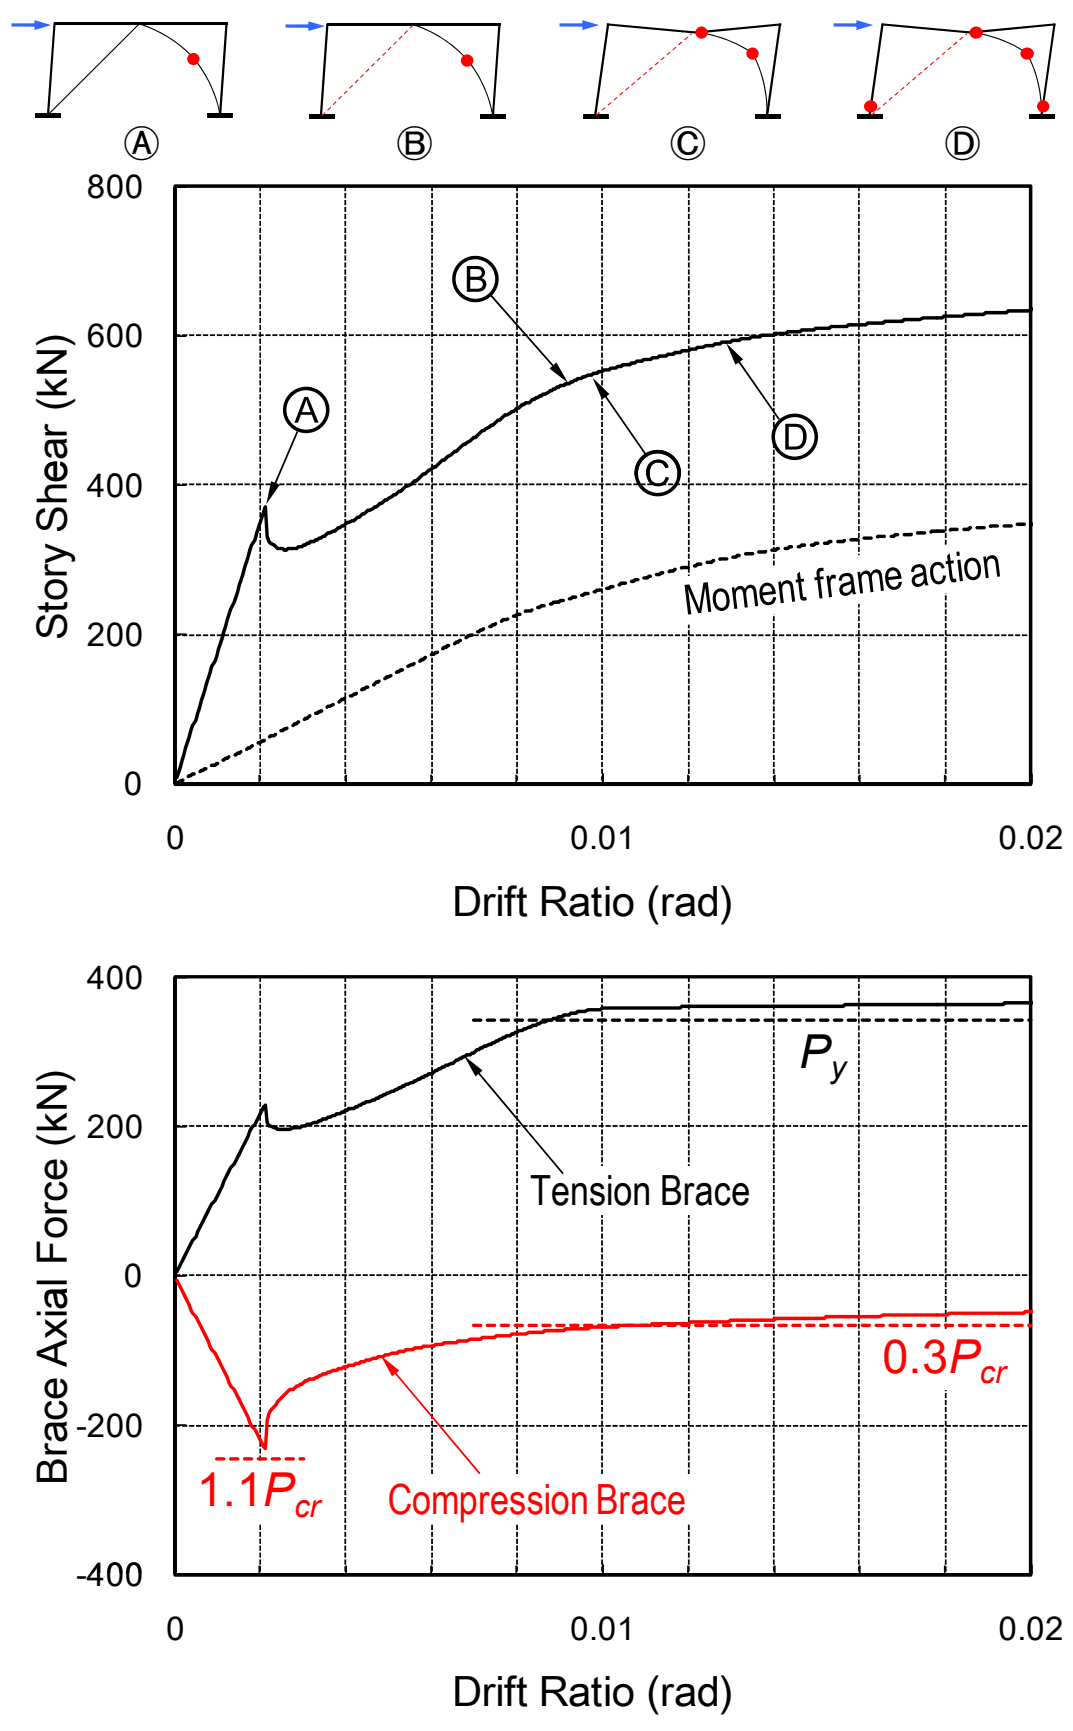
Figure 3

1 strength of the beam to carry mid-span load is a function of the moment distribution produced by
2 moment-frame action. Fig. 3(a) shows a static pushover response obtained from the modeling
3 procedure described later and where gravity load is neglected. The same figure shows the story
4 shear developed in the columns by moment frame action. Fig. 3(b) plots the axial force in the
5 two braces as the story drift increased, along with key strength values specified in the *2005 AISC*
6 *Seismic Provisions*. Prior to buckling of the compression brace, the braces account for 84% of
7 the frame strength. This ratio reduces to 73% after the compression brace buckles (Stage A
8 indicated in Fig. 3(a)) and to 54% when the tensioned brace yields (Stage B). The compressed
9 brace buckles at a story drift ratio of 0.0022 rad., the tension brace yields at 0.0095 rad., and at
10 0.01 rad., a plastic hinge forms at the end of the rigid offset near the center of the beam (Stage C).

11 The force in the compressed brace reduces to below $0.3P_{cr}$, which is the strength used to evaluate
12 the beam mid-span load in chevron CBFs. Even after a beam mechanism is formed, the frame
13 strength continues to increase. It is cautioned that deterioration of beam strength at the beam-to-
14 column connection is not modeled, and because gravity load is not accounted for, the model is
15 not affected by P-Delta effects.

18 The dynamic response of the specimen was quite different from the response predicted by
19 monotonic loading analysis. While the monotonic analysis in Fig. 3 suggests the likelihood of
20 forming a plastic hinge at mid-span of the beam, no sign of yielding was observed at this location
21 in the shake-table test or in the numerical simulation of the specimen. While Fig. 3 suggests that
22 the tension brace can develop substantial yielding, the braces in the shake-table test and

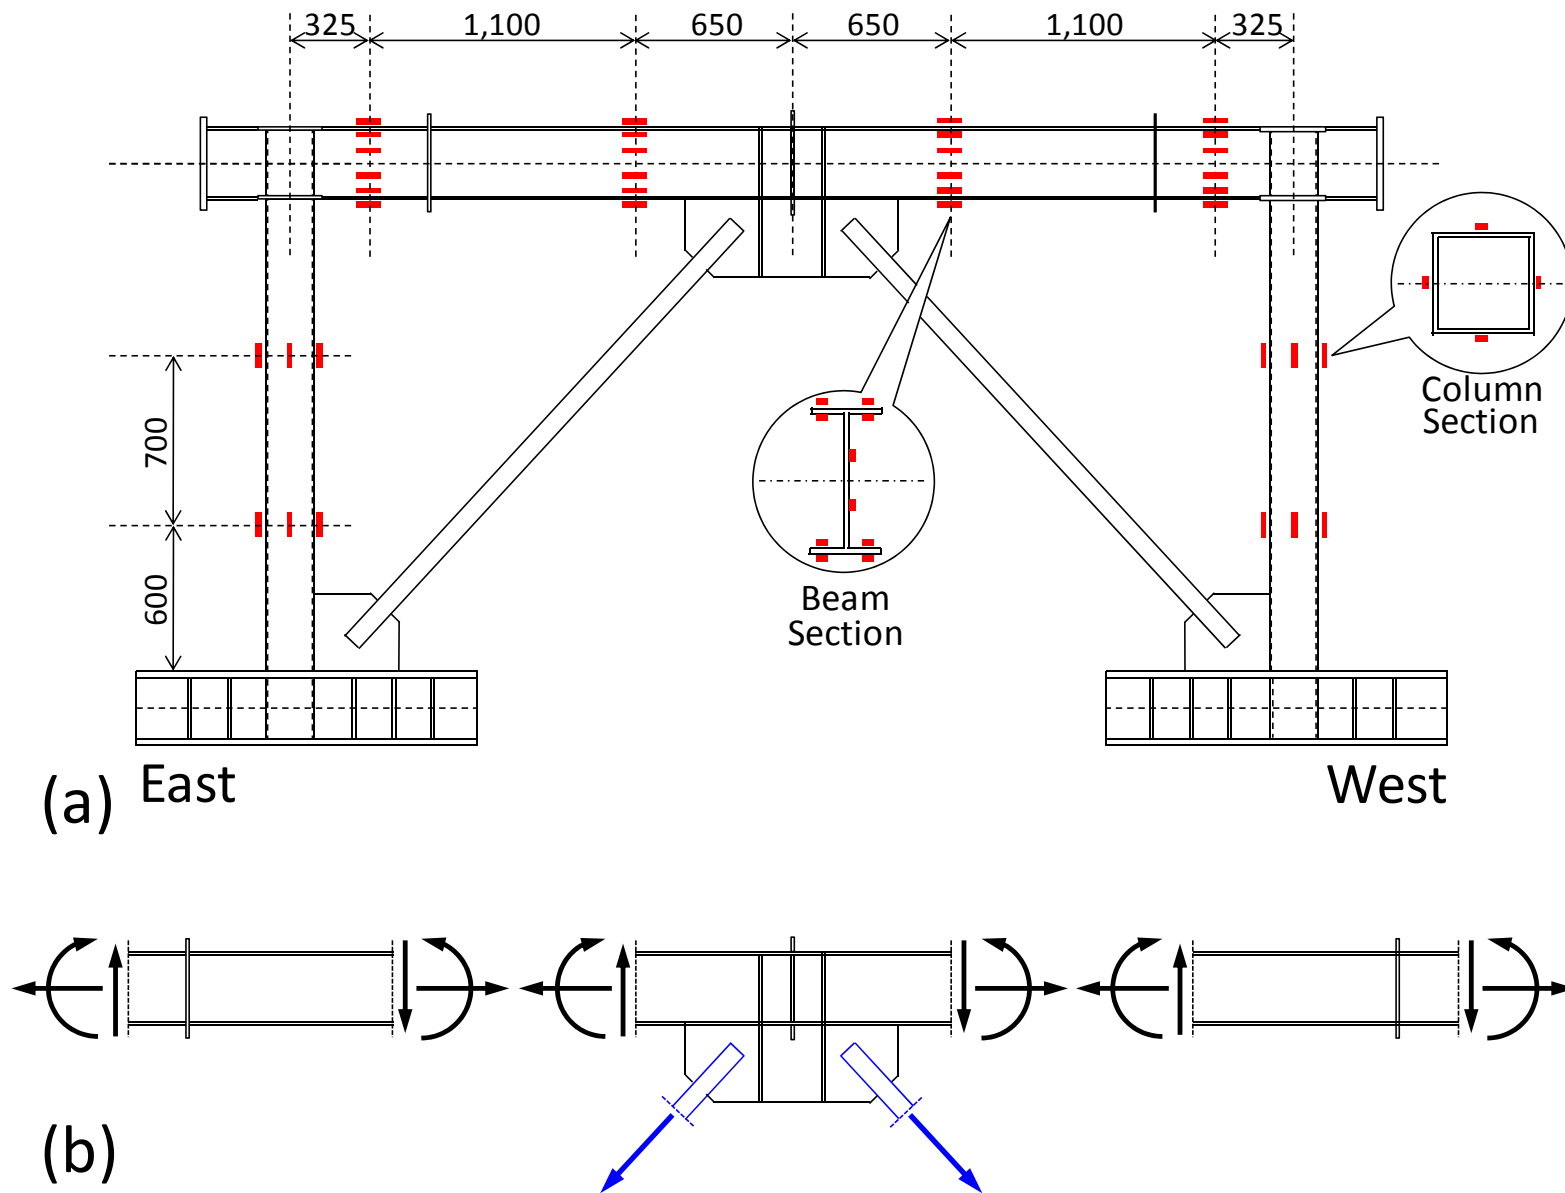
Figure 6

1 The load cells mentioned above were used to evaluate the story shear force. Displacement
2 transducers were used to monitor story drift and out-of-plane deformation of the beam and braces.
3 As shown in Fig. 6(a), strain gauges were placed at selected sections of the beam and columns.
4 The section forces estimated from strain gauge readings were combined with the equilibrium
5 conditions indicated in Fig. 6(b) to compute the axial force in the braces. Elongation of the brace
6 was measured from the change in length of the HSS member. Data was collected at a rate of
7 1,000 Hz. All data was passed through a low-pass filter to eliminate frequency content above 50
8 Hz.

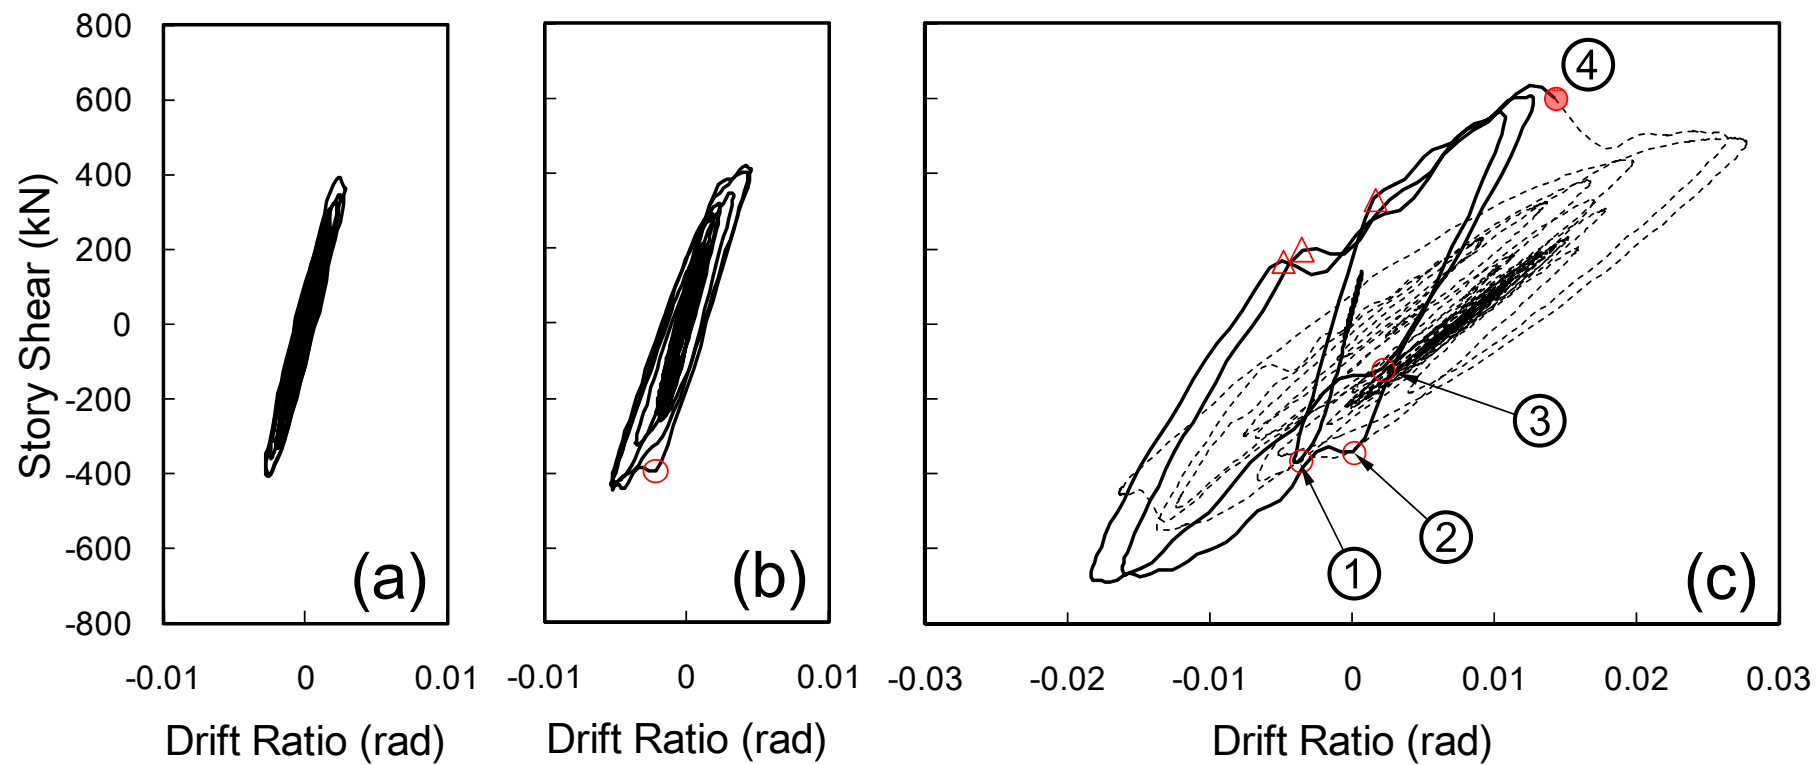
Figure 7

13 Fig. 7 shows the story shear versus story drift response measured for the three tests using
14 the 28, 42, and 70% motions. The figure indicates that the structure responded linearly during the
15 28% motion, but some nonlinearity occurred during the 42% motion. The response from the 70%
16 motion plotted in Fig. 7(c) suggests that the system was affected by buckling and yielding of the
17 braces during two and one-half drift cycles of -0.015 to $+0.01$ rad. The circles and triangles in
18 the figure correspond to the time instants when key phenomena were observed in the East and
19 West braces, respectively. The numbers 1 to 4 in Fig. 7(c) correlate with buckling and fracture of
20 the East brace indicated in later figures. The braces buckled and fractured within three negative
21 to positive drift excursions between -0.015 and 0.01 rad. Each occurrence of brace buckling

1 caused a reduction in stiffness and drop in story shear, although the frame was able to regain
2 strength as the drift increased further. Near the instant when the East brace fractured at stage 4,
3 the West brace started to fracture under large contraction. The response after stage 4 is indicated
4 by a dotted line. After both braces fractured, the specimen acted as a moment resisting frame,
5 developing large deformation between -0.018 and $+0.028$ rad. without any strength loss. Fig.
6 7(c) clearly indicates the reduction in stiffness after the braced frame reduced to a moment
7 resisting frame. At the end of the 70% motion, a residual drift of $+0.007$ rad. remained.

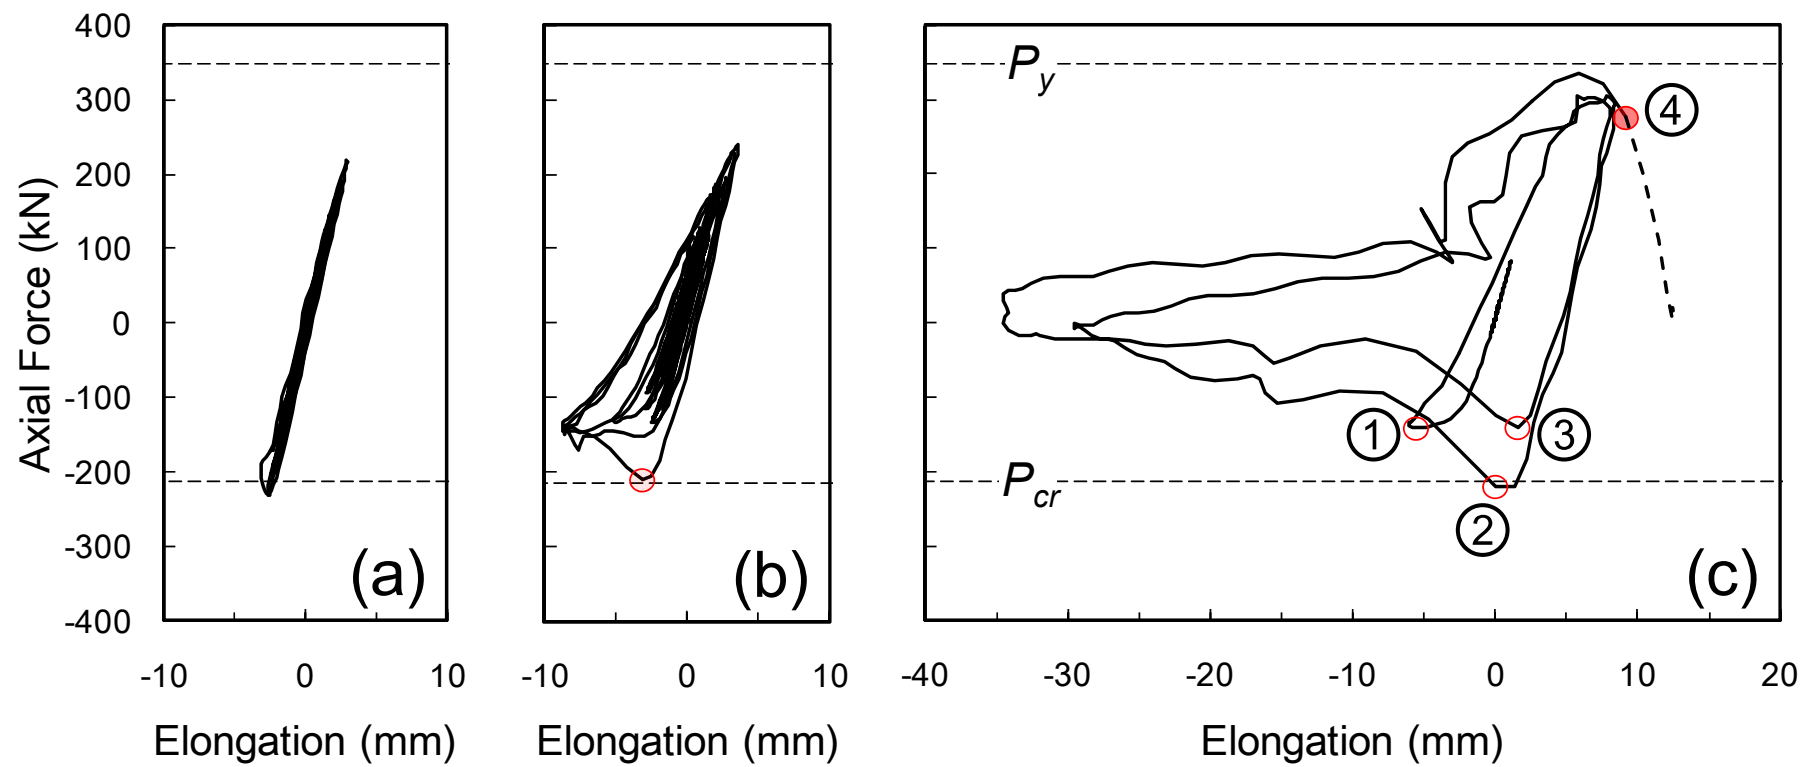
Figure 8

19 Fig. 8 shows the axial force (tension taken as positive) versus elongation relationship
20 measured from the East brace for the 28, 42, and 70% motions. Fig. 9 shows the rotation of the
21 top and bottom ends of the East brace measured from the same motions. The response of the
22 West brace was similar to that of the East brace. In Figs. 8 and 9, the horizontal lines indicate the

1 tensile yield strength P_y and compressive strength P_{cr} of the brace member computed based on
2 the measured yield strength and a slenderness ratio of $KL/r = 82.5$.

12 As seen in Fig. 8(c), the braces deformed more substantially in contraction than in
13 extension, and did not develop their tensile yield strength. The reason of this behavior is
14 explained in Fig. 11, which compares the history of extension of the East and West braces and
15 vertical displacement measured at the middle of the beam. The beam displaced downwards as
16 much as 15 mm as one of the two braces contracted and the other extended to produce force
17 unbalance. The figure indicates how the vertical displacement added to brace contraction and
18 reduced brace extension. After the East brace failed in tension (stage 4 in Fig. 8(c)) and the West
19 brace began to fracture, the beam was no longer subjected to substantial downward forces.

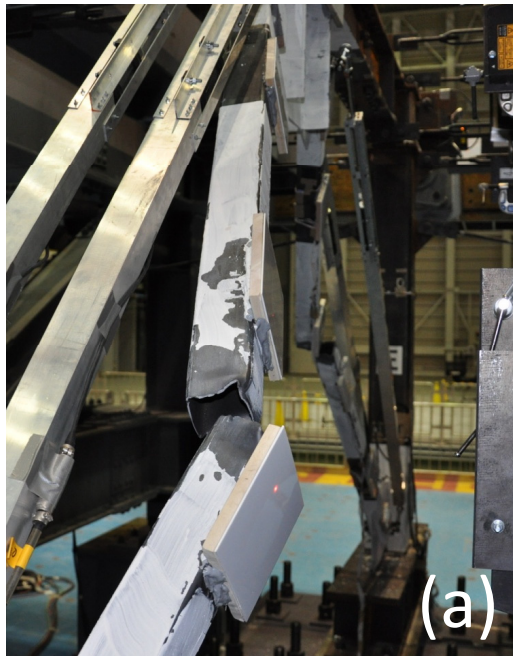
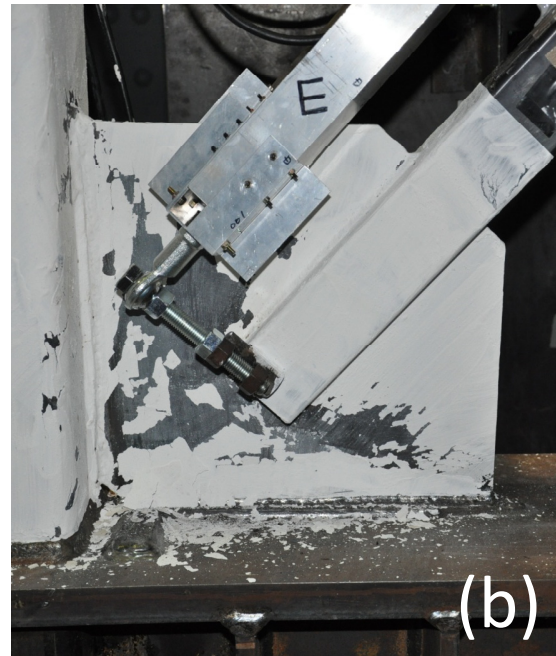
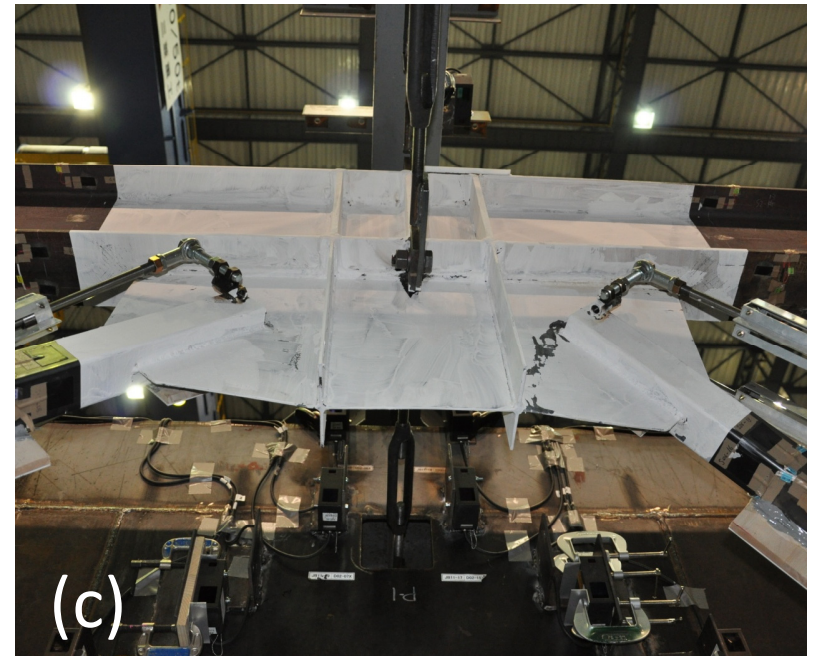
Figure 10

- Fig. 10 Specimen after 70% motion: (a) fractured West brace; (b) gusset plate at the East column base; (c) gusset plate connecting braces to beam.
- Fig. 11 Brace elongation and beam deflection: (a) brace elongation; and (b) vertical displacement (upward positive) of beam.

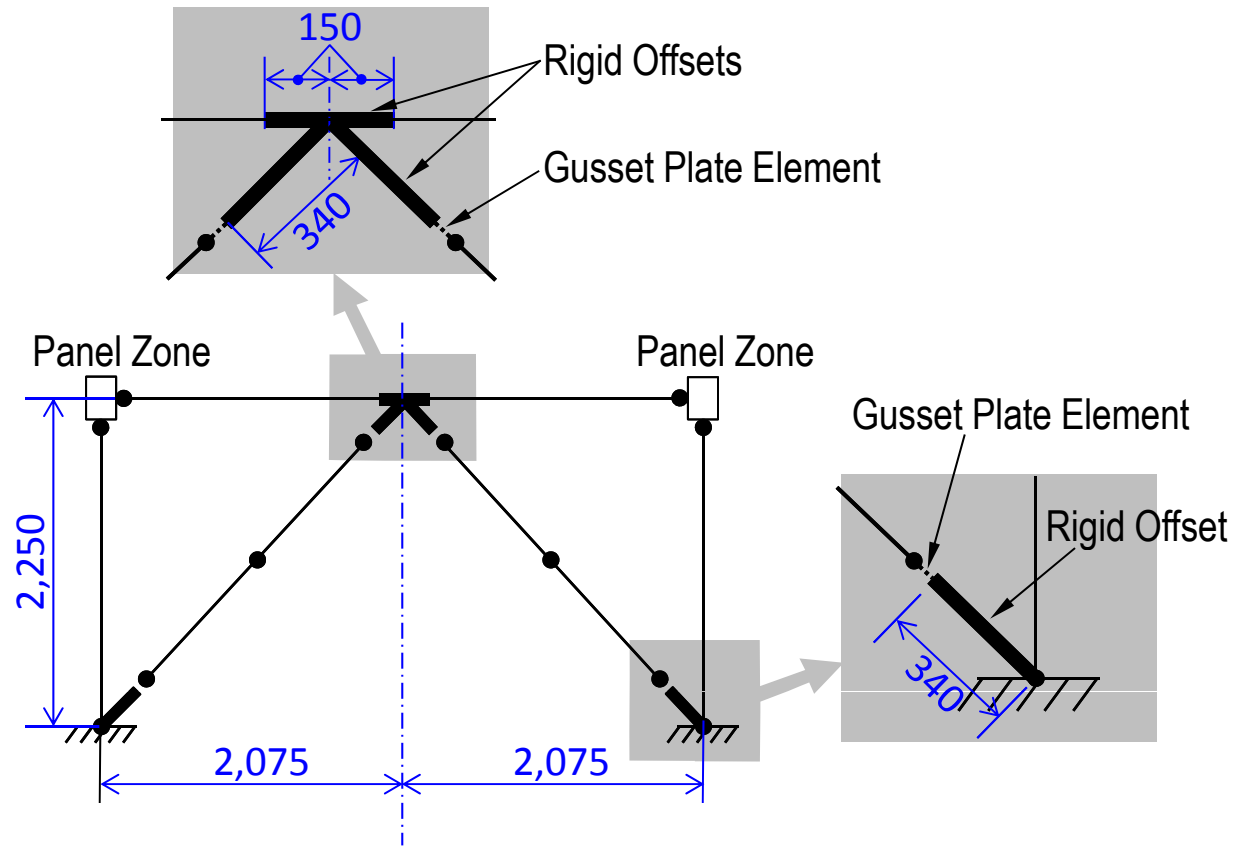
Figure 12

19 Fig. 12(a) shows the numerical model constructed in the OpenSees simulation platform
20 (McKenna 1997). The model included panel zones modeled according to Gupta and Krawinkler
21 (1999) and a 300-mm-long rigid segment in the middle of the beam. The test-bed system was

1 modeled by connecting each end of the beam to a leaning column that support half of the test-
2 bed mass. Nonlinear geometry was considered with corotational transformation. The members
3 were modeled with a displacement-based fiber element that uses the Gauss-Lobatto quadrature
4 rule. Five integration points were used along their lengths including the two placed at the ends. A
5 16×4 mesh was used for the flange and web of the beam and columns and a 10×4 mesh was used
6 for each wall of the braces. Material nonlinearity was modeled using the Giuffre-Menegotto-
7 Pinto model with isotropic strain hardening and the measured material properties listed in Table
8 1. Three-percent mass proportional damping was assumed at the first vibration period of the
9 numerical model (0.20 sec) to represent friction in the test bed.

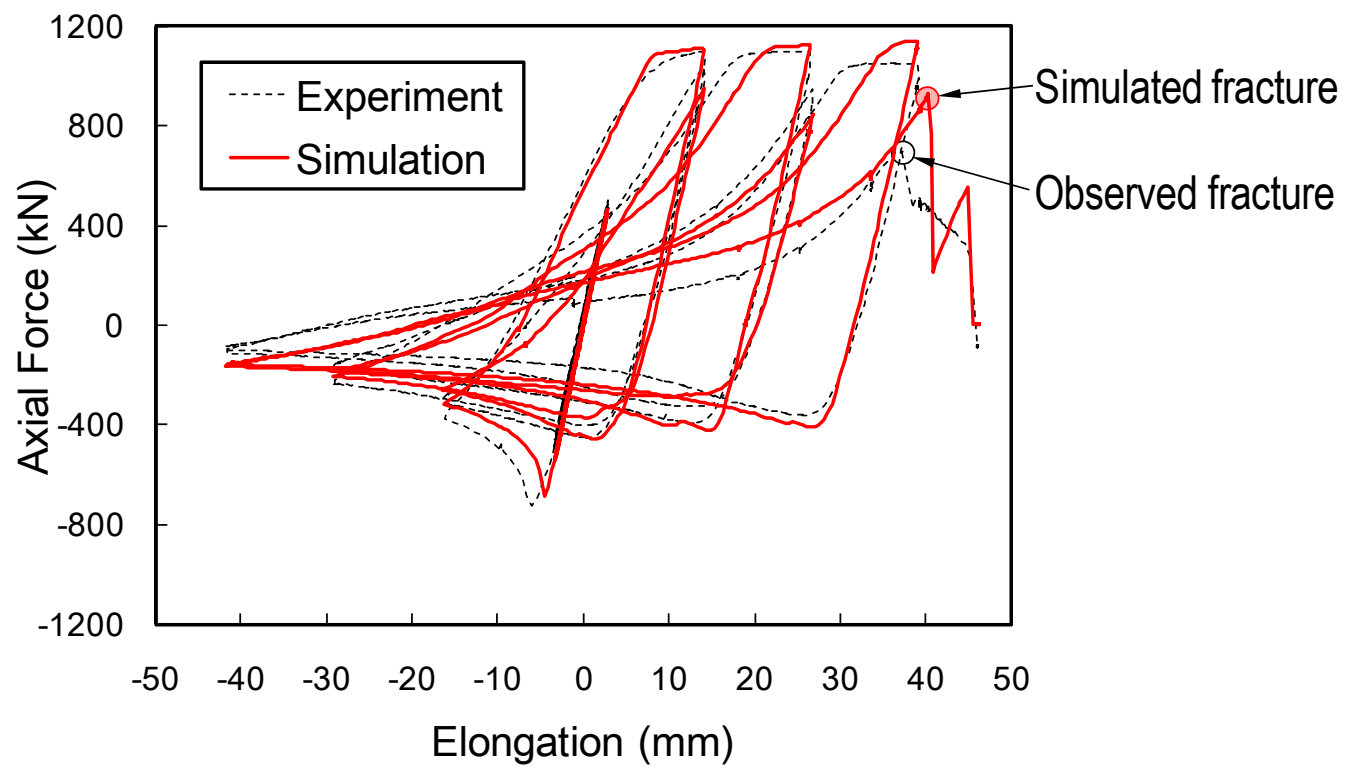
Figure 13

10 The braces were modeled using a technique similar to the technique developed by Uriz et
11 al. (2008) and described in NIST (2011a). Each brace was split into two fiber elements and
12 provided with an initial imperfection equal to 0.1% of the brace length. The gusset plates were
13 modeled by a fiber element with a length equal to twice the gusset plate thickness and with two
14 integration points. Fracture in the critical section was considered by tracking the strain history in
15 each fiber and assigning zero stiffness to any fiber that exceed the low-cycle fatigue limit defined
16 by a rain-flow-count rule. The low-cycle fatigue limit was calibrated against quasi-static tests on
17 square-HSS braces by Fell et al. (2009) and *Black* et al. (1980) that had similar geometric
18 properties ($L/r_y = 80$, $b/t = 16$) as the braces in the shake table tests ($L/r_y = 82.5$, $b/t = 20.4$). Fig.
19 13 shows an example where the calibrated brace model captured the buckling, yielding, post

- Fig. 12 Numerical Model. (Unit in mm).
- Fig. 13 Validation of brace hysteresis and calibrated fracture model using test by Fell et al. (2009).

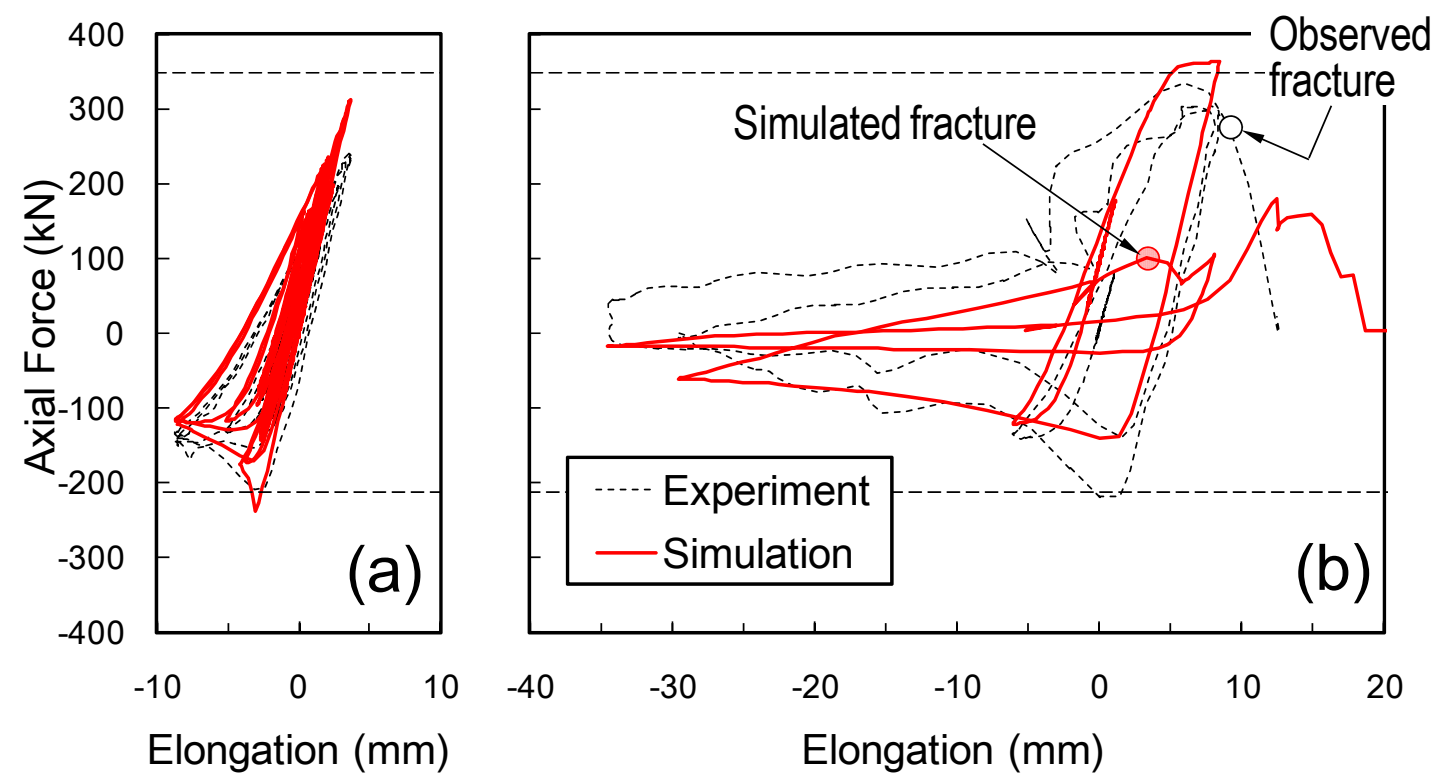
Figure 14

1 The measured motions of the shake table were applied to the numerical models in
2 sequential order to consider the cumulative damage effects on the nonlinear response from phase
3 to phase. Fig. 14 compares the simulated versus experimental hysteresis of the East brace for the
4 42 and 70% motions. The figure shows that the simulation traced the experimental response
5 fairly accurately for the 42% motion, including buckling and post-buckling response, although
6 larger tensile force was developed in simulation. For the 70% motion, the simulation did not see
7 substantial recovery of compression strength after undergoing tension, which was observed in
8 the experiment. The simulated brace fractured before completing the second major tension
9 excursion, while fracture in the experiment occurred during the third major tension excursion. As
10 described above, the fracture limit in the numerical model was calibrated against available test

11 data on braces similar to the braces in the shake table specimen. While the timing of fracture
12 could be matched by adjusting the fracture limit, the difference in timing of fracture seen in Fig.
13 14(c) indicates the difficulty of predicting fracture based on a priori information, and also
14 indicates the sensitivity of how the fracture model affects the simulated behavior of braces.

15 Fig. 14 shows the story shear versus story drift response for the 42 and 70% motions. The
16 figure shows that the simulation traced the experimental response fairly accurately for both
17 motions. The discrepancy between experimental and simulated response for the 70% motion is
18 primarily due to the difference in timing of brace fracture. As in the experimental response, the
19 simulation acted as a moment resisting frame after both braces fractured. As in the experimental
20 response, the simulation did not form a plastic hinge in the beam. This observation is contrary to
21 the prediction from the monotonic loading response shown in Fig. 3, and which was obtained
22 from the same model.

13 due to the slightly larger b/t ratio. However, Fig. 14 to 15 show that the braces survived one
14 more inelastic cycle than the simulated braces. Therefore, although no conclusive statement can
15 be made, Fig. 14 to 15 suggest that the loading rate produced by severe earthquake ground
16 motions do not cause negative effects on the performance of CBFs.

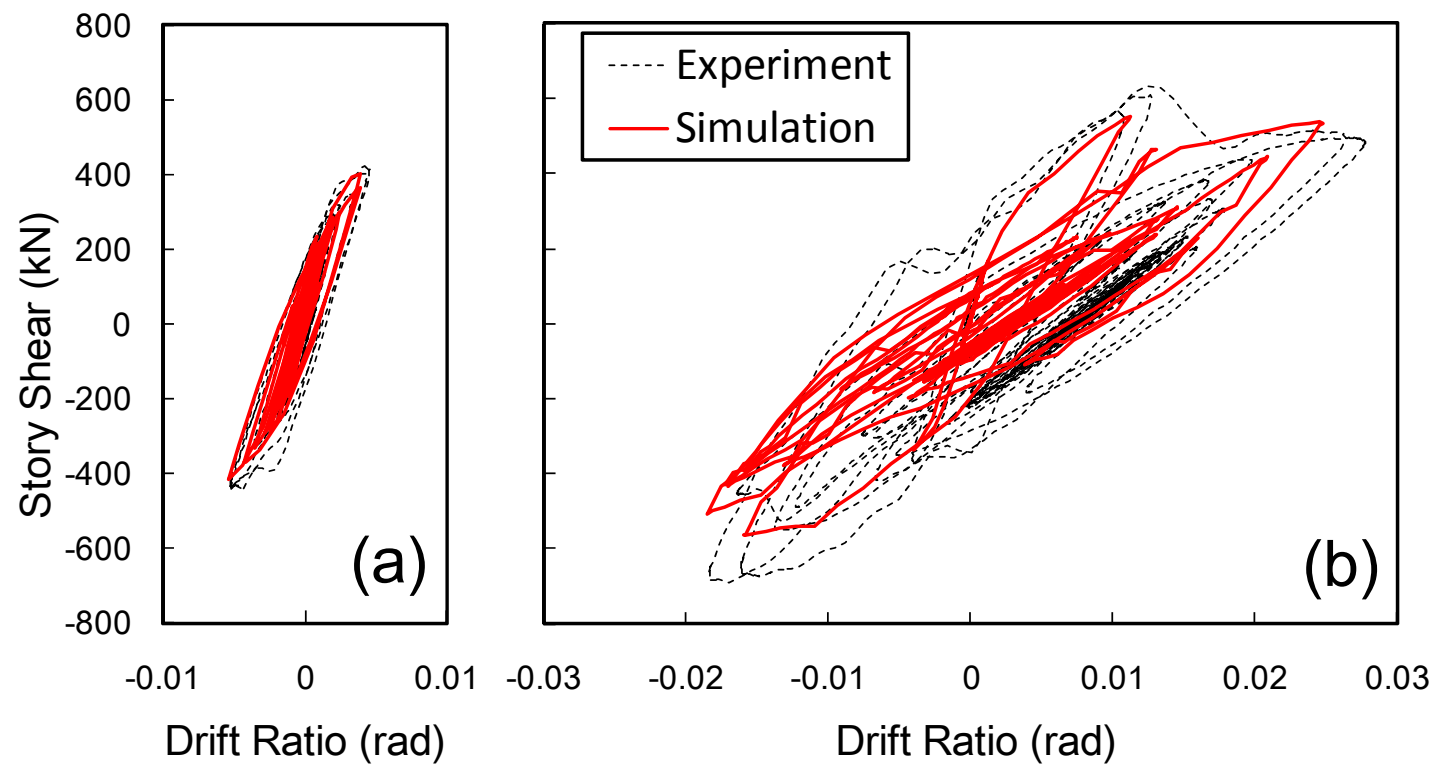
Figure 15

Fig. 15 Simulated versus experimental frame response for (a) 42%; and (b) 70% motion.

21 tests was traced fairly accurately by the numerical model. The model was able to predict the
22 occurrence of brace fracture and subsequent behavior of the frame although the timing of
23 fracture was not captured.
