| Title | PERFORMANCE EVALUATION OF MASONRY SHEAR WALLS STRENGTHENING BY TWO DIFFERENT FRPS |
| Citation | Proceedings of the Thirteenth East Asia-Pacific Conference on Structural Engineering and Construction (EASEC-13), September 11-13, 2013, Sapporo, Japan, D-4-4., D-4-4 |

# PERFORMANCE EVALUATION OF MASONRY SHEAR WALLS STRENGTHENING BY TWO DIFFERENT FRPs

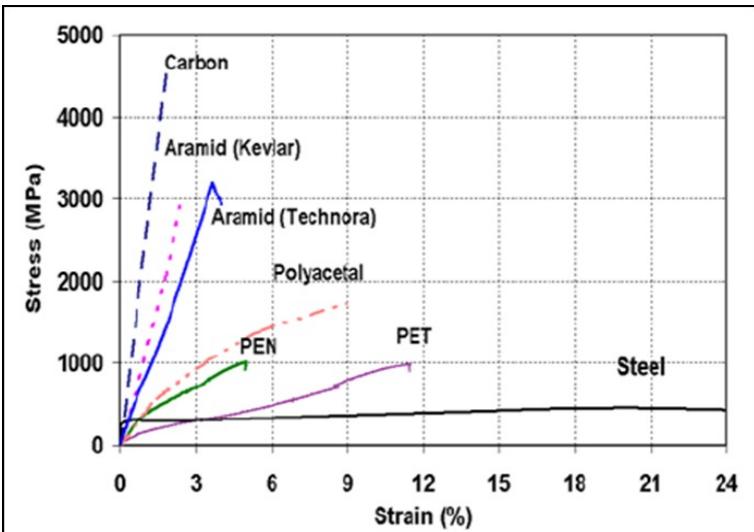
**Figure 1: Tensile strength of different FRPs**

Externally bonded Polyethylene Terephthalate (PET) fiber with a large fracture strain is one of the retrofitting technique that has drawn a significant attention as an unique alternative to CFRP or GFRP due to its pronounced ductile behavior and relatively low material cost (Figure 1), but not compromising the other advantages of FRP like low weight-strength ratio, short installation period and a minimum intervention during the fabrication process. The main objective of using FRPs is to enhance performance of structure at normal loading condition and to offer greater resistance at the time of severe loading. Neither too much stiffness nor the very high strength will be coherent with the overall performance of the masonry structures. Material with high stiffness will produce very little deformation before complete failure and the failure if any will be brittle and explosive in nature without any prior warning, which is not the expected failure mode from a well performed

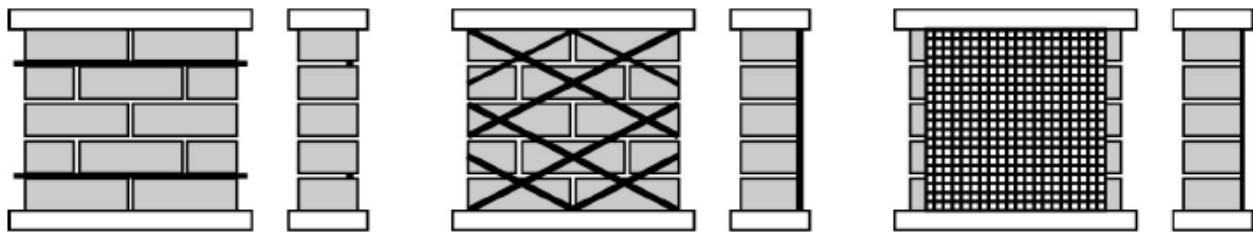
(a) Near surface mounted FRP bars   (b) Strip FRP in diagonal fashion   (c) Sheet FRP over the wall

**Figure 2: Different techniques of FRP installation on masonry wall**

structure. On the other hand too soft material with nominal strength will not be well fitted with the purpose of strengthening. A variety of approaches has previously been undertaken to investigate masonry strengthened with FRPs. Masonry wall strengthening by GFRP (Stratford et al. 2004) shows quite ductile behavior prior to failure and a significant increase of shear load capacity (65%) where as the failure was primarily for the debonding of the GFRP sheet. Another technique of strengthening is done by mounting the FRP rod inside the horizontal mortar joint and is embedded near the surface as shown in Figure 2a. (Tinazzi et al.2000; Tumialan et al. 2001). Alternative to this system is to attach the FRP strips over the surface of the wall in a diagonal fashion (Schwegler 1994). The FRP strip act as a truss made from unidirectional fibers (Figure 2b).

The load-deflection response for the entire shear walls strengthening by PET and CFRP are given in Figure 5. Among them CW3 and PW3 were reinforced by CFRP and PET respectively in diagonal fashion (Figure 2d). These walls were wrapped by CFRP and PET strips having a width of 80 mm from both sides of the wall that covers approximately 20% of the wall area. To facilitate FRP wrapping, the corner of the wall is chamfered as the same width of the FRP strips. Only two strain gages are attached on the wall. One was along the tension diagonal strip and the other one was along the compression diagonal.

**Failure of CW2:** This wall was strengthened by CFRP strip of 70 mm width in a cheakard fashion as shown in Figure 2c, which cover about 40% of the wall gross area. The initial stiffness was quite similar of that of CW3 and the nature of the curve was almost identical. A crack along the wall heel appeared at a load of 87kN. With the increase of displacement through the jack, the load increased a little but the crack opening widened further. After a little while another crack appeared at the mid height of the wall on the loading side (Figure 9a). The load did not increase further, after that and with increase displacement toe crushing happens and the load gradually felled to a minimum without the rupture of any CFRP strip.

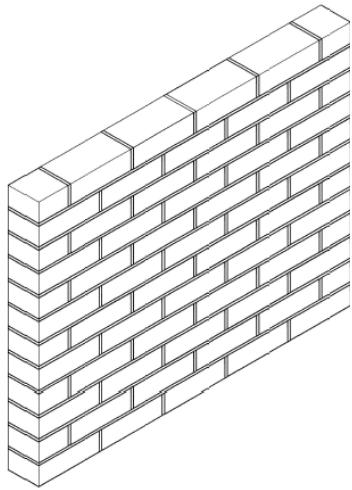
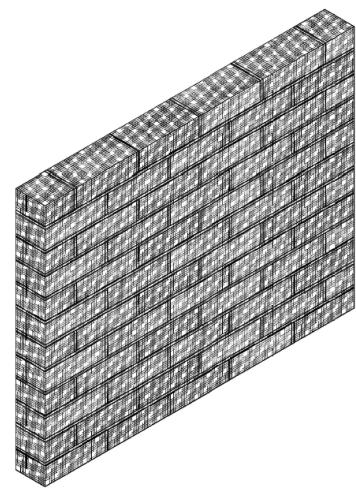
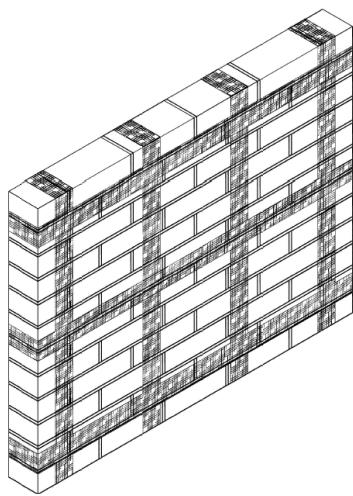
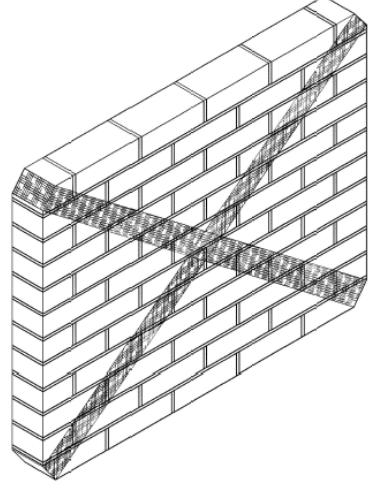
(a) Control wall(RW2)

(b) 100% area covered by FRP (CW1, PW1)

(c) 40% area covered by FRP (CW2, PW2)

(d) 20% area covered by FRP (CW3, PW3)

**Figure3: Wrapping technique of masonry wall by FRP**

PET and CFRP sheet both having unidirectional fiber was applied on wall specimens in three different fashions as shown in Figure 3. The FRPs were applied in wet layup procedure as follows:

- Epoxy resin having the properties mentioned in Table 2 was then applied over the wall where it was necessary. FRP sheets were cut in accordance with the length needed for the walls to cover the 100%, 40% and 20% of the wall gross area (see Fig. 3). Resin was then applied with the help of a roller brush all over the FRP strip so that it was fully saturated by the resin. As soon as the application of the resin was completed, the FRP strips were laid over the wall and wrapped tightly to keep them in place.

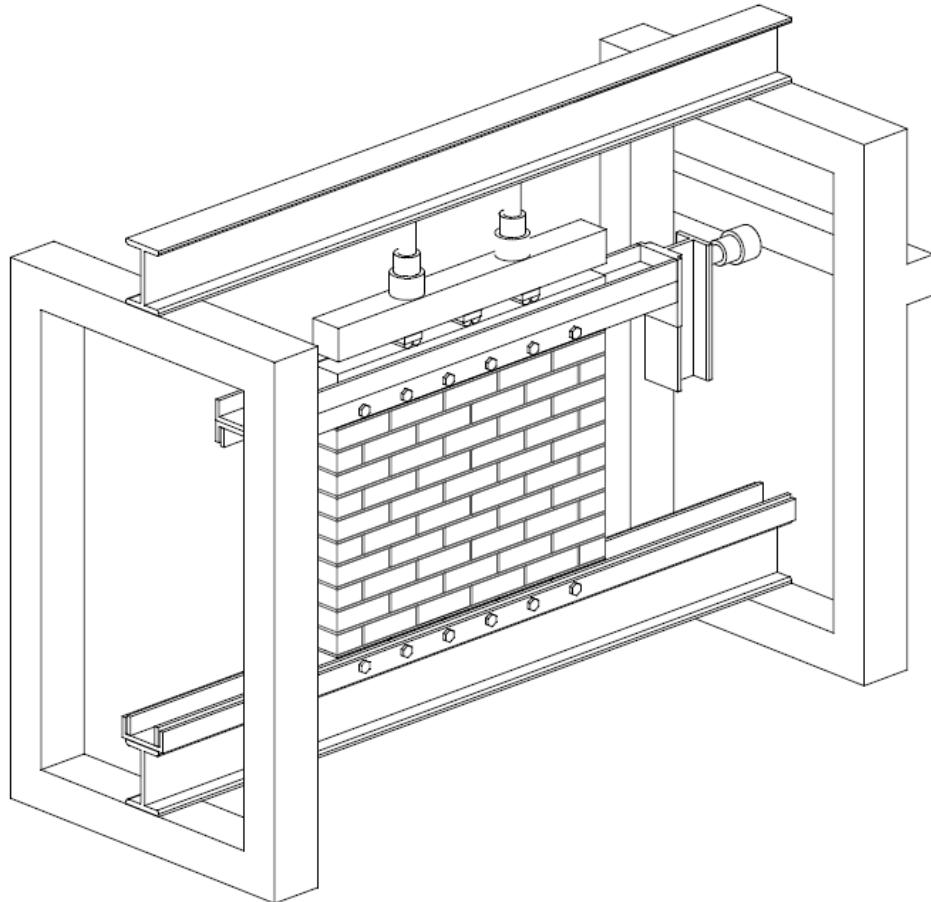
**Figure 4:** Experimental setup for a typical shear wall

After the required curing period, the wall was transferred to the testing frame. The wall top and bottom were anchored with the top and bottom channel beams with the help of six 22 mm bolts as shown in Figure 4. In between wall and the side of the channel beam, a steel plate of 16mm thick was inserted so that the plate creates tremendous pressure on the wall through the tightening of the bolts. Paris plaster was also used to offer a flat surface between wall and steel plate.

A pre-compression of 40 kN which was equivalent to uniform pressure of 0.25MPa was applied on the top of the wall through two hydraulic jacks, ahead of the shear loading to simulate the load of structural component coming on the wall from the above in the real world. Sufficient wire strain gages (KYOWA-5) and LVDTs were used to record all the necessary information during the course of testing. Loads were applied on roller and ball-bearing system to avoid any excessive friction and deviation of loading points. The lateral load was then applied with the help of a hydraulic jack having a capacity of 50 tons. Remote pump was used to increase the lateral load gradually until complete failure of the masonry wall was ensured. All of the data (displacement, strain, load) were accumulated through a digital data logger.

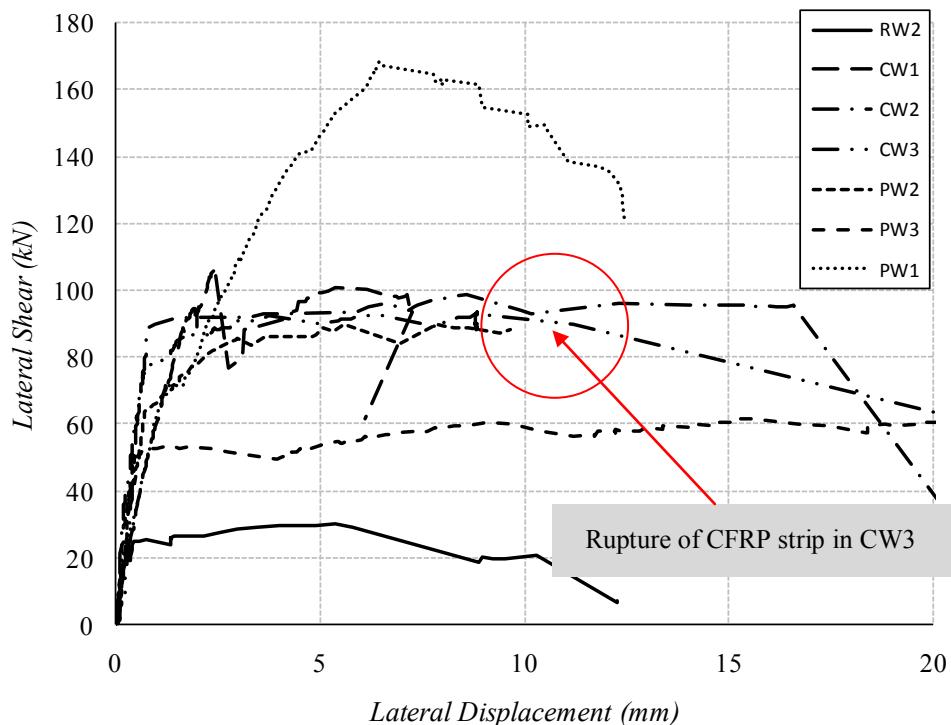
**Figure 5: Load Vs deflection envelop of shear wall specimens**

The load deflection relationship for all of the seven shear walls are given in Figure 5. The evolution of damage and critical observation with loading process for each of the walls is given in the following sections.

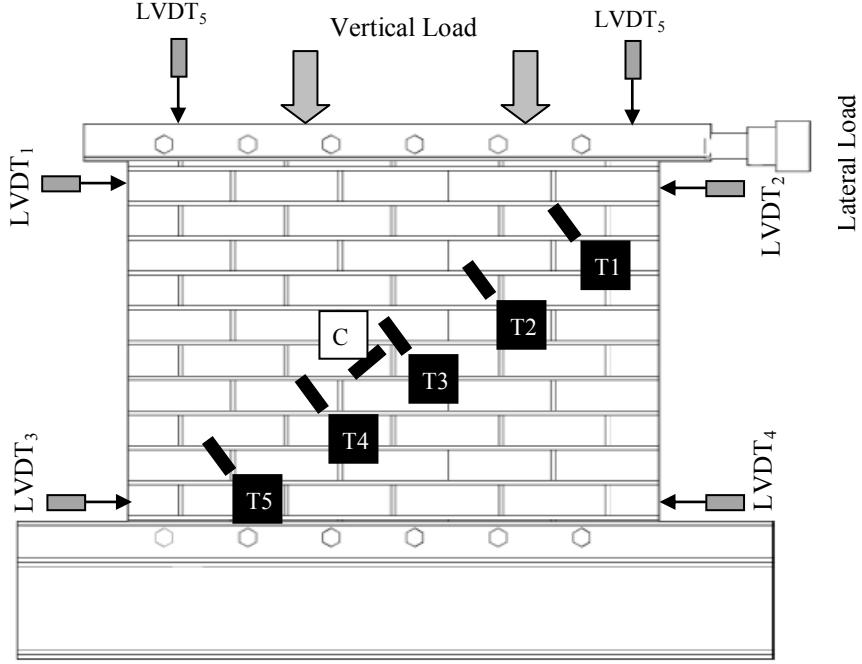
**Figure 6: Experimental setup for RW2**

The reference wall was tested as per the test setup shown in figure 6. Six LVDTs are installed at various locations that measure the deflections at that particular location and direction. Variation of diagonal tensile strain along the compression diagonal were measured by five mechanical strain gages orthogonally set along the compression diagonal in equal intervals. One strain is attached in parallel of compression diagonal to measure the compressive strain at the center of the wall.

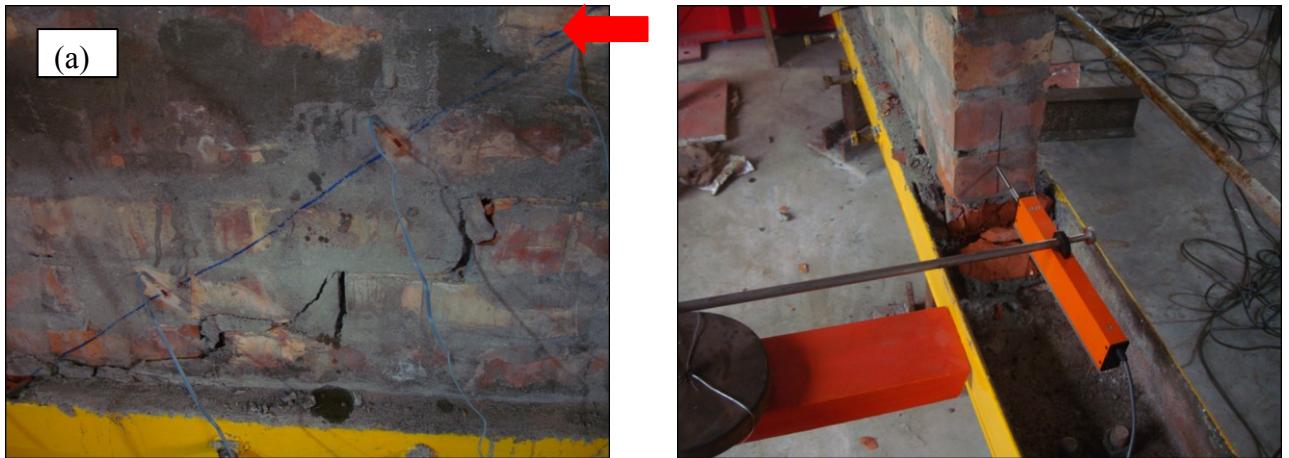
**Figure 7: a) Crack opening displacement and b) crushing at wall toe for RW2**

and travelled all the way to the wall heel (Figure 7a). During this evolution of crack no significant degradation of load was observed, rather it increased in a steady state and go to a peak of about 30kN. During this loading process the crack only widened and a wall move slightly to out of plane due to crack opening and separation on wall heel. A faster crushing (Figure 7b) on the wall toe caused a rapid decreased in load.

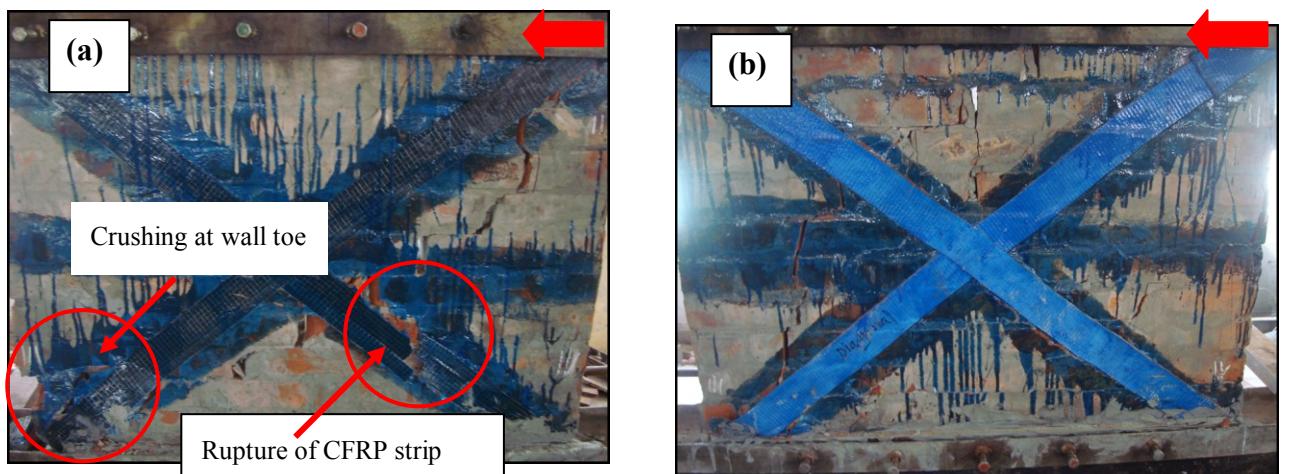
**Figure 8: a) Failure wall CW3 with rupture of CFRP strip and b) Failure of wall PW3**

Accumulated compressive stress caused a complete failure at wall toe just before the rupture of the CFRP strip which can be seen clearly in Fig. 8a. Debonding of CFRP strip from wall could also be seen at some places specially along the tension diagonal on both sides of the wall.

**Failure of PW3:** The initial stiffness was quite similar to that of CW3 and remains almost same to attain a load of 50kN. During that time some crack appeared at the mid height of the wall on loading side and propagate towards the bottom in a stepped fashion. Another crack appeared almost at the same time along the center line of the wall on the wall top. This crack also travels downward towards the wall toe with a stepped way. Both of these two cracks intercepted at tension diagonal strip of PET and temporarily arrested here to propagate further. At this stage the load climbed to a peak and remained same with the further deformation of the wall. With the applied displacement of the loading jack, the peak load did not change much but some phenomenological changes occurred at the wall. Debonding of the diagonal tension strip was seen at the upper half of the wall and that make it easy for the crack to travel further downward. (Figure 8b). A crushing in the wall toe can also be seen.

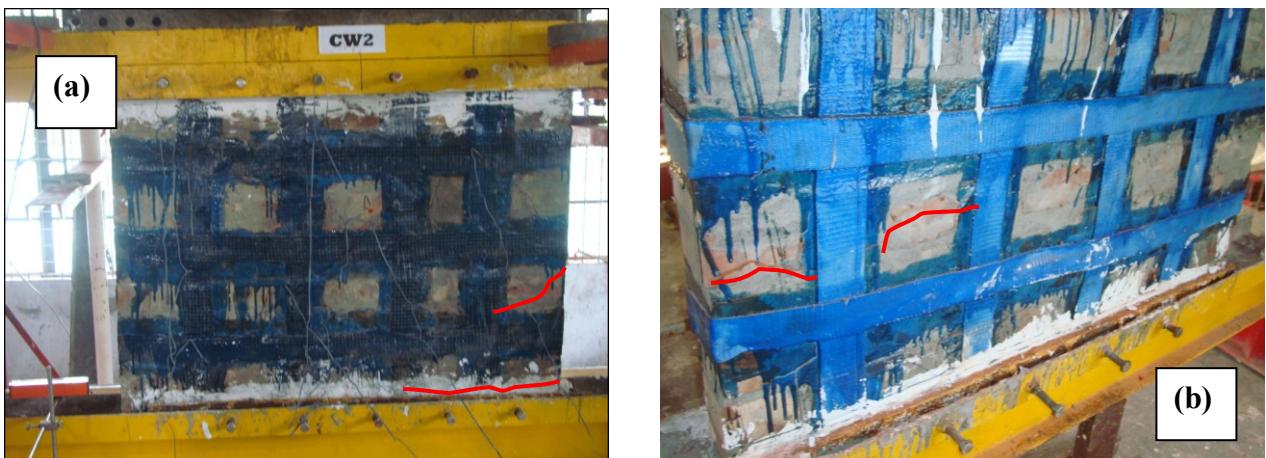
**Figure 9: a) Failure at wall CW2 and b) PW2**

**Failure of PW2:** The initial stiffness traced the same way of that of CW2 but at a load of 63 kN the stiffness reduced to some extent but the load still went up and at a load of 90 kN crack appeared at the mid height of the wall on loading side as can be seen in Figure 9b. After that stage the load did not increased but with the further displacement the wall suddenly slipped from the horizontal jack and the whole experimental process was terminated.
