LOW-CYCLE FATIGUE FAILURE MECHANISM OF WIND TURBINE FOUNDATION DUE TO VIBRATION OF UPPER STRUCTURE

K. YONETSU^{1*}, C. FUJIYAMA^{2†}

This paper investigates the failure mode of a foundation structure supporting a wind turbine tower subjected to a cyclic load using three-dimensional non-linear FE analyses. The model, incorporating a steel tower and reinforced concrete foundation, was made up mainly from solid elements. Anchor bolts were modeled using line elements.

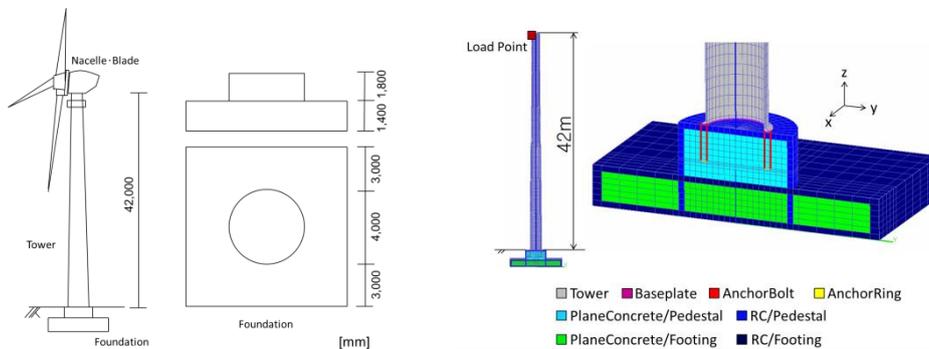
Figure 1: Schematic and model for analysis

Fig. 1 shows a schematic of targeting wind turbine and its model for-analysis. Hub height of the model is 42 m. The tower and foundation are connected by 88 anchor bolts and an anchor ring. Because of symmetry, only half of the wind turbine is needed to be modeled. The model is made primarily from solid elements. Only the anchor bolts are modeled by line elements, with particular tension strains representing torque. To account for bond and friction between steel and concrete, interface elements are used between tower and foundation (Yasojima and Sakamoto 2012).

Concrete strength of the pedestal and footing are 28.6 N/mm^2 and 29.3 N/mm^2 , respectively. Yielding strength of the tower and anchor bolts are 400.0 N/mm^2 and 931.6 N/mm^2 , respectively. The total dead weight of nacelle and blades are applied as a 650 kN axial force on the tower. The torque tightening the tower and foundation is $2.12 \text{ kN}\cdot\text{m}$.

The bottom of the model was fully restrained in the vertical. The X-axis was restrained in a symmetrical cross section. In this study, it is assumed that the influence of elasticity of the ground can be ignored.

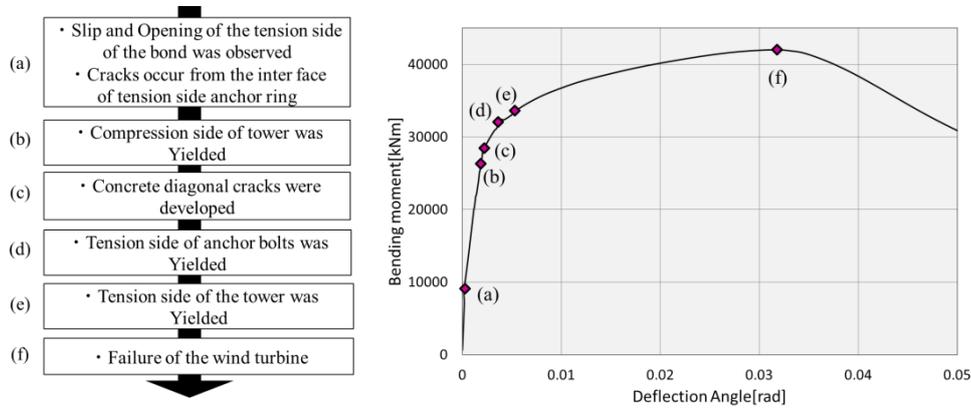
Figure 2: Failure process for static analysis

Fig. 2 shows the result of the static analysis in this study. The cone-shaped failure from the anchor ring was confirmed from principal strain contour and deformation. This means that the behavior of the anchor bolt affects the failure of the wind turbine. The failure process observed can be broken

down into steps (a) to (f), which are represented in the diagram of bending moment versus deflection angle of the bottom of the tower. The results agree with past research.

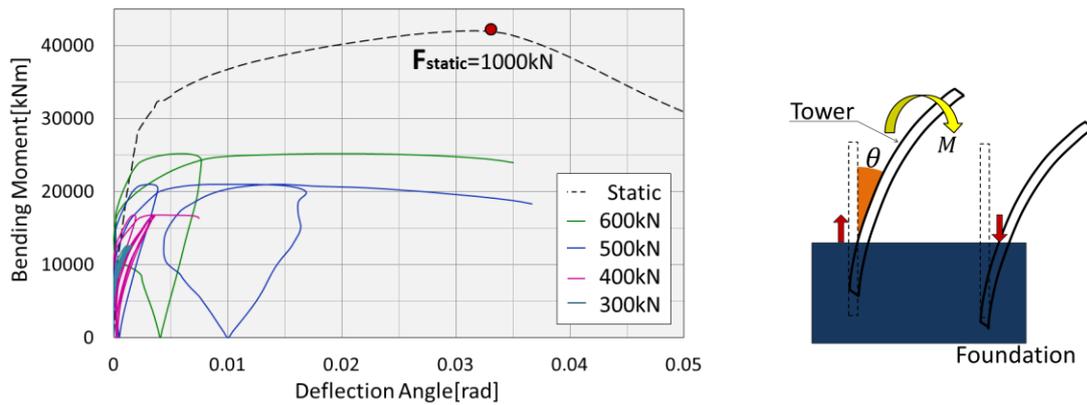
Figure 3: Relation of the bending moment to the deflection angle

Fig. 3 shows the relation of the bending moment to deflection angle of the tower at the bottom. The deflection angle of the tower at applied tension side was adopted as an indicator. The deflection angle at an amplitude of 300 kN overwrote the same path during the whole load history, although deflection angles at amplitudes 400 kN, 500 N and 600 kN increased rapidly after particular load cycles. In other words, repetition of a load whose amplitude is over 40% of the ultimate load F_{static} could cause failure of the wind turbine.

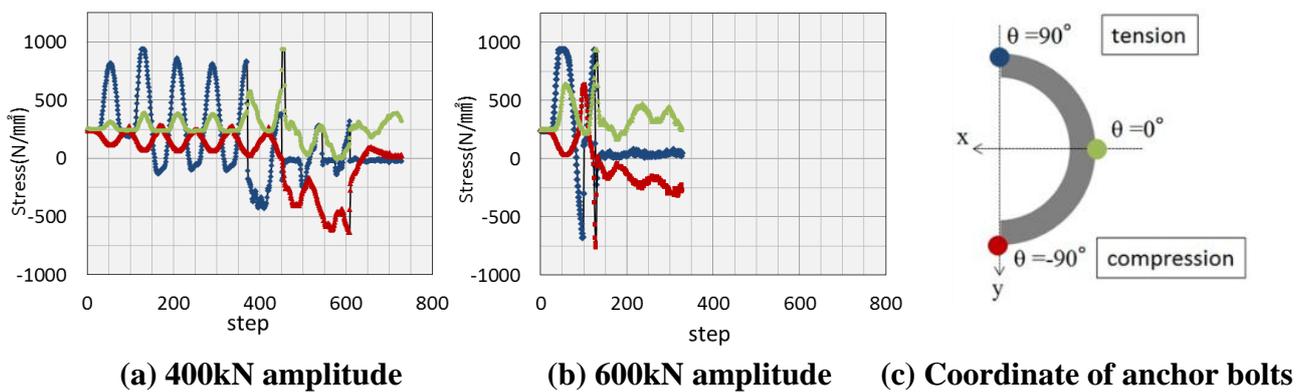
Figure 4: Stress of the anchor

Yielding of anchor bolts due to dynamic load was guessed by the relation of stress-step. In order to simplify the description, the location of an anchor bolt was defined using polar coordinates. The anchor bolt in the neutral area was defined as $\theta = 0$ degrees. As well, tension side of the anchor bolt and compression side of the anchor bolt were defined as $\theta = 90$ degrees and $\theta = -90$ degrees, respectively (Fig. 4(c)).

The stress of anchor bolts at amplitudes 400 kN and 600 kN are shown in Fig. 4(a) and (b). For 400 kN, the order of yielding of the anchor bolts was 90 degrees, 0 degrees, -90 degrees (Fig. 4(a)). The anchor bolts yielded from tension side to compression side. On the contrary, for 600 kN, anchor yield of focused three anchor bolts coincided at the first loading.

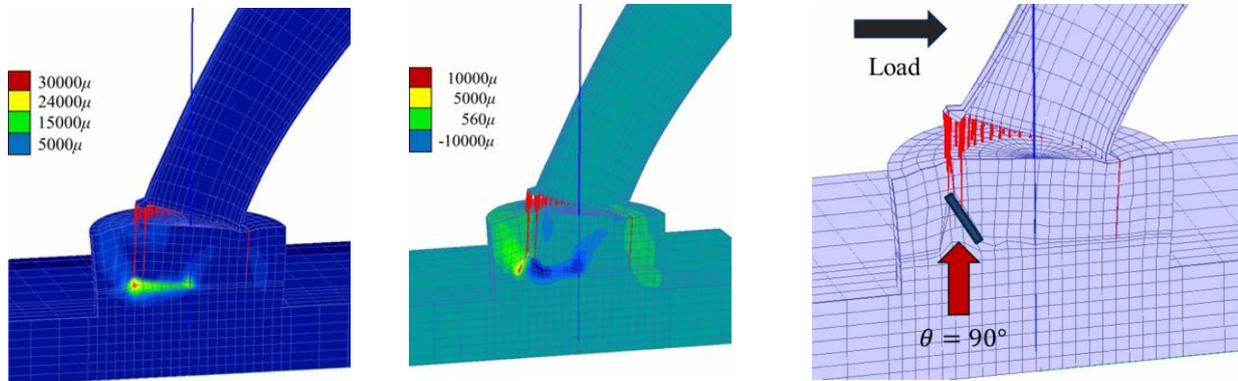
Figure 5: Strain contour and deformation of foundation for 400 kN at failure

The mechanism of failure was revealed in detail by strain contour and deformation of the foundation. First, failure mode at amplitude 400 kN was studied. Fig. 5(a) shows the contour of the principal strain and 10 times magnified deformation at the failure. The predominant strain areas were cone-shaped from the tip of the anchor ring to the top surface of the pedestal. The cone-shaped failure can be observed from the contour of shear strains shown in Fig. 5(b) as well. Fig. 5(c) shows

a 10 times magnified deformation of the foundation. At cycle number 28, the anchor ring at $\theta = 90$ degrees looked like it was being pulled out. At cycle number 290, the anchor ring at $\theta = -90$ degrees was pushed out. This behavior of the anchor ring could be due to the concrete fracture which was simulated by advanced dynamic analysis. We define this failure process as Mode I.

(a) Principal strain contour (b) Shear strain contour (c) Magnified deformation (disp. x50)

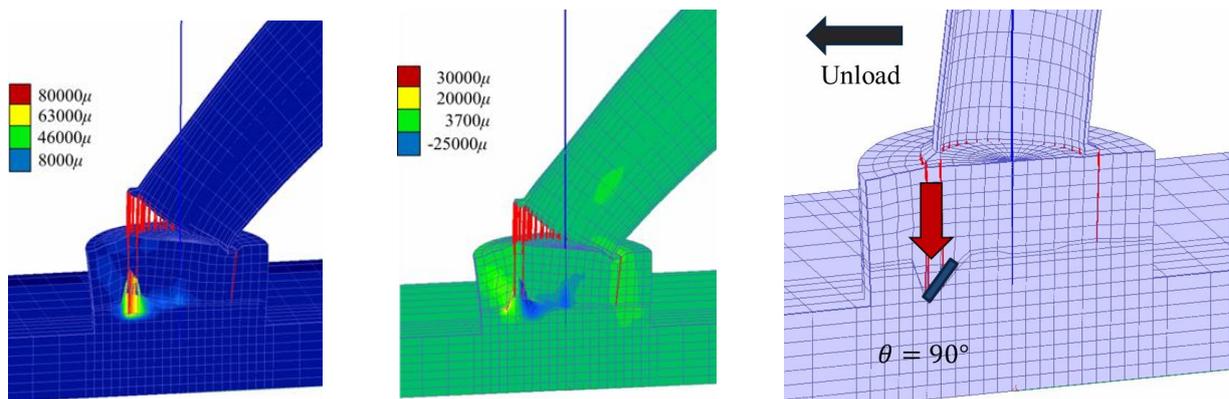
Figure 6: Strain contour and deformation of foundation for 600kN at failure

Second, load amplitude 600 kN was studied. Cone-shaped failure similar to that of 400 kN was not clearly observed from principal strain contour, though it could be inferred from shear strain contour (Fig. 6(a), 6(b)). At 50 times magnified, just before the failure, at the first loading, the anchor ring at $\theta = 90$ degrees looked like it was being pushed out, as shown in Fig. 6(c). During the following loading, the anchor ring at $\theta = 90$ degrees was pulled out and the anchor ring at $\theta = -90$ degrees was pushed out. This behavior of the anchor ring was caused by concrete fracture due to the dynamic load of tension and compression alternating. We define this failure process as Mode II.

(a) Principal strain contour (b) Shear strain contour (c) Magnified deformation (disp. x50)
(Just before failure)

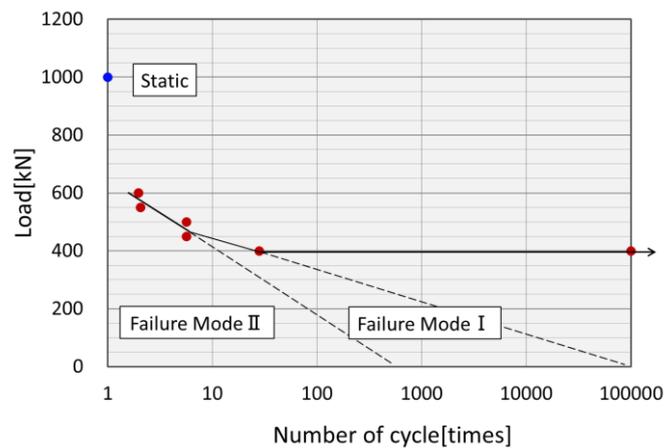
Figure 7: Load – Number of cycle

The relation of load amplitude and number of cycles at failure are shown in Fig. 7. The area was separated into two that correspond to failure modes I and II. In dynamic and static load, the

relevance of the relation of the load and failure mode was not confirmed. Failure occurred in low-cycle fatigue at less than 100 cycles. However, with amplitude less than 400 kN, no number of cycles resulted in a collapse of the wind turbine. This suggests that wind turbine collapse during low-cycle fatigue requires a minimum threshold amplitude.

This study shows that a dynamic load over 40% of the ultimate static load could cause failure of a wind turbine in low cycle fatigue. The cone-shaped failure was confirmed from strain contour and deformation. Furthermore, failure mode of a wind turbine under dynamic load was classified as Mode I and II based on the process of the development of strains and deformations of the foundation. This therefore indicates that in order to predict failure of wind turbines, more attention should be devoted to development of cracks around the anchor due to cyclic loads. On the other hand, there was no collapse of the wind turbine with less than 40% of the ultimate static load under the conditions of this study. Further analysis considering resonance with the natural frequency and vibration mode of the tower are needed.
