<b>Title</b>	MICROSTRUCTURAL COMPOSITION OF HARDENED CEMENT PASTE EXPOSED TO FIRE
<b>Author(s)</b>	KIM, J. J.; JEON, H. -K.; LEE, S. -H.; LEE, Y. -H.; RYU, D. -W.; YOUM, K. -S.
<b>Citation</b>	Proceedings of the Thirteenth East Asia-Pacific Conference on Structural Engineering and Construction (EASEC-13), September 11-13, 2013, Sapporo, Japan, F-6-3., F-6-3
<b>Issue Date</b>	2013-09-12
<b>Doc URL</b>	<a href="http://hdl.handle.net/2115/54403">http://hdl.handle.net/2115/54403</a>
<b>Type</b>	proceedings
<b>Note</b>	The Thirteenth East Asia-Pacific Conference on Structural Engineering and Construction (EASEC-13), September 11-13, 2013, Sapporo, Japan.
<b>File Information</b>	easec13-F-6-3.pdf

# MICROSTRUCTURAL COMPOSITION OF HARDENED CEMENT PASTE EXPOSED TO FIRE

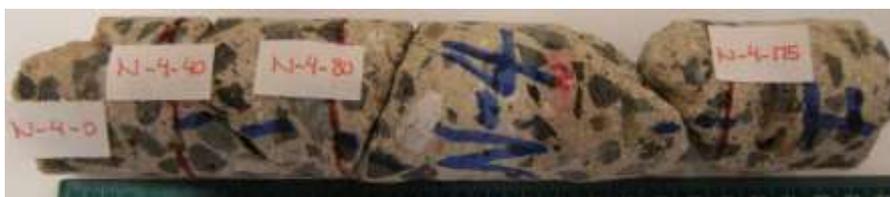
**Figure 1: Core sample from RC column after fire test.**

A fire test of an RC column following ISO-834 standard fire curve (ISO-834 1975) for 180 minutes was conducted in order to obtain core samples from the specimen. It was constructed following the design specification proposed by the Korean Concrete Institute (KCI 2009). The RC column has the square section of 350 mm by 350 mm and the height of 1500 mm. The column was reinforced with 8- $\phi$ 22 mm steel rebars longitudinally and  $\phi$ 10 mm hoop bars were placed at 300 mm spacing along the column height. Grade 420 steel rebars, which have the yield strength of 420 MPa, were used to reinforce the column.

slump of fresh concrete was controlled in the range from 180 mm to 220 mm. The mixture proportion of the concrete was comprised of water, cement, sand and gravel contents at 175 kg/m<sup>3</sup>, 320 kg/m<sup>3</sup>, 827 kg/m<sup>3</sup> and 939 kg/m<sup>3</sup> respectively. The temperatures in concrete following the standard fire curve were measured at the center section of the column located 750 mm from the bottom of the column. The time histories of temperatures following the standard fire curve for 180 minutes were measured at the surface, the depth of 40 mm and 80 mm from the surface and the center of the column section respectively. After the fire test, core samples passing through the column section as shown in Figure 1 were obtained.

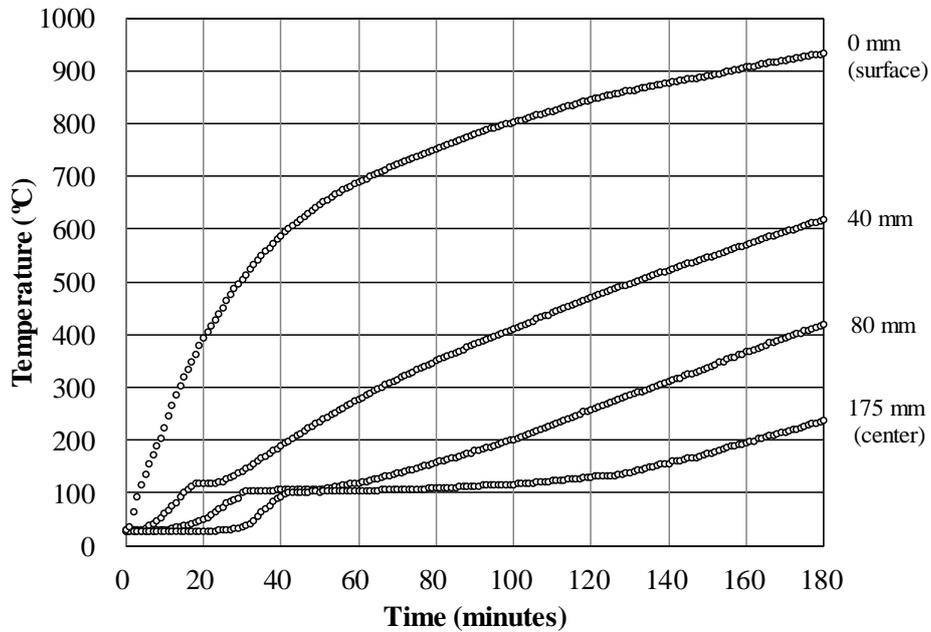
The time histories of temperatures measured at the surface, the depth of 40 mm and 80 mm and the center of the column respectively are shown in Figure 2. The maximum temperatures at the end of test time of 180 minutes were observed as 932 °C, 618 °C, 419 °C and 236 °C at the surface, the depth of 40 mm and 80 mm and the center of the column respectively.

Figure 2: Temperature evolution during the fire test of RC column.

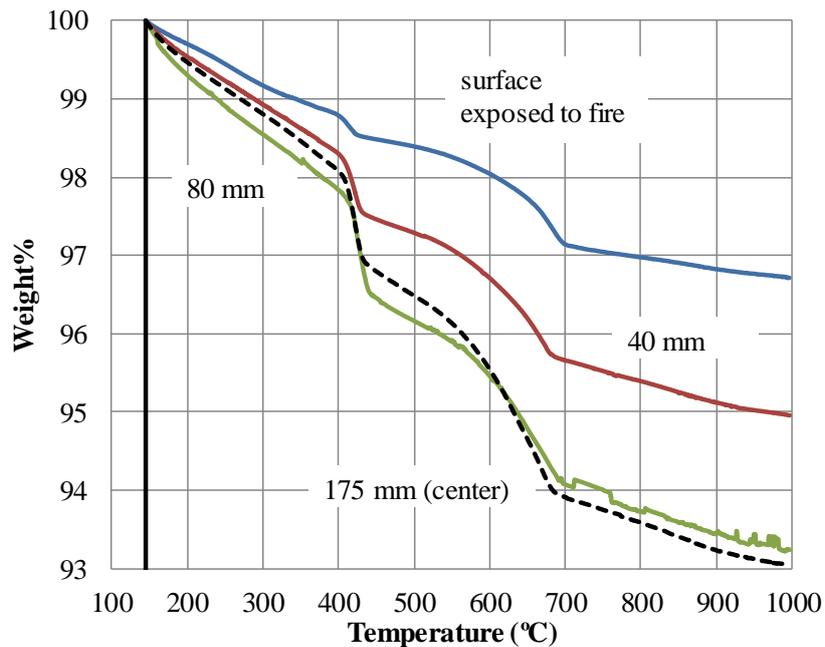
Figure 3: TGA results.

TGA curves for the hydrated cements according to the depth from the surface are shown in Figure 3. As the hydrated cement samples might absorb additional humidity prior to performing the TGA, the initial weight is taken at 145 °C to preclude the potential humidity absorption. The mass loss percentages for the corresponding ranges caused from the dehydration of C-S-H, the dehydroxylation of calcium hydroxide and the decarbonation of calcite are presented in Table 1. It can be seen from the TGA results that while the cements at the center of the column exposed to fire showed the highest fractions of calcium hydroxide of 2.6% and calcite of 2.1% among those at the other depth from the surface, the cements at the depth of 80 mm showed the highest fraction of C-S-H of 2.2%. The contents of calcium hydroxide at the center of the column and the depth of 80 mm, where the temperatures were 236 °C and 419 °C during the fire test, respectively, had the similar contents of 2.6% and 2.3% respectively.

TGA tests were performed from 25 °C to 1000 °C, heated at 10 °C/min. The mass losses at the temperature ranges from 145 °C to 400 °C, from 400 °C to 600 °C and from 600 °C to 825 °C are considered in this study for the dehydration of C-S-H, the dehydroxylation of calcium hydroxide and the decarbonation of calcite respectively.

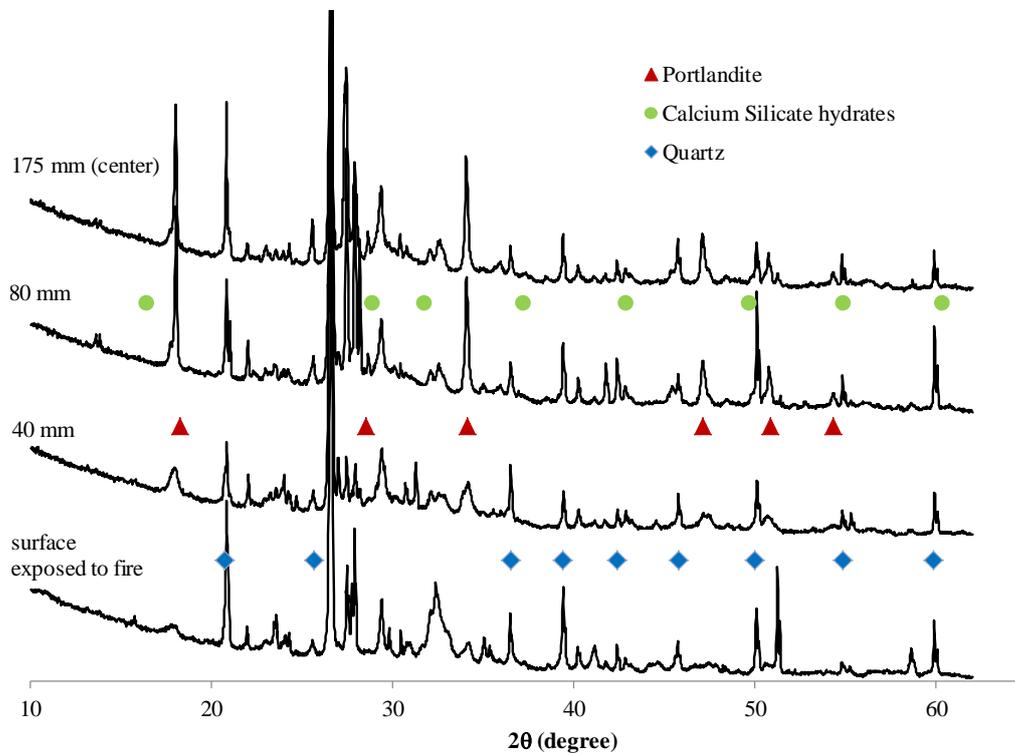
**Figure 4: XRDA results.**

The resulting XRDA spectra are shown in Figure 4. XRDA intensities represent calcium hydroxide peaks at  $2\theta$  of 18.2 °, 28.5 °, 34.1 °, 47.1 °, 50.8 °, 54.3 ° were disappeared or decreased in the cements at the surface and the 40 mm deep from the surface.

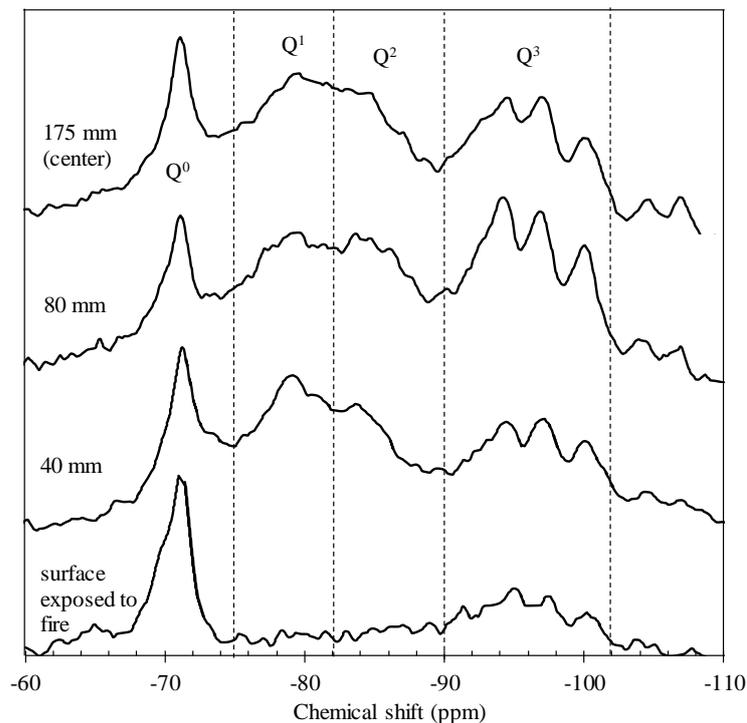
The resulting  $^{29}\text{Si}$  MAS NMR spectra were presented in Figure 5. The integration results of the  $Q^n$  intensities at the corresponding chemical shift range of -65 ppm ~ -75 ppm, -75 ppm ~ -82 ppm, -82 ppm ~ -90 ppm, -90 ppm ~ 102 ppm for  $Q^0$ ,  $Q^1$ ,  $Q^2$  and  $Q^3$  respectively are presented in Table 2.  $Q^3$  level of polymerization was considered due to the inclusion of fine aggregates. Therefore, the relative fractions except  $Q^3$  are also presented in Table 2. At the surface exposed to fire, almost no silicate connections of  $Q^0$  and  $Q^1$  were observed. The results showed that the silicate polymerizations in C-S-H at the center of the column and the depth of 40 mm, where the temperatures were 236 °C and 618 °C at the end of the fire test respectively, had the similar degree of connectivity of 1.43 and 1.45 respectively.

**Figure 5: NMR results.**

High values of  $D_c$  represent high polymerization of C-S-H. <sup>29</sup>Si MAS NMR spectroscopy was performed in 7 mm cylinders spun at 4 kHz. Approximately 10,000 scans were performed on each sample. The <sup>29</sup>Si chemical shifts are respectively referenced relative to tetramethylsilane Si(CH<sub>3</sub>)<sub>4</sub> (TMS) at 0 ppm, using Si[(CH<sub>3</sub>)<sub>3</sub>]<sub>8</sub>Si<sub>8</sub>O<sub>20</sub> (Q8M8) as a secondary reference (the major peak being at 11.6 ppm relative to TMS).
