| Title | EXPERIMENTAL INVESTIGATION OF MASONRY CALCAREOUS WALLS REPAIRED AND STRENGTHENED BY C-FRP |
| Citation | Proceedings of the Thirteenth East Asia-Pacific Conference on Structural Engineering and Construction (EASEC-13), September 11-13, 2013, Sapporo, Japan, H-5-4., H-5-4 |

# EXPERIMENTAL INVESTIGATION OF MASONRY CALCAREOUS WALLS REPAIRED AND STRENGTHENED BY C-FRP

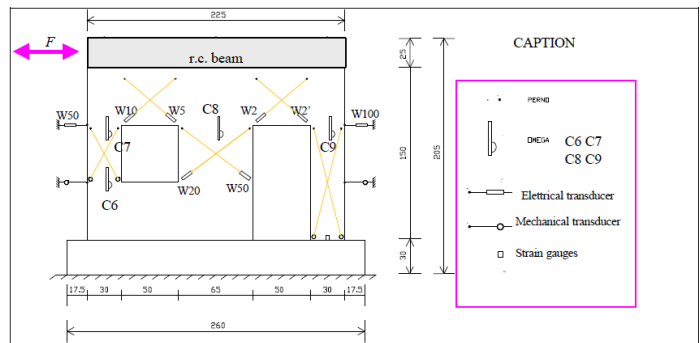
Figure 3. Instruments disposition

The unreinforced control “as-built” wall (URM) was cyclically tested up to the failure. The panel is 150 cm high and 225 cm wide with a thickness equal to 15 cm. They are built by using a gothic disposition (Anania et al. 1995, 1997) at double thickness, of white calcareous rock bricks (fig. 2-3). This stone was taken from a local quarry and cut in bricks with dimensions equal to 7x7x15 cm<sup>3</sup>. The bricks are joined together by means of a cement mortar named “M4” in accordance with the Italian rules. The ratio between the thickness of mortar joints and the height of the bricks is kept equal to 11 as we can often see in practice. The masonry panel is instrumented in order to record the displacement in the same direction of the increasing horizontal load, as well as the displacement and the rotation of bays of wall and the flat arches and the relative shift, measured along the axes of the bay of wall, between flat arches and bays. The instruments’ disposition is drawn in figure 3. Under these conditions a sidesway mechanism (fig.4) is obtained for a collapse load of 7,5 kN, this is due to the presence of the r.c. beam which works like the curb used to reinforce the flat arch. The wall cracking pattern is displayed in Figure 4 and the hysteretic loops of the wall are shown in Figure 5, illustrating the sudden degradation of strength and stiffness of the as-built wall specimen at a low ductility level ( maximum displacement of 0,96 mm).

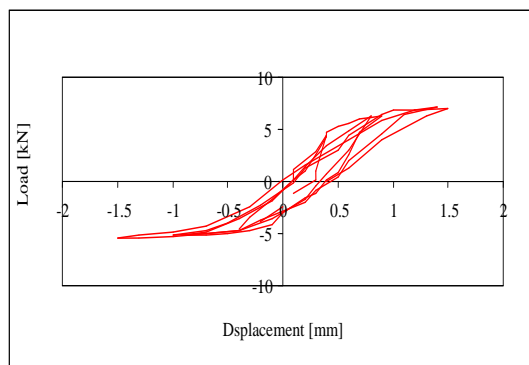
Figure 5. URM :F vs Displacement plot

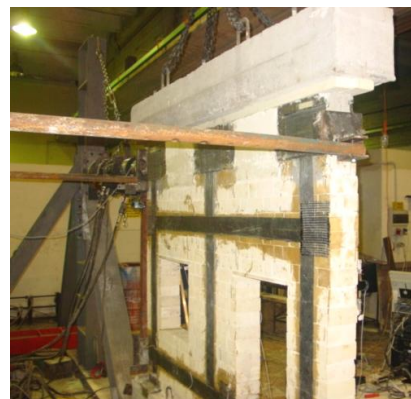
Figure 7. Overview of the strengthened model out of plane constrained

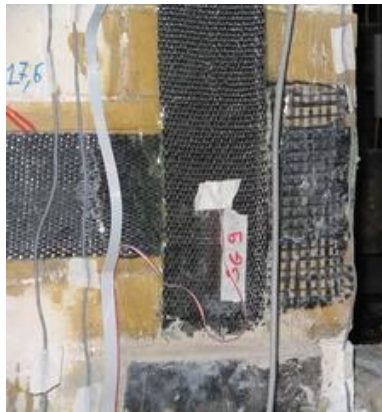
**Figure 8. Anchorage at the free extremities**

To this aim the cracks were, firstly, repaired either by filling them with high strength epoxy resin or, sometimes, by re-building some highly damaged small masonry portions; then, a grid of single layer uniaxial carbon/epoxy composite laminate 100 mm wide was applied on each side of the wall. The free extremities of the CFRP strips were special anchored transversally by placing a bi-axial CFRP strip at the extremity of the reinforcement (Anania et al. 2007, 2013). The connection between the strip and the basement of the panel was ensured by L steel profiles bolted to the basement (fig.8-9)

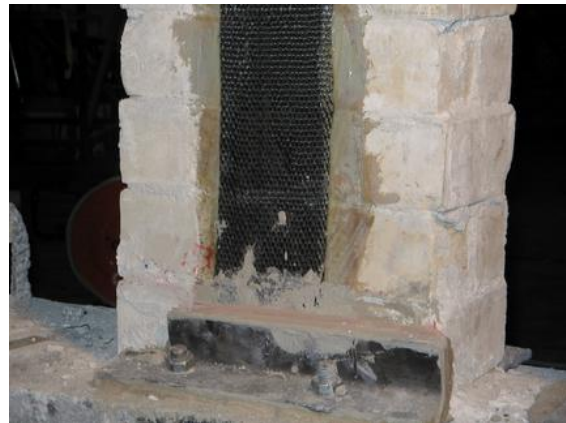
**Figure 9. CFRP -basement Connection**

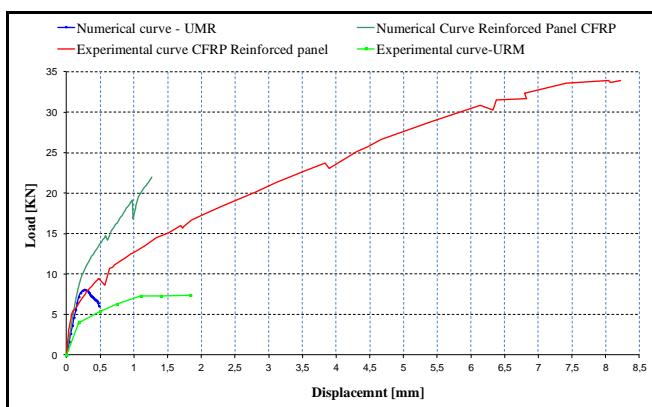
**Figure 10. F vs  $\delta$  curves comparison**

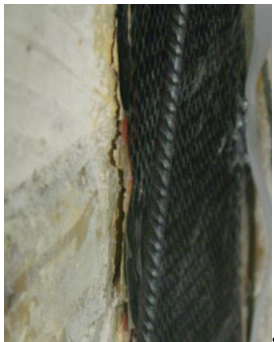
**Figure 18. Delamination at the top of the column**

At the ultimate loading step, the failure of the reinforced wall is a consequence of a global sliding of

the masonry along the mortar bed located near the basement just below the CFRP strip; while a limited delamination is observed in the vertical deployed strips (fig.18-19).

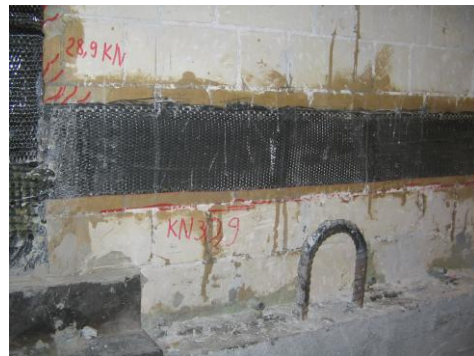
**Figure 19. Sliding along the mortar bed**
