# In-Plane Shear Performance of Masonry Walls after Strengthening by Two Different FRPs

Ataur Rahman<sup>1\*</sup> and Tamon Ueda<sup>2</sup>

**Abstract:** The present experimental study was aimed to investigate the in-plane shear performance of externally strengthened masonry walls using two types of fiber reinforced polymer (FRP) sheets– CFRP (Carbon fiber reinforced polymer) and PET-FRP (Polyethylene Terephthalate) sheets. Among these two, PET-FRP has a low tensile strength but possess a higher fracturing strain than CFRP. Twelve masonry walls made from clay brick were tested for static lateral loading under constant compression, after bonding CFRP and PET-FRP sheets onto their surfaces in three different configurations. The ultimate shear strength and deformation at peak load were the two important observations. The mechanisms by which load was carried were observed, varying from the initial uncracked state, to the final, fully cracked state. The results demonstrate that a significant increase in the in-plane shear capacity of masonry can be achieved by bonding these two FRPs to the surface of the walls but ductility is compromised when CFRP is used. Walls retrofitting with P

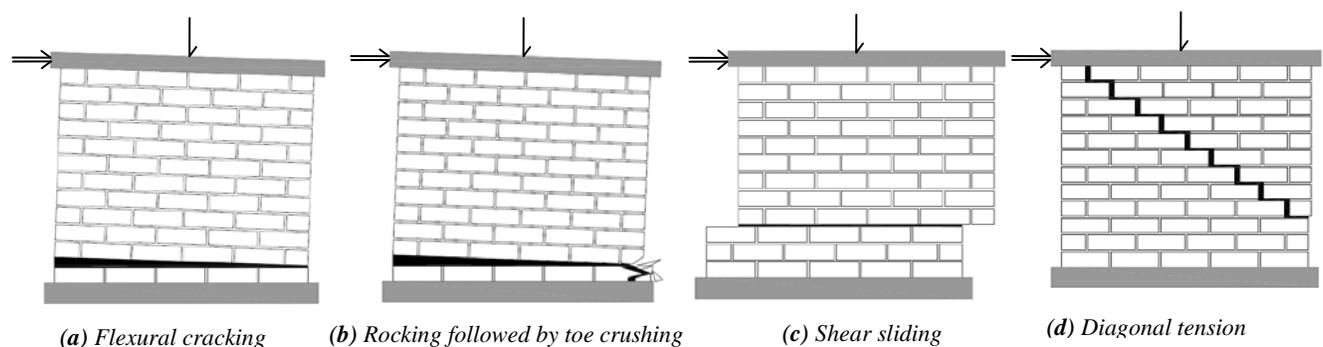
**Fig. 1.** Different Failure modes of URM

dominates through bed joint sliding or diagonal tension modes of failure (Magenes and Calvi 1997, Zhuge 2010, Tomažević and Gams 2009). Among these four inelastic failure modes (Fig.1), rocking and sliding shear are classified as deformation controlled phenomena because large lateral deformation of walls and piers is possible without a significant loss in strength (Foraboschi 2009). In contrast, diagonal tension and toe crushing behavior modes are known as force controlled phenomena because the ultimate failure can be abrupt with little or no subsequent deformation. Stair-stepped diagonal cracking can also be considered as a deformation controlled action because frictional forces along bed joints are conserved with vertical compressive forces. However, diagonal tension cracking must be classified as a force-controlled action unless stair-stepped cracking can be distinguished from diagonal cracking through units (FEMA 274, 1997). It should be noted that not all these failure modes will involve collapsing of the masonry shear wall, and the final failure may be a combination of several failure modes. A more general way of representing the various failure modes of masonry shear wall is given in Fig. 2, where the interactions between normal and shear stresses on the masonry bed joints are shown. It is evident in Fig. 2 that the failure modes in masonry shear walls are generally dictated by the magnitude of vertical compression force applied over the wall. However, a rationally developed failure criteria should be able to predict the tensile, compressive and shear types of failure.

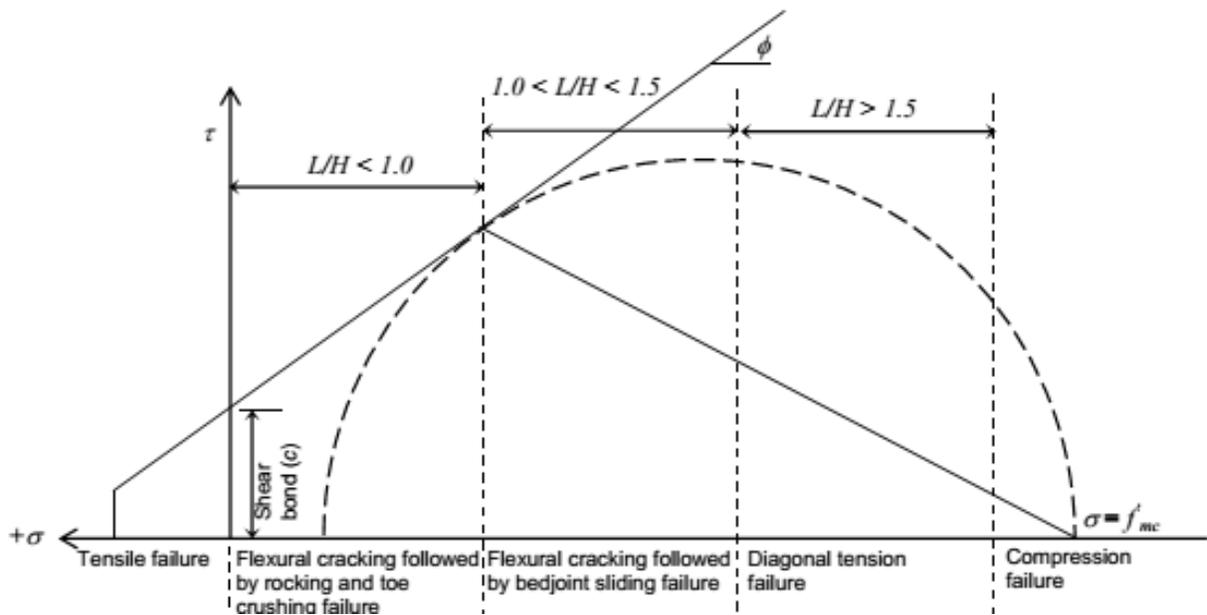
Fig. 2. Generalized behavior of URM under combined shear and normal stress

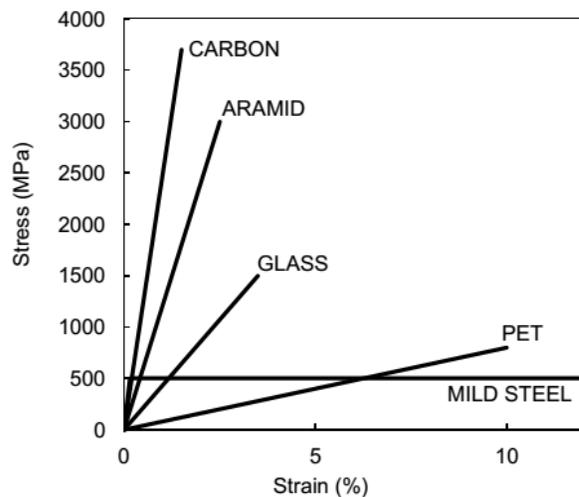
Fig. 3. Tensile strength of different FRPs

fibers, such as Glass, Aramid, Carbon, etc (Fig. 3) to achieve certain properties better than either of the base materials, is getting popular for retrofitting of the existing masonry structures. The benefit of using FRPs as potential strengthening material comes from the reduction in handling costs; despite additional material costs, and they are easy to install due to light weight (Burgoyne and Balafas 2007). Externally bonded PET-FRP with a large fracturing strain (more than 10%) is a retrofitting technique that has drawn significant attention as a unique alternative to CFRP or GFRP. High fracturing strain in PET-FRP yields substantial inelastic deformation in masonry which compensates the inherent brittleness of these structures, without compromising the other advantages of FRP. In Japan, the use of PET-FRP has emerged as an alternative to traditional FRPs, such as carbon and glass FRP, where ductility is a major concern than strength (Anggawidjaja et al. 2006).

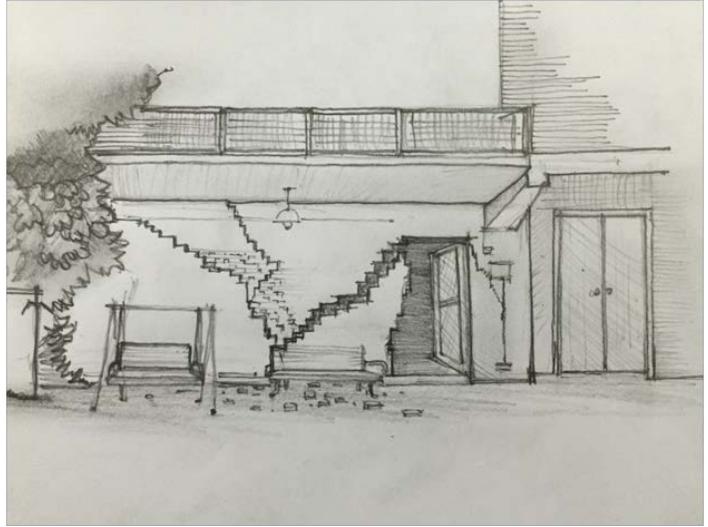
*Fig. 4. Typical diagonal tension failure in a squatting wall during Emiliana Earthquake in Italy, 2012*

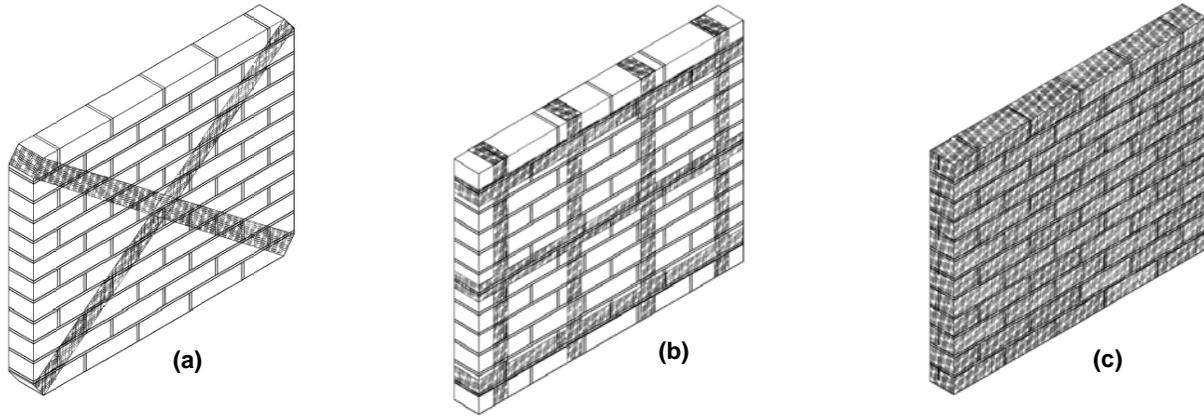
**Fig. 5.** FRP reinforcement layout, (a) FRP cross diagonal bracings (CSD, PSD); (b) FRP strips in grid system (CSG, PSG); (c) Fully wrapped by FRP (CSF, PSF)

PET-FRP and CFRP sheets both having unidirectional fibers, were applied using a wet layup procedure on wall specimens in three different configurations as shown in Fig. 5. At first, the wall specimens were cleaned by removing loose mortar and dirt with the help of a wire brush. Epoxy putty (filler) was used to fill the depression on the wall surface to provide a smooth plane surface ready for FRP laying. A thin layer of primer was then

These four walls were externally strengthened by two diagonal CFRP and PET-FRP strips each, of 80 mm in width in a fashion shown in Fig. 5(a). No noticeable crack appeared on either of the wall until the lateral load reached about 75% of the ultimate strength. In the case of the wall CSD1 two flexural cracks appeared at the wall top on the loading end and at the wall bottom on the far end [Fig.10(c)] followed by some debonding of the CFRP tension diagonals. No rupture or damage of the CFRP was observed. For wall CSD2, some fine line cracks appeared at the top of the wall on far end and started to propagate downward in a stepped fashion. Almost simultaneously another crack, parallel and above to this one appeared and began to propagate downward in a same manner but with a lesser degree of crack opening displacement. Once the load increased to a maximum of 94 kN, a sudden rupture of the diagonal tension strip on the both sides of the wall took place and the load suddenly dropped to the half of the peak load. Accumulated compressive stress caused some crushing at wall toe just before the rupture of the CFRP strip which can be seen Fig. 10(d).

These four walls were strengthened with CFRP and PET-FRP strips of having 70 mm width each in a grid system as shown in Fig. 5(b). In the case of the CFRP reinforced wall (CSG1), at a load, amounting to 70% of peak load, some fine-line diagonal cracks appeared at the central area of the wall. More cracks appeared across the tension diagonal with simultaneous debonding of the CFRP strips, while the load reached at a level of 130 kN [Fig. 11(a)]. Almost simultaneously, one of the horizontal CFRP strips ruptured with a loud explosive sound, and the load dropped to 109 kN. With further displacement, the crack width increased and, in some places, the CFRP totally separated from the wall. In CSG2, at a load equal to about 75% of the peak load, flexural crack along the bottom of the wall appeared and followed by another flexural crack at the mid-height of the wall and a web crack at the center [Fig. 11(b)]. With further displacement the peak load did not change from 99 kN, which only widened the crack opening. No rupture of CFRP was noticed, except some debonding in horizontal strips at few places.

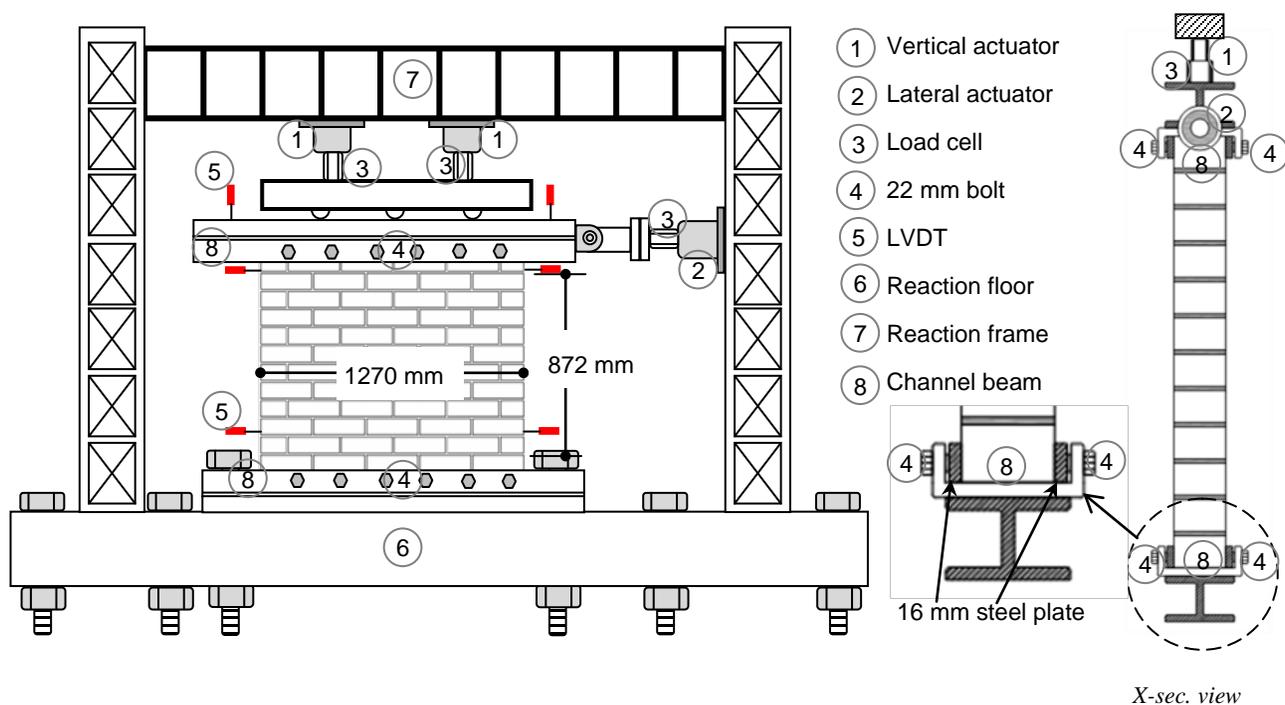
**Fig. 6.** Schematic diagram of experimental setup of shear wall

After the required curing period, the wall was transferred to the loading frame as shown in Fig. 6, specially designed for this experimental study. The wall top and bottom were anchored to the top and bottom channel beams, with the help of twenty four 22

mm bolts as shown in Figs. 6 and 7. Between the wall and the channel beam, a 16mm thick steel plate was inserted so that pressure could be applied on the wall by tightening the bolts. Gypsum plaster was used to fill the gap between the wall and the steel plate. For FRP strengthened walls, the FRP itself was wrapped in a U-shape anchorage, so there was almost no chance of slippage of the FRP during the experiment. Although this kind of anchorage system is not very much practical for the real structure, it has been chosen so for this experimentation to avoid premature anchorage failure of FRP prior to attaining full shear strength. For fully wrapped masonry walls,

prior to incrementally increasing lateral loading (Fig. 6). Lateral load was applied gradually, increasing at a constant rate of 5 kN/min until it reached at peak. In post-peak regime, a constant displacement of 2mm/min was applied until complete failure. The two vertical loads restricted the rotation of the top beam only to some extent, as the beam was not restrained against rotation during the evolution of lateral load. A fixed-free experimental condition was maintained throughout the loading process.

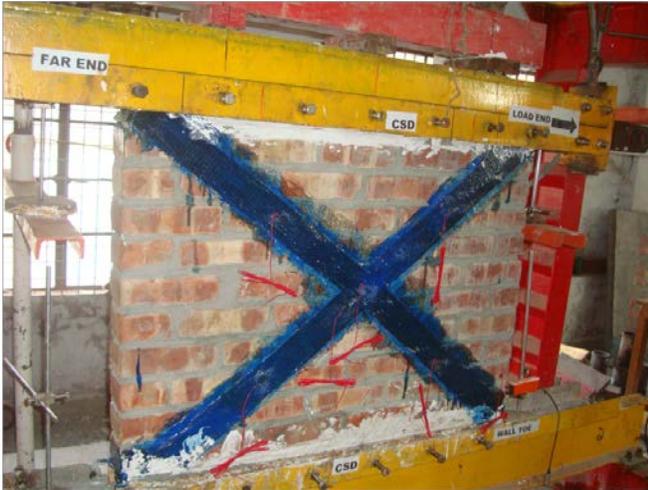
Fig. 7. Experimental setup of FRP reinforced masonry panel

horizontal FRP sheets were installed on the wall in 360° wrapping (Fig. 8) and vertical sheets were anchored to the top and bottom channel beams with 22 mm bolts as shown in Fig. 7.

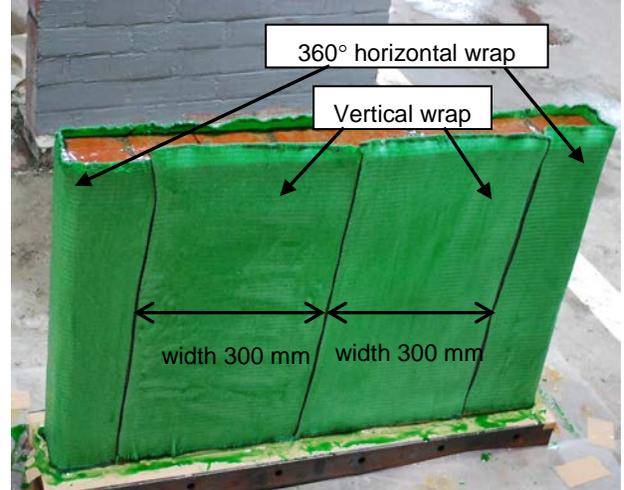
Fig. 8. FRP installation in fully wrapped wall

These two walls were strengthened after fully wrapped with CFRP and PET-FRP sheets according to Fig. 8. For CSF, the stiffness as well as the lateral load capacity was so high that at a later stage the grip at the wall bottom prematurely failed before the wall attained its full strength [Fig. 11(e)]. Since the wall was fully wrapped by the CFRP sheets, damage, if any, could hardly be detected by visual observation. On the other hand, the wall PSF showed constant stiffness until it reached about 60% of its peak shear capacity. Only after that, did the stiffness show a reduction, but no damage or crack whatsoever was seen on the wall [Fig. 11(f)]. Once it reached its full strength, further displacement only resulted in load reduction and the wall failed at its grip at the bottom similar to the wall CSF. It was quite clear from fully wrapped wall that higher the percent of FRP higher is the stiffness as well as some enhancement in shear strength of masonry wall. However, higher amount of FRP materials do compromise with the ductility of the wall and are not fitting well with the purpose of seismic strengthening.

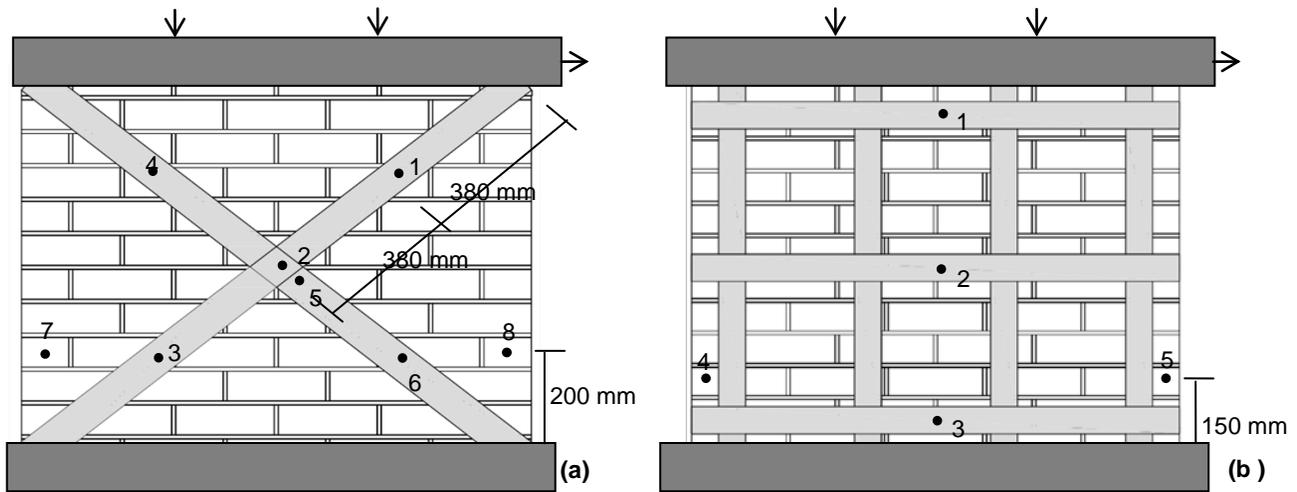
Fig. 9. Strain gauges layout (a) cross digonal layout (b) grid layout

**Fig. 14.** Load–strain responses in diagonal FRP strips of retrofitted panels at point 2 on Fig. 9(a)

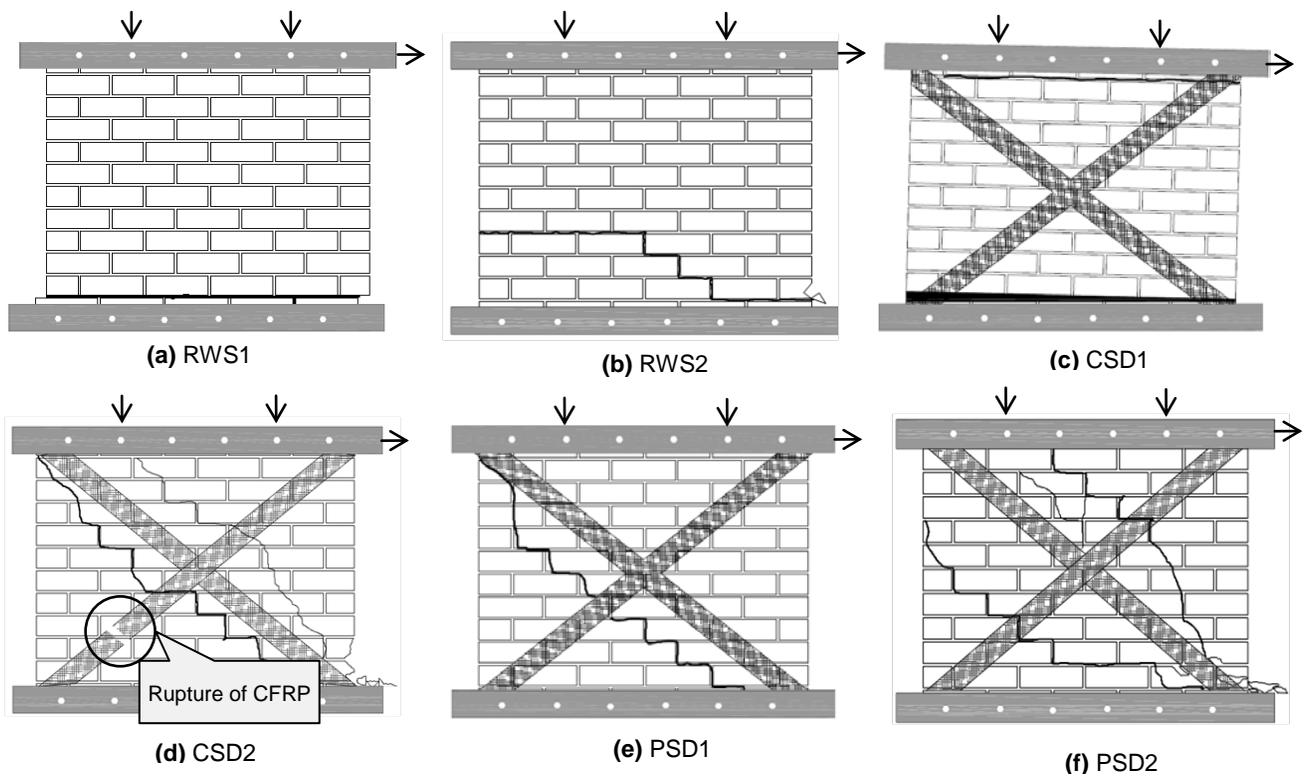
Fig. 10. Schematic illustration of crack patterns in unreinforced and FRP retrofitted masonry panels

The difference in failure modes for the reference specimens RWS1 and RWS2 can be attributed to the location where the first flexural cracks appeared in these two specimens and their line of propagation [Figs. 10(a) and (b)].

In RWS1, first flexural crack appeared at the very bottom course of the wall and propagated horizontally in a straight fashion towards the wall toe [Fig. 10 (a)], which facilitated the wall to slip along the crack path. Once a crack forms at the wall heel, no tension force perpendicular to the crack can be transmitted across it, and the load drops by a little but as long as the crack is narrow, the wall can still transmit some shear forces in its own plane through friction of the surface roughness that can be characterized as elasto-plastic behavior. With further deformation and slip, the interlocking planes suffer substantial damage and are flattened to some extent after which the wall reaches in a state of kinematic equilibrium where only some residual frictional shear resistance prevails (Rahman and Ueda 2014), which does not diminish with the applied displacement as can be seen in Fig 12(a). In reference wall RWS2 first flexural crack appeared three courses above the bottom course on the wall heel side and propagated towards the wall toe in a stepped fashion [Fig. 10(b)]. This failure pattern prompted a rocking phenomenon in the wall instead of shear sliding and consequently a softening behavior was observed in the post-peak regime [Fig. 12(a)] caused by a toe crushing in the wall. It is worth noting here that the location where the first flexural crack will appear is somehow difficult to predict as was the case for these two reference walls. This is largely because of the non-homogeneous nature of masonry fabrication that creates several plane of weakness along the horizontal bed joints.

Experimental results summarized in Table 3 illustrate that the in-plane shear capacity of the tested walls was significantly enhanced by the proposed strengthening technique but the ductility behavior was not essentially the same. Figs.10 and 11 depict the crack patterns and failure modes for all the retrofitted walls. It is interesting to see that the mode of failure in masonry when they are strengthened with diagonal FRP, is

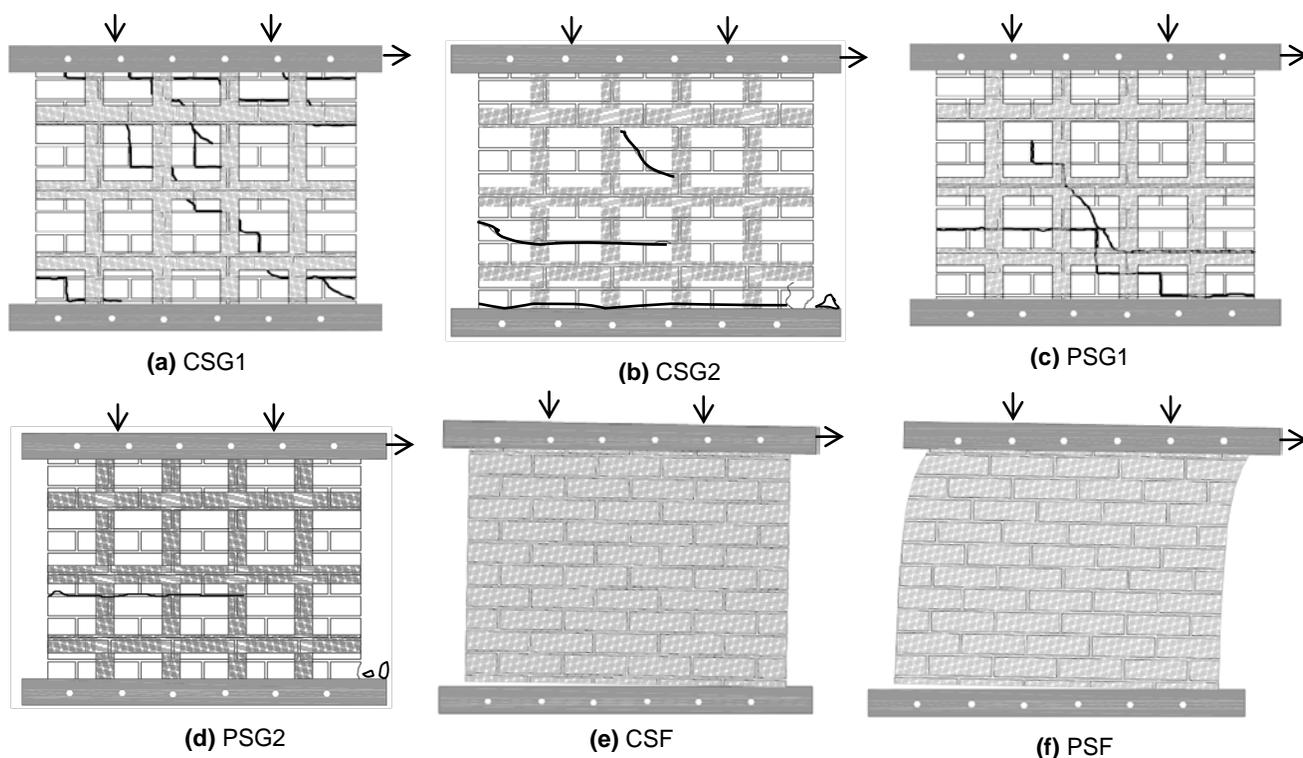
**Fig. 11.** Schematic representation of crack patterns in grid system and fully wrapped panels

In the case of FRP grid system, mixed mode of failure can be seen in Fig.11 for both CFRP and PET-FRP reinforced walls, and their load-deformation responses are quite similar to each other [Fig. 12(c)]. This is due to the fact that beyond certain limit of FRP amount, the failure mode of masonry wall commutes from diagonal tension to predominantly flexural cracking irrespective of the type of FRP. Numerical modeling and analysis of masonry is the best tool to evaluate this threshold value. The horizontal strips of FRP played a crucial role here that restricted the wall from failing in a diagonal tension mode. These horizontal strips made the walls stronger in shear than in flexure. Though the vertical strips contributed in flexural strength to some extent, eventually it could not out strength the shear capacity, and caused the wall to fail in flexure. It is also interesting to make a comparison between Figs. 12(b) and (c) that once masonry walls are strengthened with CFRP in gird fashion, its brittleness in diagonal configuration changed into a ductile one. High FRP stiffness (11420 MN) did not change the overall stiffness of the masonry wall substantially, rather it helped the wall to deform as a composite system in such a way that can be compared as elastic-perfectly plastic deformation. But of course the deformability of high stiff CFRP will be less than that of PET as PET has higher deformation rate than CFRP. Another important point here to note that by increasing the amount and stiffness of FRP material on the surface of the wall does not necessarily increase the shear strength of the strengthened wall. Because it was point out earlier that a suitable material that has a moderate strength with a good deformability will be coherent with the fragile nature of masonry. One interesting observation that could be made here is that, in absence of vertical strips the wall would have been experienced in shear sliding along the planes that are not offset by the horizontal strips (Alcaino and Santa-Maria 2008). So it can be concluded that:

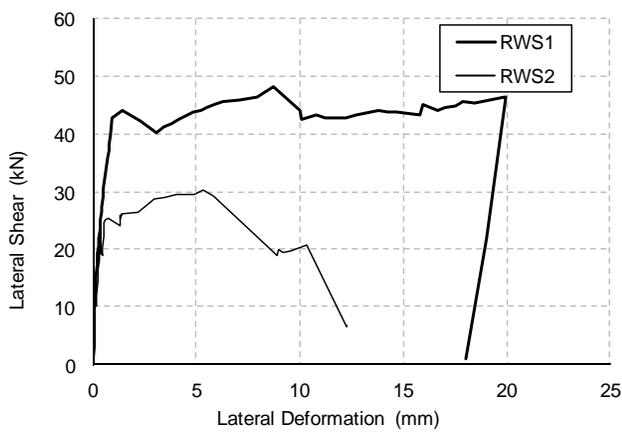
(a) Reference panel RWS1 and RWS2

**Fig. 12.** Load-deformation responses of unreinforced and retrofitted masonry shear walls

The load-deformation characteristics of reference walls (RWS1 and RWS2) are depicted in Fig. 12(a). It is quite evident from the figure that, before appearance of any potential flexural crack, the load-deformation relationship is almost linear for both the two walls. It is interesting to note that RWS1 shows quite ductile behavior while maintaining a constant lateral strength due to shear slip at the wall bottom. On the other hand RWS2 shows a rapid reduction in lateral shear after a crushing took place at the wall toe.

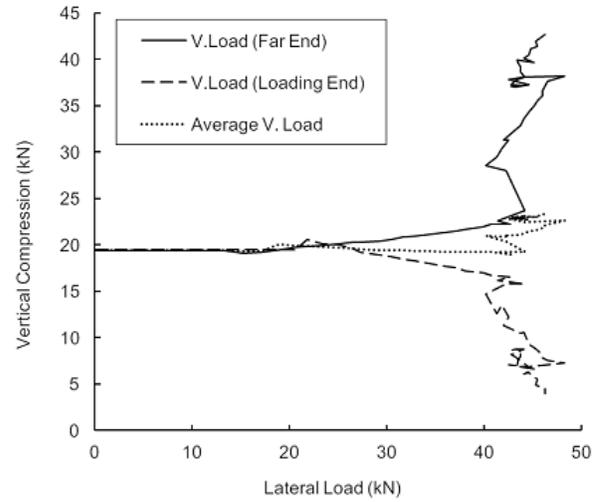
**Fig. 13.** Variation of vertical load with progressive shear

Fig. 13 shows the variation of vertical pre-compression with the progress of lateral load. It is evident from Fig. 13 that the vertical load on the far-end increased with the progressive shear, while the vertical load went down on loaded-end. This is due to the fact that, with the increase of lateral load, the top beam on the wall underwent a small

rotation, which exerted a vertical upward pressure on the far-end jack on the wall. However, the average vertical load (broken line in Fig. 13) did not change much from the initial stipulated value of 20 kN.

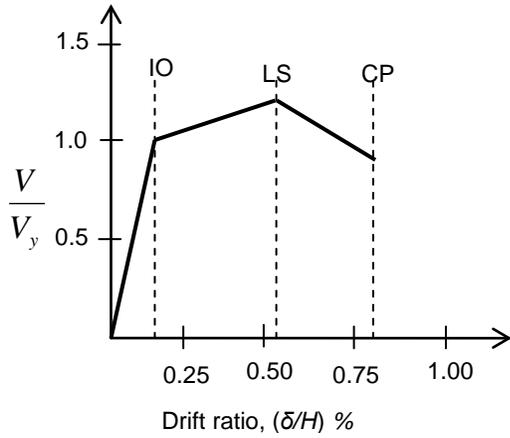
**Fig. 15.** Performance indices

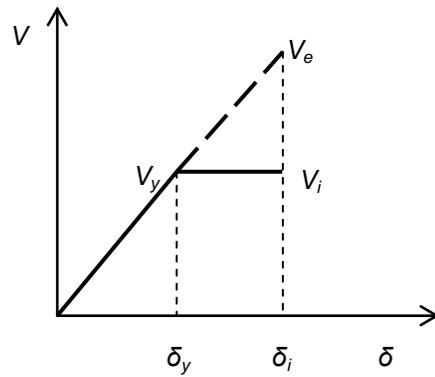
**Fig. 16.** Equal displacement rule for linear elastic analysis

inelastic displacements are the same for structures beyond yield strength shown in Fig. 16). With this assumption, as noted in Eq. (5), elastic design force due to earthquake and gravity loads,  $V_e$ , will be equal to the inelastic strength,  $V_i$ , times the ductility factor,  $m$ , which is defined as the inelastic deformation at a given limit state,  $\delta_i$  divided by the yield deformation,  $\delta_y$  [Eq. (6)]. FEMA 356 provides a set of ductility factors,  $m$  for different limit states and for two different failure modes (rocking and shear sliding) of masonry. Table 4 provides the  $m$ -factors and drift ratios ( $\delta/H$ ) recommended by FEMA 356, along with the estimated performance of the shear walls in this study.

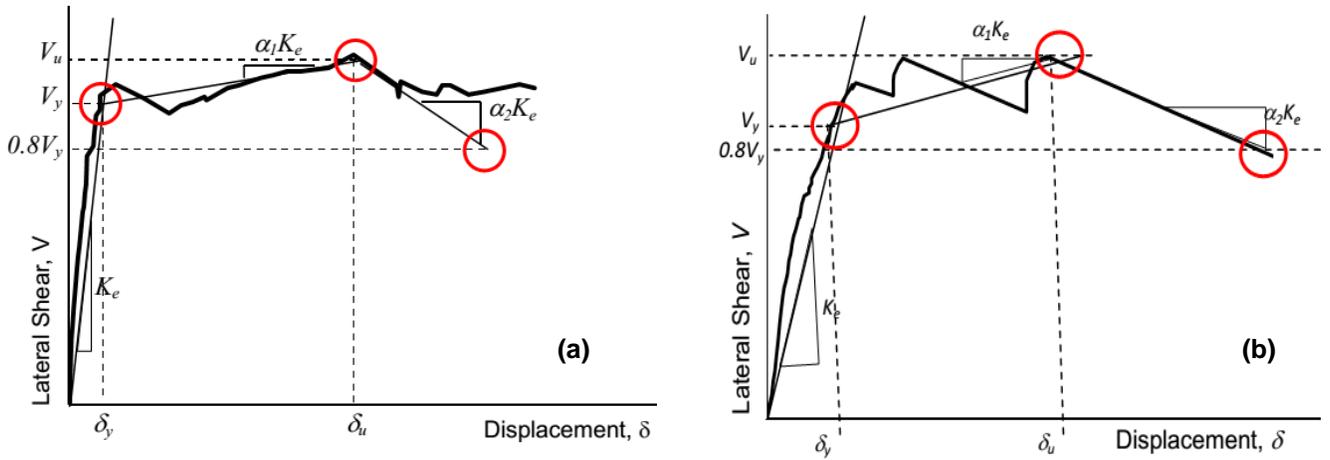
Fig. 17. Idealized force-displacement curve for (a) RWS1 and (b) CSD1 panels

The nonlinear force-displacement curve (also known as pushover capacity curve) of the component of the structure shall be replaced with an idealized relationship to calculate the effective lateral stiffness,  $K_e$ , and effective yield strength,  $V_y$ , of the building. Tri-linear idealization of the lateral force displacement curves of a URM wall as well as of a FRP strengthened walls are shown in Figs. 17(a) and (b), respectively. In this study, the target displacement,  $\delta_t$ , which is intended to represent the maximum displacement likely to be experienced during the design earthquake, has been simply assumed equal to,  $\delta_u$ , the deformation corresponding to ultimate shear strength. The detailed idealization technique and more accurate calculation of  $\delta_t$  can be found in FEMA 440 and ATC 40. From the idealized curve, the effective lateral stiffness,  $K_e$ , shall be taken as the secant stiffness calculated at a base shear force equal to 60% of the effective yield strength  $V_y$  of the structure. In the case of the unavailability of a pushover curve, a reasonable estimation of in-plane shear stiffness of URM is suggested here, by Eq. (7), provided all the parameters related to masonry are readily available (Al-Chaar 2002).
