Experimental and numerical investigations on cantilever failures for cohesive riverbanks

Supapap Patsinghasanee

Doctor's Thesis
Division of Field Engineering for Environment
Graduate School of Engineering, Hokkaido University
September 2016

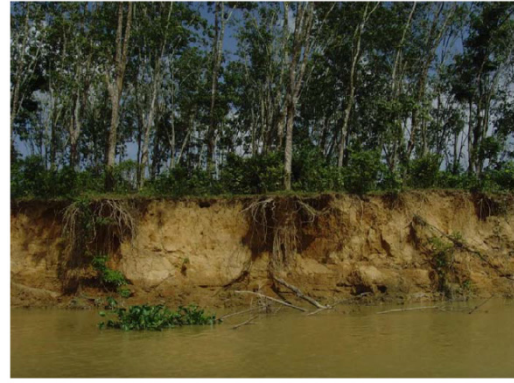
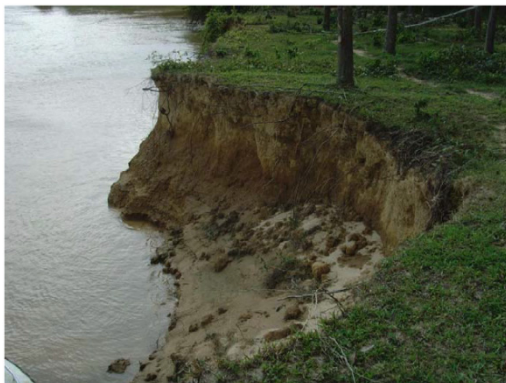
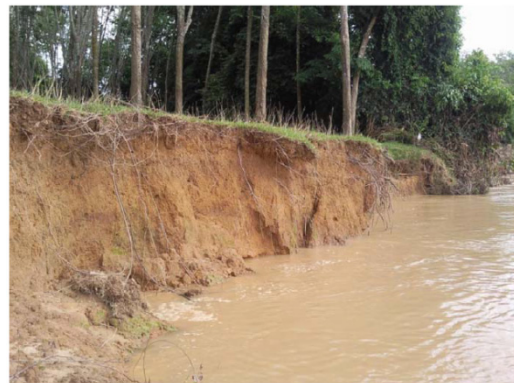
Fig. 1.2 Cantilever failure and destruction of the overhanging block of four cross-sectional data of the U-Tapao River, Thailand. (Semmad, 2010)

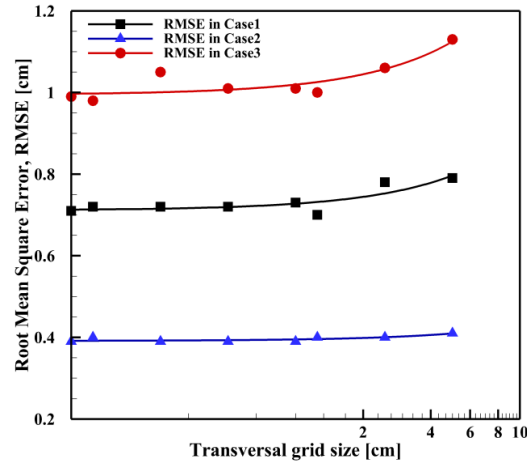
Fig. 2.5 The results of transversal grid sensitivity analysis.

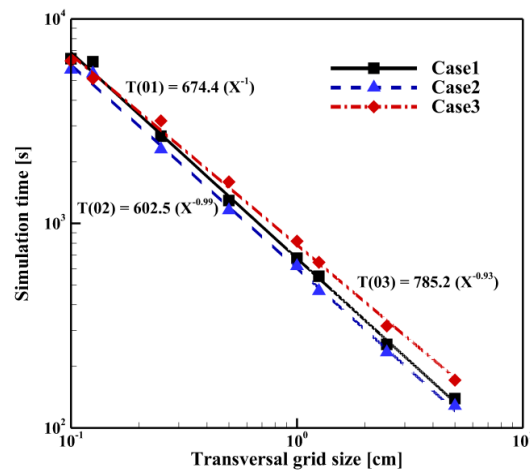
Fig. 2.6 The results of computational time in difference transversal grid size.

The transversal grid sensitivity analysis indicated that when the transversal grid size was finer than 1 cm, the accuracy of the numerical model was not dramatically different than that with a transversal grid size of 1 cm. Therefore, the suitable transversal grid size for this study was set to 1 cm. The results of the transversal grid sensitivity analysis are shown in **Fig. 2.5**. In addition, the required simulation time for the difference transversal grid size are shown in **Fig. 2.6**.

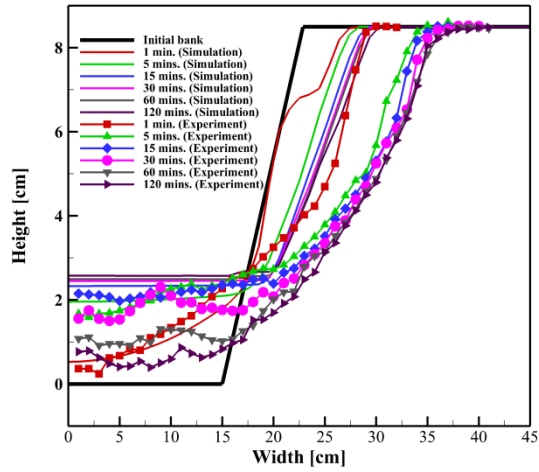
(a) The comparison results in Case 4.

(b) The comparison results in Case 5.

(c) The comparison results in Case 6.

Fig. 2.8 shows the temporal change in cross-sectional profile averaged over longitudinal direction for the case of heterogeneous condition. The comparison results between the computational results and experimental data show a good agreement for the bank erosion rate. In contrast, the bed deformation results illustrate an unsatisfactory agreement.

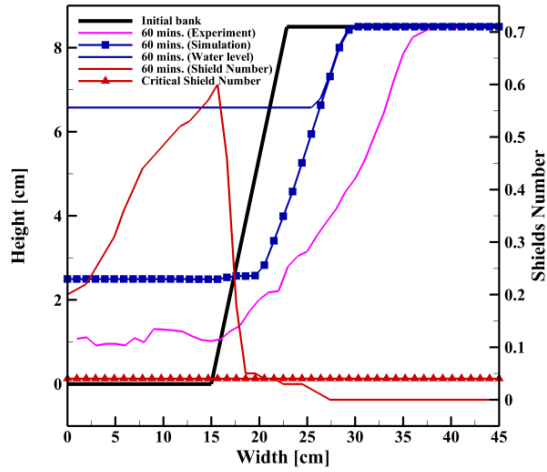
(a) The dimensionless shear stress in Case 4.

(b) The dimensionless shear stress in Case 5.

(c) The dimensionless shear stress in Case 6.

Fig. 2.9 The dimensionless shear stress profile of heterogeneous condition.

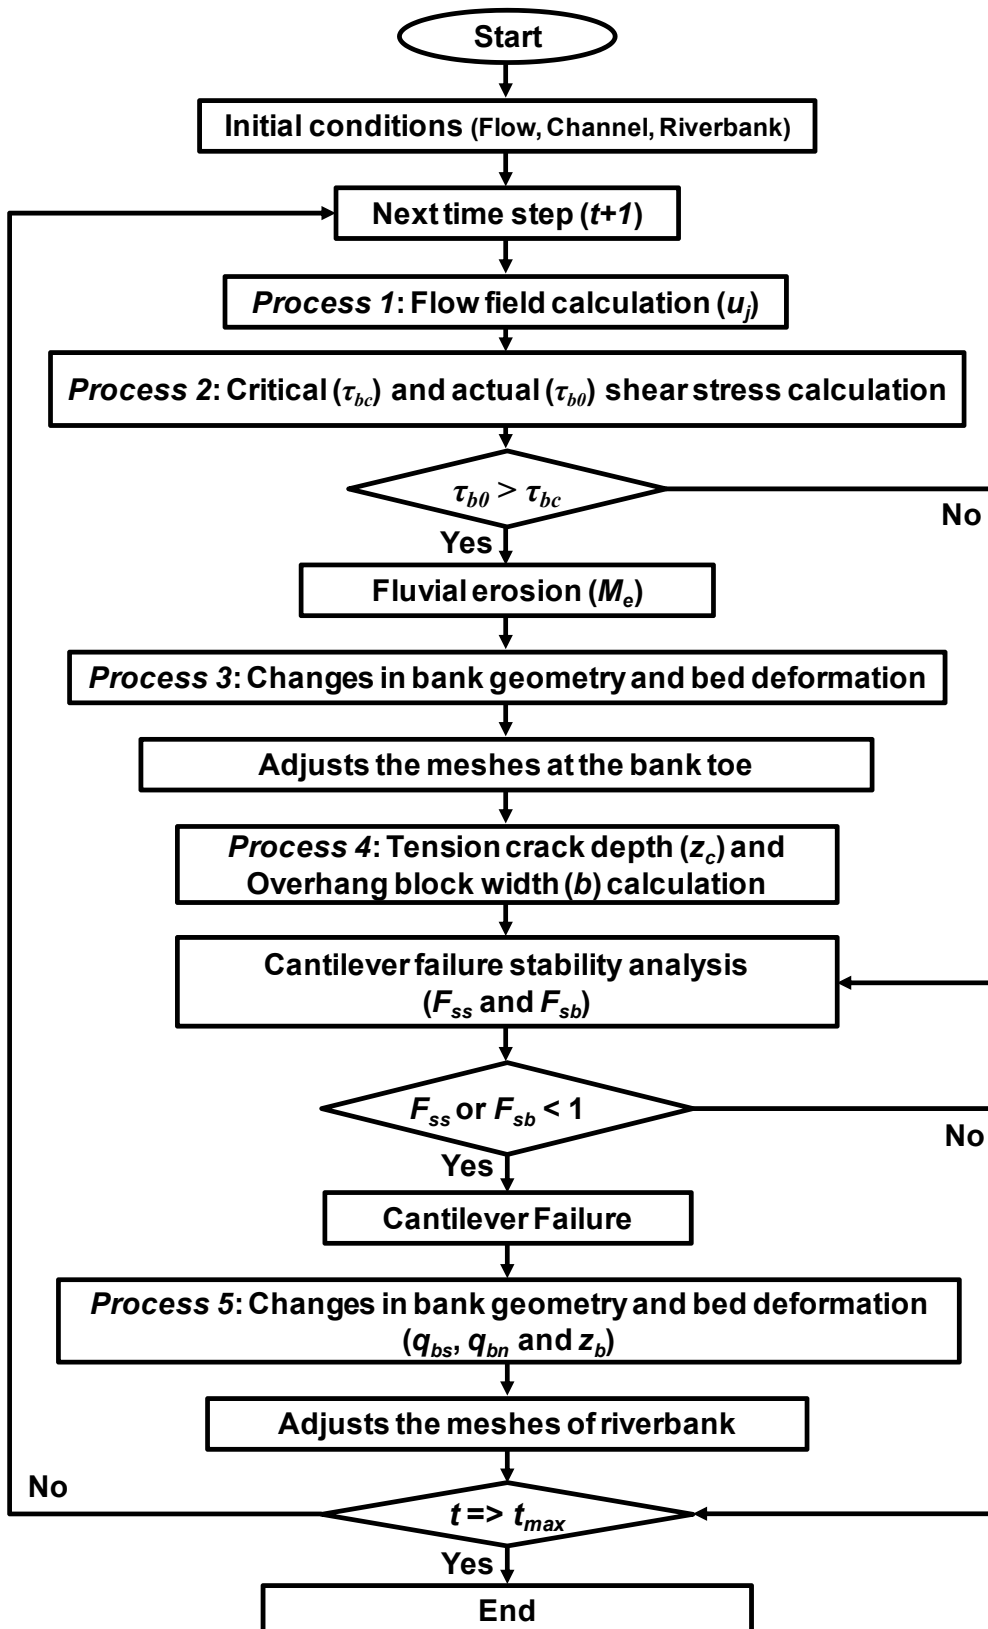
Fig. 3.5 Logic diagram of the computational sequence.

For fluvial erosion, calculation of the bank erosion rate was required to determine the hydraulic parameters and riverbank geometries (Process 2 in **Fig. 3.5**). The set of equations for fluvial erosion consists of three main equations — namely, one for the erosion coefficient (E), one for the depth-averaged bank erosion rate from fluvial erosion ($\bar{\xi}$) and one for the bank erosion rate (M_e) (Duan, 2005).

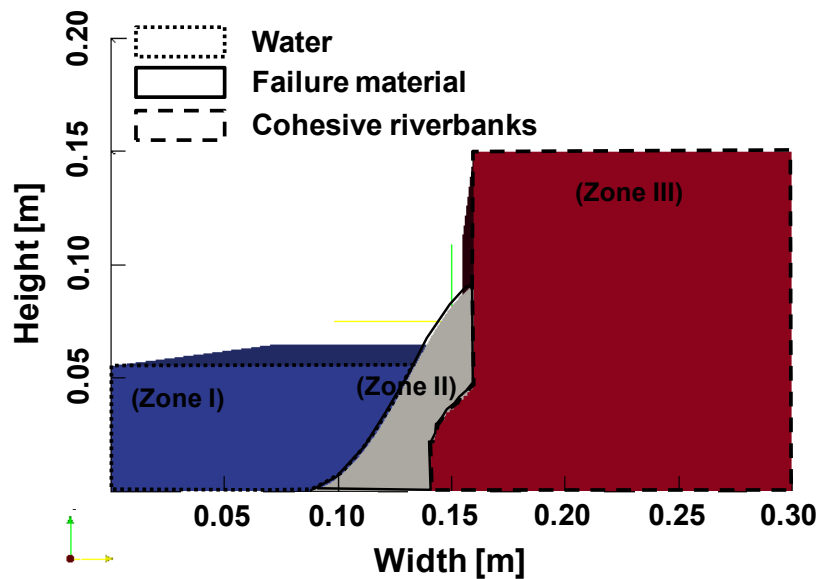
(b) Beam-type failure.

Fig. 3.9 Cross-sectional views of fluvial erosion and beam-type failure mechanism of Case 3. (Zone I, II and III are water, failure material and cohesive riverbank, respectively.)

Fig. 3.9 shows cross-sectional views at two time stages, simulated using the numerical model. **Fig. 3.9(a)** shows the fluvial erosion in the submerged zone. This process occurs through the fluvial entrainment of materials from the bank-toe, leading to an undermining that produces an overhanging block. **Fig. 3.9(b)** shows the beam-type failure of a cohesive riverbank, which is a common mechanism of a cantilever failure. Following the drop process of the numerical model, the failure materials were assumed to be non-cohesive materials that come to rest at the intermediate drop point.

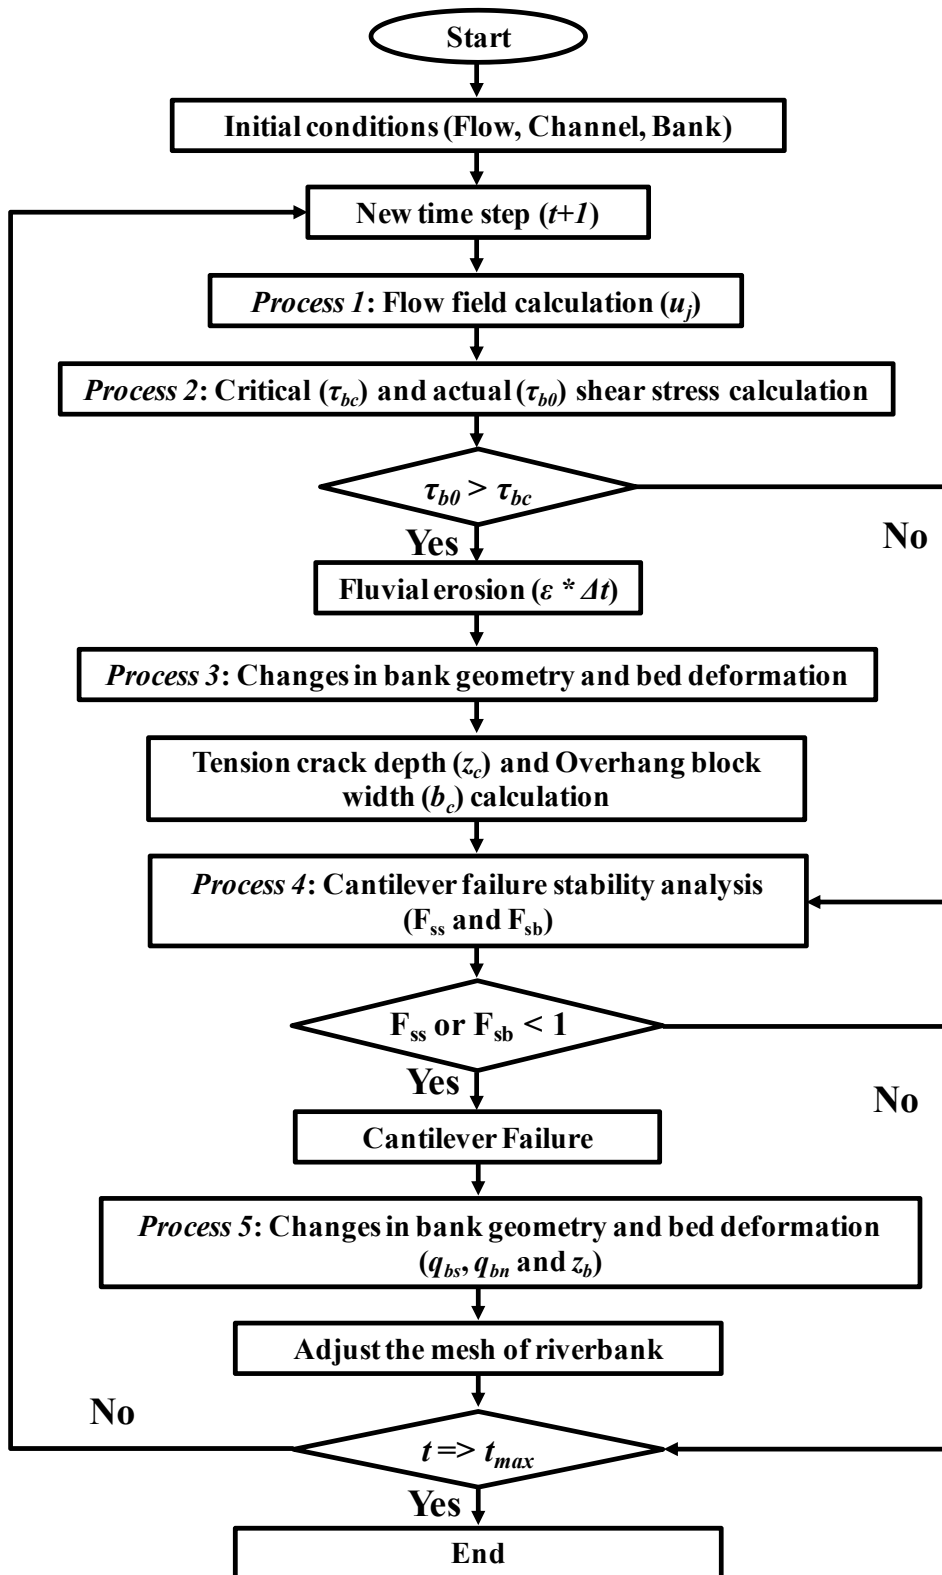
Fig. 4.7 Logic diagram of the computational sequence of the coupled modeling.

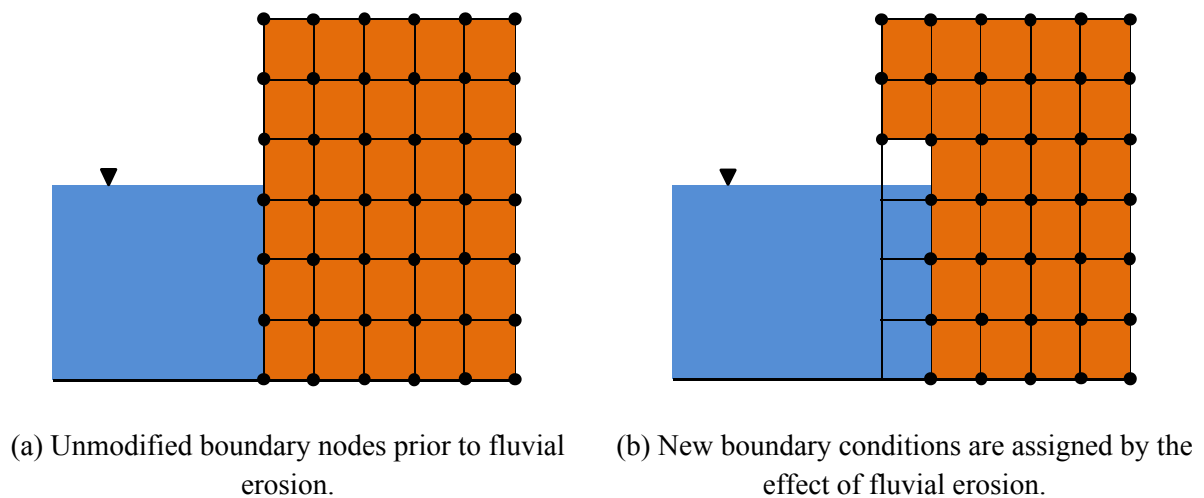
Fig. 4.8 Illustration of the two schemes used to adopt the boundary nodes by the effect of fluvial erosion.

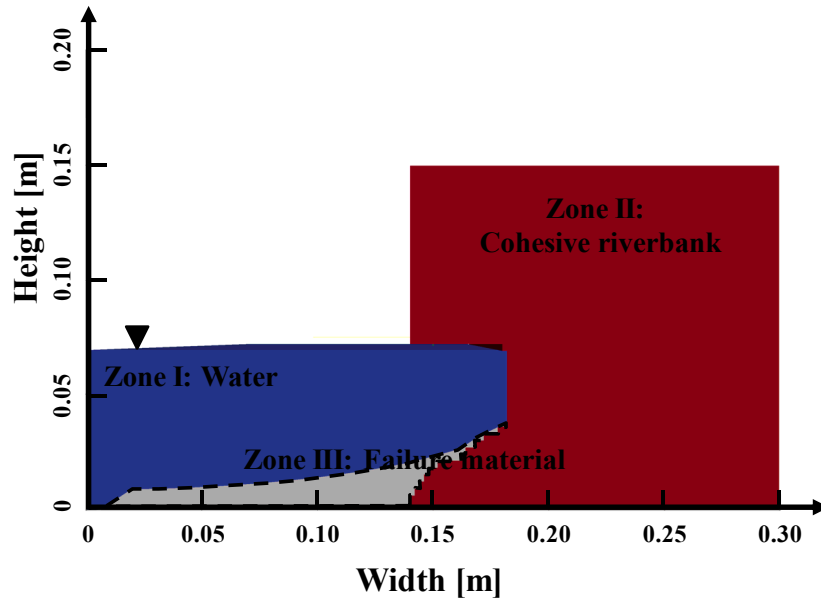
(a) Fluvial erosion stage.

(b) Beam-type failure stage.

Fig. 4.10 Cross-sectional views of fluvial erosion and beam-type failure mechanism at two time stages for Case 5. (Zone I is water, Zone II is the cohesive bank, and Zone III is the failure material.)

Moreover, the validation results of the temporal variations of the spatially averaged bank width by the current numerical modeling, and the experimental results are shown in **Fig. 11**. The current numerical results show a better agreement with the experimental results than those the previous numerical results (Patsinghasanee et al., 2015b, 2015c). This is due to the fact that the current numerical modeling used the erodibility coefficient from the experimental values. In contrast, the previous numerical results illustrate quite poor validation agreement in terms of the temporal variations of the spatially averaged bank width because the previous numerical modeling employed analytical equations for calculating erodibility coefficient. Additionally, the current numerical modeling can reproduce the first cantilever failure with high precision in terms of the times and the overhanging block width. For the current numerical modeling, significant errors occurred after the cantilever failure because the failure material dropped into the channel and protected against further fluvial erosion at the bank-toe. Therefore, the slump block effect must be considered in the new numerical modeling.

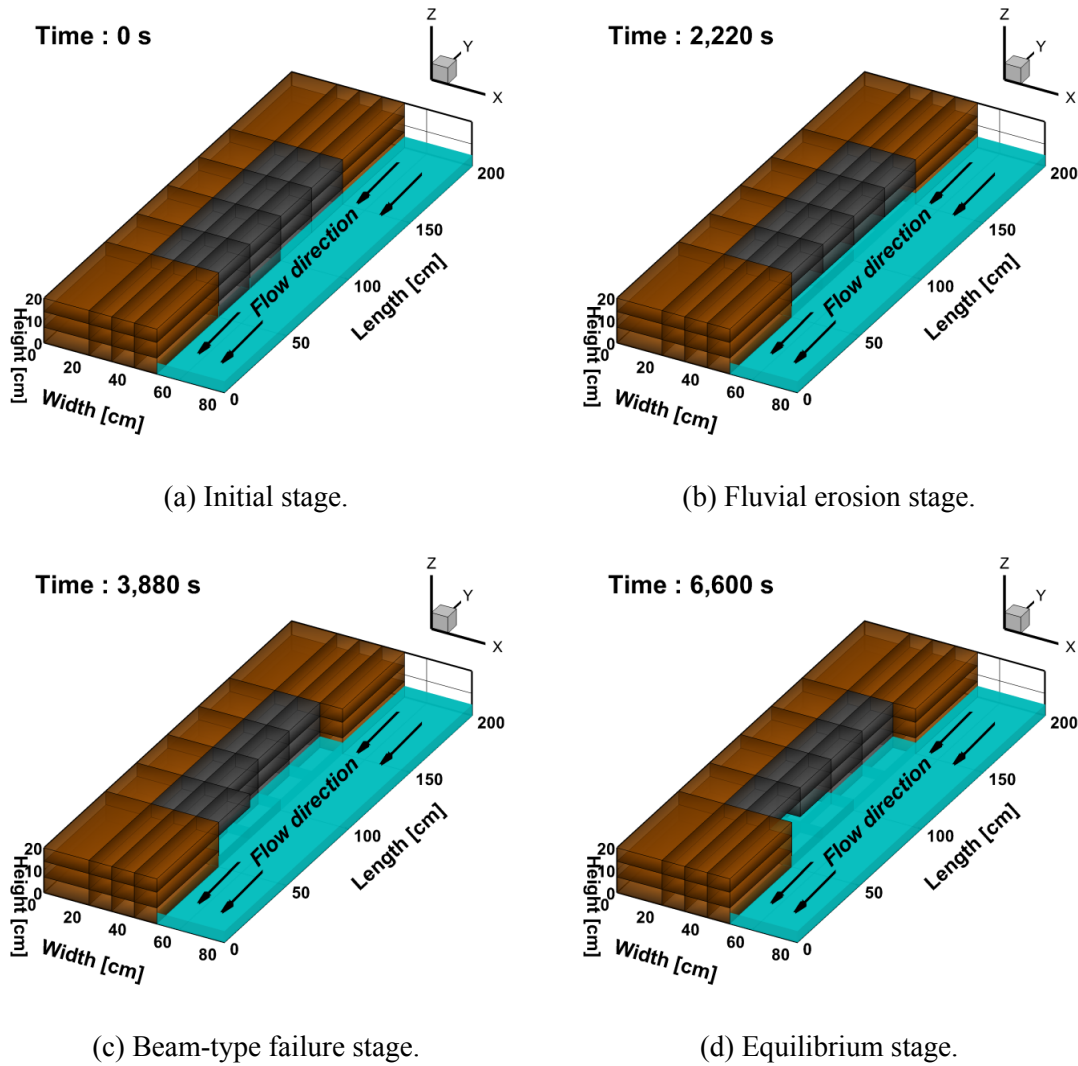
Fig. 5.5 Example results of Case 2 (SC = 20%) using the acceleration sensors.

measured using the acceleration sensors as shown in Fig. 5.5. For Fig. 5.5, a representative block of a sensor (10 cm in width, 25 cm in length and 6 or 7 cm in height) was removed from an initial cohesive riverbank, if the acceleration signals varied greatly.

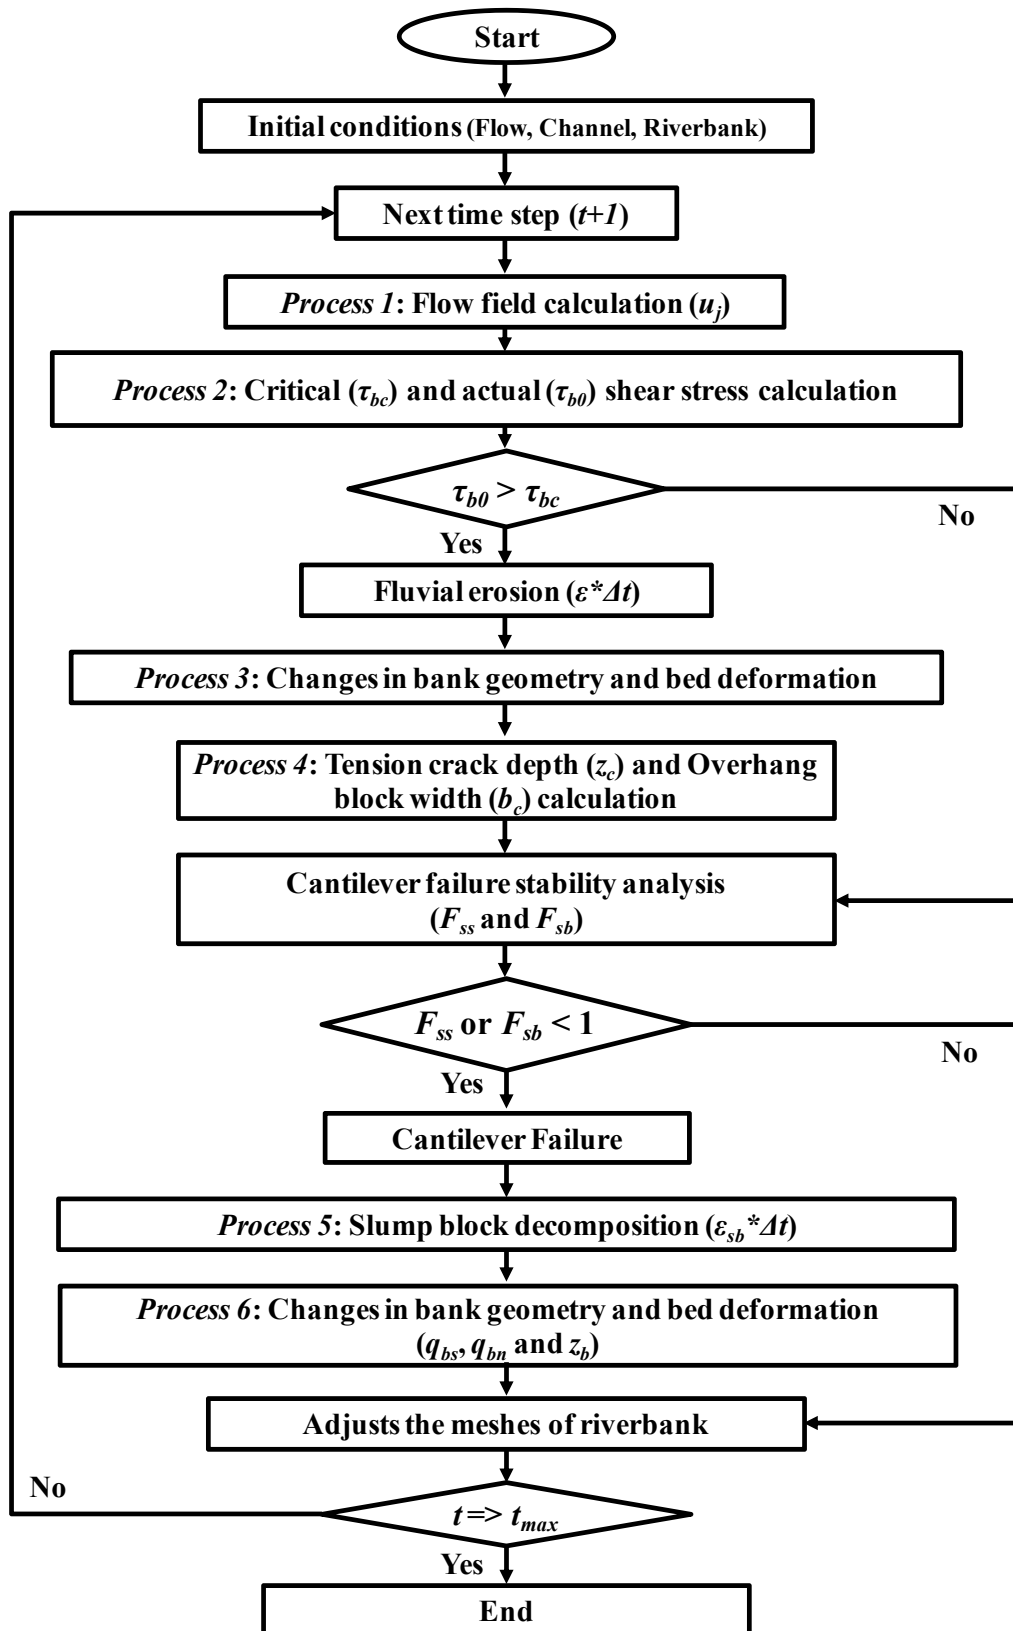
Fig. 6.4 Logic diagram of the computational sequence of a cantilever failure with slump block effect.

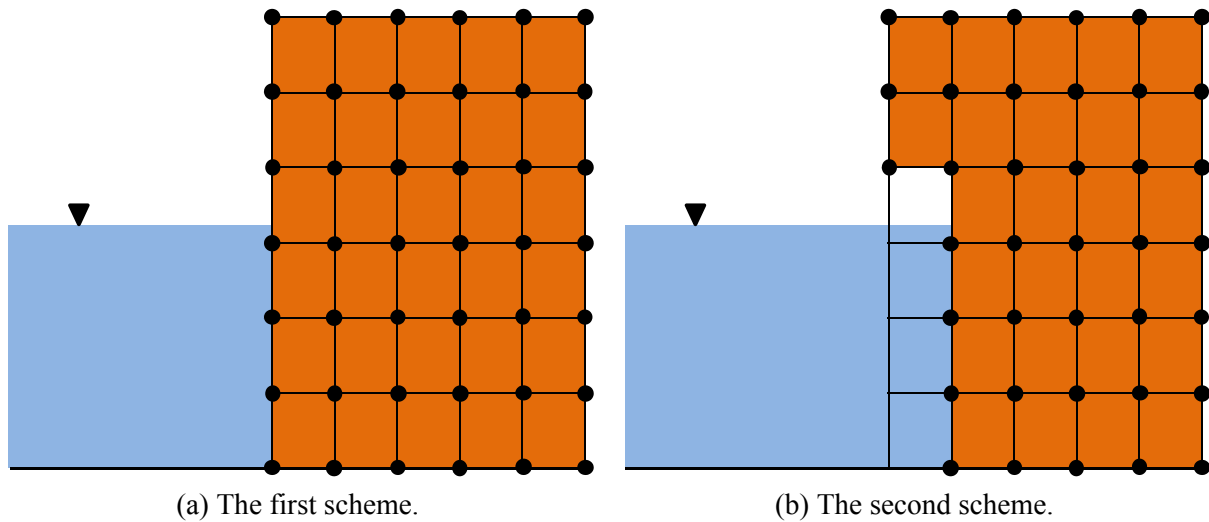
Fig. 6.5 Illustration of the two schemes used to adopt the boundary nodes by the effect of fluvial erosion.
