**Performance recovery of rebar-corroded reinforced concrete beams
repaired by cement mortar mixed with recycled nylon fibers from used
fishing nets**

SRIMAHACHOTA Teeranai

A THESIS SUBMITTED IN PARTIAL FULFILLMENT OF THE REQUIREMENTS FOR
THE DEGREE OF THE DOCTOR OF PHILOSOPHY

Graduate School of Engineering, Hokkaido University

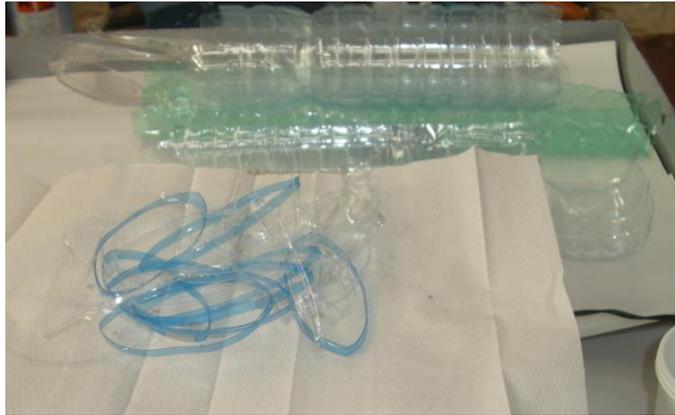
Figure 1.6 Circular R-PET fibers.

Recycled polyethylene terephthalate (R-PET) fibers reinforcement was reported to have high potential usage for reinforcing cementitious materials. Forti Dora studied the R-PET reinforcement in concrete from the recycled PET bottle with 3 types of reinforcement: 1) circular-shapes R-PET (Figure 1.6), half-bottle R-PET (Figure 1.7), and R-PET strips (Figure 1.8). Results showed that, with the addition of fiber, bending capacity was improved. Moreover, R-PET fibers responded to a post-peak capacity of the beam [29]. Adding R-PET fiber seems to have no noticeable effect on the density of concrete as well as the compressive strength, however, fibers may change mortar porosity especially at the interface between fiber and cement matrix [30]. The study of the degradation in R-PET fiber reported a slight degradation on the surface of R-PET fiber in high alkaline environment as seen in Figure 1.9 [31]. Although this degradation had negligible effect on the mechanical properties except the toughness that was decreased with time. This study also confirmed in accordance with [29, 30] that compressive strength as well as modulus of elasticity have negligible affect from the addition of R-PET fiber. Overall, R-PET fibers showed good alkali resistance comparable to other type of fibers such as polypropylene and PVA fibers [32].

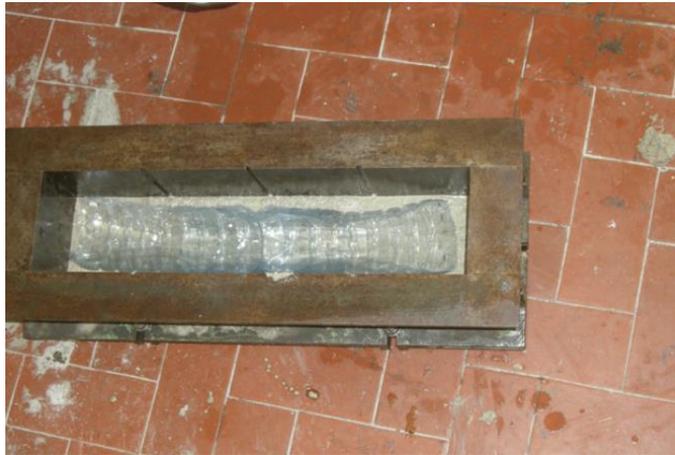
Figure 1.7 Half-bottle reinforcement.

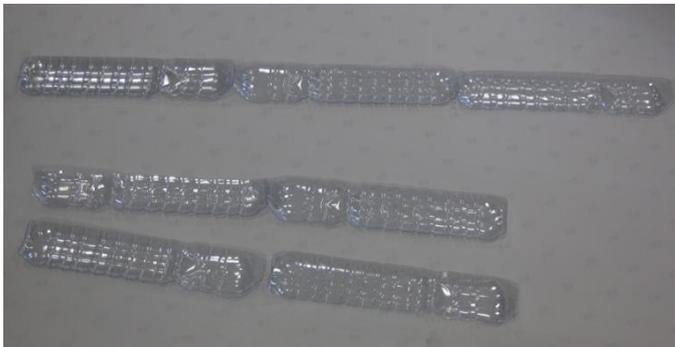
Figure 1.8 R-PET strips.

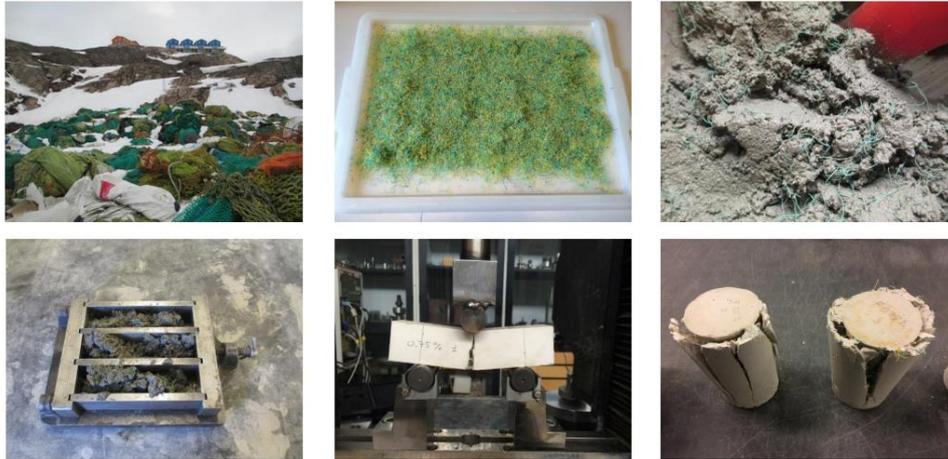
Figure 1.11 Recycled HDPE fiber from waste fishing nets.

The expanding in fishery industries and the growing concern of the waste pollution in the ocean make fishing nets are being interested in civil engineering applications. The research conducted on the engineering properties of HDPE fibers between the new and waste fishing nets (Figure 1.11) guaranteed that young's modulus and the ultimate elongation strain remain unchanged; however, tensile strength slightly reduced compared to new HDPE fibers. Alkaline resistivity of the HDPE fibers from waste fishing nets was found to inferior to those of new nets [35, 36].

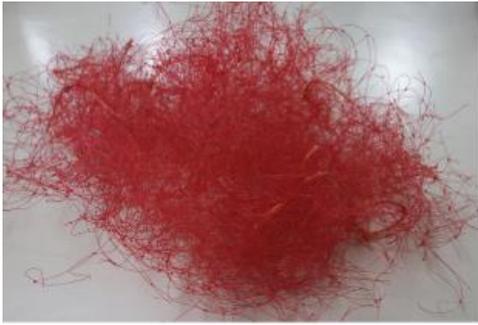
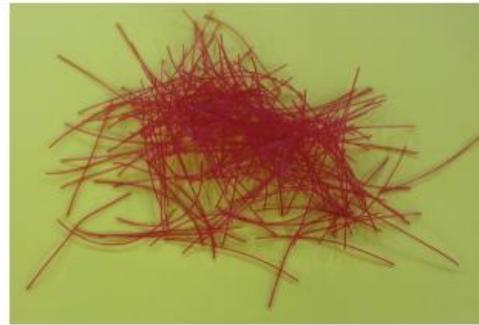
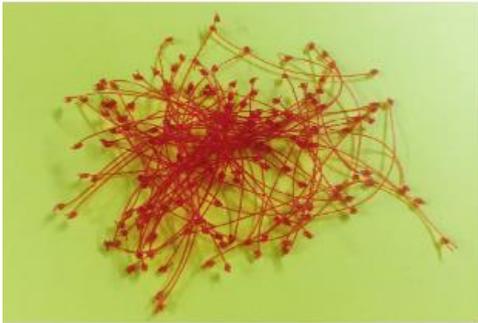
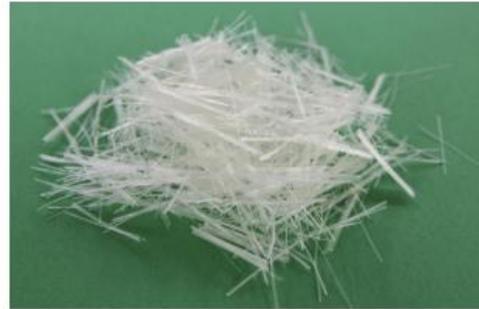
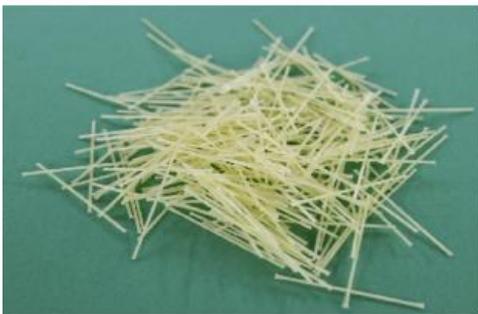
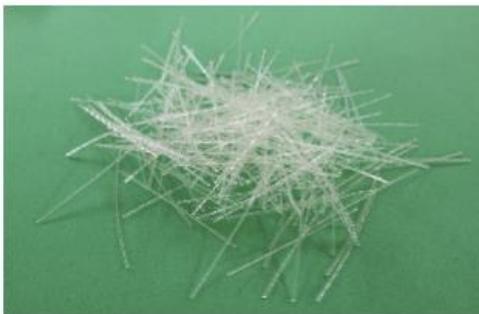
(a) Waste fishing net

(b) Straight R-Nylon fiber

(c) Knotted R-Nylon fiber

(d) PVA fiber (18 mm)

(e) PVA fiber (30 mm)

(f) R-PET fiber

Figure 1.12 Types of fiber.

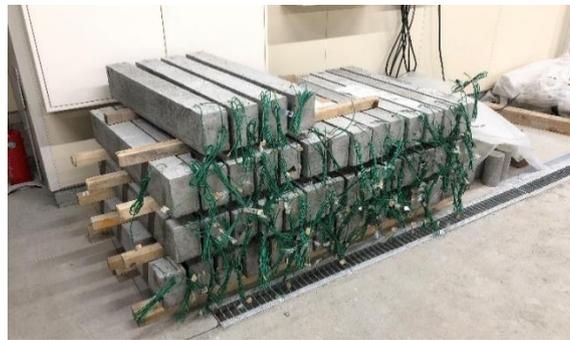
Figure 2.2 Test RC beams.

The RC beams measuring 900 mm in length, 100 mm in width, and 150 mm in height were casted. Ordinary Portland cement (OPC) was used for making RC beams and the design strength was 33 MPa. The beams had water-to-cement ratio (w/c) of 0.5, and the sand-to-aggregate (s/a) ratio was 0.45. Mix proportion of the RC beams is given in Table 2.2. Galvanized coated steel rebars were used for making stirrups so that the corrosion concentrated on the tensile rebar. In addition, an electrical wire were connected to the tensile rebar for monitoring steel corrosion during the exposure (Figure 2.2). The beams were wrapped by wet towel for 7 days after the casting, then transported to the exposure site in Kagoshima. Figure 2.3 shows the geometry and reinforcement details of the RC beams.

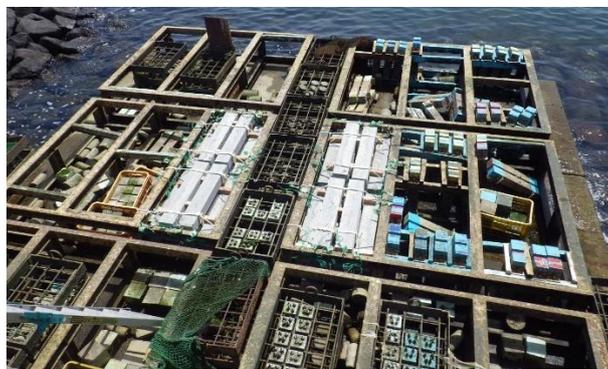
Figure 2.4 Exposure site.

RC beams were transported to exposure site located in Kagoshima. RC beams were experience tidal exposure to induce steel corrosion. The duration of the exposure was 1 year. Exposed beams were installed in the docking and placed at the seawater level (Figure 2.4) so that the test beams experienced sea tide. In addition, PCM-PE cylinders (100 mm in diameter and 200 mm in height) were casted and exposed to the same environment simultaneously as the beams to investigate the chloride ion penetrability of PCM itself. Figure 2.5 illustrates installation layout of the exposed beams.

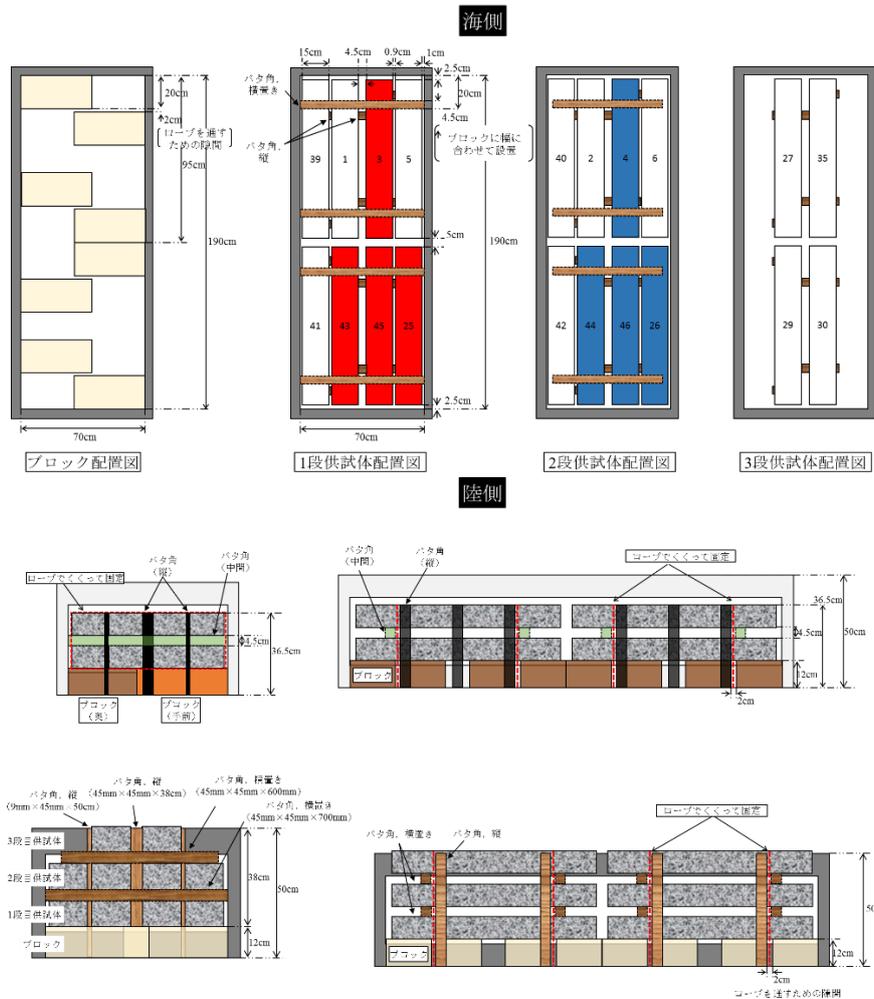
Figure 2.5 Specimen installation layout.

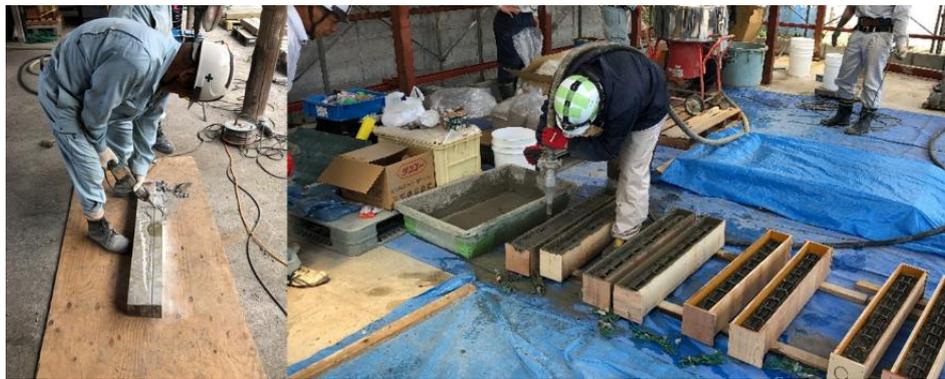
Figure 2.8 Removal of concrete cover and spraying PCM on RC beam.

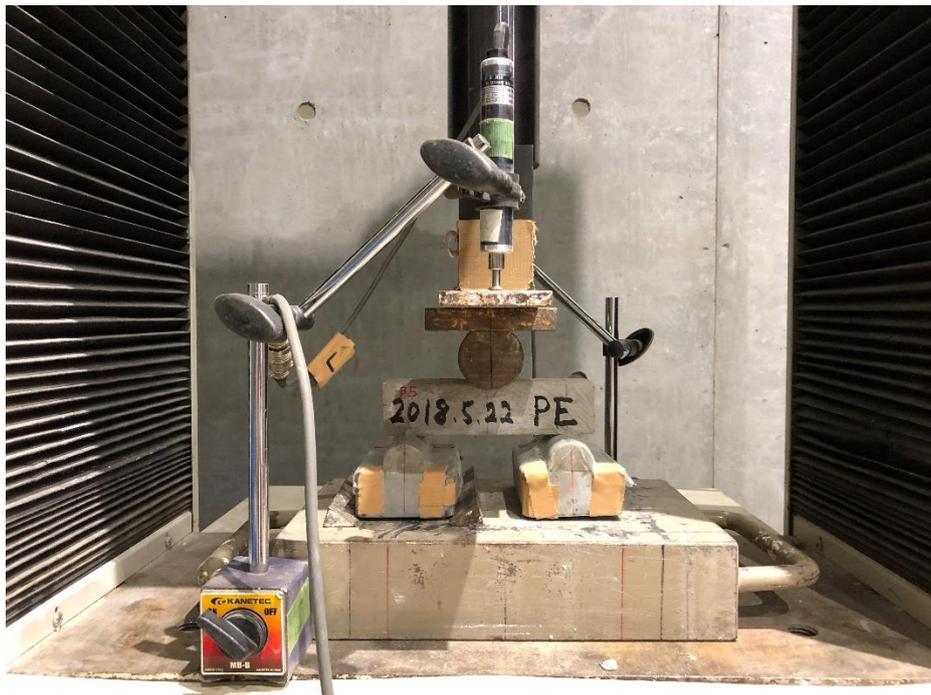
Figure 2.12 Flexural strength tests for PCM specimens.

For PCM specimens, compressive strength tests as per JIS A 1108 [5] and flexural strength tests following the JIS R 5201 [6] were conducted. Specimens were cure in water condition at 28 days before the tests. Autograph loading machine was used for the flexural strength tests and the load speed was set at 0.05 mm/min. Experimental setup of PCM is shown in Figure 2.10. Photographs show actual setting during the loading tests are given in Figure 2.11 and Figure 2.12.

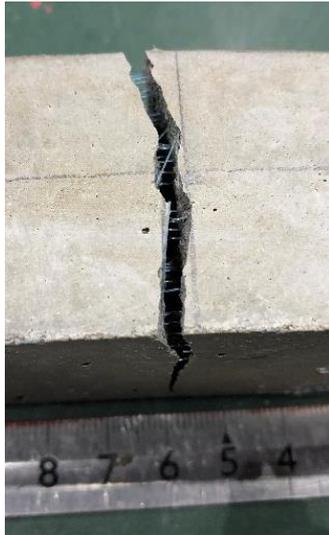
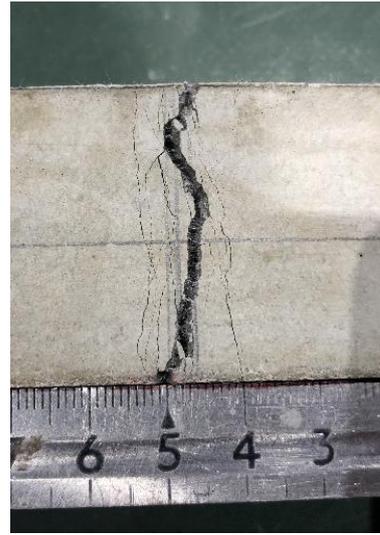
(a) PCM-RN

(b) PCM-PE

The final cracks at the bottom face of the beam after the experiment are shown in Figure 2.14. PCM-RN had a wide single crack while PCM-PE had many small cracks aside the main crack at the center. This phenomenon confirmed that PE fiber transfers stresses by dispersing damage from a wide single crack into many small cracks. No breakage of RN fiber was observed; therefore, RN fibers were rather pulled-out than rupture during crack openings. Since the fiber did not break, the strength of reinforcement was rather depended on the bonding and pull-put strength of fiber. This behavior was also confirmed by Readon et al. that embedded fiber in matrix does not rupture but pulled-put during the loading test [14]. For the case of PE fibers, breakage of fiber was clearly observed at the main crack. Contrary to RN fibers, PE fiber breaks rather than pulled-out. It is concluded that RN fiber transfers stresses through wide cracks while PE fiber bridges small or micro cracks.

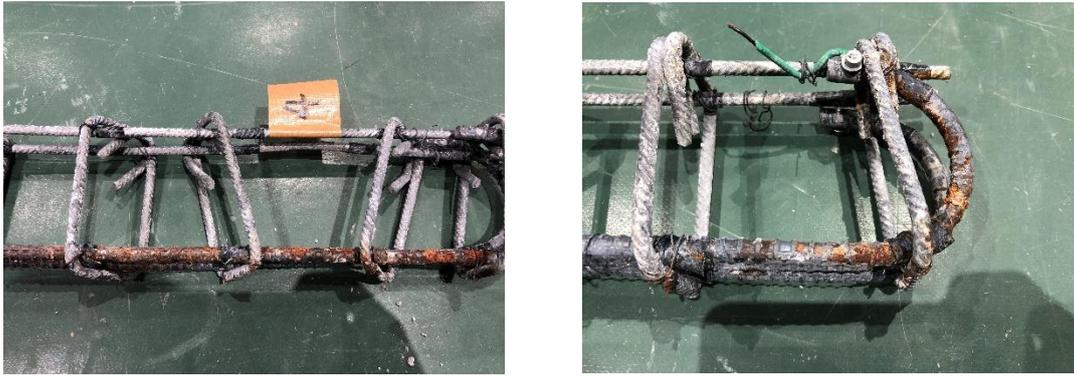
Figure 2.20 Rust formation in the tensile rebar.

All RC beams were manually broken into pieces after the flexural tests, and the tensile rebars were collected from the beams carefully. The rebars were washed using diammonium hydrogen citrate solution, and the rebar mass losses were measured. The measured mass losses are given in Table 2.9. RC1 showed the highest mass loss rate up to 1.3% while the other exposed beams (group C) had 0.6 – 0.8%. RN1 and PE1 had lower mass loss rates of 0.8% comparing to RC1. Rusts were found mostly spread along the bottom side of the beam, and some rusts were found at the anchorage near end-section as shown in Figure 2.20. It is possible that the anchorage of steel bar was placed near the surface during concrete casting, the concrete cover near the end face of the beam may be less than that of the bottom face of the beam.

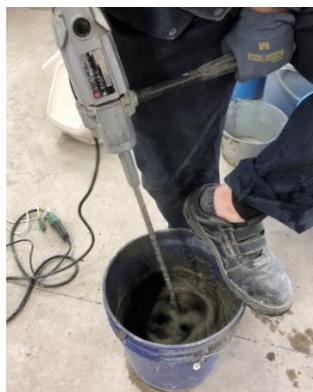
Figure 4.1 Mixing of PCM.

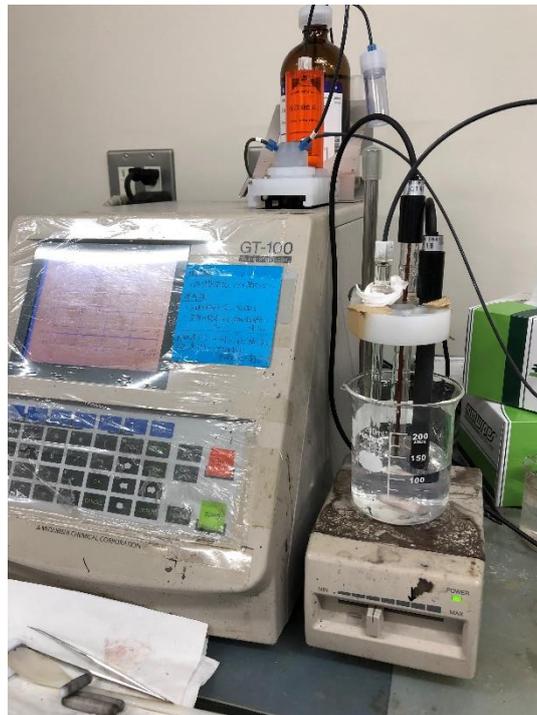
Figure 4.5 Potentiometric titrator.

Chloride ion concentrations in anode side were measured using potentiometric titrator (Figure 4.5). Silver nitrate (AgNO_3) solution of 0.1 Mol/L was used as a titrant. Supplied current, temperature and chloride ion concentration in cathode tank were also monitored periodically. The sampling interval was set at every 24 hours; however, sampling time may change to every 12 hours if the chloride ion concentration increased rapidly. Measurement data were carefully record during the testing period. The experiment ended when the increment of chloride ion concentration in anode tank become steady for the 5 consecutive measurements.

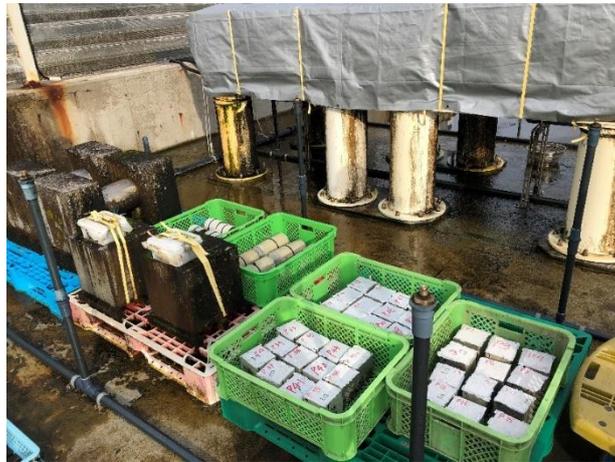
Figure 5.4 Testing specimens at the exposure site.

Cube specimens were sprayed with seawater for 2 times a day, 3 hours each, for the duration of 3 months (92 days) and 1 year (408 days). Figure 5.4 shows testing specimens at the exposure site.

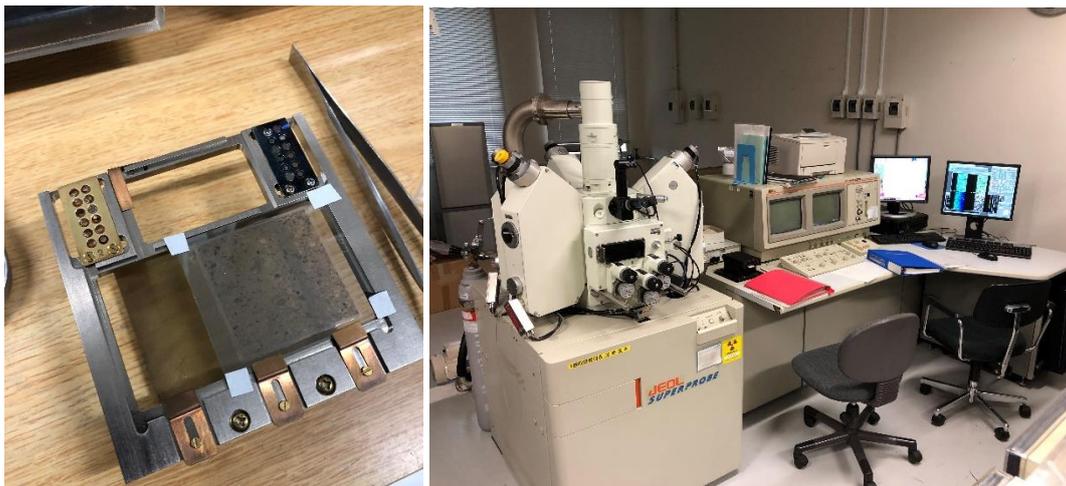
Figure 5.6 (Left) Testing sample on sample stage and (Right) EPMA device.

EPMA machine model JEOL JXA-8900R with 3 WDS spectrometers was used for analyzing spatial distribution of chloride ions in mortar. Figure 5.6 shows sample stage and the EPMA device. Analysis was performed following the JSCE G574-2005 [3] and the measurement conditions are shown in Table 5.3.
