| Title | Experimental investigation on rehabilitation effectiveness of locally corroded RC slabs using external CFRP strip plates |
| Relation | Proceedings of the 10th International Symposium on Reliability Engineering and Risk Management (ISRERM 2026), June 28 - July 1, 2026, Sapporo, Japan |

## Experimental investigation on rehabilitation effectiveness of locally corroded RC slabs using external CFRP strip plates

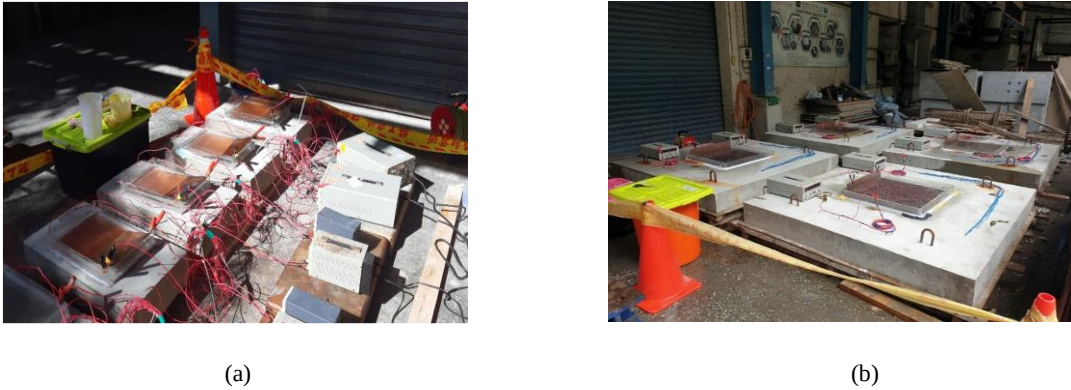
**Figure 1.** Constant current accelerated corrosion setup; (a) one-way RC slab specimen; (b) two-way RC slab specimens.

specimens, the control specimen was designated as CG. For the two-way RC slab specimens, the control specimen was RCS-0, along with specimens artificially corroded to 10% (RCS-10) and 20% (RCS-20). The remaining specimens were repaired and retrofitted using various selected materials, including non-shrink cement mortar (N), lightweight epoxy mortar (E), welded wire mesh (WWM), CFRP sheets (CFRP-s), and CFRP strip plates (CFRP-p), respectively. Material tests were performed for each RC slab specimen, including concrete compressive strength, tensile strength of reinforcing steel bars, and tensile strength of CFRP strip plates. An accelerated corrosion technique was applied by maintaining a constant current to achieve the targeted reinforcement mass loss (Figure 1), with all bar intersections insulated using tape and ties to prevent electrical conduction, and theoretical mass loss calculated using the Faraday equation (Ikehata 2020, Said 2019, Qian 2022) (see Eq. (1)).

For the selected patch repair materials, flexural, compressive, and bond strength tests were conducted in accordance with relevant standards. Seven scaled RC slabs with identical geometry were constructed and tested under monotonic loading. The one-way slabs were simply supported at both ends, while the two-way slabs were supported along all four edges with allowance for corner uplift and subjected to monotonic loading. In addition to the experimental investigation, the moment strength of CFRP-p retrofitted specimens was analytically evaluated using the ACI 440.2R code, showing strong agreement with test results. This study introduces a modified design approach that considers localized corrosion to determine the optimal CFRP-p dimensions, developed and validated through experimental findings. Furthermore, the work revises existing design formulas to optimize the application of CFRP strip plates for retrofitting locally-corroded slabs, aiming to restore reduced initial stiffness while ensuring adequate flexural strength and improved ductility.

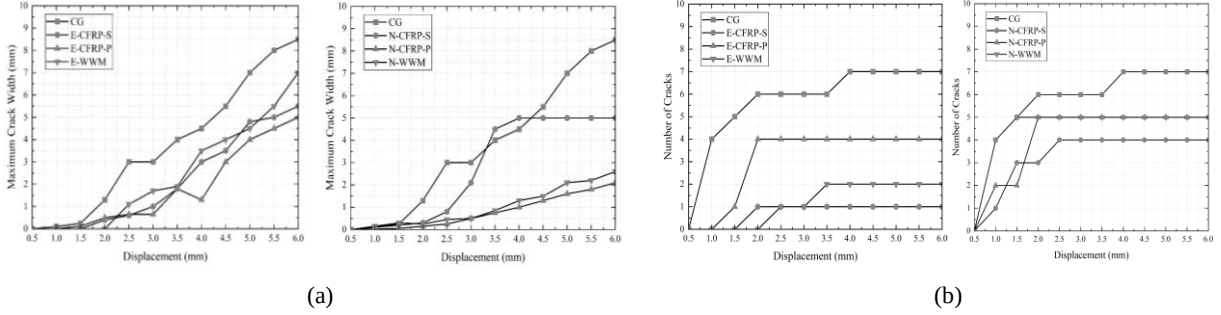
Figure 2. (a) Crack width of each specimen; (b) Number of cracks of each specimen.

Specimens repaired with lightweight epoxy mortar exhibited fewer cracks but larger widths, mainly at the concrete epoxy interface, with no cracks inside the repaired zone. In contrast, non-shrinkage cement mortar resulted in more cracks of smaller width, occurring at both the interface and within the repair material. CFRP-p retrofitting significantly reduced crack width due to its high tensile strength and stiffness, effectively limiting deformation and crack propagation. Additionally, the CFRP-p repaired specimens exhibited fewer cracks than those retrofitted with WWM or CFRP-s, as shown in Figure 2.

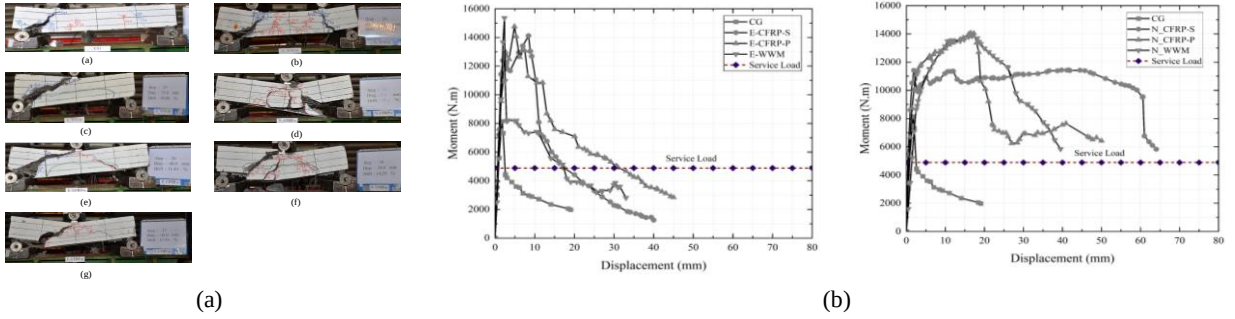
Figure 3. (a) Crack patterns at the final stage of each specimen; (b) Moment-displacement curve of repaired specimens for lightweight epoxy mortar and non-shrinkage cement mortar.

Artificial corrosion tests showed severe damage near specimen centers. Weight loss and minimum bar diameter were measured digital weight measurement machine. Before patch repair, concrete cover was grouted, remove corrosion products, and repair areas defined based on concrete cover damage extent for effective rehabilitation. Failure modes for one-way RC slabs were identified through response curve analysis. Shear failure exhibited a steep initial slope followed by a sudden load drop, indicating brittle behavior with minimal deformation. Flexural-shear failure showed gradual load increase, a yield plateau, and moderate decline after peak, reflecting ductile behavior. Based on these criteria, two modes were observed: shear failure (CG, E-WWM) and flexural-shear failure (N-WWM, N-CFRP-s, N-CFRP-p, E-CFRP-s, E-CFRP-p). Specimens E-CFRP-p and N-CFRP-p achieved moment resistance improvements of 81.3% and 72.8% over the control (CG). Except for E-WWM, CFRP-p retrofitted slabs showed the highest recovery rates. Patch repair materials significantly influenced deformation capacity, with non-shrink cement mortar providing better deformation performance than epoxy mortar. Service load performance was evaluated at 60% of CG's tested moment strength (4885.04 kN-mm) to define flexural stiffness, Said and Hussein (2019). Results indicate CFRP-p effectively controls deformation under service loads, while N-CFRP-s offers the best deformation control. Regardless of the patch repair materials, CFRP-p provides a similar flexural stiffness when the applied moment is lower than the specified moment strength, as shown in Figure 3.

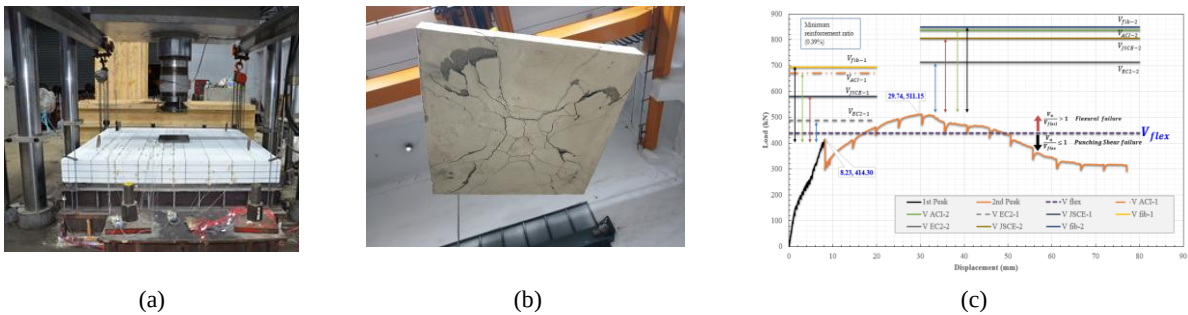
Figure 4. (a) RCS-0 specimen during monotonic loading; (b) Crack pattern at the final stage; (c) load-displacement diagram.

For two-way RC slab specimens, the post-test analysis of the control specimen (RCS-0), particularly after cutting at the edge of the loading plate revealed a failure mode classified as flexural-triggered punching shear failure. The load displacement diagram indicates that a 10% mass loss significantly reduces initial stiffness and peak load capacity. This degradation alters the failure mechanism: instead of a flexural-triggered punching failure, the slab failure transitions to a pure flexural failure mode. Verification using various design codes confirms that shear reinforcement significantly contributes to the second peak strength by enabling load redistribution following the initial punching failure, as shown in Figure 4. The control specimen (RCS-0) exhibited an initial stiffness of 101.84 kN/mm, whereas the corroded specimen (RCS-10) with 10% mass loss showed a reduced stiffness of 82.20 kN/mm, representing a 19.28% decrease. Specimen RCS-10 exhibited a 33.4% increase in energy dissipation capacity compared to RCS-0, primarily due to the reduction in reinforcement ratio caused by rebar corrosion. This reduction promotes a more ductile failure mode, enabling greater deformation and energy absorption. By modifying the existing formula Soudki, El-Sayed, and Vanzwol (2012), and determining the optimal size of CFRP-p, the goal is to enhance only the damaged or reduced capacity of the two-way RC slab. After evaluating the change in capacity, repairs are applied only to the areas where a reduction is observed, as illustrated in Figures 4 and 5.
