Title	Geomorphic Process and Natural Revegetation on Landslide Scars in Teshio Experiment Forest, Hokkaido University
Author(s)	AIPASSA, Marlon; アイパッサ, マルロン; SHIMIZU, Osamu et al.
Citation	北海道大學農學部 演習林研究報告, 45(3), 691-716
Issue Date	1988-06
Doc URL	<a href="https://hdl.handle.net/2115/21274">https://hdl.handle.net/2115/21274</a>
Type	departmental bulletin paper
File Information	45(3)_P691-716.pdf

## Geomorphic Process and Natural Revegetation on Landslide Scars in Teshio Experiment Forest, Hokkaido University

### Abstract

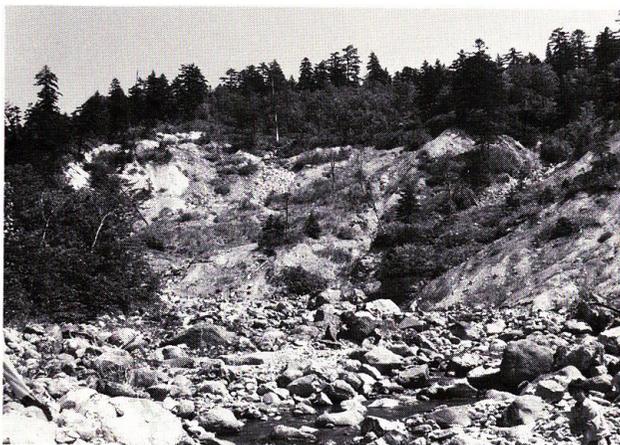
**Photo 1.** Landslide scar investigated in the serpentine area.

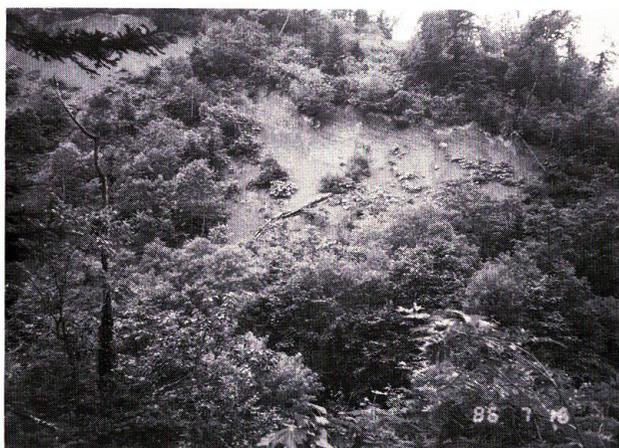
**Photo 2.** Landslide scar investigated in the mudstone area.

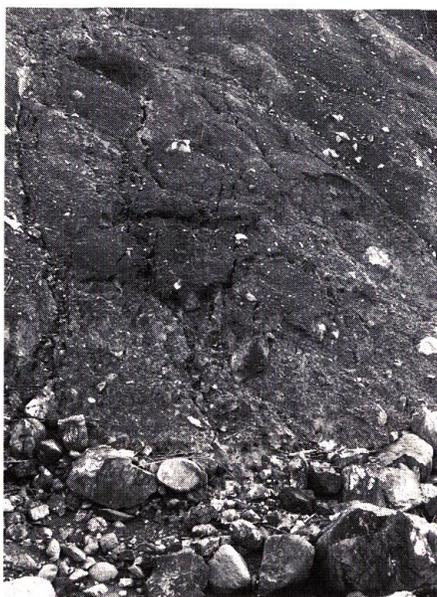
**Photo 3.** Characteristics of slope materials in the serpentine area.

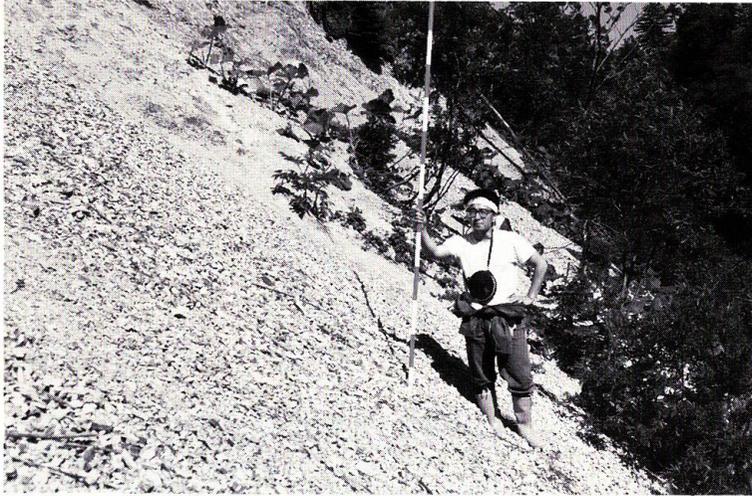
**Photo 4.** Characteristics of slope materials in the mudstone area.

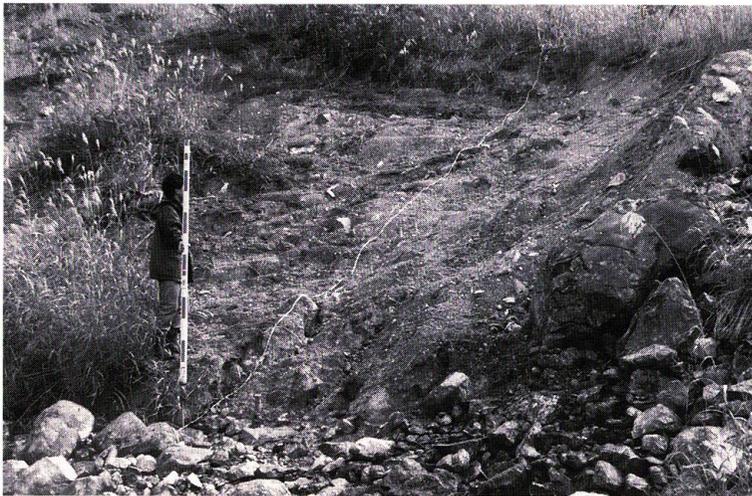
**Photo 5.** Soil creep measurement, carried out in the serpentine area.

In order to understand the characteristics of soil movement on landslide scar, soil creep activity was analyzed. Soil creep measurement was only conducted in serpentine area and was examined with respect to the slope degree and the amount of water. Those factors constitute the agencies affecting the rate of soil creep (SHARPE, 1938; and TERZAGHI, 1950). Soil creep measurement was performed by knocking small pegs into the soil and measuring their displacement with reference to a marker embedded in the slope surfaces. Pegs are systematically plotted on three sites of slope, namely the lower part, middle part, and upper part, respectively. In each part of the slope, several measurement points of soil creep were performed over a certain length, from which the soil creep of each part is counted. The slope surface gradient of each part were also measured to understand the effect of slope degree to the soil creep. In addition, the water content of soil was also measured so as to know their effect. Unfortunately this later measurement was only carried out in the final measurement of soil creep. Consequently, the result is not fully representative of the whole duration of measurement since the value of water content may vary according to the period of season.
