Successive Landslides and Debris Movement in Forested Drainage Basin

Marlon AIPASSA*, Osamu SHIMIZU* and Tohru ARAYA*

ABSTRACT

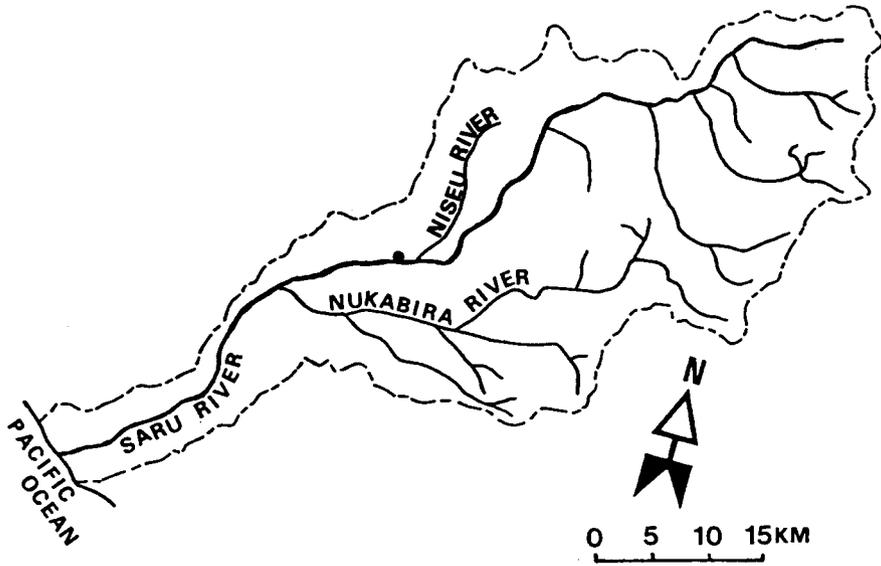
Fig. 2. Study site in Saru River Basin.

The study sites lie in north and central Hokkaido (Fig. 1). The first study site is located in the middle reach of the Saru River, about 1.6 km downstream from the junction with the Niseu River (Fig. 2). This river flows from the Hidaka mountain range and ends in the Pacific Ocean. Most of the Saru River Basin is underlain mainly by sedimentary rocks including metamorphic rocks of the Cretaceous period, with sedimentary rocks of the Tertiary period distributed in the riversides of the lower reaches. A dam ("Nibutani Dam") is being constructed on the lower reach of the Saru River to control floods and sediment stemming from two main sources, the upper reach of the Saru River itself and the Nukabira River. Stream-side sliding due to heavy rainfall temporarily occurred in many areas of this basin. Rotational slides frequently combine with flows in compound slides or with lateral spread, producing complex landslides.

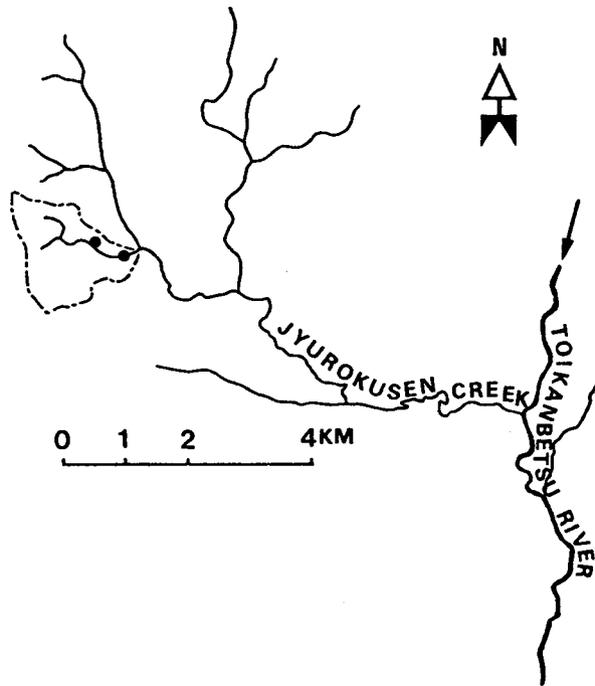
Fig. 3. Study site in Jyurokusen Creek Basin.

The second study site is the Jyurokusen Creek Basin (Fig. 3), a tributary of the Toikanbetsu River flowing south to the lower reach of the Teshio River which ends in the Japan Sea. Based on its geologic structure, this basin is chiefly composed of sandy mudstone and mudstone which belong to the Neogene System of the Tertiary era. Mixed forest of coniferous and broad-leaved trees are widely distributed in this creek basin. Debris slides and rock falls are widespread along the steep slope sites which are dissected by this creek. Debris slides tend to produce a relatively higher volume of material. They often recur in the same sites and can form a talus cone on the foot slopes. Unlike debris slides, rock falls involve small volumes of coarse material.

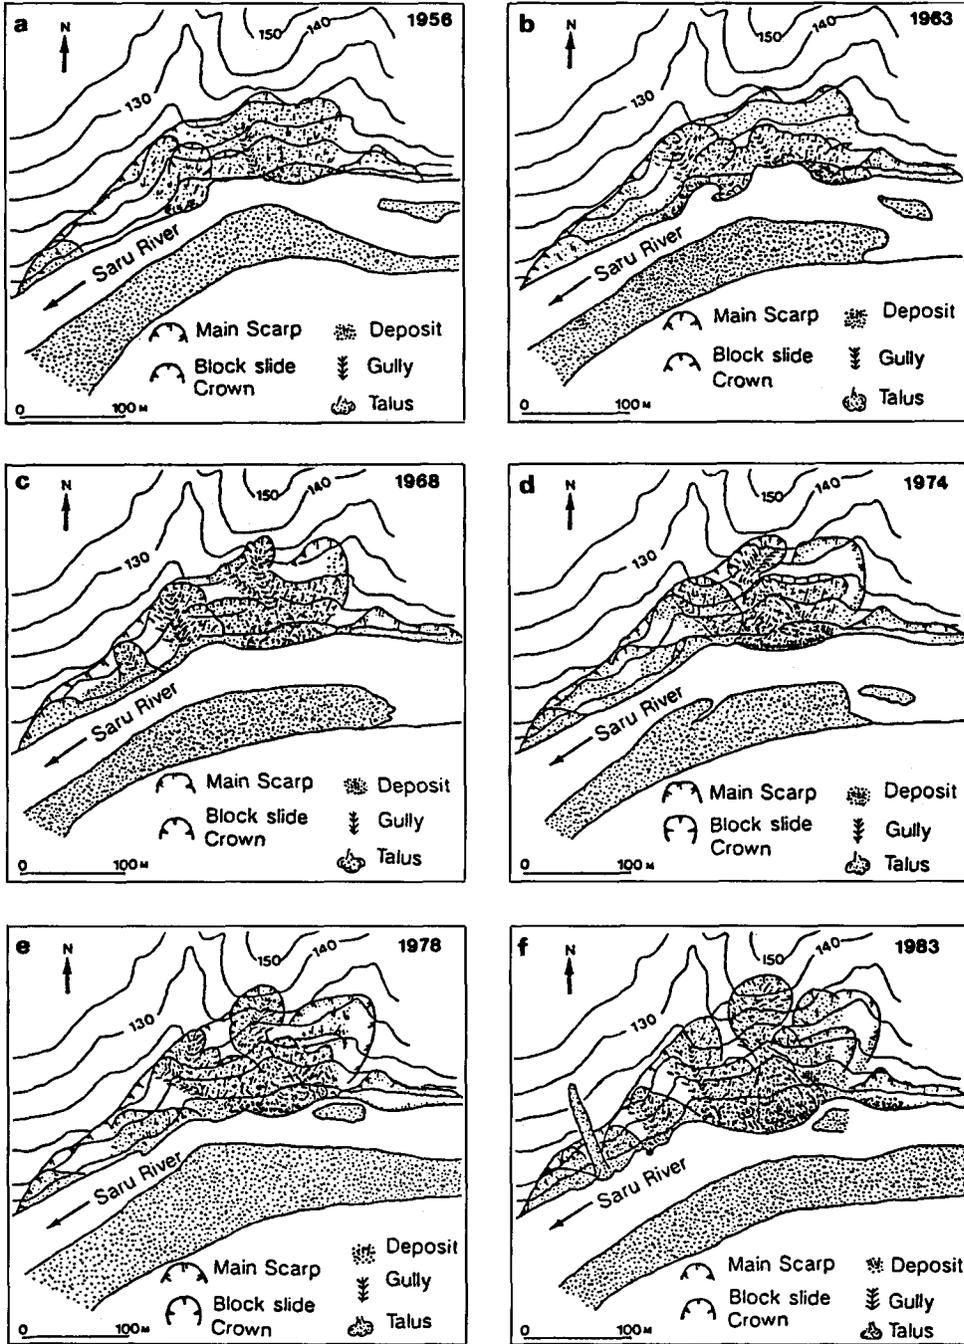
Fig. 4. Landslide scars based on the interpretation of the time-sequential sets of air photos.

Prior to 1956, surface erosion predominantly occurred as the main type of slope failure. Deep-seated landslides also occurred to some extent, particularly on the left slope (Fig. 4a). Through these processes, debris accumulated on the foot slope. The area affected by slope failure was estimated to be about 2.0 hectares.

The headscarp subsequently enlarged and deepened after successive deep-seated landslides in 1970 and 1973 (Fig. 4d). The former intersecting discontinuity planes were rebuilt into a steeply dipping continuity plane during these times. Gullies continue to be an important source in supplying colluvial soil generated from the upper scar, and result in a rapid and erosive debris flow particularly on the steeper sites of the scar. The total area of the landslide scar became gradually larger (2.6 hectares), affected especially by the deep-seated landslide and hillslope surface erosion.

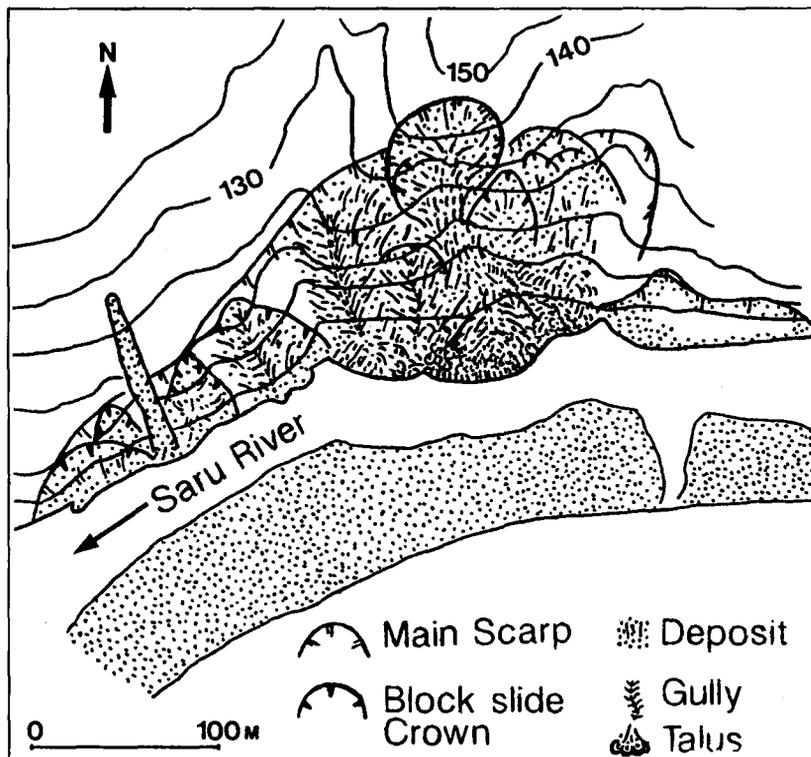
Fig. 5. Vertical view of landslide scar, based on the interpretation of air photo taken in 1988.

The profile of the landslide scar based on the aerialphotos taken in 1988 is shown in Fig. 5. In the sense of debris movement and of slope morphology, at least three definite areas of landslide scars could obviously be distinguished under the present condition (Fig. 6).

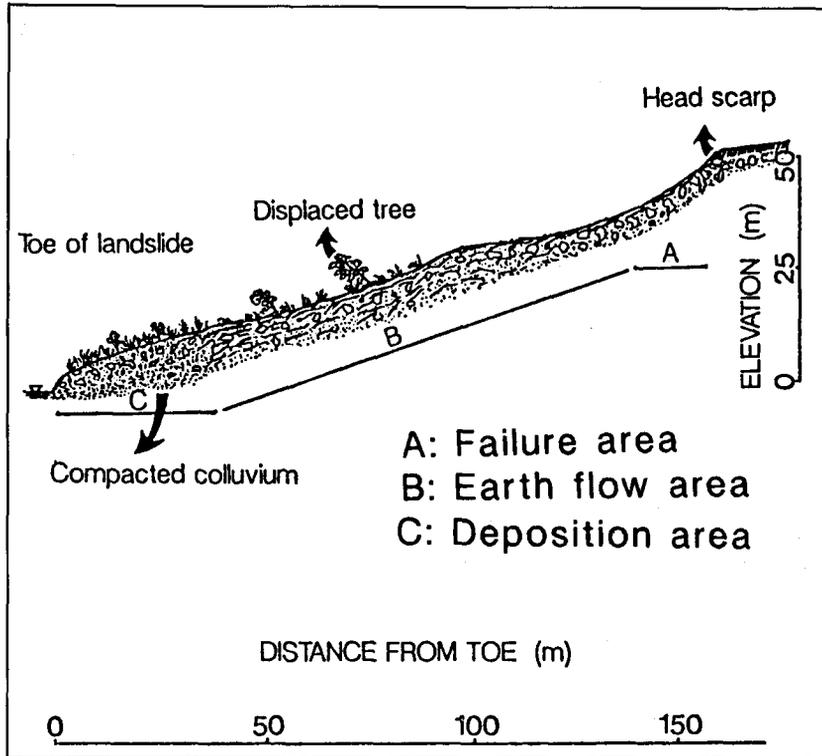
Fig. 6. Longitudinal profile of landslide scar showing mass movement zonation.

Firstly, the failure area, "A", is mainly located on the upper slope forming a concavity plane. During the successive failures, the slide mass rotated backward so that the slope of the upper surface of block was diminished, while the displaced soils formed a block which slipped down along a parallel slip surface, leaving a sharp cliff on the summit of the

Secondly, the earth flow area (shown as "B"). The landslide debris, which mostly consists of uncompacted clay fill, then moved downslope as a viscous mass, particularly on the steeper sites of the scar. In this area, many young pioneer trees were displaced by the active flow which was generally accelerated by the increased water content of the mass during heavy rains or by the thawing of snow cover. The displacement of colluvial deposit on this area was measured by installing several red-painted wooden stakes (30 cm height) which were embedded vertically into the ground surface. The distance from each stake ranged from a meter to 2.5 meters. The displacement was measured with reference to the markers embedded in the ground surface. Based on the measurements obtained for a one year period (1988-1989), the values ranged from 60-70 cm during the snow thawing and rainy periods (ground slope: 21 degrees). It was suggested that the displacement of colluvial deposit in this area could have been greater in the past decade during the heavy

Thirdly, the deposition area is shown as "C". The landslide debris was transmitted through the earth flow area and finally accumulated in the gentler slope that was located in the foot slope, forming a terraced-shaped talus, with some of the debris damming the adjacent main channel. The materials in this area consisted of compacted colluvial. The displacement of debris was relatively slower (4-6 cm) than that in the earth flow area. The maximum length of this area was about 40 meters with a 16-degree average inclination. Most of this area has been covered with bushes and young trees which most likely invaded the area sometime since the latest storm in 1981. In many parts of the landslide scar, the slope was still bare, mostly steep, and composed of deeply weathered parent material which was sensitive to failure.

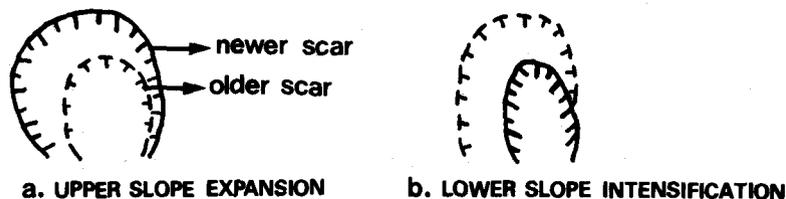
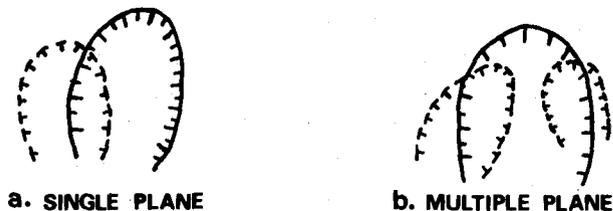
1. Duplication on the same plane

2. Overlap to the adjacent plane

Fig. 7. Types of landslide recurrence (simplified from Shimokawa, E. 1984)

sidered probable that many of the scars would have gradually expanded as time passed by. Two types of landslide recurrences could be broadly classified (Fig. 7). Firstly, the subsequent failure might occur in the older failure as a "duplication on the same plane". It might expand toward the upper slope (1a) or on the contrary, it might be just in a part of the lower slope of the older failure (1b). Secondly, the following failure might partially "overlap to the adjacent plane" (2a) or it might also partially overlap several smaller older scar planes (2b) regardless of the position on the former slope (either upslope or lower slope).

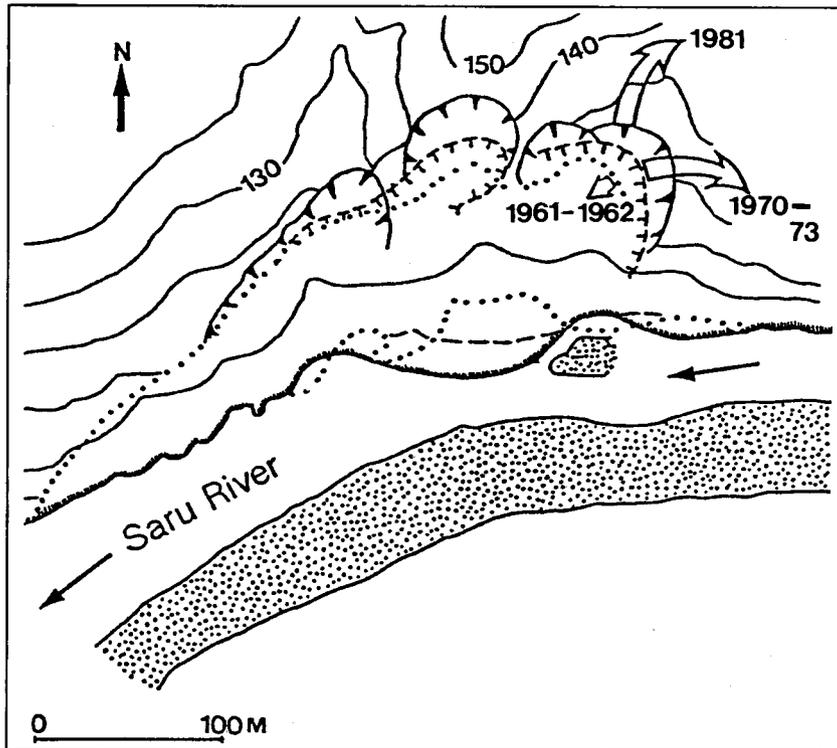
Fig. 8. Expansion of headscarp and extension of foot slope by successive landslides.

Expansion of the headscarp and extension of the foot slope were found during the next period of successive heavy rains (1970, 1973, 1974, 1975). The latest occurrence of a major landslide was in 1981. The headscarp retreated 15 meters towards the upslope site. The total scar area after the latest landslide amounted to 3.2 hectares. Since that time, no other major landslide was found. The expansion of headscarp and the extension of foot slope by the successive landslides is shown in Figure 8.

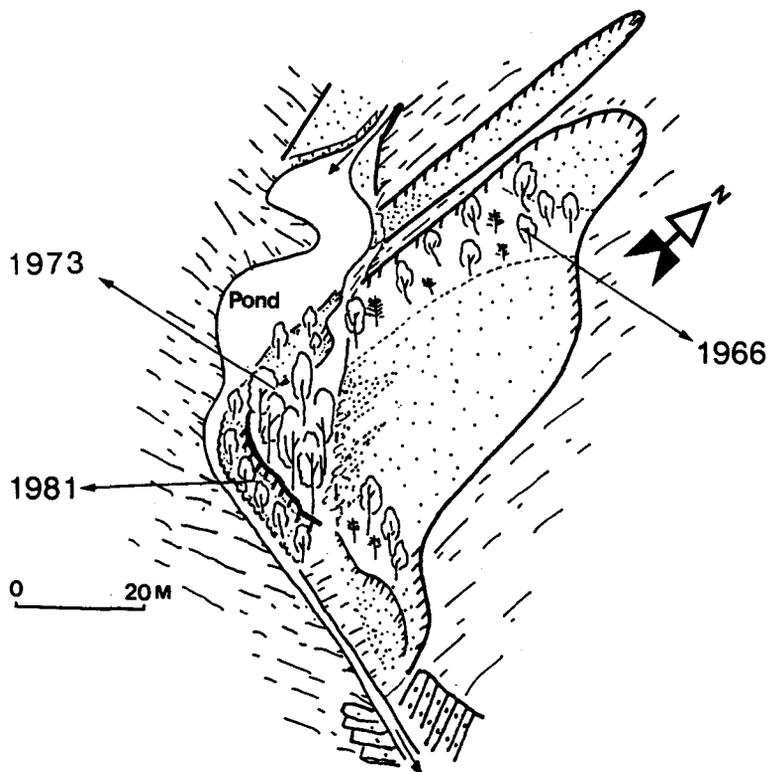
Fig. 9. A typical debris slide found in the Jyurokusen Creek (Shimizu, O. and Aipassa, M. 1988).

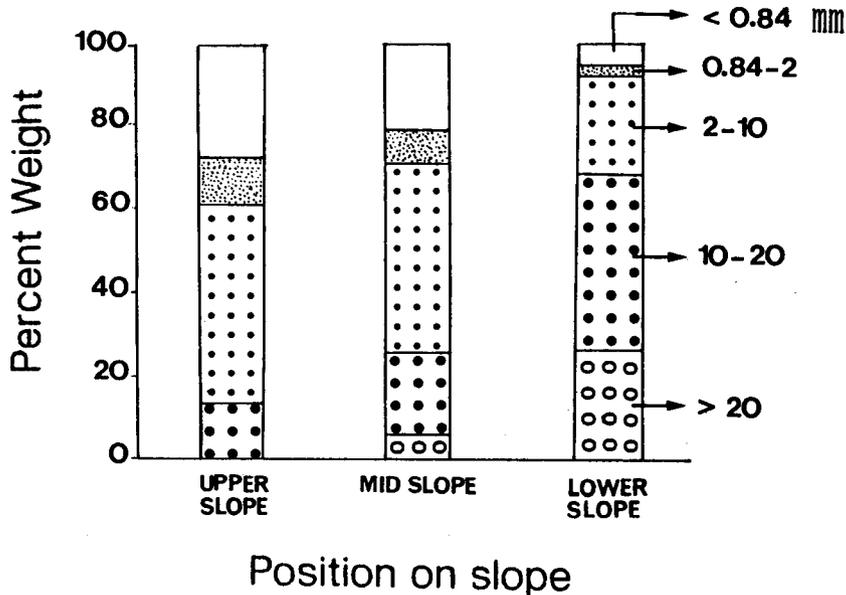
Fig. 10. Particle size (mm) of overlying debris.

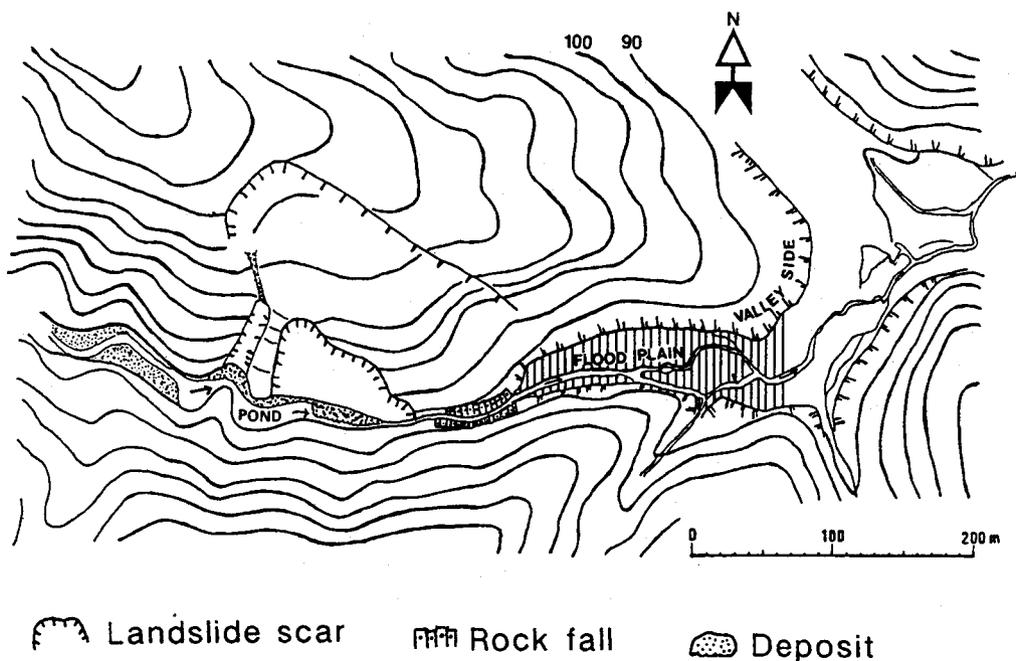
Fig. 11. Topographic map of the lower reach of Jyurokusen Creek.

Figure 11 shows the general description of the landslide sites, rock falls, and flood plain morphology in the lower reach of Jyurokusen Creek Basin. Besides debris slides, rock falls also supply sediment into this creek.

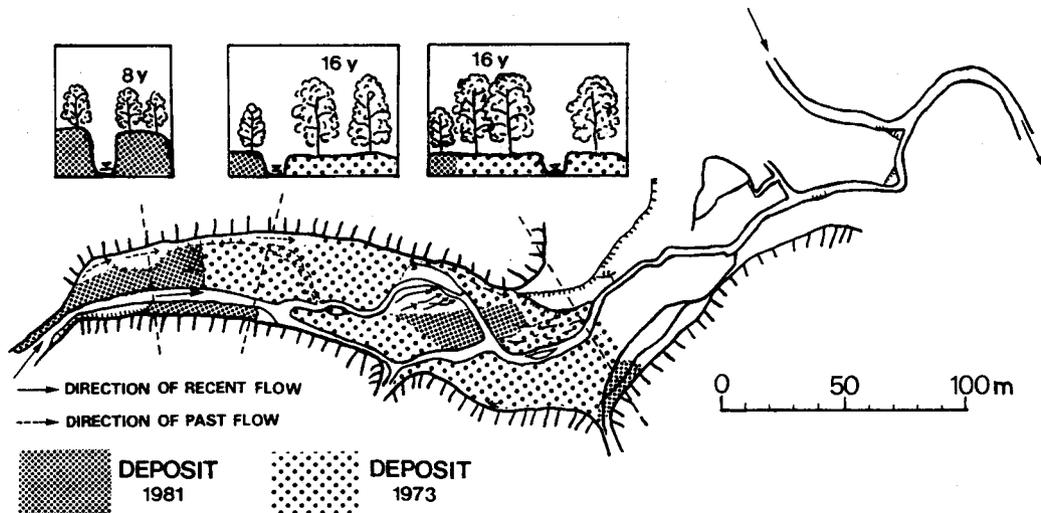
Fig. 12. Distribution of deposit on overloaded channel, based on tree age.

Based on age of deposit and elevation of surface morphology, the flood plain could generally be divided into two distinct areas (Fig. 12).

The lower area was mostly occupied by the older deposit (16 y). The elevation of horizontally bedded deposit in this area is lower than that of the upper area. This deposit was widely distributed, its length being about 190 meters. The average thickness of the deposit was 0.4 meter. In this area the stream-bed material was composed of coarser and finer surface materials. Most of the coarser surface materials existed in the upper site of this deposit area. This material had presumably been sorted out from the finer material and left as a residual accumulation since it was not readily transported. The finer surface materials were mostly carried farther, either as a thinner layer or a vertical accretion

The higher area was covered by the newer deposit (9 y) which was found to be thicker (1.1 meter average). This area was established primarily as a deposit bedding above the water level. The surface material of this area was finer and gradually grew coarser vertically approaching the water level.

During the heavy rainfall in 1981, it was recognized that the sediment production was smaller (1,500 cubic meters) than that in 1973. No major sediment production was discharged by landslides to the stream channel. However, it was recognized that some sediment production was supplied by rock fall located near the landslide scar. Besides this, it was suggested that some older deposit which had rested on the foot slope of landslide scar was carried downstream at this time. However, the transport capacity during this time was suggested to be relatively slower so that the debris flow could not be washed as far as at during the storm 1973. The stream channel is relatively narrow in this area, and since the transport capacity was relatively slower, the sediment was not readily delivered to a longer distance. Consequently, it accumulated in narrow areas forming a thicker deposition (Fig. 12) and causing the channel to shift to a new course.

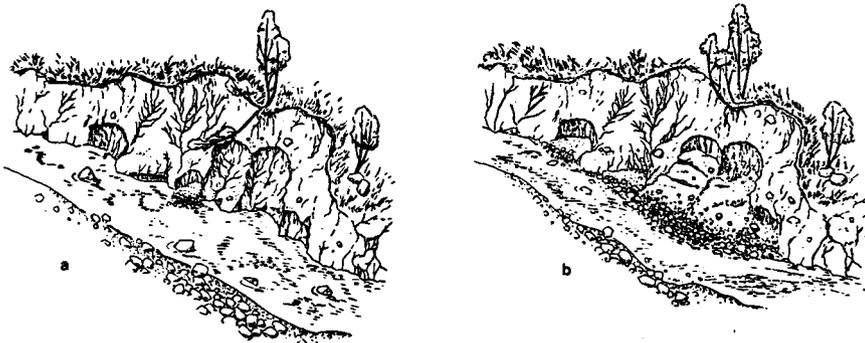
Fig. 13. Illustration of channel response to landslide debris in the torrential river.

When the capacity of the river flow to remove the landslide debris from hillslope was relatively higher, substantial widening of the valley floor could result (Fig. 13a). This phenomenon could be clearly seen in the Saru River during the major sediment transporting

On the other hand, when the fluvial transport could not keep pace with the rate of discharge of the landslide debris from the hillslope, the formation of a large talus could be expected on the toe of a slope (Fig. 13b). This might also cause a constriction of the river channel. This phenomenon could be clearly seen in the landslide of 1966 and even more dramatically during the storm of 1981 in the Saru River.

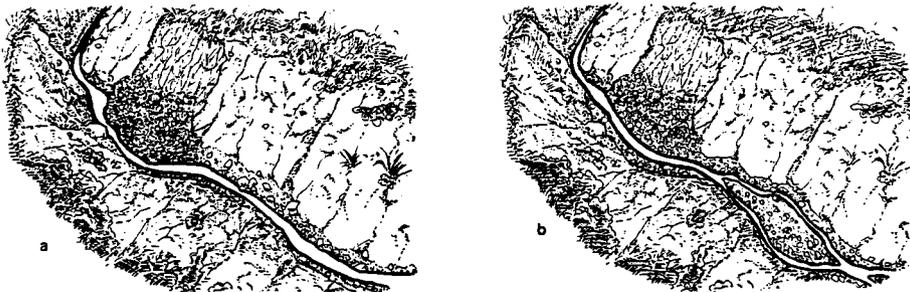
Fig. 14. Illustration of channel response to landslide debris in the placid stream.

In the case of a placid stream, as with Jyurokusen Creek, the responses of the channel were characterized by the formation of a pond in the area of the moving hillslope (Fig. 14a) and an abrupt change in the stream bed in the adjacent lower reach (Fig. 14b). This was because the transport ability of stream flow was insufficient to remove the higher rate of sediment produced by landslides.

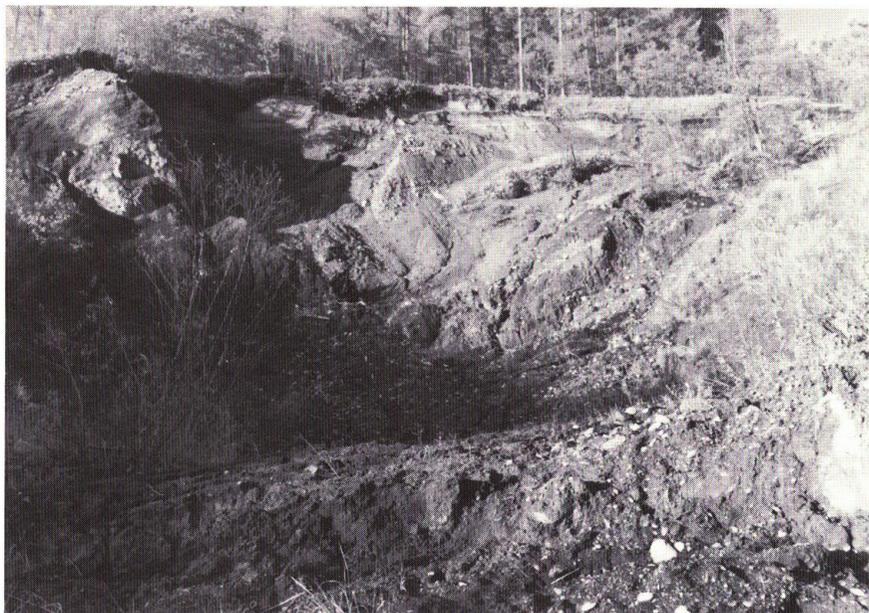
Photo 1. Scars formed by successive deep-seated landslides (Saru River).

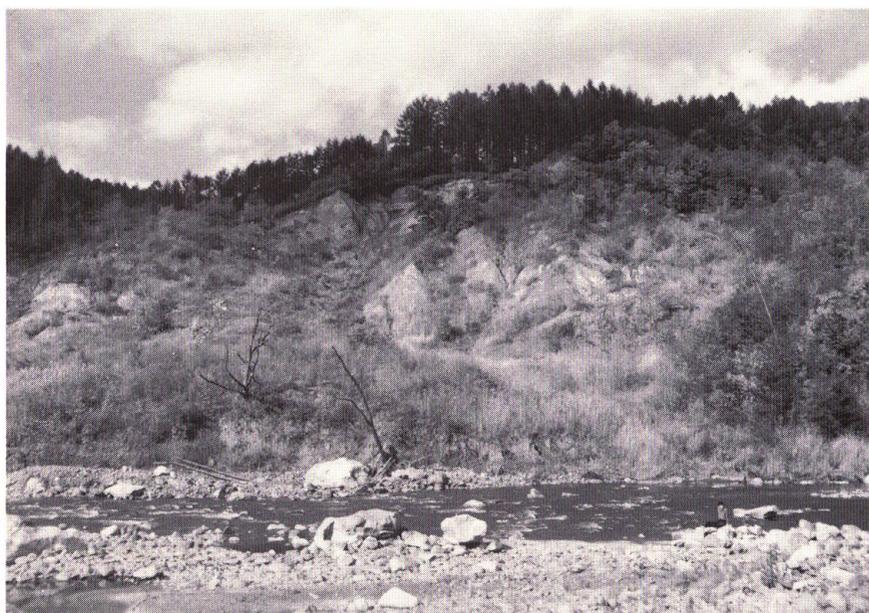
Photo 2. Large accumulation of landslide debris in the foot slope (Saru River).

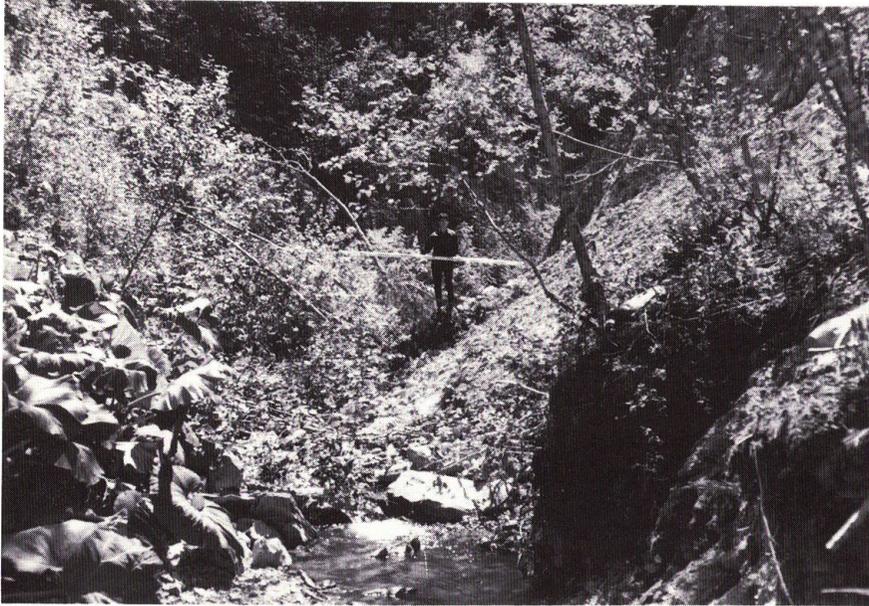
Photo 3. Effect of slope movement in the area of the moving hillslope (Jyurokusen Creek).

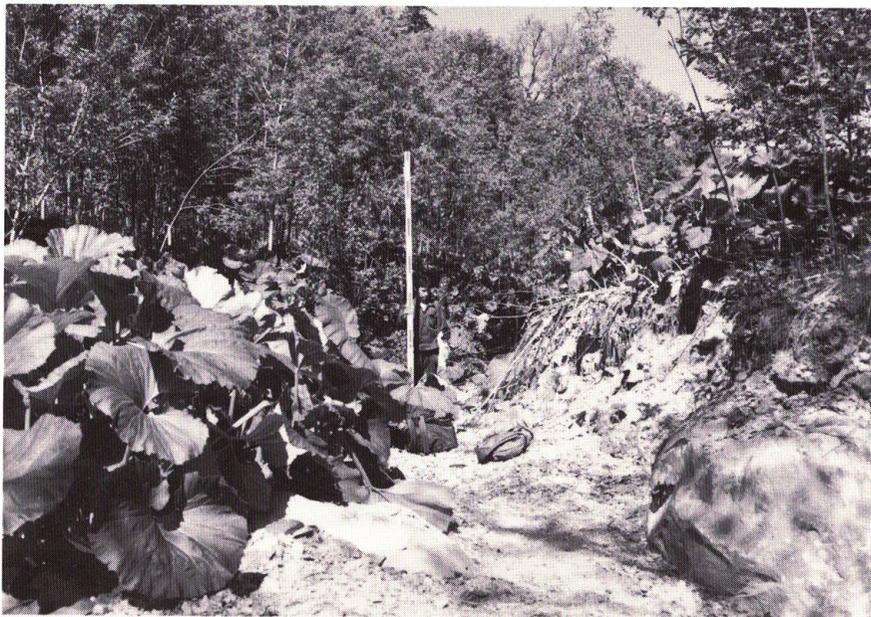
Photo 4. Effect of slope movement on adjacent channel (Jyurokusen Creek).
