Title	Landslide Debris Movement and its Effects on Slope and River Channel in Mountainous Watershed
Author(s)	AIPASSA, Marlon Ivanhoe; アイパッサ, マルロン アイファンフー
Citation	北海道大學農學部 演習林研究報告, 48(2), 375-418
Issue Date	1991-09
Doc URL	<a href="https://hdl.handle.net/2115/21346">https://hdl.handle.net/2115/21346</a>
Type	departmental bulletin paper
File Information	48(2)_P375-418.pdf

# Landslide Debris Movement and its Effects on Slope and River Channel in Mountainous Watershed\*

Marlon Ivanhoe AIPASSA\*\*

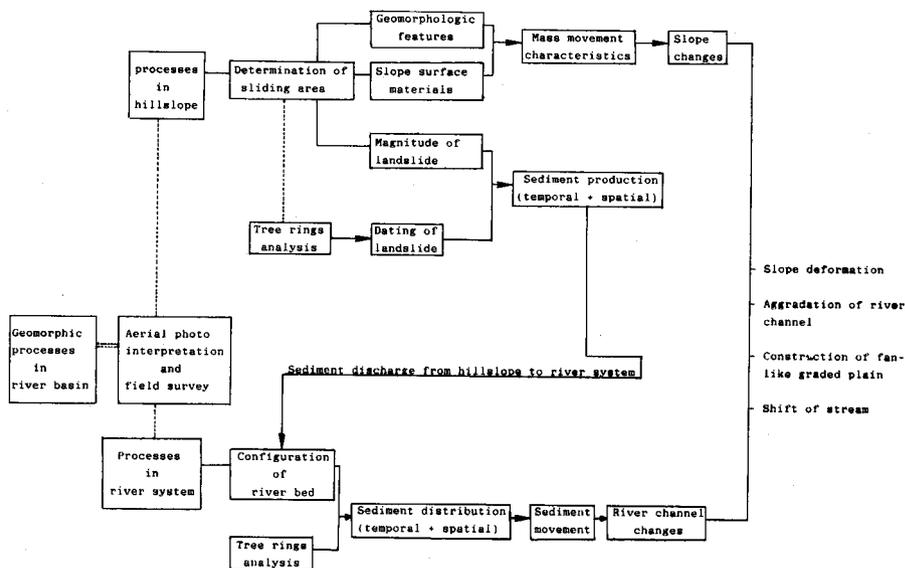
Fig. 1. Methodology of study for effects of landslide on slope and river channel.

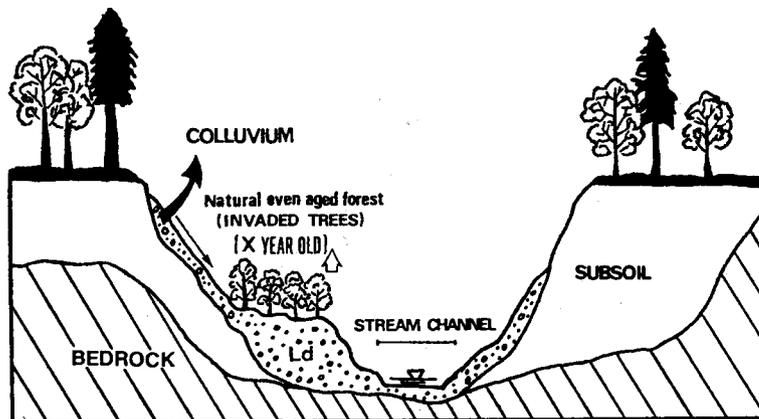
Ld: Deposition of landslide debris (aged x year)

Fig. 2. Schematic cross section of landslide scar.

Figures 2 and 3 show the method to date the initiation of landsliding and to estimate the ages of deposit stored on the river channel. This method actually has long been applied by Araya (1986). The effectiveness of this method has been proved in various parts of Hokkaido, particularly in the study of the changes of topography caused by landslide (Higashi, 1979).

Landslide could be dated through tree-ring analysis of leaning trees with adventitious sprouts, stem deformations, and corrosion scars. Tree ages on new deposits provide a minimum time since relative stability was reached. Tree trunks grow radially during

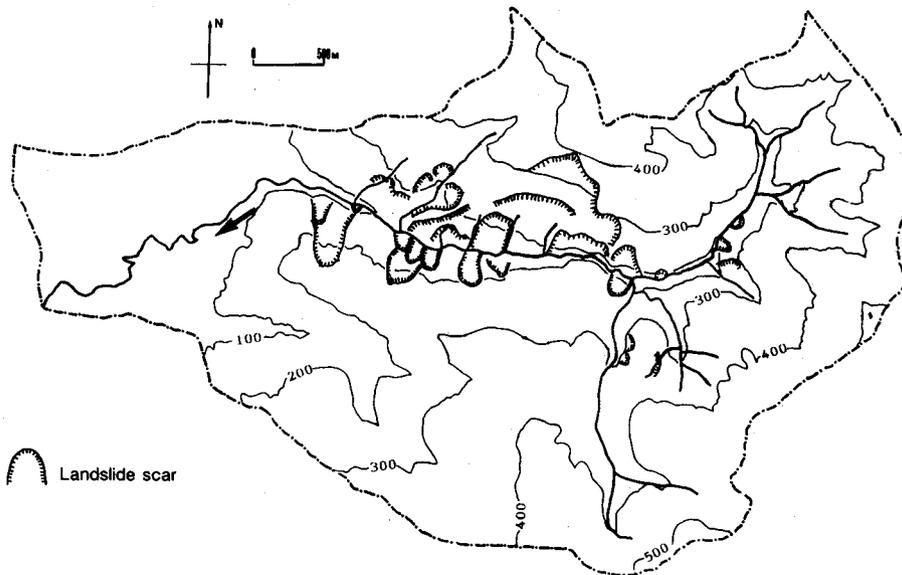
**Fig. 6.** Distribution of landslide in the Mukaihassen River Basin.

Figure 6 shows the distribution of landslide in river basin. It was clearly recognized that landslide mostly occurred in the middle reach of the river basin. They are higher either in number or area. Landslide scar was found to be as many as 19 in number in the middle reach occupying an area as large as 88 hectares (Table 2). Most of the landslide scars are located near or in contact with the main river or first order stream. As for the upper reach of the basin, landslide was found to be 10 in number and about 4 hectares in area. No landslide scar was found in the lower reach of the river basin.

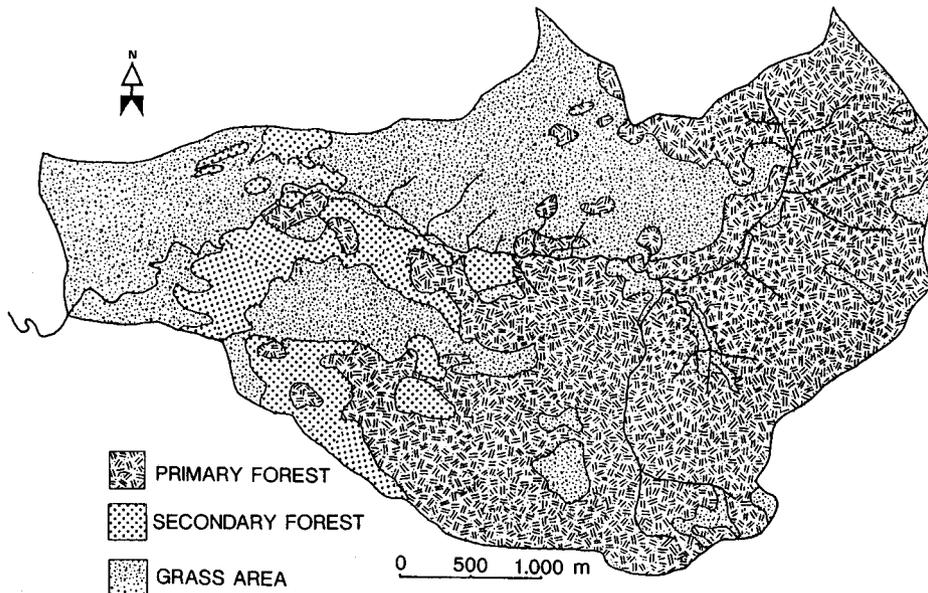
Fig. 7. Distribution of vegetation types in the Mukaihassen River Basin.

Figure 7 shows the distribution of vegetation types in the Mukaihassen River Basin. Basically, three types of vegetation can be observed in this river basin. Primary forest which mainly consist of natural forest of *Picea* spp. can be found in the upper reach and partially in the middle reach. In the lower reach and part of the middle reach, treeless areas predominantly composed of *Micanthus* spp. abound.

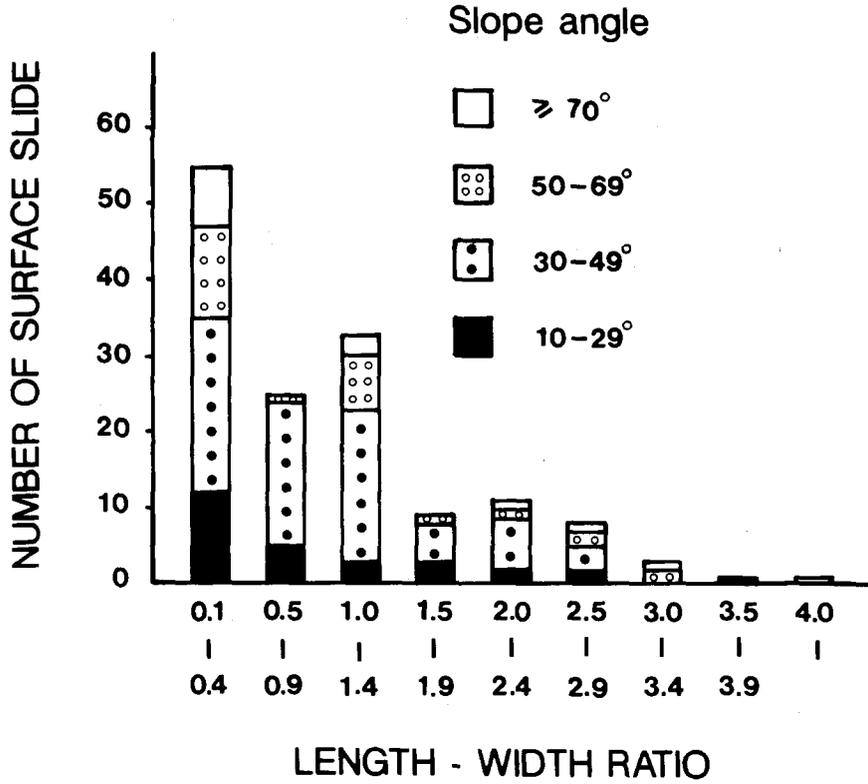
Fig. 8. Relation between number and length-width ratio of surface slide.

In attempt to characterize the shape and nature of the slope surface failure in the watershed unit, length-width ratios were measured, and these were then categorized in term of slope angle (Figure 8). This figure shows the characteristic of slope surface failure for 4 classes slope angles to have a length-width ratio in the range 0.1-3.9 that is from circular to ellipse (elongated or broaden) shapes. The ratios of 0.1-0.9 (broaden ellipse) are the most common in this river basin. The sites of the active landslide were apparently the sites prone to the occurrence of slope surface failure, particularly in their head scarps. The extent width of the head scarp of the active landslide might indicates the commonest shape of slope surface failure. These phenomena were mainly observable in the middle reach especially on the upslope position of the zero order system which were the most common site of the active landslide. No clearly typical relationship of length-width ratio is evident for any class of slope. As in the common cases, most of the slope surface failure occurred in the slope 30-49 centigrade degrees. The number of slope surface failure gradually decrease as the slope gradient increase and eventually they drop sharply when slope gradient exceed 70 degrees centigrade.

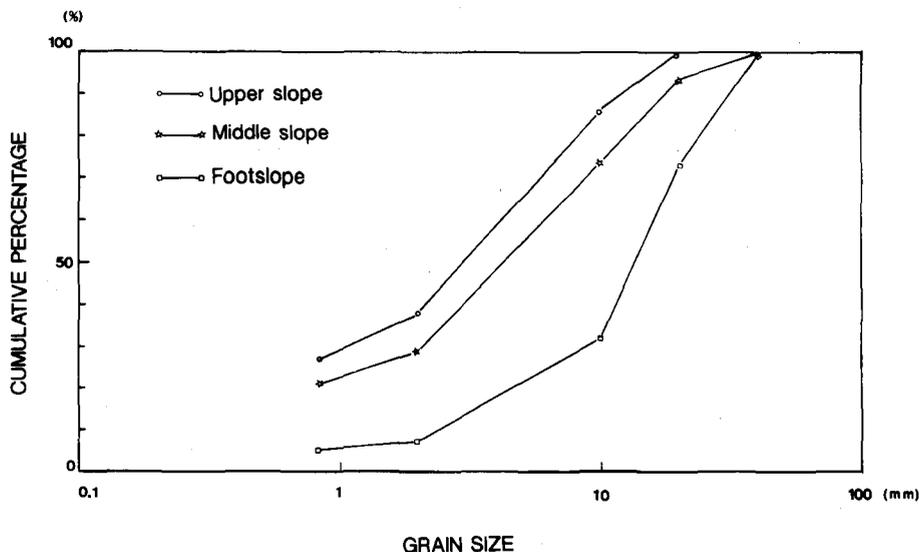
Fig. 9. Curve of particle size distribution.

The size of overlying debris varied from 2 to 20 millimeters. In the upper part of slope, materials were mainly composed of finer materials. This part was mostly dominated by materials with sizes varying from 2–10 millimeters (occupy 48.8%), followed by the materials with sizes less than 2 millimeters. The coarser materials (10–20

millimeters) existed in confined amounts (13.7%). Materials with sizes bigger than 20 millimeters were not found entirely in this part.

In the middle part of slope, composition of grain size tend to change. As observed in the upper part of slope, the percentage of finer materials begins to decrease even if they still dominate. Concurrently, the materials with sizes bigger than 20 millimeters and with sizes between 10-20 millimeters start to occupy this part of the slope. However, the percentage is still small, about 6.2% and 19.7%, respectively. Based on these percentages, it can be said that this part is the transition site of grain size change.

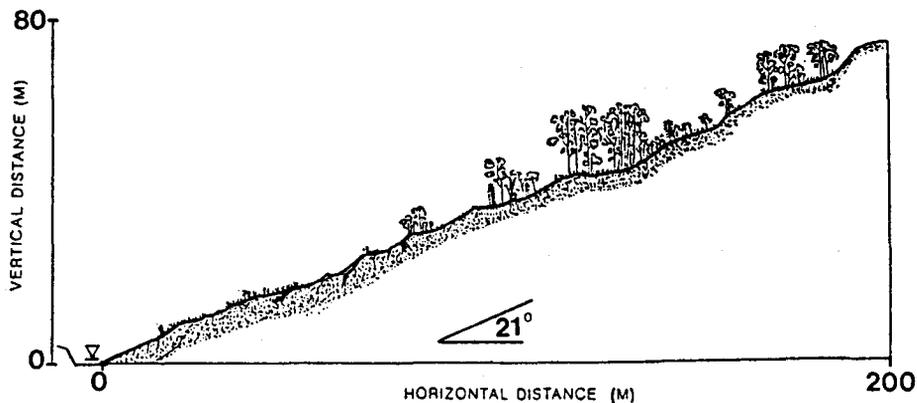
Fig. 10. Longitudinal profile of the landslide scar, investigated in the serpentine area.

The determination of slope form due to landslide was undertaken based on the survey of the longitudinal profiles of landslide scar. The survey was carried out in the Mukaihassen and Jyurokusen River Basins which are composed of serpentine and mudstone bedrocks, respectively. The longitudinal profiles of landslide scar investigated in serpentine and mudstone areas are presented in Figures 10 and 11. In the serpentine area, complex form of slope (convex, concave, and rectilinear) was found; simple slope form (rectilinear or straight in profile) was observable in the mudstone area.

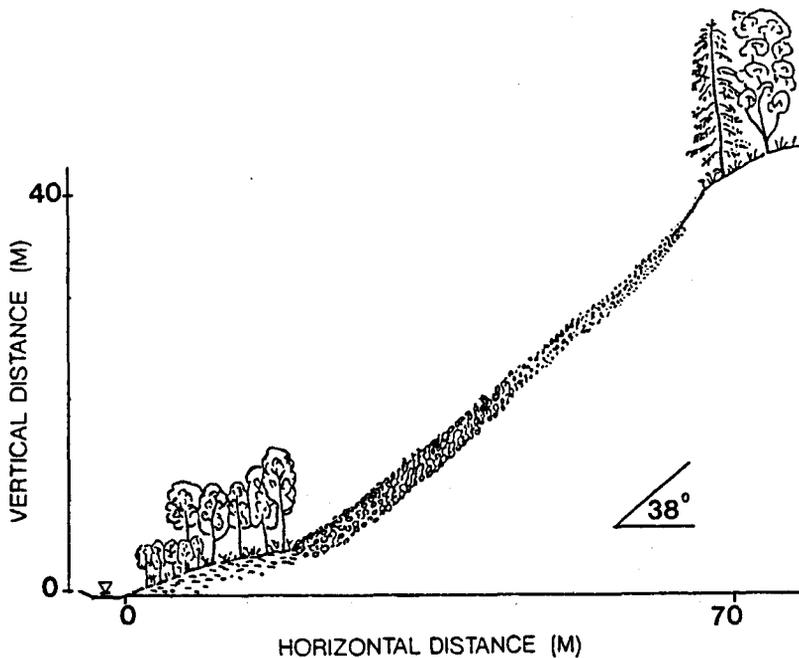
Fig. 11. Longitudinal profile of the landslide scar, investigated in the mudstone area.

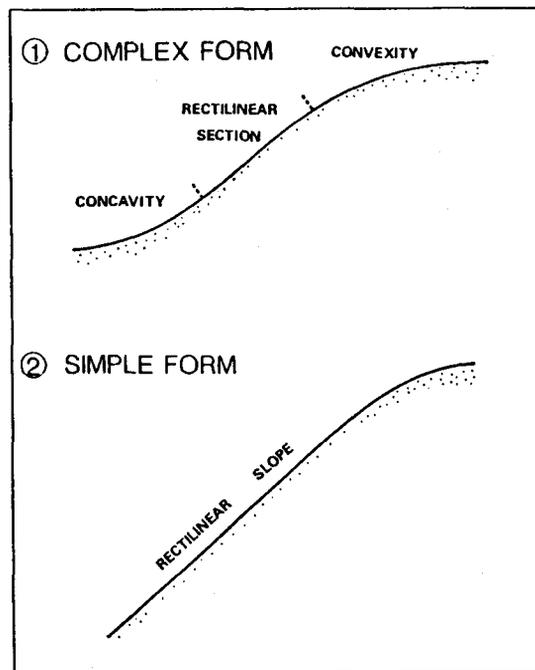
Fig. 12. Slope forms after landsliding observed in the study basins.

Two forms of slope was observable in the study basins (Fig. 12). The slope form in the Mukaihasen River Basins, was found to be complex (concave, convex and rectilinear slopes). This was inferred to have been formed as a result of rainwash and deposition processes which took place alternately over the extensive length of the relatively gentle slope. Unlike the slope form in the Mukaihasen River Basin, extensive rectilinear slope was found to be the prominent slope form in the Jyurokusen River Basin.

“Concave slope” was formed where rainwash effectively took place particularly on the steep part of slope. The slope material in this part of slope was mostly transported downward from the crest and finally resulted in the waning development (concavity section). It is theoretically possible to envisage rainwash as an important formative process on the steeper part of slope, particularly near and at the summit of slope. This process was also found at the lower part of slope, where surface flow had increased to the extent that small scale channels could occur. Thus, it is believed that unconcentrated wash of upper convexity becomes concentrated into numerous surface flows toward

"Convex slope" was commonly formed by the accumulation of transported materials. These materials are deposited on the gentle part of the slope and they finally lead to a gradual waxing development (convexity section). This section was ordinarily found on the absence of effective wash, and so soil creep activity is usually and on the contrary highly developed in some convex sections of slope.

"Rectilinear slope" appeared to be more characteristic of areas with steeper slopes and was restricted to the central part of the slope profile, where it separates a convex section above from a concave section below. This section may reflect a condition of approximate balance between the downslope increment of load and the downslope increase of efficiency of slope transportation. This kind of slope form were widely found in the Jyurokusen River Basin. Slopes not containing upper slope convexity and lower slope concavity, however, were also found. In the Mukaihassen River Basin, slopes bordering a heavily aggraded river valley show no lower concavity as it was buried beneath the alluvium. The absence of talus accumulation suggests narrow valleys in which the rivers were engaged in active downcutting.

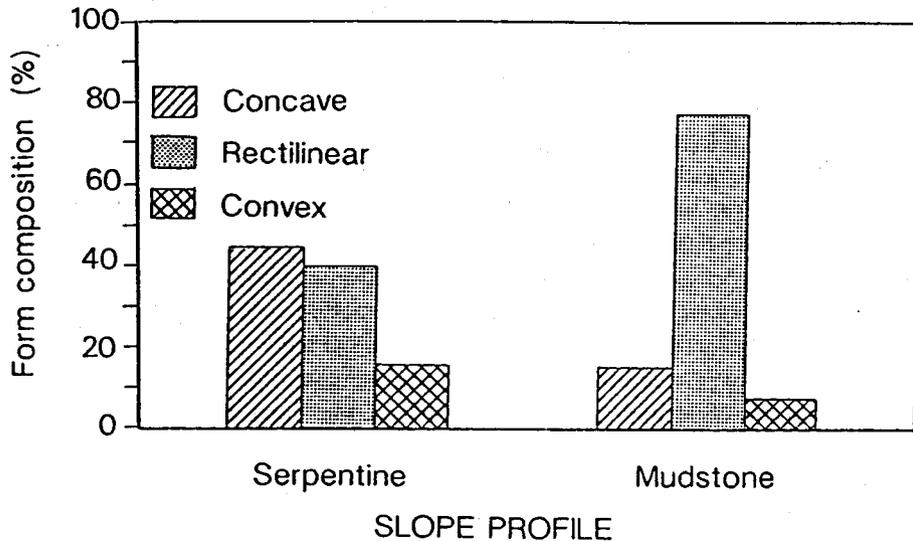
Fig. 13. Proportion of slope surface form of landslide scars in the Mukaihassen and Jyurokusen River Basins.

The proportion of slope profiles in two areas is presented in Figure 13. The concavity observed in serpentine area was found to be the dominant form (44.8%) of the total length of slope, while the convex slope was found to be a minor slope form (15.5%). The rectilinear slope form was also found to be as extensive (39.7%) as the concave slope form. The slope form observable in mudstone area in somewhat different from what was found in serpentine area, where marked rectilinear section dominated about 77.5 percent of the total length of the slope, while convex and concave slope forms are conversely displayed at minimum.

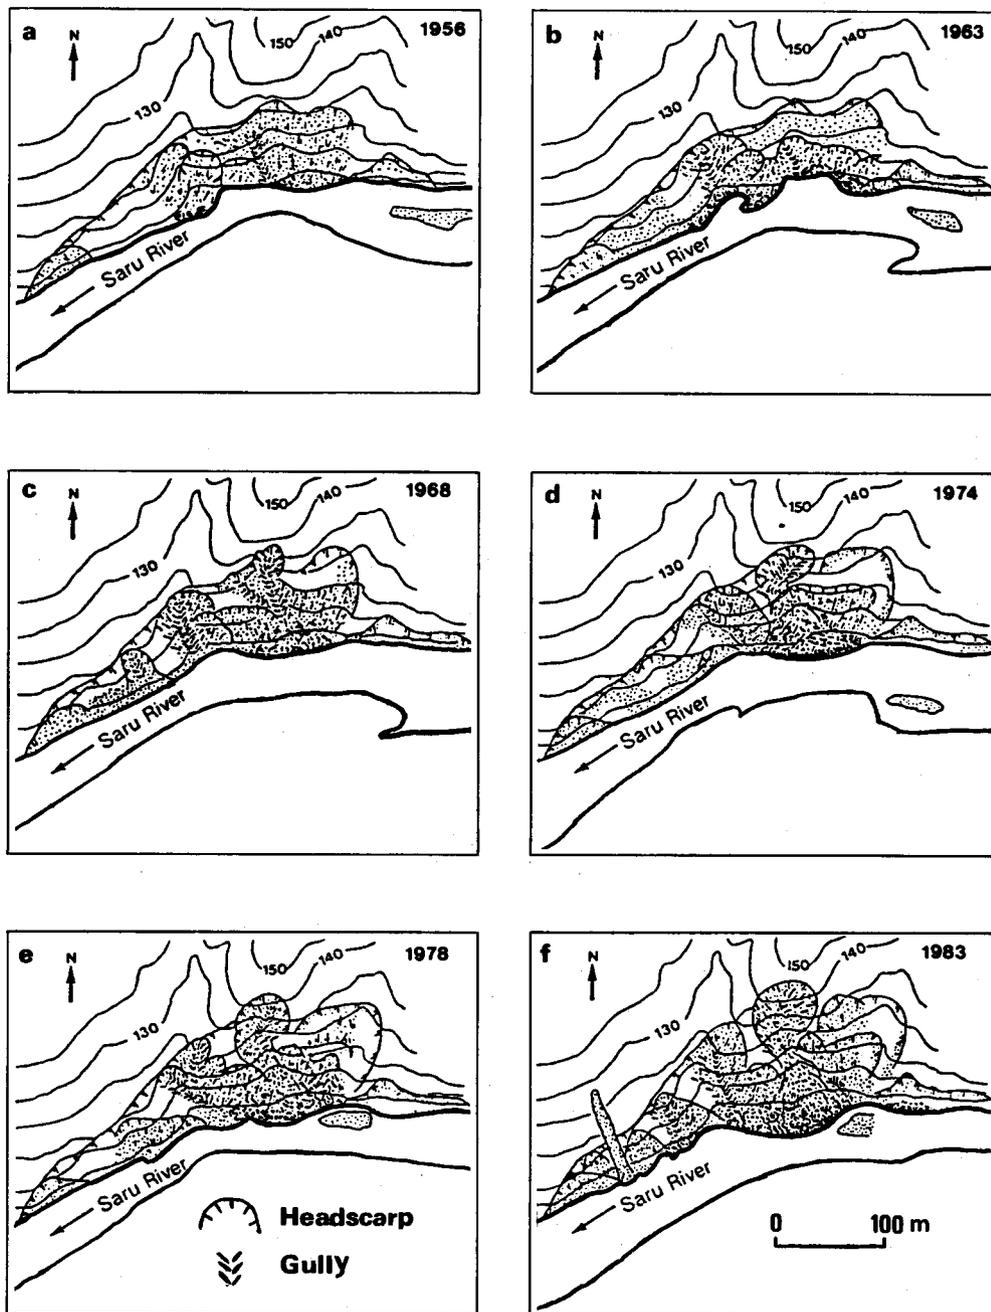
**Fig. 14.** Landslide scars based on the interpretation of the time-sequential sets of air photos (redrawn from Aipassa et al, 1990).

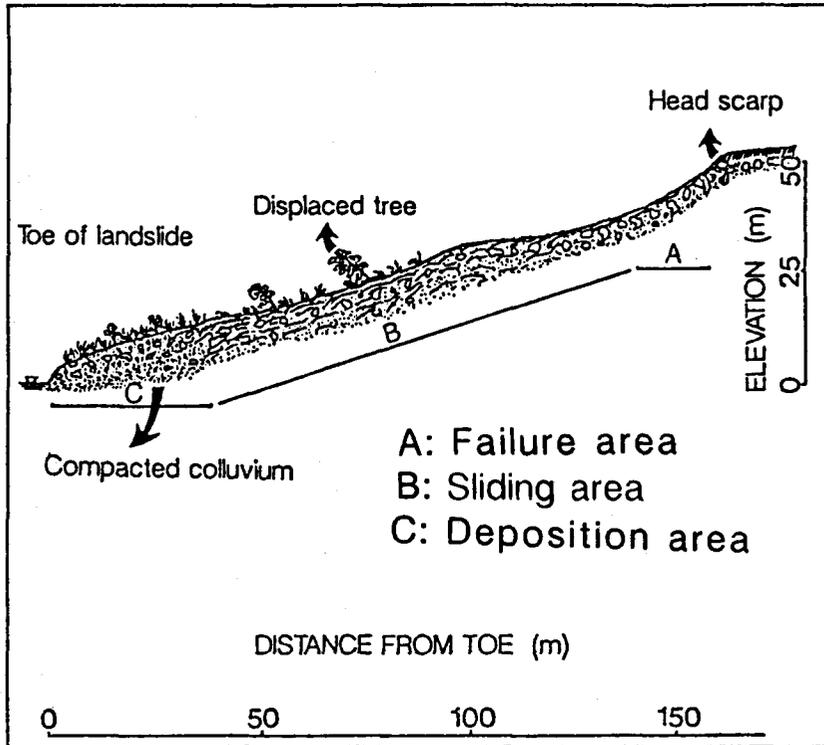
Fig. 15. Longitudinal profile of landslide scar, showing mass movement zoning (after Aipassa et al, 1990).

In the sense of debris movement and of slope morphology, at least three definite areas of landslide scars could obviously be distinguished as the failure area, earth flow area and deposition area (Fig. 15). The failure area is mainly located on the upper slope froming a concavity plane. In the area of the largest deep-seated landslide, the failure area might have reached an area of about 0.3 hectare with a 40 meter failure-plane length. Cliff became gradually steeper as the scar overtopped, dipping at an inclination of around 43 degrees. The steep-sided inner scar reached a maximum depth of 5 meters, and it consisted of 4 meters of thick sandy soil and a meter thick upper and lower layer of stratified gravels, respectively. Deep gullies, swales and scarps were formed in this area. In the earth flow area, many young pioneer tress were displaced by the active flow which was generally accelerated by the increased water content of the mass during heavy rains or by the thawing of snow cover. This area can be classified as a creeping area since the debris movement in this area is relatively higher than the other areas.

The maximum length of the earth flow area was about 80 meters. The landslide

debris was transmitted through the earth flow area and finally accumulated in the deposition area as a gentler slope located at the foot slope, forming a terraced-shaped talus, with some of the debris blocking the adjacent main channel. The materials in this area consisted of compacted colluvial. The maximum length of this area was about 40 meters with a 16-degree average inclination. Most of this area have been covered with bushes and young trees invaded since the latest storm in 1981.

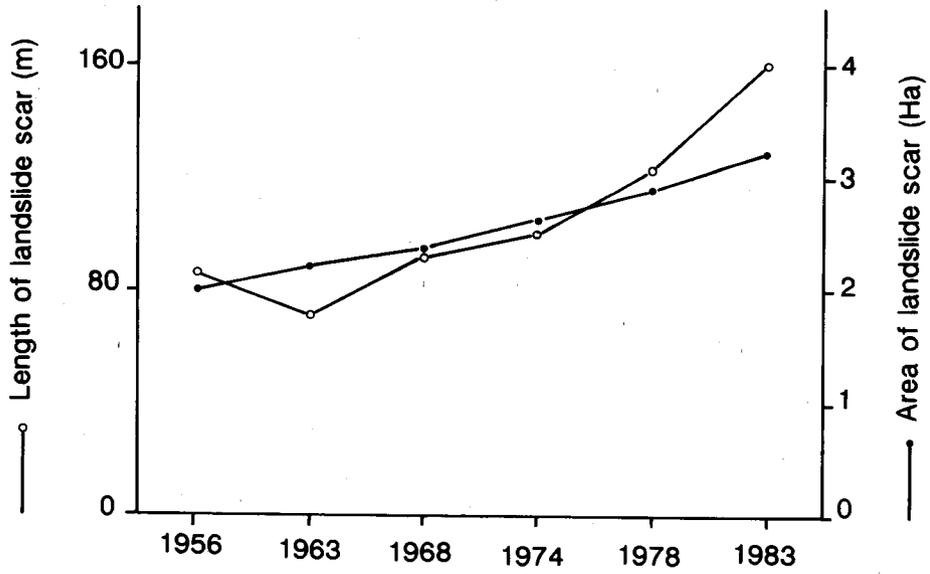
Fig. 16. Curve of extension and enlargement of landslide scar.

Voluminous debris was produced by deep-seated landslides which occurred in 1961 and 1962. The length of the main scar was about 72 meters, being shorter than the previous one (Fig. 16). This might be caused by the intense lateral erosion of the river which washed out a large amount of either the previous debris perched on the foot slope or the debris produced during these times.

The scar became longer (92 meters) after the landslides during the single storm of 1966, causing the expansion of the upper scar and the extension of the foot slope. It was found that although the amount of failure debris was smaller than of the previous debris (1961, 1962), the area of talus on the foot slope was 6 times larger than former one.

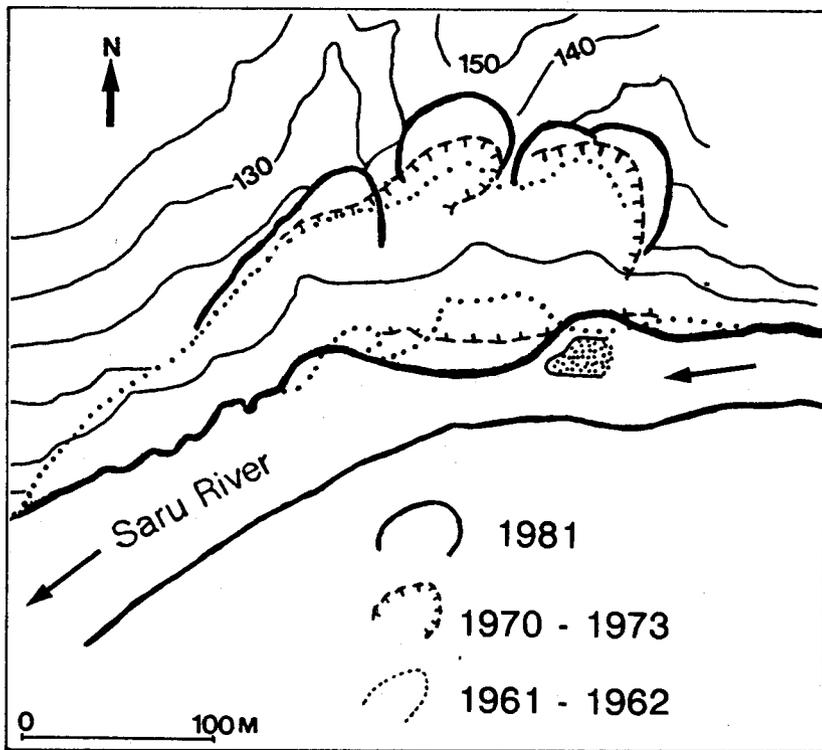
Fig. 17. Expansion of headscarp and extension of footslope by successive landslides (redrawn from Aipassa et al, 1990).

of successive heavy rains (1970, 1973, 1974, 1975) is shown in Figure 17. Duplication on the same plane with upper slope expansion and overlap to the adjacent plane were found during the storms of 1966, 1970 and 1973. Upper slope expansion was found to be the most frequent type during the successive landslides and was the single type of landslide recurrence in 1961 and 1962. These successive landslides caused the length of the main scar to gradually become longer and longer. The landslide debris, moreover, accumulated on the foot slope, moving rapidly into the main channel during the landslides occurrence without the intense lateral erosion.

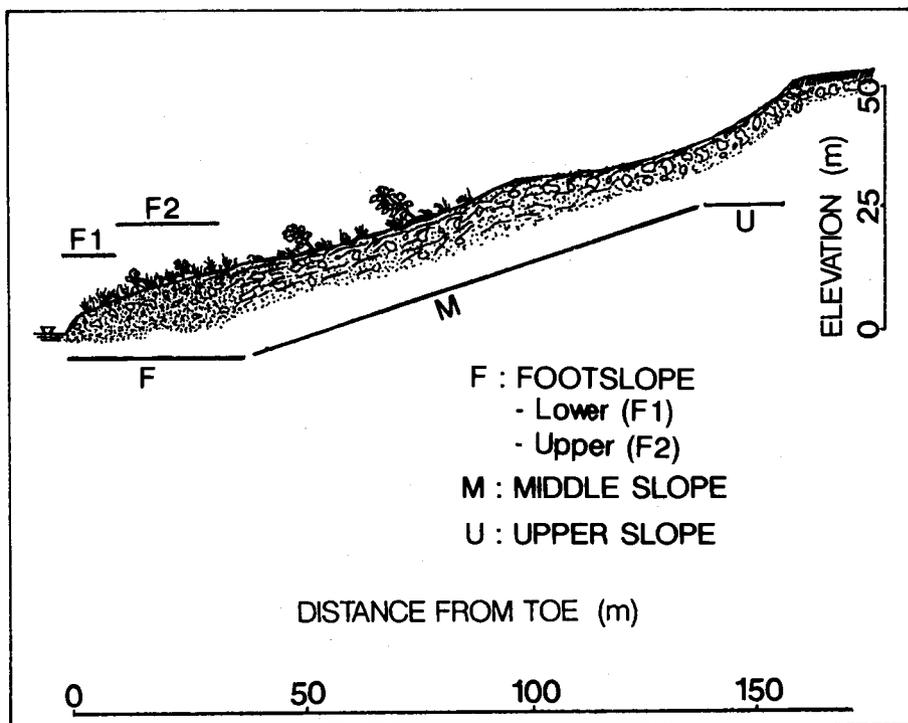
Fig. 18. Position of stakes embedded on landslide scar to measure soil creep in the Saru River Basin.

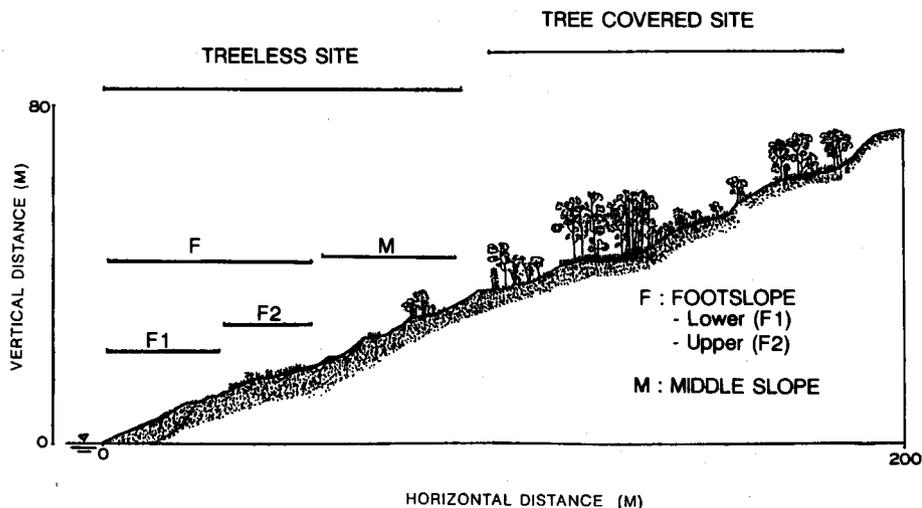
Fig. 19. Position of stakes embedded on landslide scar to measure soil creep in the Mukaihassen River Basin.

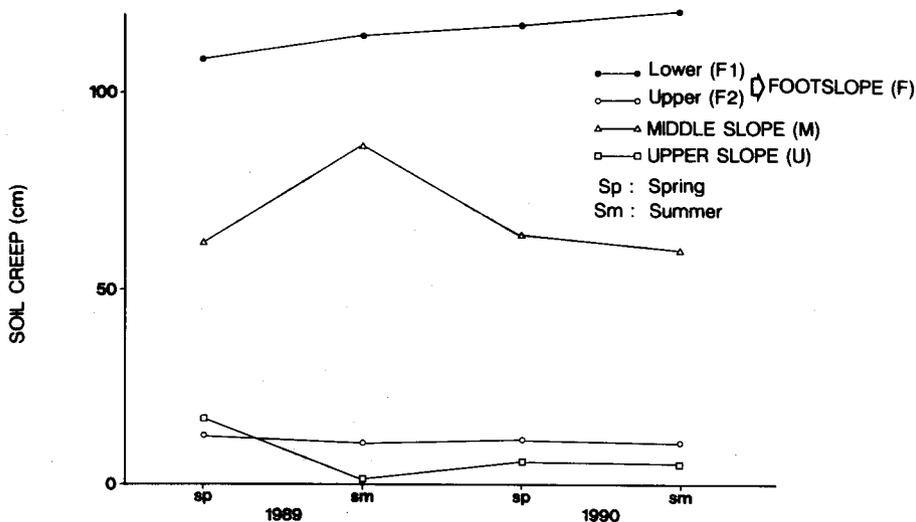
Fig. 20. Soil creep measured on landslide scar in the Saru River Basin.

Figures 20 and 21 present the values of soil creep. It was found that the soil creep in the sites in contact with the river channel (F1) was relatively higher than that of the sites not in contact with the river channel both in the two investigated sites. It was suggested that these sites might be subject to higher pore pressure either from river flow power or

upslope seepage forces. In the middle slope sites (M), soil creep was found to be higher than that of the sites just near the river bank (F2). These sites are usually filled with a huge colluvium deposit from the collapsed area and are the deposit transmitting sites to the downslope site which may also be periodically active erosive debris sites. In the debris depositing sites (F2), soil generally undergo a compaction which proceeds at much lower value of creep. Unlike in the river bank and middle slope sites, sites just near the river

It was found that the values of soil creep on each site of slope measured in the Saru River Basin was relatively constant, while in the Mukaihassen River Basin soil creep values fluctuated all along the measured periods. High values were seen during summer (rainy seasons) in the Mukaihassen River Basin. Water action is intermittent and is really effective only during and after prolonged or heavy rainfall or when thawing of snow cover takes place. Complete water saturation by heavy rains might greatly increase the value of soil creep and might lead to a sudden and even catastrophic displacement of overlying debris on slope.

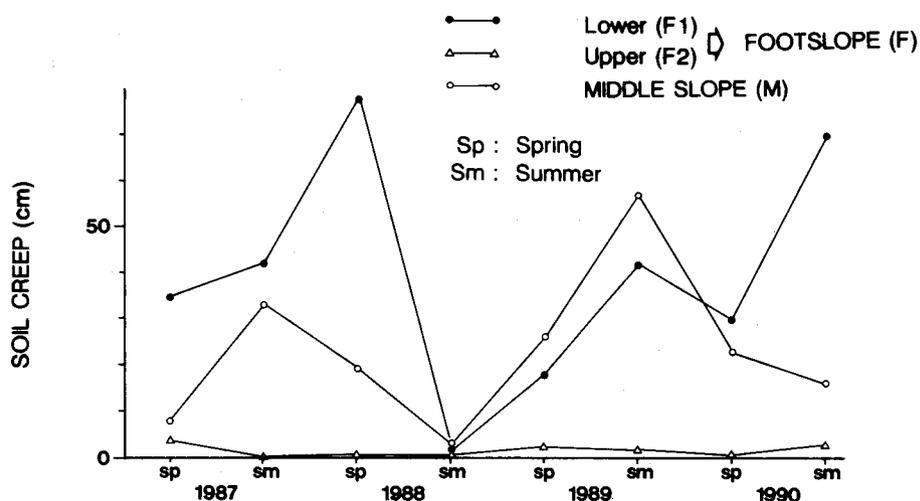
Fig. 21. Soil creep measured on landslide scar in the Mukaihassen River Basin.

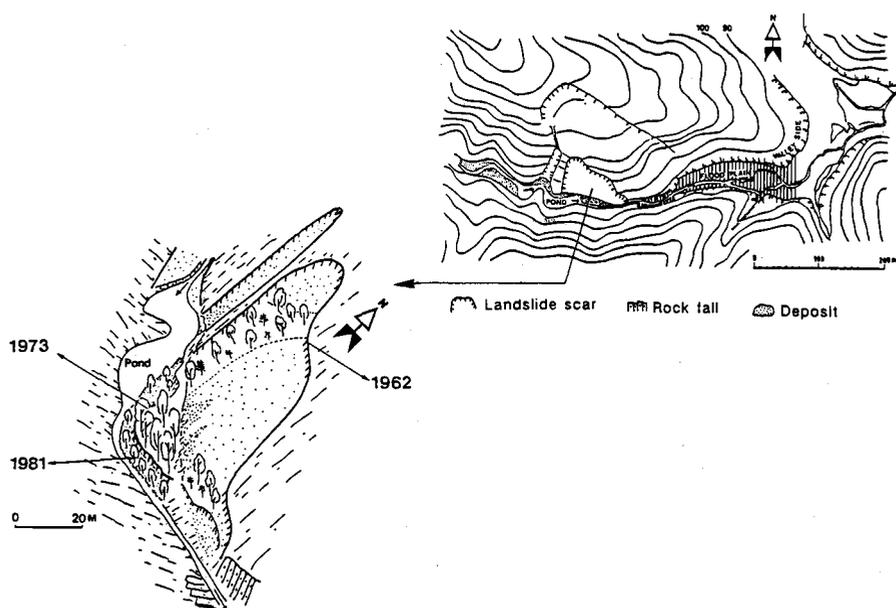
Fig. 22. Dating of landslide occurrence by means of tree rings analysis (redrawn from Aipassa et al, 1990).

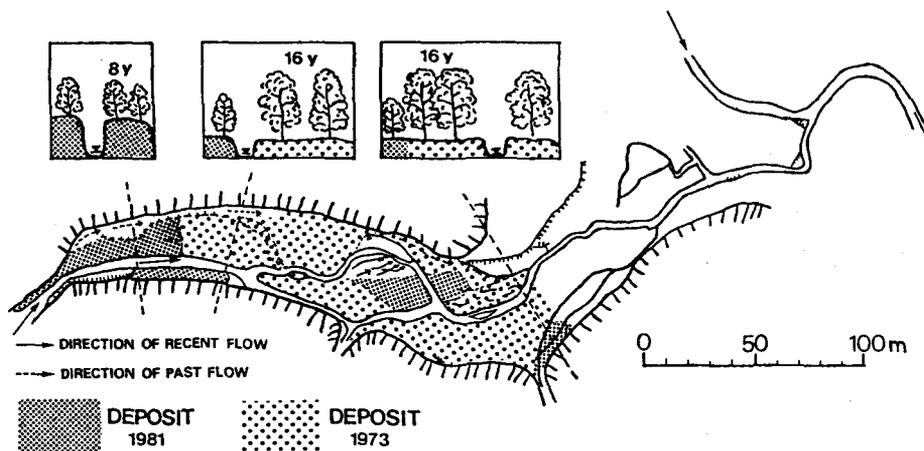
Fig. 23. Distribution of deposit on overloaded channel, based on tree age (after Aipassa et al, 1990).

The higher area was covered by a thicker newer deposit. This area was established primarily as a deposit bedding above the water level. The surface material of this area was finer and gradually grew coarser vertically approaching the water level.

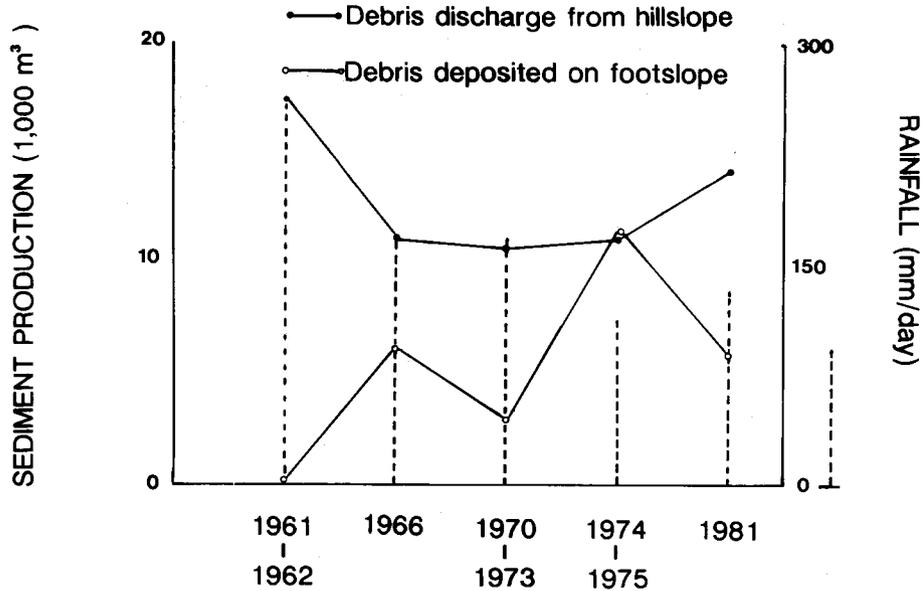
Fig. 24. Relation between sediment production and rainfall.

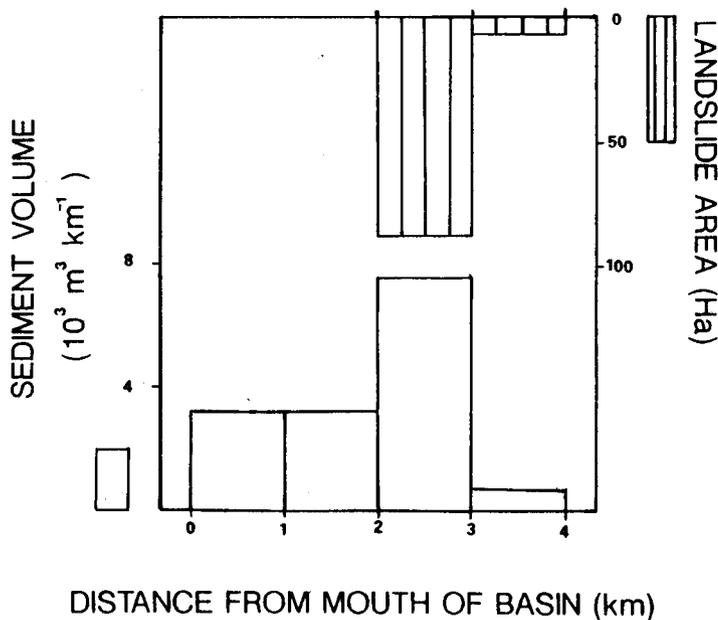
**Fig. 25.** Relation between sediment volume and landslide area.

a variety of features in each zone. Figure 25 shows the relationship between sediment volume and landslide area along river basin.

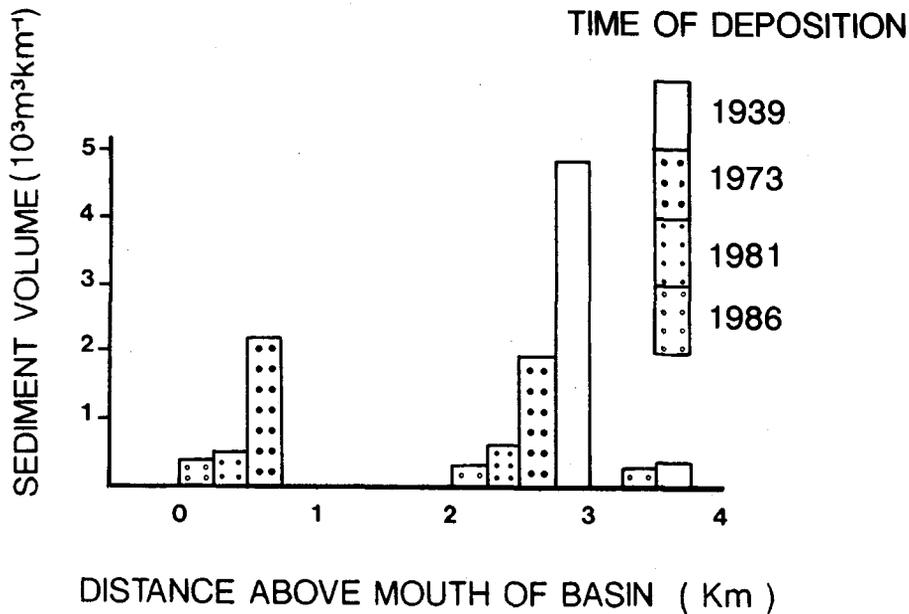
Fig. 26. Distribution of sediment stored in channel, based on age.

Figure 26 shows the distribution of sediment deposit stored in the river channel, based on age of sediment. It was recognized that at least four groups of sediment of different ages were stored in the river channel. In the middle reach, the older deposits (51 y and 17 y) were predominantly stored. Figure 27 displays the schematic river channel and deposition profile observed in the middle and lower reaches of the Mukaihassen River. Most of the sediment deposit formed higher terraces at the out point of river bed near the valley site, while the 17 years old deposit filled continuously at the face sites of the oldest deposit forming a relatively thinner deposit bedding. The 17 years old deposit was found to be the oldest deposit and the highest in volume in the lower reach. This deposit was located at the out point of river bed like the oldest deposit in upper stream. No 51 years old deposit was found in this zone. The younger deposits (9 y and 4 y) were scattered in these two zones. The oldest deposit stored in this zone was thought to have been supplied

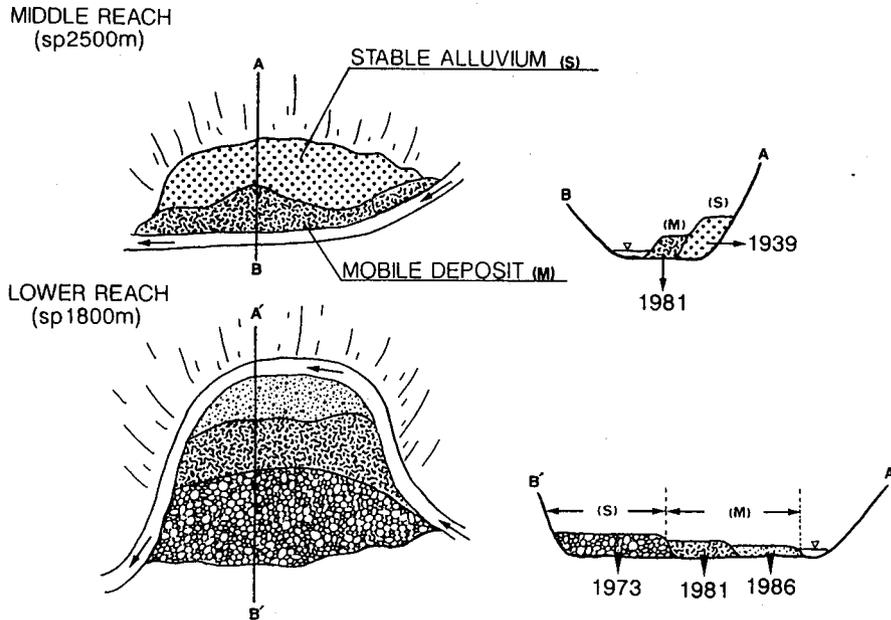
Fig. 27. Schematic river channel and deposition profile in the middle and lower reaches of the Mukaihassen River.

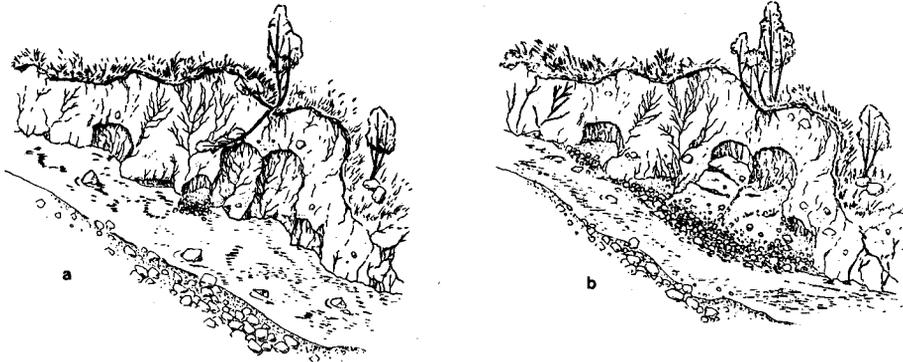
Fig. 28. Illustration of channel response to landslide debris in torrential river (after Aipassa et al, 1990).

When the capacity of the river flow to remove the landslide debris from hillslope is relatively higher, substantial widening of the valley floor could result (Fig. 28a). This phenomenon can be clearly seen in the Saru River Basin during the major sediment transporting events (1961 and 1962). The failure of foot slopes and the extreme bank erosion was found to have occurred during these torrential rains. We found no significant

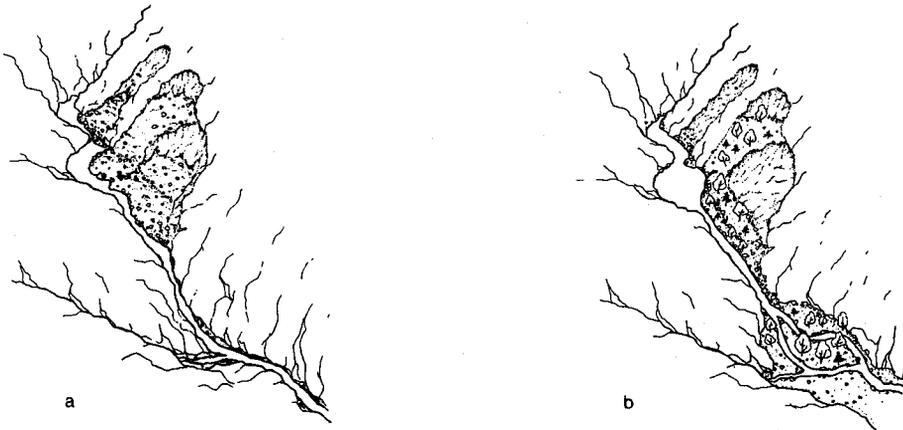
Fig. 29. Illustration of channel response to landslide debris in placid river (redrawn from Aipassa et al, 1990).

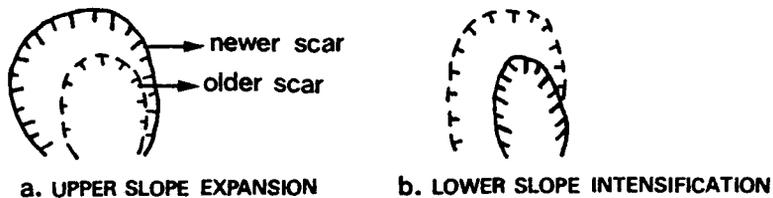
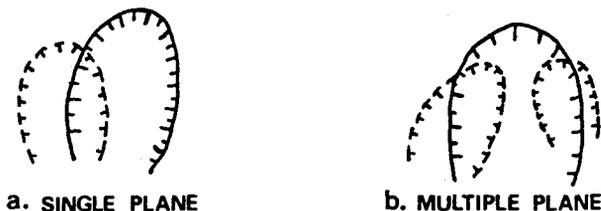
### 1. Duplication on the same plane

### 2. Overlap to the adjacent plane

Fig. 30. Repetition types of landslide (after Aipassa et al, 1990).

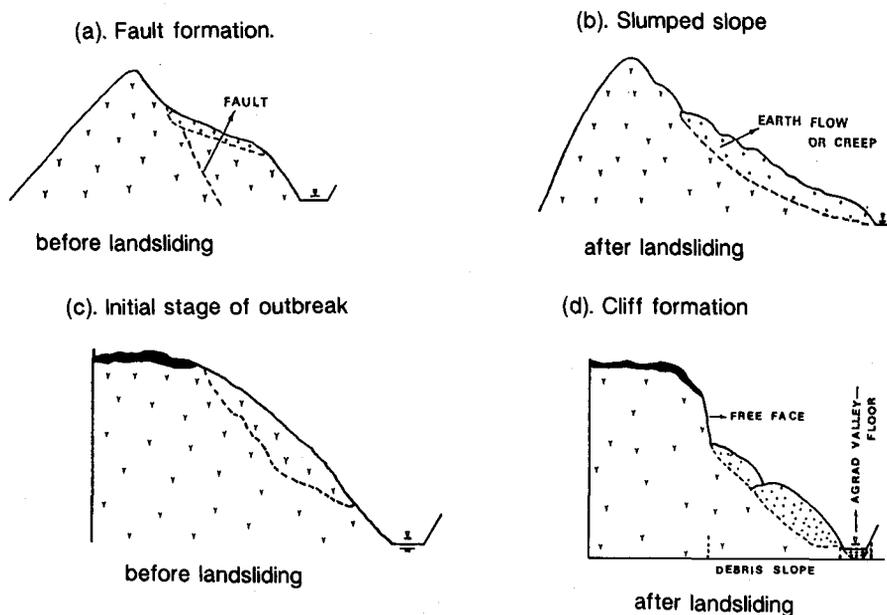
Fig. 31. Slope changes by landsliding in serpentine and mudstone areas.

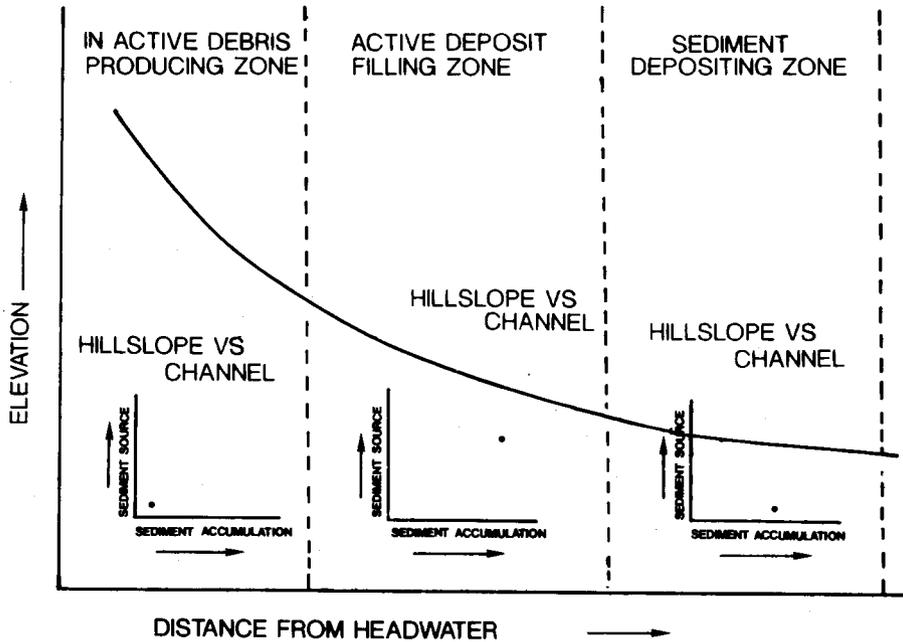
Fig. 32. Diagram showing geomorphic processes on segments of river basin.

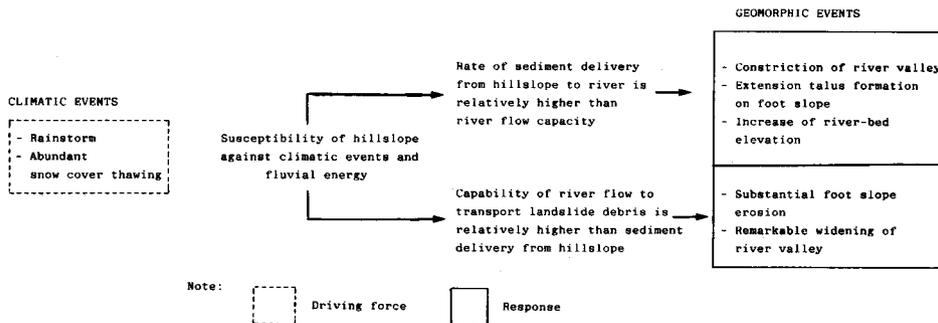
Fig. 33. Conceptual model for river change due to landslide debris movement.

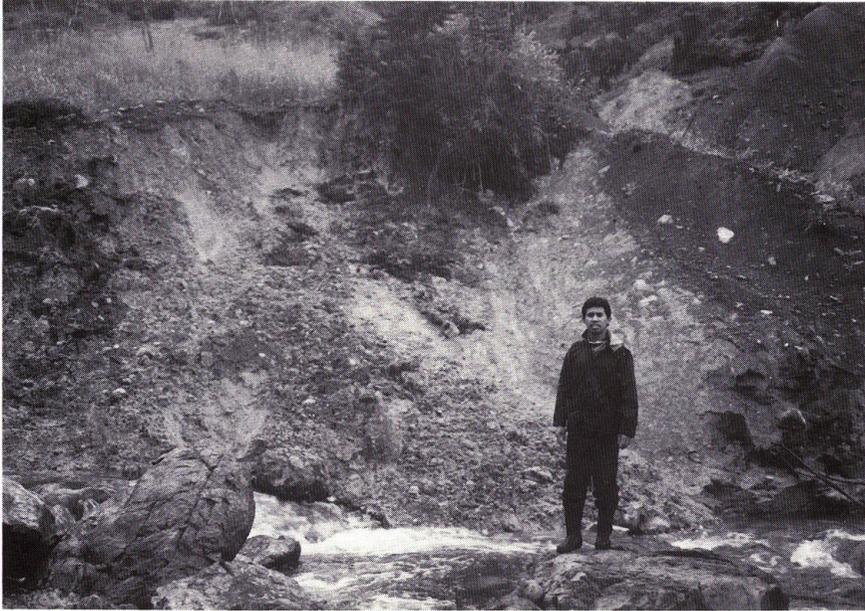
**Photo 3.** Earth flow developing from a landslide scar in the Mukaihassen River Basin. October 1990.
