| Title | 1977-1978噴火後の有珠山における侵食と泥流（1977年8月～1979年12月） |

## Erosion and Mudflows at Usu Volcano after the 1977-1978 Eruption : August 1977-December 1979

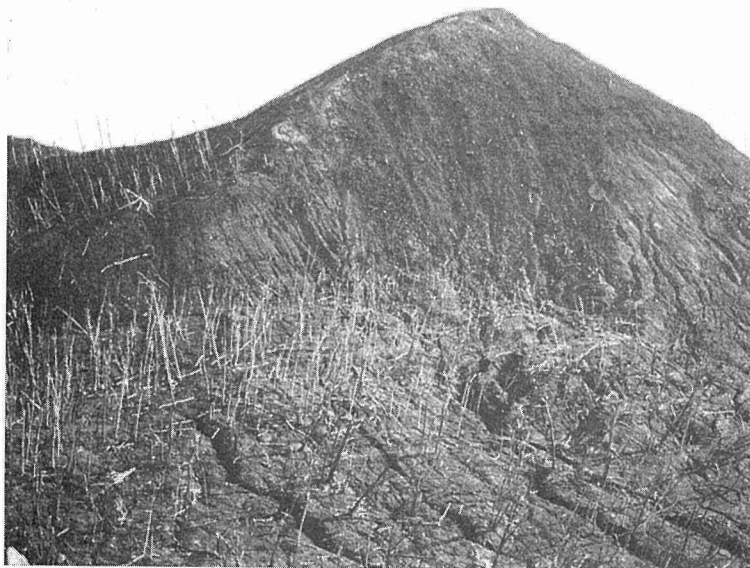
**Photo 1.** Forest vegetation in the summit atrio was completely destroyed by air-fall pumices and volcanic blocks and bombs ejected during the First Stage eruption in August 1977. Backing hill is a New Mountain (cryptodome) upheaved due to the rise of subsurface magma body underneath the atrio, accumulated upheaval reaching 120 m up to July 1979.

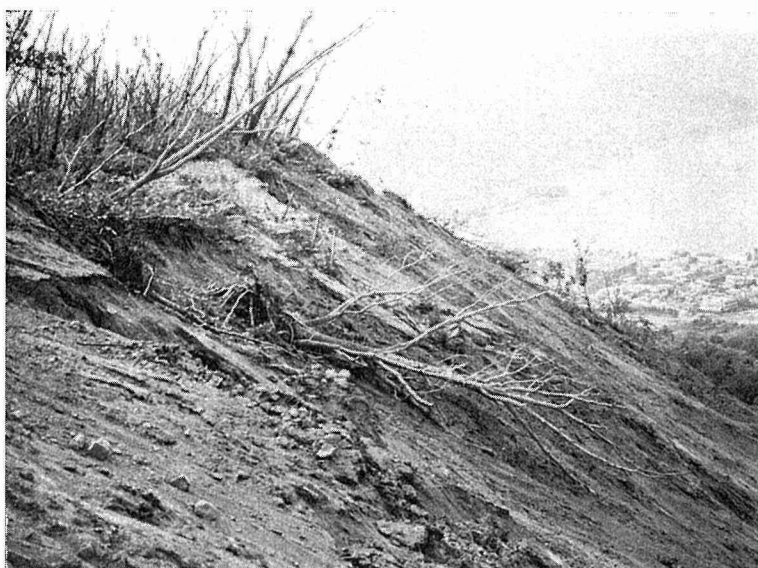
**Photo 3.** Close up of deformed uppermost slope of the northern somma. On the right are Toyako-onsen spa and Lake Toya.  
*June 17, 1979. Photo by T. Imagawa.*

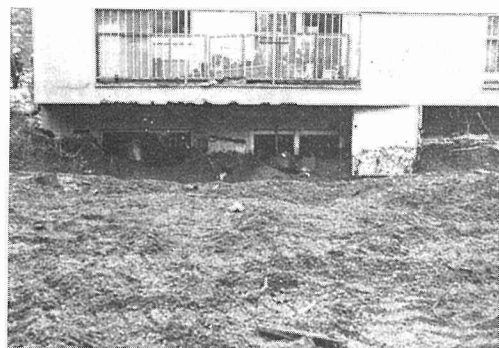
**Photo 8.** The ground floor of a three-storied apartment house, which is seen in the rearmost right in Photo 7, was penetrated and completely buried by the mudflow of new tephra with a depth of more than 2.5 m.

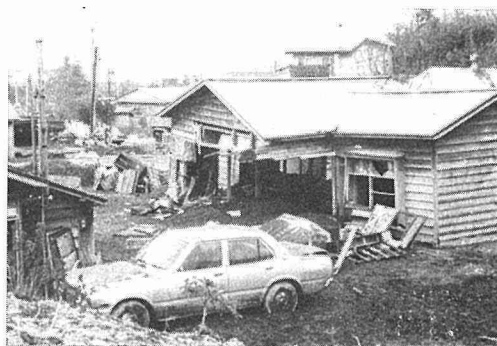
**Photo 9.** A wooden house almost completely destroyed by the mudflow of October 24, 1978, near the apex of R. Nishiyama alluvial fan.

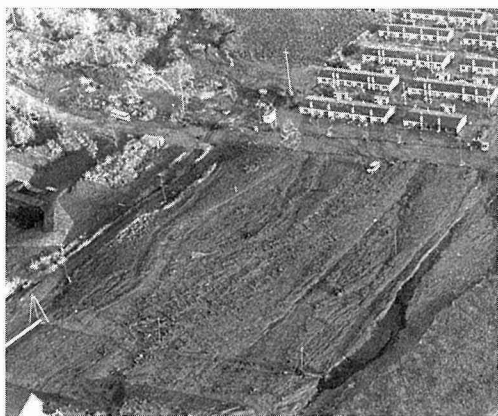
**Photo 11.** Trace of the rocky mudflow of October 24, 1978 on the upper part of alluvial fan of Sobetsu-onsen. Most of houses in the upper right were inundated by the flood of mud. October 25, 1978. *Curtesy Disaster and Fire Prevention Section of Hokkaido Government.*

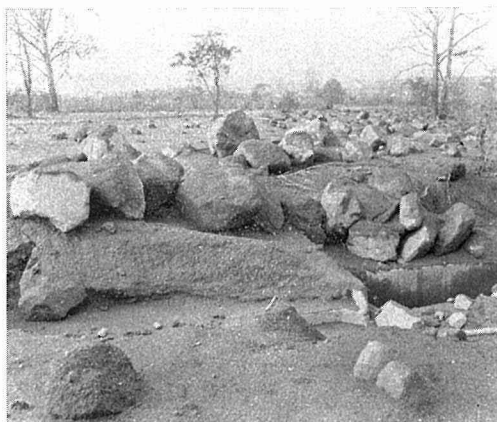
**Photo 12.** Boulders of lava which were derived from scouring of former valley fill in the upstream spread onto an alluvial fan of R. Izuminosawa, southwest foot of the volcano. October 26, 1978. *Curtesy of Publicity Section of Hokkaido Government.*
