## Conversion of Old Buildings into Reuse in Historic Quarters

Mitsuru MORISHITA and Fujio ADACHI

### Abstract

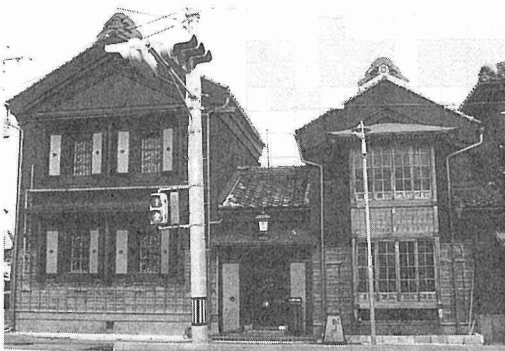
Facade of “Dozo” style

**Photo 1** Coffee shop (formerly a storehouse of “Dozo” style)

wall. As for the interior, half of the floor has been removed on the second floor, and has been remodeled into a void. The wooden roof truss and large beams have been exposed to emphasize the solid and strong characteristics of the storehouse. The void space emphasizes the impression of the large volume in the interior space (Fig.3, Photo.1).

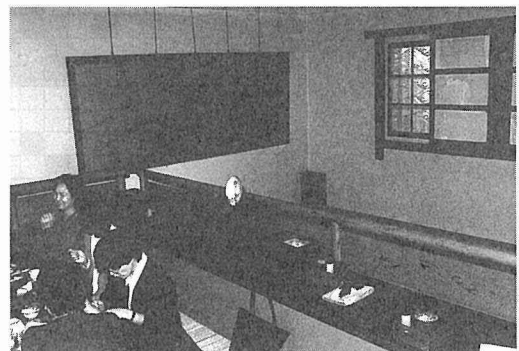
Interior of the second floor with void space

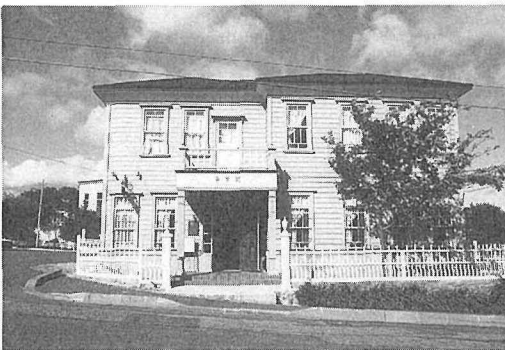
Facade of western style. A porch was provided

**Photo 2** Atelier and coffee shop (formerly a medical office and a dwelling house)

This is an example of a typical western style house with the wood-siding, and double-hung windows. This was converted into a coffee shop on the first floor and an atelier on the second floor from a medical office and dwelling was built in 1922. The total area is 220m<sup>2</sup>. The interior was renovated to give the building a new life ; on the first floor, large space for a coffee shop was installed by reinforcing with two columns and removing other columns. A porch and the parking lot were provided ; on the second floor, the partition wall was changed and all rooms were renewed. A part of the exterior was remodeled, the balcony restored, and a fence was added. The characteristic of the typical western style house is maintained, though both the interior and the exterior were remodeled (Fig.4, Photo. 2).

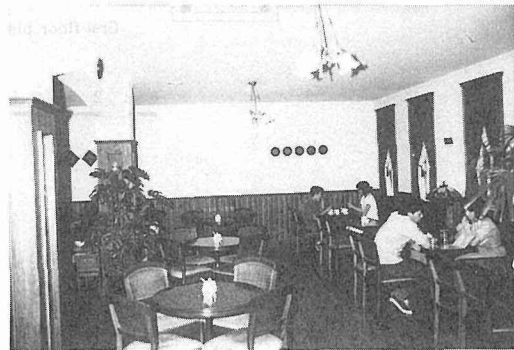
Coffee shop in the first floor. Large space was installed by reinforcing with two columns and removing other columns

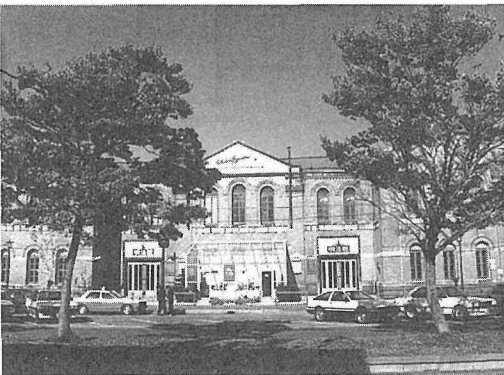
Facade on boulevard

**Photo 3** Complex of studios, restaurants, shops and offices (formerly a post office)

complex of studios, restaurants, shops and offices by a group of eight young craftsmen. The interior was renovated and remodeled for reuse. Partition walls were rearranged, the second floor deck around the central square was installed, a new roof truss at the top of the void on the square was constructed. This square with a glazed roof is literally designed as the central space of the building. The exterior, though the openings were installed and the approach was changed, retains the historical characteristics (Fig.5, Photo.3).

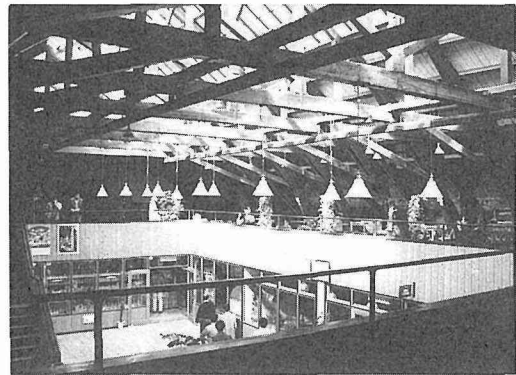
A deck around the central square, a new roof truss at the top of the void space

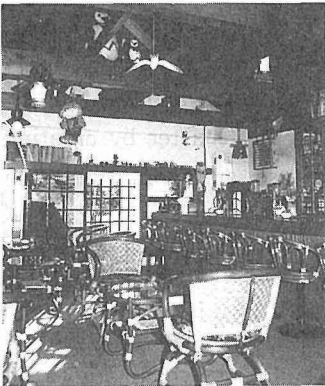
**Photo 4** Exposed large beams.  
It is difficult to obtain these materials and space structure in new buildings.

- 1) Creating original and diverse spaces ; Large columns and beams, large volume in the interior space, etc. ; these materials and space structure in new buildings (Photo.4) are hard to obtain. In an example of the conversion into an art gallery from a storehouse with solid and strong characteristics, a tearoom was constructed with slender steel columns and beams, and transparent glass. These had a strong effect by contrast between solid and light, old and new (Photo.5). The unexpected and surprising conversion, is a hotel from a bank, a "secular" coffee shop from a "holy" church (Photo.6). In all case the original and diverse spaces were created.
- 2) Putting the building to a public use ; The conversion into tourist facilities of hostels, coffee shops and shops from dwelling houses and storehouses may mean in a sense a change

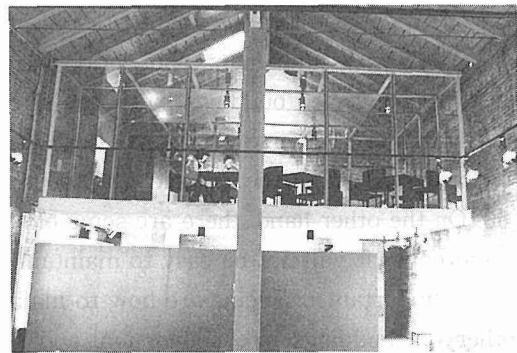
**Photo 5** Conversion into an art gallery from a storehouse with solid and strong characteristics. A tearoom was constructed with slender steel columns and beams, and transparent glass. Contrast between solid and light, old and new

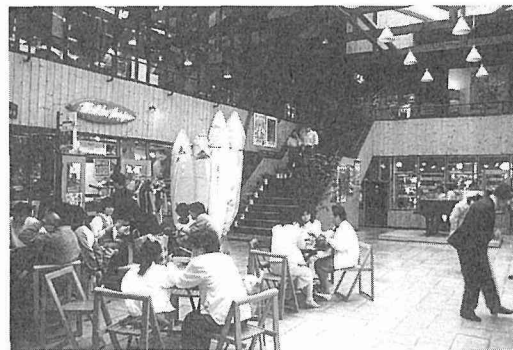
**Photo 7** An inner large space was remodeled into a square space, and a place for meeting was created

of utility of the building from individual use to public use. As an example, an inner large space was remodeled to serve as a square space, and a place for meeting of persons was created (Photo.7). These offer richness to life space, especially to the surroundings.
