| Title | DIAGNOSTICS OF STEEL ROOF STRUCTURES OF SPORT STADIUMS |
| Description | The Thirteenth East Asia-Pacific Conference on Structural Engineering and Construction (EASEC-13), September 11-13, 2013, Sapporo, Japan. |

# DIAGNOSTICS OF STEEL ROOF STRUCTURES OF SPORT STADIUMS

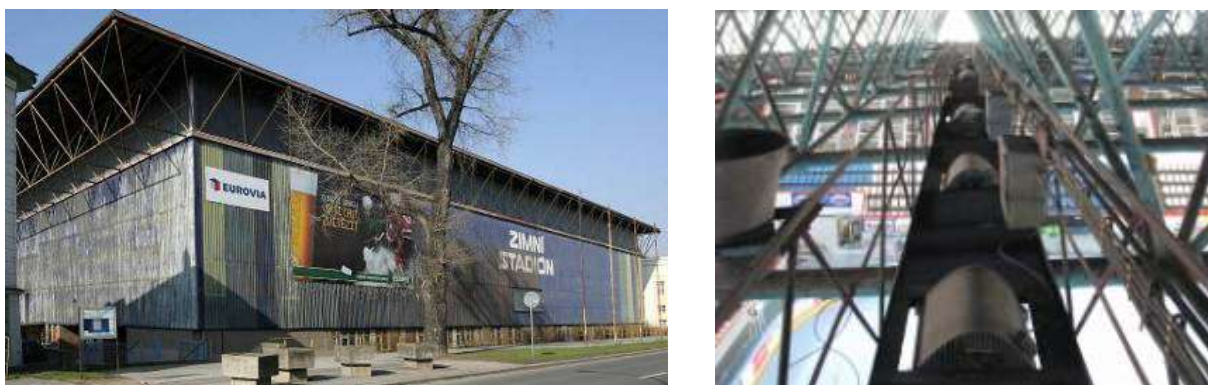
**Figure 2: Winter sport stadium in Olomouc city – overall view and roof structural system.**

The roof structure of the winter sport stadium in the city of Olomouc is represented by the spatial truss grid consisting of circular tube members connected by the spherical joints. The scheme of the spatial truss grid of roof structure is drawn in Fig. 1 and the illustrations of the structural system real configuration are shown in Fig. 2. This stadium construction was realized in the period of 60<sup>th</sup> years of the 20<sup>th</sup> century, so that the age of all load-carrying structures is almost 50 years.

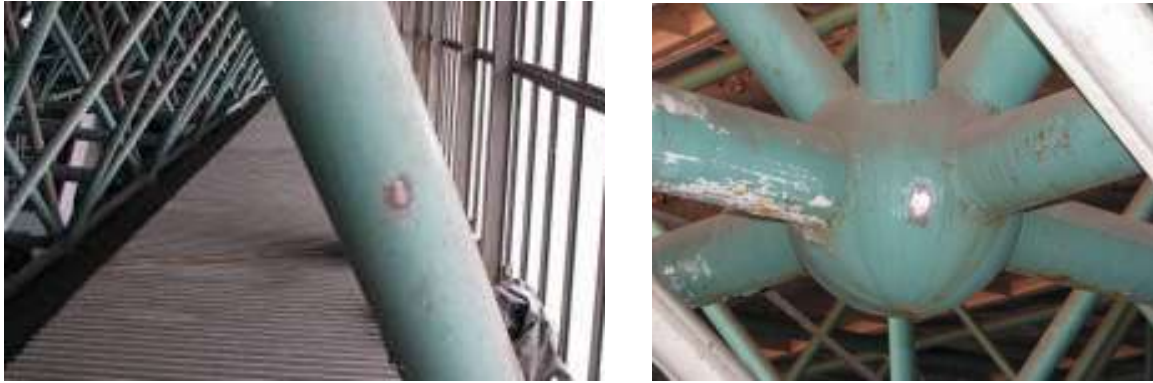
On each verified member 3 measuring bases have been prepared. Before measuring the colour layers have been removed and the surface has been aligned to be the smoothest (see Fig. 4, for example). On each measuring base of the area of  $30 \times 30$  mm, minimally 3 measurements of the wall thickness have been always performed and subsequently the mean values have been calculated.

**Figure 4: Preparation of surface of measuring bases on verified members.**

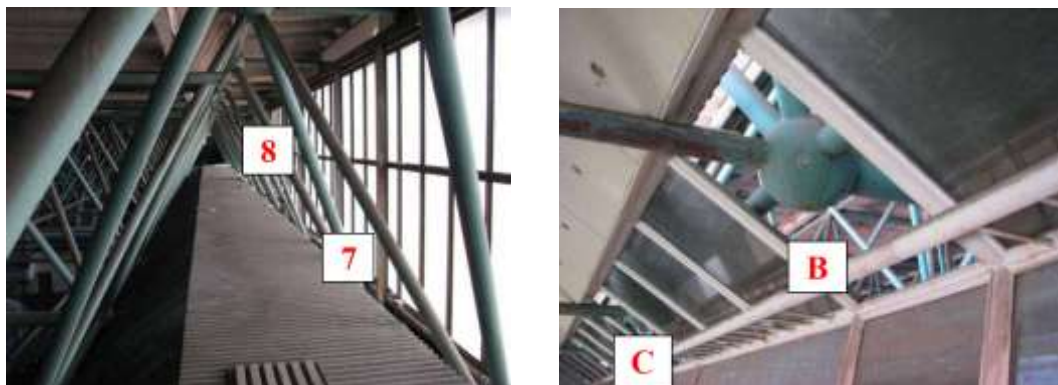
**Figure 5: Examples of verified members of tube diagonals and spherical joints.**

Illustrations of examples of verified members including measuring places are depicted in Figs. 5 and 6; the overview of the thicknesses measured is listed in Table 1; for more see (Láník 2012).

Using ultrasound device “SONIC 1 200 HR”, the thicknesses of the walls of selected statically important structural members of roof structure of the winter sport stadium in Olomouc city have been verified. Applying 10 MHz ultrasound probe and precise preparation of the verified members surface the measuring accuracy of  $\pm 0.4$  mm has been achieved. Based on the results of ultrasound measurement and available documentation of the roof structural system, it can be deducted, that the

actual thicknesses of particular selected members, which have been measured, correspond with the thicknesses mentioned in drawing documentation.

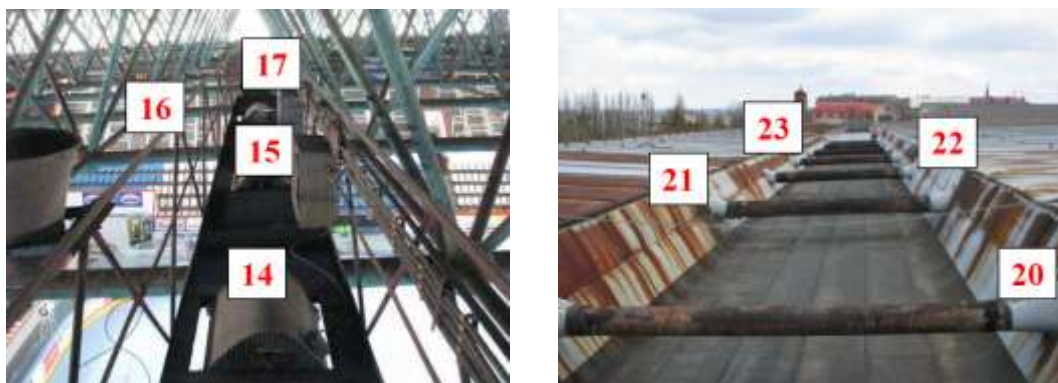
**Figure 6: Examples of verified members of tube lower chords and upper chords.**

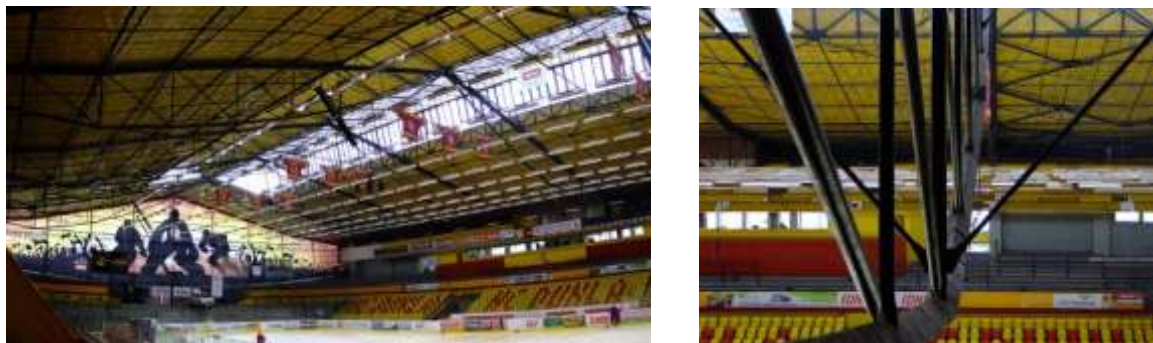
**Figure 7: Winter sport stadium in Jihlava city – roof structural system.**

The roof structure of the winter sport stadium in the city of Jihlava is composed as the member structure consisting of plane girders – garland truss main roof girders with ties, parabolic truss purlins and bracing system (see Fig. 7). The construction was built at the turn of the 60<sup>th</sup> and 70<sup>th</sup> years of the 20<sup>th</sup> century, so that the age of structures is about 40 years. The width and length of the roof structure in the plan are 60 x 100 m.

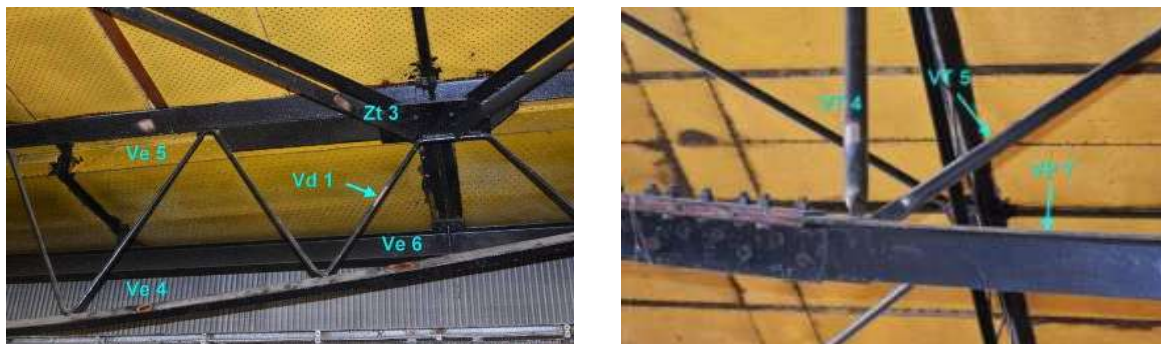
**Figure 8: Measured locations on purlin (Ve, Vd), bracing (Zt), main girder (VP, VT)**

The aim of tests performed was to verify steel properties in various members of the roof structure. According to the documentation, the material of the purlins chords (Ve) and bracings members (Zt) is steel of the grade of 11 353 (design ultimate strength is  $f_{ud} = 350 \text{ MPa}$ ), as well as steel of purlins diagonals (Vd). Further, according to that documentation, the material of main truss girders chords (VP) is the same steel of the grade of 11 523 ( $f_{ud} = 520 \text{ MPa}$ ), while the material of tube diagonals (VT) is steel of the grade of 11 373 ( $f_{ud} = 370 \text{ MPa}$ ). For purlins, bracings and main girders suitable locations have been selected to be covered almost of important members for the measurement (see Fig. 8). Following total numbers of locations have been measured: 7 locations on the chords and 7 locations on diagonals of main girders, 6 locations on the chords and 2 locations on the purlins diagonals and 3 locations on the bracings.

Material of the roof structure consisted of truss main girders, purlins and bracings can be classified as follows: steel of main girder chords can be classified like as current steel of the grade of S 355 corresponding with steel class of 52, steel of main girder diagonals is current steel of the grade of S 235 corresponding with steel class of 37 used in the period of structure realization; steel of purlins and bracings is current steel of the grade of S 235 corresponding with steel class of 37.
