| Title | DYNAMIC LOADING TESTS CARRIED OUT AFTER REPAIR WORKS OF THE YODOGAWA BRIDGE |
| Description | The Thirteenth East Asia-Pacific Conference on Structural Engineering and Construction (EASEC-13), September 11-13, 2013, Sapporo, Japan. |

# DYNAMIC LOADING TESTS CARRIED OUT AFTER REPAIR WORKS OF THE YODOGAWA BRIDGE

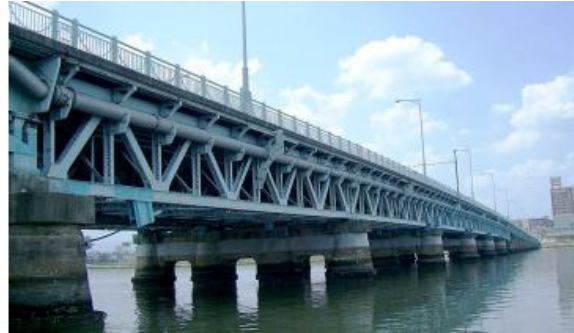
**Figure 1: Yodogawa Bridge.**

Yodogawa Bridge having a total length of 723.3m is composed by 30 spans, 6 of which are simply supported truss bridges with span length of 32.918m. Completed in 1926, the bridge is located on a heavy traffic route and underwent repair works after being severely damaged during the World War II.

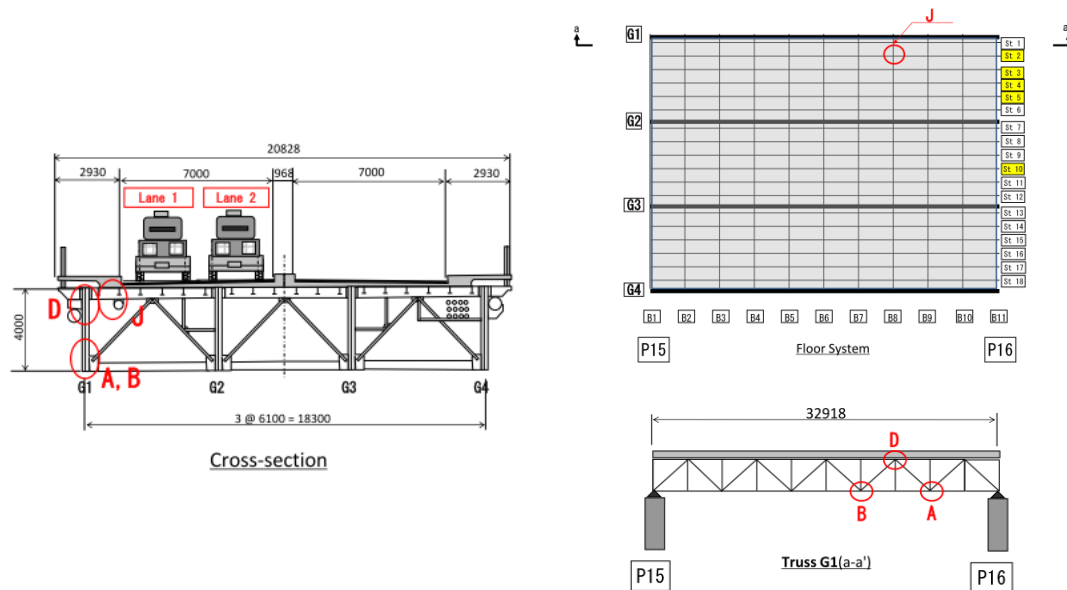
**Figure 2: Measurement points**

Based on the deterioration scenario obtained from the series of investigations carried out in 2011 (Natsuaki et al., Kohno et al., Ichinose et al., 2011), critical members were selected for repair and, after the execution of repair works, stress measurements were carried. Stress measurements were carried out through strain gages installed at the measurement points shown in Figures 2 and 3.

Dynamic loading tests were carried out by loading the test vehicle shown in Figure 4 on the two traffic lanes shown in Figure 2. The vehicle moved at a velocity of about 40 km/h and stress measurements were carried out at night when the number of vehicles crossing the bridge is relatively small and the influence of temperature can be considered small.

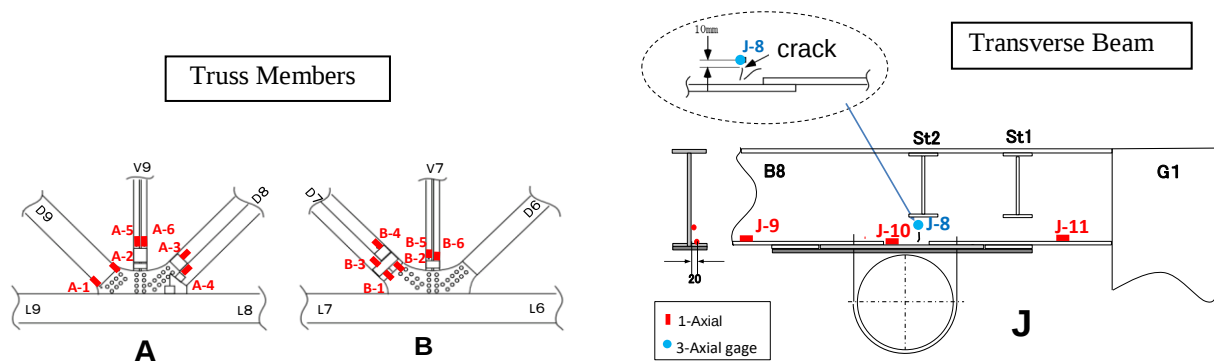
**Figure 3: Example of strain gage installation**

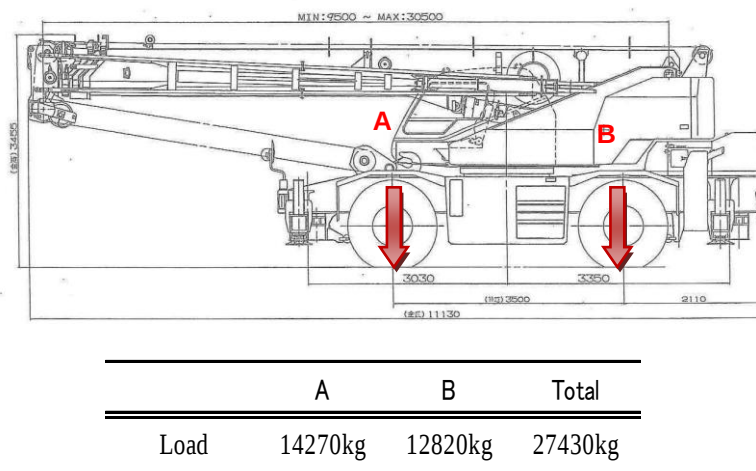
**Figure 4: Test vehicle**

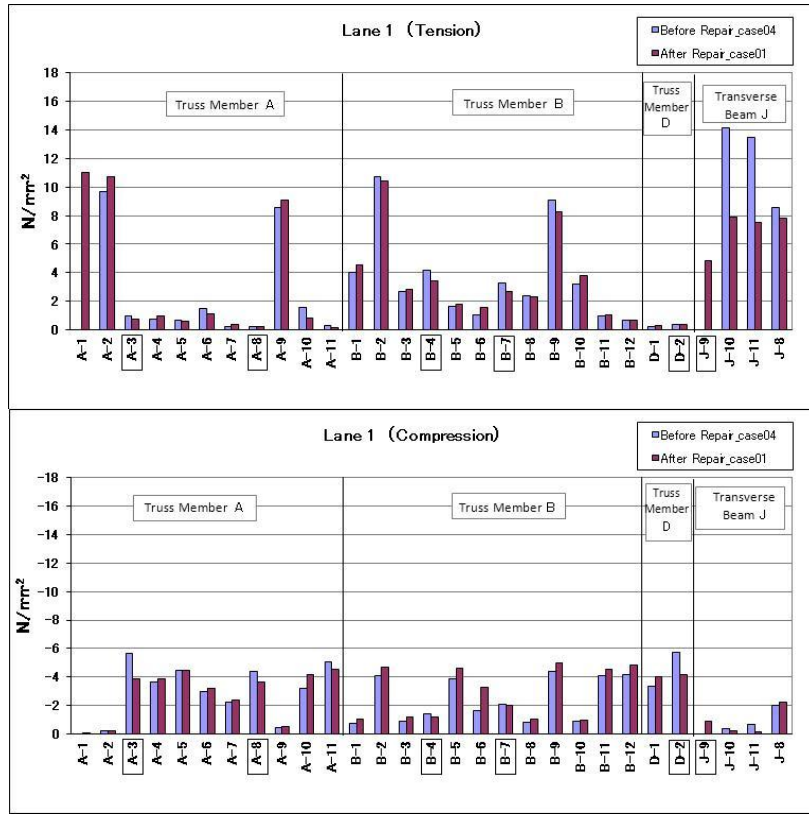
The results of the dynamic loading test, compared to the results obtained in measurements carried out before the execution of repair works, showed relatively small differences for stresses measured in the truss members, whereas considerable improvements were observed in the transverse beam stresses. Measurements results for lane 1 are shown in Figure 5. The figure presents the measured stresses for the structure before and after the execution of repair works. In particular, it was observed that stresses at the lower flange of the repaired transverse beam presented a considerable reduction of stress (about 40%) after being retrofitted.

Figure 5: Stresses before and after repair works (Dynamic loading test)

In the dynamic loading tests, stresses at the truss members did not present considerable differences compared to that measured before the execution of retrofitting works, whereas the stresses at the lower flange of the reinforced transverse beam presented considerable stress reduction (40%), proving the effectiveness of the retrofitting works.

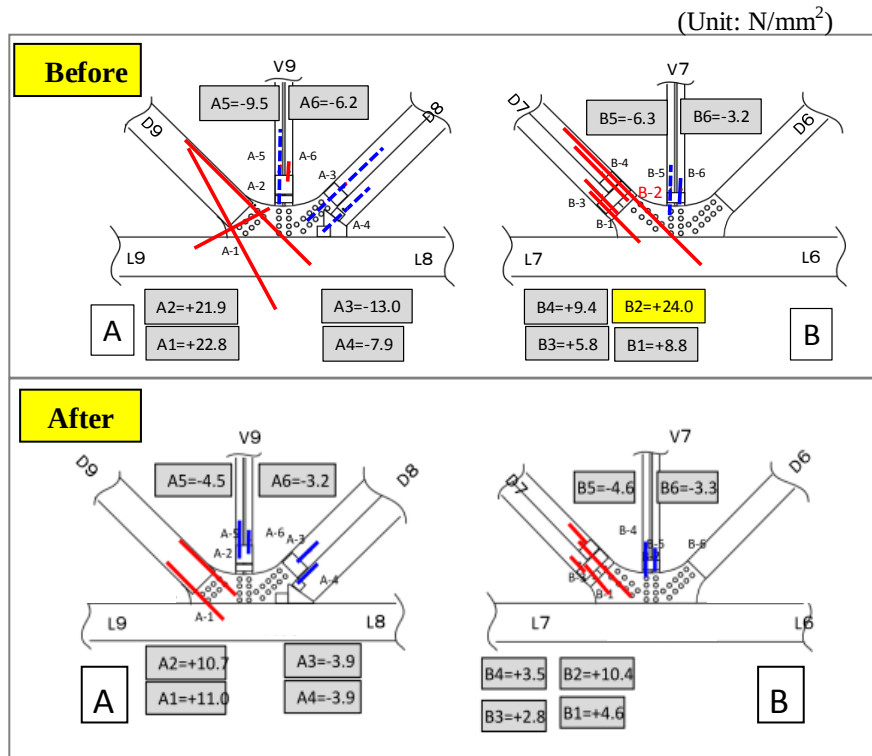
Figure 7: Stresses under traffic load before and after repair works (truss members)

The stresses measured during the 72 hours (3 consecutive week days) presented relatively small values, being most of them within the fatigue limit. Maximum stresses observed in truss members and transverse beam during the measurements are shown in Figure 7 and 8, respectively.

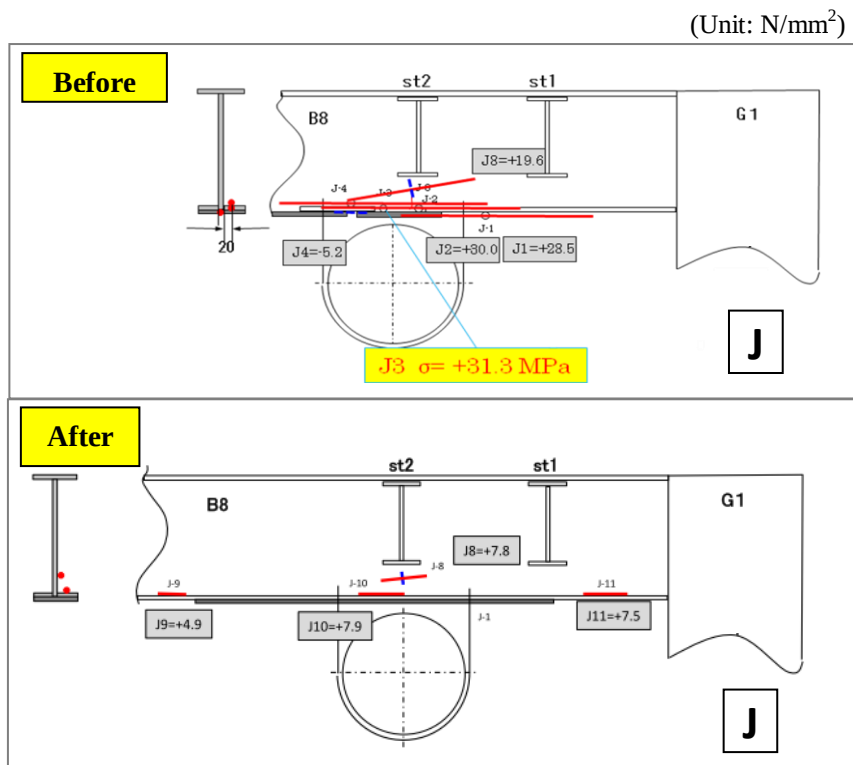
Figure 8: Stresses under traffic load before and after repair works (transverse beam)

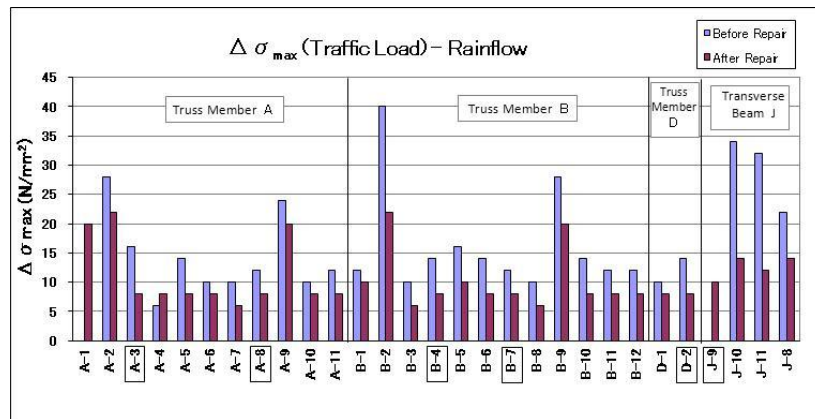
Under traffic load, stresses were considerably improved in both truss members and the transverse beam, what can be also seen in Figure 9 which shows a decrease in the stress range ( $\Delta\sigma$ ) after the execution of repair works for almost all the measurement points. The transverse beam, in particular,

had its predicted fatigue life extend to more than 10 times of that of before the execution of repair works.

**Figure 9: Maximum stress range before and after repair works (Traffic load)**

Measurements carried out under traffic load showed improvements in the stress range for almost all the measurement points. However, the fatigue life obtained based on these measurement results did not show dramatic changes in the fatigue lives of most measured members, except for the lower flange of the retrofitted transverse beam, which presented a fatigue life improved to 10 times of that of before retrofitting .
