# DEGRADATION OF LOAD-CARRYING CAPACITY OF STEEL I-GIRDER END DUE TO CORROSION

E. YAMAGUCHI\*, and T. AKAGI

*Department of Civil Engineering, Kyushu Institute of Technology, Kitakyushu, Japan*

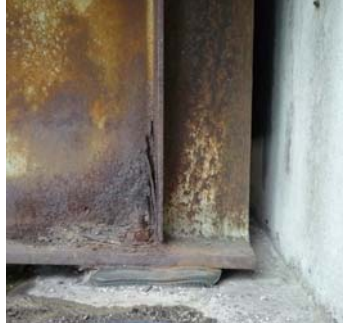
The waterproof function of an expansion joint is quite susceptible to damage due to impact loads of moving vehicles. Therefore, water leakage from the expansion joint is often found, leading to the corrosion environment near the girder end. As a result, more corrosion problems occur near girder ends than in the other parts. Photo 1 shows an example. Clearly observed is the thinning of the transverse stiffener at the bearing.

**Photo 1: Corrosion of transverse stiffener.**
