| Description | The Thirteenth East Asia-Pacific Conference on Structural Engineering and Construction (EASEC-13), September 11-13, 2013, Sapporo, Japan. |

# STRENGTH EVALUATION FOR A CORRODED DAMAGED STEEL GIRDER END CONSIDERING ITS COLLAPSE MECHANISM

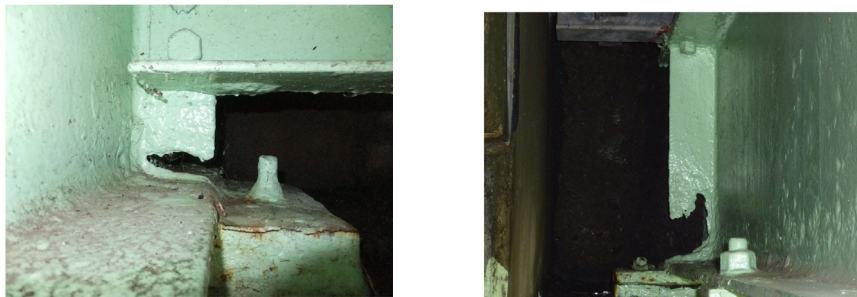
**Figure 1: Examples of corroded girder ends**

In recent years, it has been well known that some of steel bridges are deteriorated by corrosion at the girder ends as shown in Figure 1.

These are caused by stagnant water and sediment deposition due to water leakage, such as salt-laden from the expansion joint and airless environment. Various studies have been undertaken for how to evaluate decrease of the ultimate strength and how to repair corrosion damage of the girder end. At the present time, it has been almost cleared the collapse mechanism (Tamakoshi et al.2006;
