| Title | STRUCTURAL CHARACTERISTICS OF A HISTORICAL REINFORCED CONCRETE TEMPLE BUILDING, HIGASHI-HONGANJI HAKODATE BETSUIN |
| Author(s) | ISHII, K. ; KIKUCHI, M. ; SHIRAI, K. |
| Description | The Thirteenth East Asia-Pacific Conference on Structural Engineering and Construction (EASEC-13), September 11-13, 2013, Sapporo, Japan. |

# STRUCTURAL CHARACTERISTICS OF A HISTORICAL REINFORCED CONCRETE TEMPLE BUILDING, HIGASHI-HONGANJI HAKODATE BETSUIN

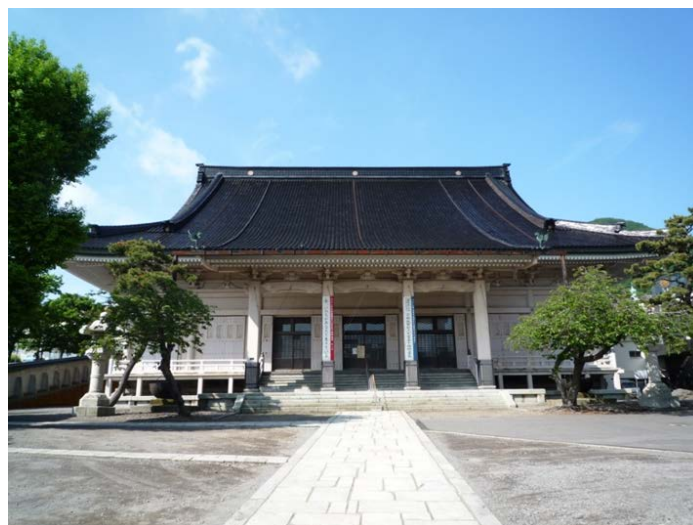
**Figure 1: Higashi-Honganji Hakodate Betsuin**

Table 1 shows the general specifications of the temple. A great fire destroyed the previous temple in 1907. To prevent future burnouts the temple was rebuilt using RC. Figures 1 – 3 show an external view and drawings (Komaki and Watanabe 2006) of the temple. The main structure is RC, except for the roof frame, which is structural steel.
