# EXPERIMENTAL INVESTIGATION OF MASONRY CALCAREOUS WALLS REPAIRED AND STRENGTHENED BY C-FRP

L. ANANIA<sup>1\*†</sup>, A. BADALA<sup>'1</sup>, S. COSTA<sup>1</sup>, G. D'AGATA<sup>1</sup> and C. GIACQUINTA<sup>1</sup>

<sup>1</sup>*Dipartimento d'Ingegneria Civile ed Ambientale, University of Catania- Italy*

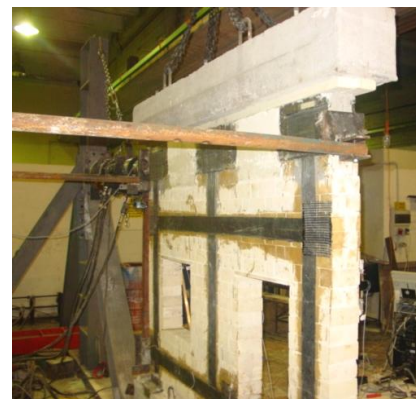
Figure 7. Overview of the strengthened model out of plane constrained

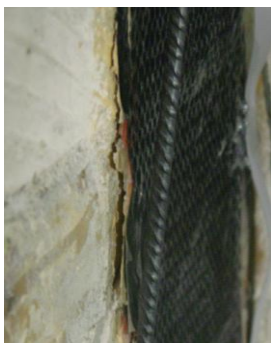
**Figure 18. Delamination at the top of the coulum**

At the ultimate loading step, the failure of the reinforced wall is a consequence of a global sliding of

the masonry along the mortar bed located near the basement just below the CFRP strip; while a limited delamination is observed in the vertical deployed strips (fig.18-19).

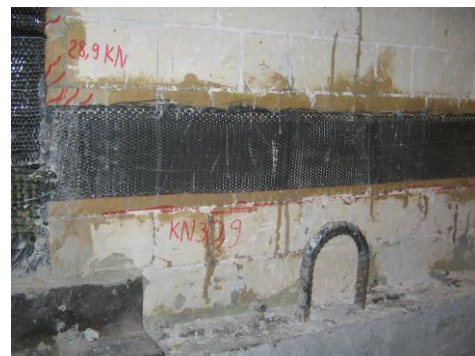
**Figure 19. Sliding along the mortar bed**
