| Title | EVALUATION FOR CORROSION STATE OF LOWER GUSSET PLATE CONNECTIONS ON STEEL TRUSS BRIDGE |
| Description | The Thirteenth East Asia-Pacific Conference on Structural Engineering and Construction (EASEC-13), September 11-13, 2013, Sapporo, Japan. |

# EVALUATION FOR CORROSION STATE OF LOWER GUSSET PLATE CONNECTIONS ON STEEL TRUSS BRIDGE

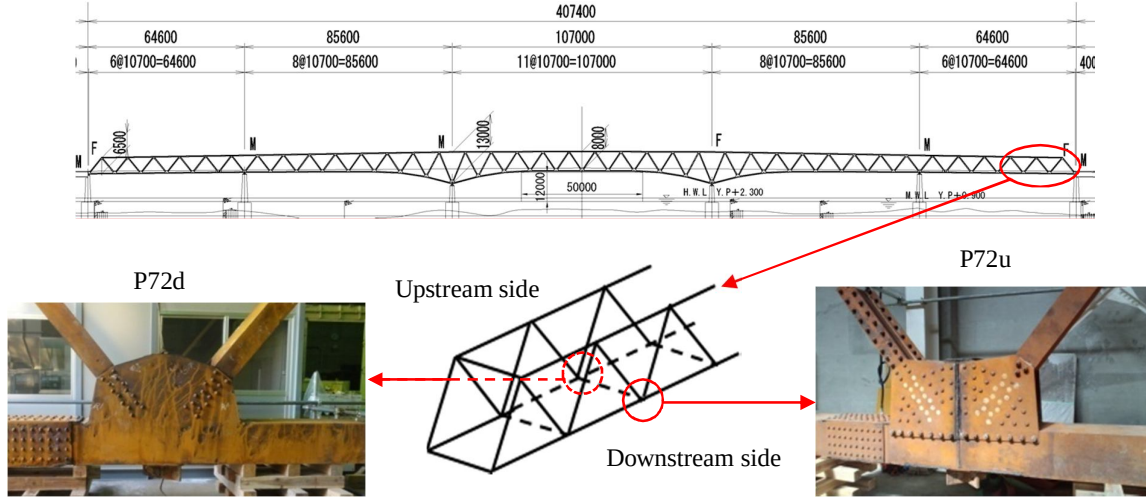
influences of salt occurred as shown in Figure 1. The connection P72d and P72u consist of the lower chord members, the diagonal members, the gusset plates and the lower lateral bracings. In the connection P72d, gusset plates, lower chord and diagonal members were connected by rivets. In the connection P72u, gusset plates, and diagonal members were connected by rivets at the beginning but after that due to the severe corrosion the gusset plates were replaced then the bolt connection was used to connect between the gusset plates lower chord members and diagonal members, besides the diagonal member also was strengthened by bolt. The terms are defined in Figure 1 as an expression of the connection parts of P72d and P72u.

Figure 1: Connection P72d, P72u in the 5 spans truss bridge and definition terms

The studied connections are P72d and P72u on the fifth span of five spans cantilever truss bridge which was demolished because over 50 years passed and the severe corrosion damage due to

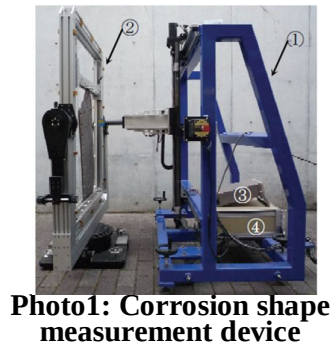
In order to measure the corrosion shapes of the two lower connections, the laser measurement equipment was used. The laser measurement equipment is designed by Tokyo Metropolitan University researchers and manufactured by Optex company that composed of ① surface roughness measuring device, ② grab tool equipment, ③ A-D converter and ④ measurement and control equipment as shown in the Photo 1. The technical specifications of this laser measurement equipment is presented in the Table 2. The maximum and minimum measurement ranges in the direction x, y of this laser measurement equipment are 1m×1m and 1mm×1mm respectively, perpendicular direction depth is  $\pm 35\text{mm}$ , the linear scale reading is  $10\mu\text{m}$ .

Photo1: Corrosion shape measurement device

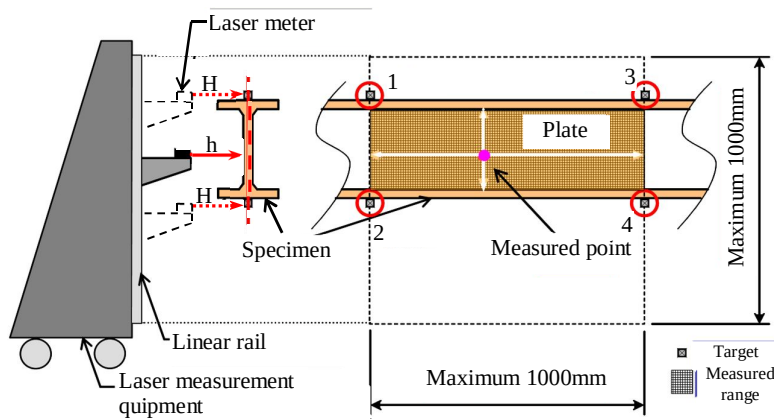
In general, when a specimen is subjected to measure the shape of the surface corrosion, it is set on cross-ties as much vertical as possible. Procedure of setting laser measurement equipment as follow:

- ① The measured surface of the specimen and the laser measurement equipment must be parallel. The position of the laser measurement equipment is determined by the A-D converter to assure that the distances between the laser measurement equipment and the 4 targets are equal.
- ② Specify the origin of a measurement device (measurement device perform automatically)
- ③ Specify the measurement range (start point and end point) (perform manually).
- ④ To determine the based-surface, the attached targets are measured from both sides.
- ⑤ Start measurement

Figure 1: The specimen installation

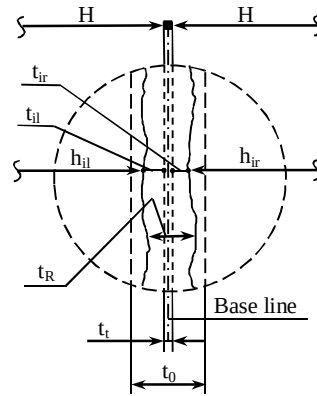
At the specific point, the corrosion depth  $t_i$  ( $i = 1, 2, \dots, n$ ) is calculated by  $t_i = H - h_i$  where ( $h_i$ ) is the distance from the laser measurement equipment to corrosion point  $i$ , ( $H$ ) is the distance from the laser measurement equipment to the based-surface. The remaining thickness  $t_R$  of the corrosion point  $i$  is calculated as  $t_R = t_{il} + t_{ir} + t_t$  where  $t_{il}$ ,  $t_{ir}$  are the corrosion depth of left and right surfaces respectively,  $t_t$  is the thickness of the target and  $t_0$  is the initial thickness as shown in the Figure 2.

Figure 2: Thickness calculation method

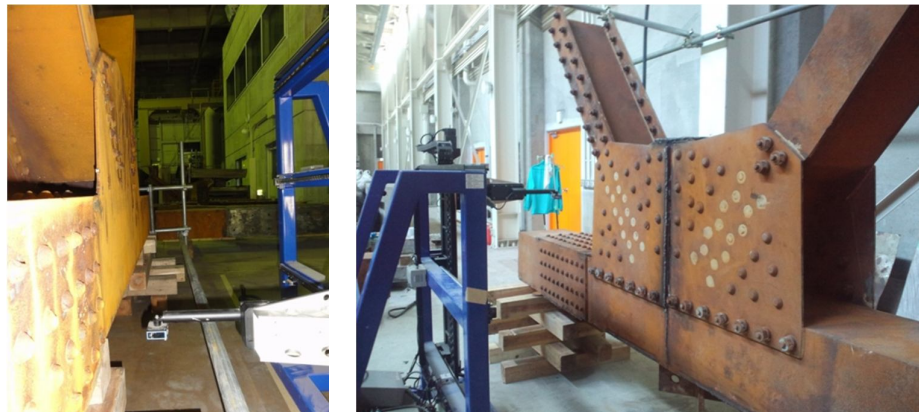
Photo 2: Laser measurement equipment set up for outer surface measurement of P72d (left) and P72u (right) connections

In order to measure corrosion shapes on the outer surfaces of the specimen, the concerned specimen must be set cross-tie as much vertical as possible as shown in the Photo 2. Due to the limited 1m×1m measurement range, the laser measurement device can not measure the outer surface of the specimen at the same time. Therefore, measurement range is divided into small parts depend on the dimension of the specimen. If the identification of the based-surface as shown in the Figure 1 of part 3.2 is too difficult so the base-surface must be determined that three ~ five target points by hands at the visually healthy place that corrosion has not occurred and then the measurement range will be selected and marked.

In order to measure the outer surface of P72d connection, the measurement interval of the laser displacement equipment was selected as 1mm interval to understand its mechanical performance and it was set up as shown in the photo 2. The based-plane was set by hands equal zero. Due to the limited 1m × 1m measurement range of the laser measurement equipment and the dimension of P72d connection, the measurement range is divided into 5 times in the vertical direction for both upstream and downstream side, as shown in the Figure 3. The corrosion occurred locally in some

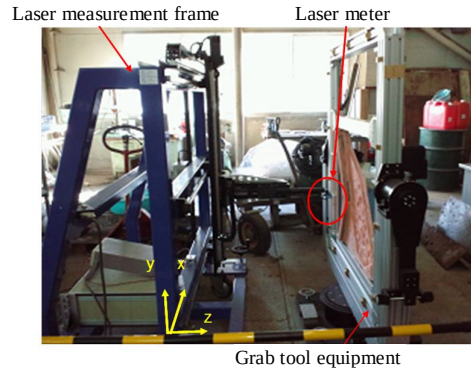
For the situation of the inner surface or narrow surface corrosion measurement, such as the inner surface of the gusset plate, where the measurement device could not measure directly so the method of molded plaster is adopted then the plaster specimen surface would be measured by laser measurement equipment as shown in the Photo 3. The plaster specimen is made by the process as shown in Photo 4. The based-plane in the case of inner surface measurement is set by using the 3-point measurement method on the plaster specimen surface. Procedure of setting laser measurement equipment is as same as the outer surface measurement process.

**Photo 3: Plaster specimen measurement**

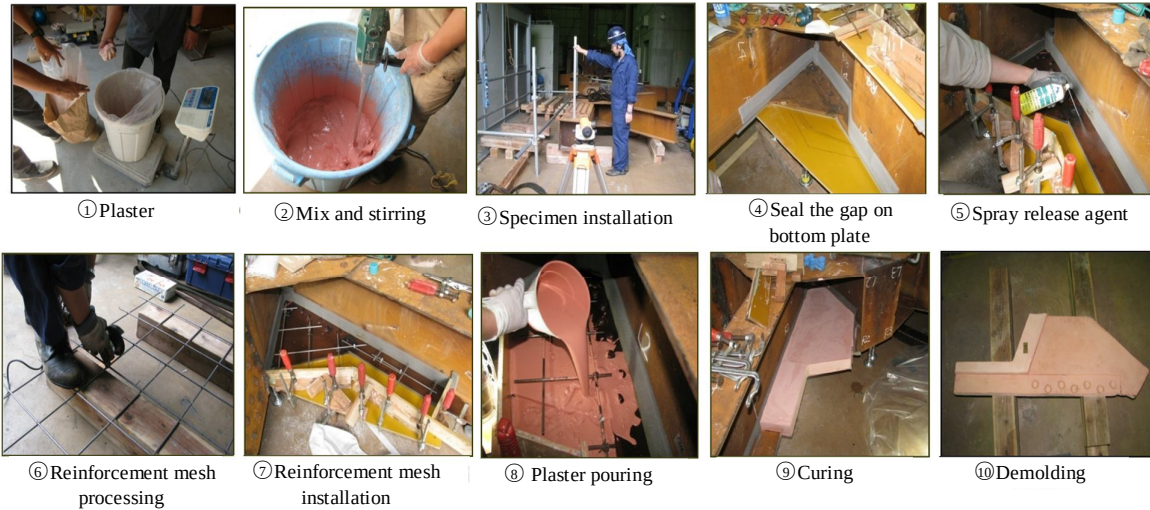
**Photo 4: Procedure for making the plaster specimen**

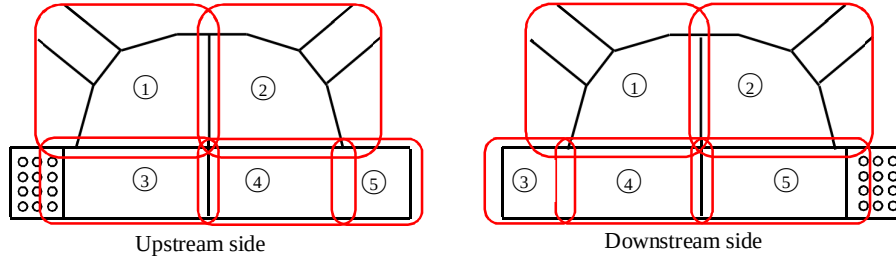
**Figure 3: The measurement range of the outer surfaces of the P72d connection**

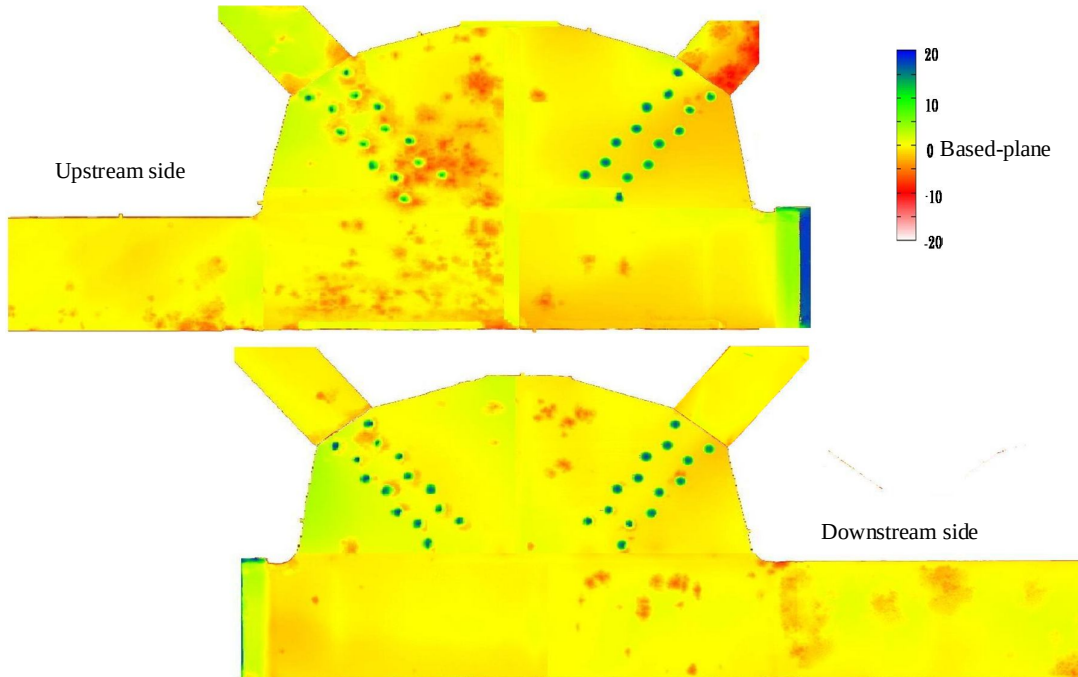
parts the outer surface of the connection P72d so the corrosion measurement was conducted with the special concentration on these area. The measurement results of the upstream and downstream side were shown on the Figure 4, the average corrosion depth and the maximum corrosion depth of the outer surface on the downstream side are 1.52 mm and 9.99mm while in the upstream side they are 0.9mm and 7.97mm, respectively. For the corrosion of outer surface of gusset plates of the P72d connection, except for the area of the rivet, the average depth of surface corrosion and the maximum corrosion depth are 0.83 mm and 7.92mm on the upstream side. For the downstream side, they are 1.79mm and 7.99mm, respectively

**Figure 4: Corrosion depth distribution on the outer surface connection P72d**

1. For the P72d connection: Corrosion occurred locally on the surface of the gusset in the upstream and downstream side and on the flange of the diagonal members in both inner and outer surfaces. On the outer surface, the maximum corrosion depth reached to 9.99mm in the downstream side and 7.97mm in the upstream side while on the inner surfaces they are 7.99mm and 8.98mm for downstream and upstream side respectively. For the inner surface of gusset, the severe corrosion has also occurred locally at the edges of the gusset plate and on the transition region between gusset plate and the flange of diagonal members in both up and downstream side.

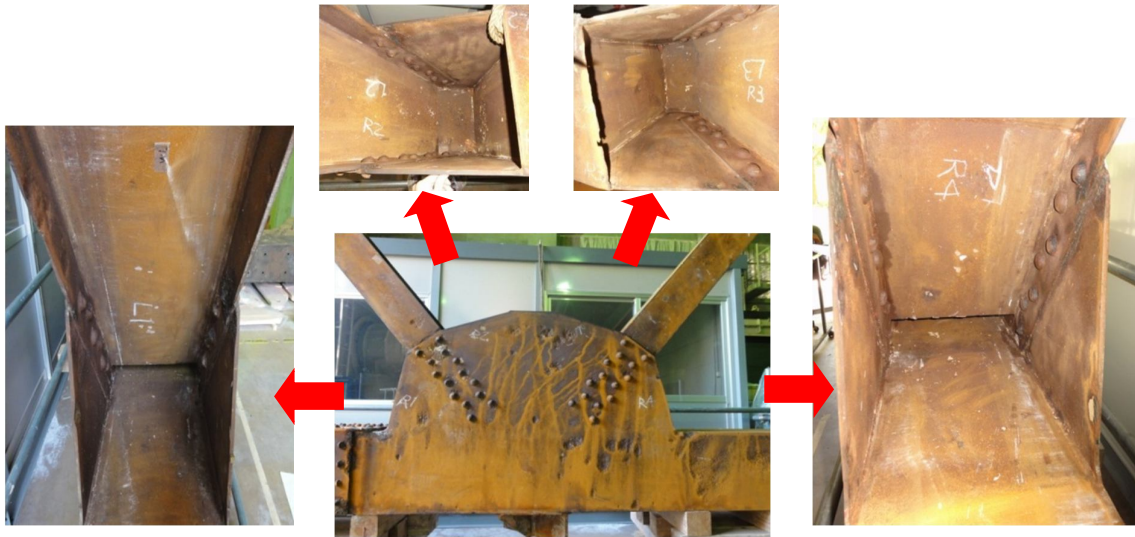
Photo 4 shows the situation of the inner surface corrosion of the gusset plate of P72d connection. This narrow section can not be measured directly by laser measurement equipment, so the method of molded plaster was adopted then the plaster specimen surface was measured by laser measurement equipment.

**Photo 4: Corrosion condition of the inner surface of narrow section**

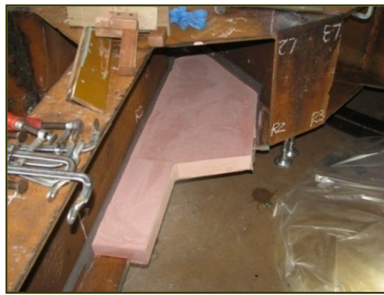
The moulage is carried out for the inner surface of gusset plate and the inner surface of diagonal member, total plaster specimen became 8 bodies as shown in the Photo 5 and the measurement results are presented in the Figure 5. Then the plaster specimen were fixed in the grab tool

**Photo 5: Plaster specimen at the inner surface of gusset plate**

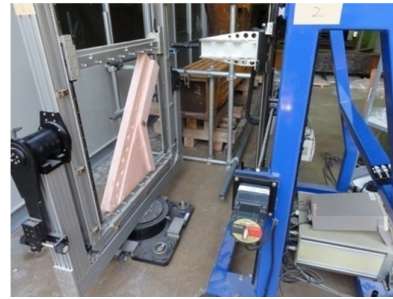
equipment, then measured by laser measuring equipment as shown in photo 5. Performance of the grab tool equipment is listed in Table 2. The based-plane of the plaster specimen was set equal zero.

**Photo 6: The plaster specimen measurement**

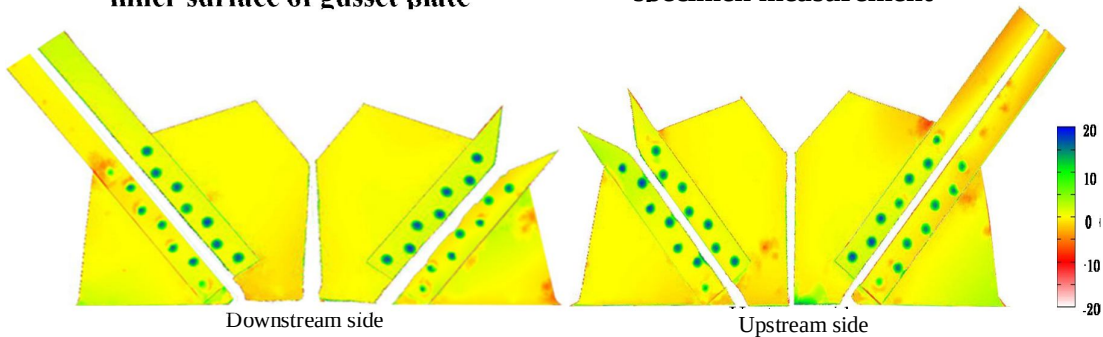
As shown in the Figure 5, the corrosion of inner surfaces of the P72d connection occurred locally and concentrated mostly on the edges of gusset plate in the upstream side, on the flanges of diagonal members and on the transition area between diagonal member and the gusset plate in the downstream side. The average corrosion depth and the maximum corrosion depth of the inner surface on the downstream side are 1.16mm and 7.99mm respectively while in the upstream side they are 1.3mm and 8.98mm

**Figure 5: Corrosion depth distribution on the inner surface of the P72d connection**

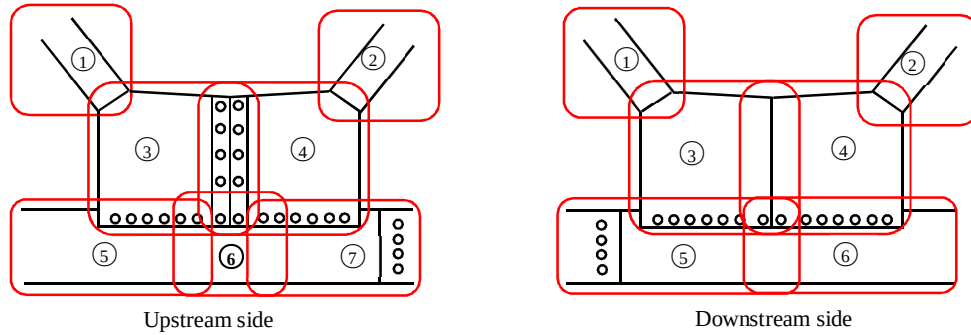
On the outer surface of the P72u connection, because of the corrosion that has not seen clearly so the measurement interval of the laser displacement equipment was selected as 3mm interval and the based-plane was set equal zero. The measurement range is divided into several times (7 times for the upstream side and 6 times for the downstream side) as shown in the Figure 5. The measurement results of the upstream and downstream side were shown on the Figure 6. The corrosion mostly occurred on the flange of the reinforced diagonal member with the average corrosion depth in these flanges are 0.53mm and 0.45mm for the upstream side and downstream side, respectively.

**Figure 5: The measurement ranges of the outer surface of the P72u connection**

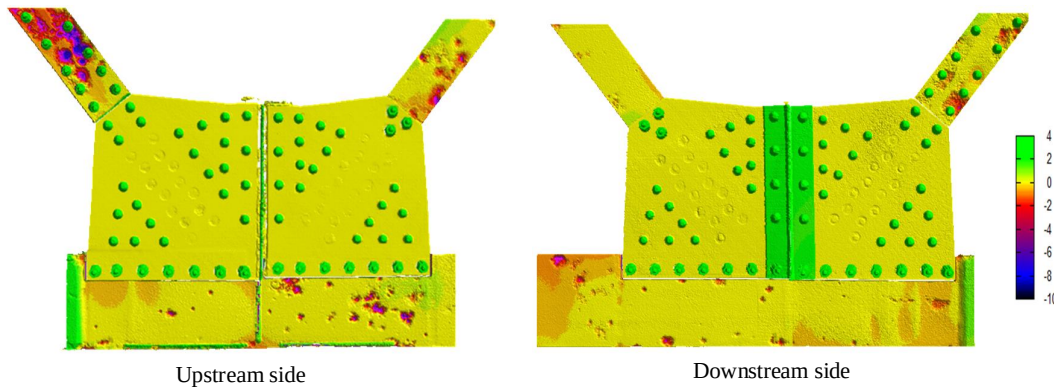
**Figure 6: Corrosion depth distribution on the outer surfaces of the P72u connection**

2. For the P72u connection: On the outer surfaces, the corrosion has not seen clearly on the whole of gusset plate, it only occurred on the flanges of the reinforced diagonal member in both upstream and downstream side with the average corrosion depth are 0.53mm and 0.45mm, respectively. In the case of P72u connection, because of the severe corrosion in the past, the gusset were replaced and the bolt connection was used. Due to this bolt connection the plaster specimen could not created and the inner surfaces were not measured.

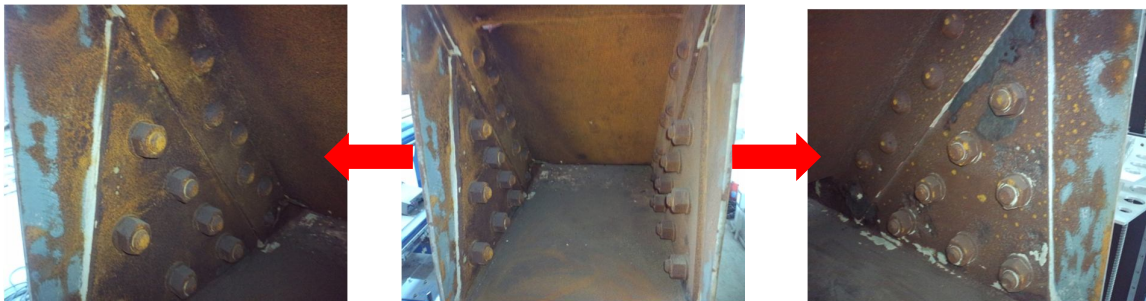
In the case of P72u connection, due to the severe corrosion in the past the gusset plate was replaced and the bolts were used to connect the new gusset plates and the flanges of the diagonal members. Because of the end of these bolts are too long, as seen on the Photo 7, the plaster specimen could not create. As the result, the inner surfaces of P72u connection could not be measured.

**Photo 7: Inner surfaces of P72u connection**
