| Description | The Thirteenth East Asia-Pacific Conference on Structural Engineering and Construction (EASEC-13), September 11-13, 2013, Sapporo, Japan. |

# DETERIORATION CHARACTERISTICS OF Sn-BEARING STEEL BY ACCELERATED EXPOSURE TESTS

A series of accelerated exposure tests with combined cycles during 300 days was carried out for investigating the basic corrosion characteristics of the Sn-bearing steel with paint coating. When noting the specimens with paint systems used for mild corrosion conditions, the blister of the painting from the cross scribe of the Sn-bearing steel was smaller than that of the general structural steel. In the case of the specimens with paint systems used for severe corrosion conditions, almost no blister of the painting from the cross scribe could be observed on the Sn-bearing steel even though the experiment was finished. The blister area from the boundary region between the painting and the steel substrate of the Sn-bearing steel was smaller than that of the SM490 steel. The results indicated the possibility for reducing the cost for maintenance of steel bridges by prolonging repair terms of painting by using the Sn-bearing steel.

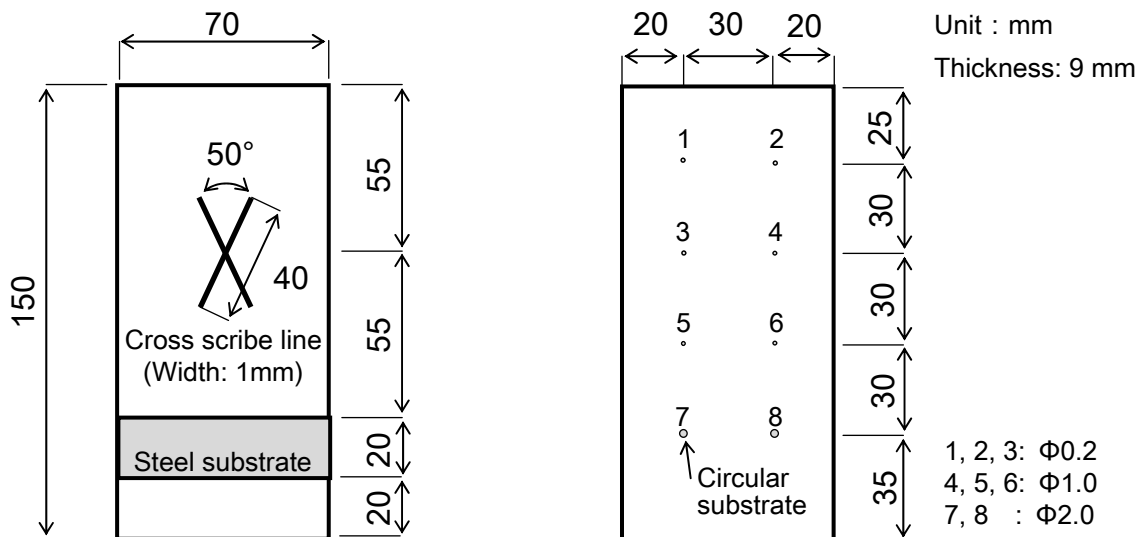
**Figure 1: Shapes and dimensions of specimens**

Artificial initial defects shown in Figure 1 were made on the painted specimens for investigating the deterioration behavior of the paint coating from the defects. In the cross cut specimen, the cross scribe defect simulated the scratch damage on the actual painting. The length and the width of the cross scribe line were 40 mm and 1 mm, respectively. The angle of the cross scribe lines was 50 degrees. The cross scribe lines reached to the substrate steels. 20 x 70 mm region at the lower part of the specimen was not coated for exposing the substrate steel. This simulated the corrosion

deterioration behavior from the discontinuous part of the paint coating such as the boundary between two members in bolted joints of actual steel bridges.

In the circular substrate specimen, the circular shape defects with different diameters (0.2, 1.0 and 2.0 mm) were made on the paint coating by using an end mill machine. The defects reached the substrate steel. This simulated the corrosion deterioration behavior from the pin-hole damage on the paint coating of actual steel bridges (Kim et al. 2007).

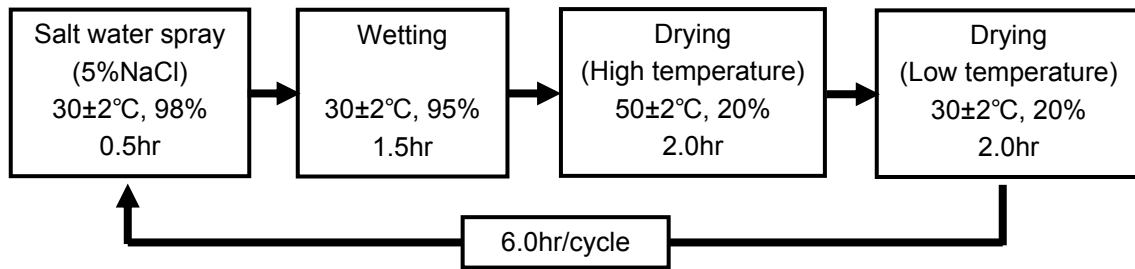
**Figure 2: Accelerated exposure test condition**

A series of the accelerated exposure tests with combined cycles of salt splaying, wetting and drying (S6 cycles) was carried out for 300 days (1200 cycles). Figure 2 shows the test conditions. The S6 cycles are specified in Japanese Industrial Standards (JIS K 5621) (Japanese Industrial Standards Committee 2006). The correlation was confirmed between the test results by the S6 cycles and the exposure tests on site (Fujiwara et al. 1997).

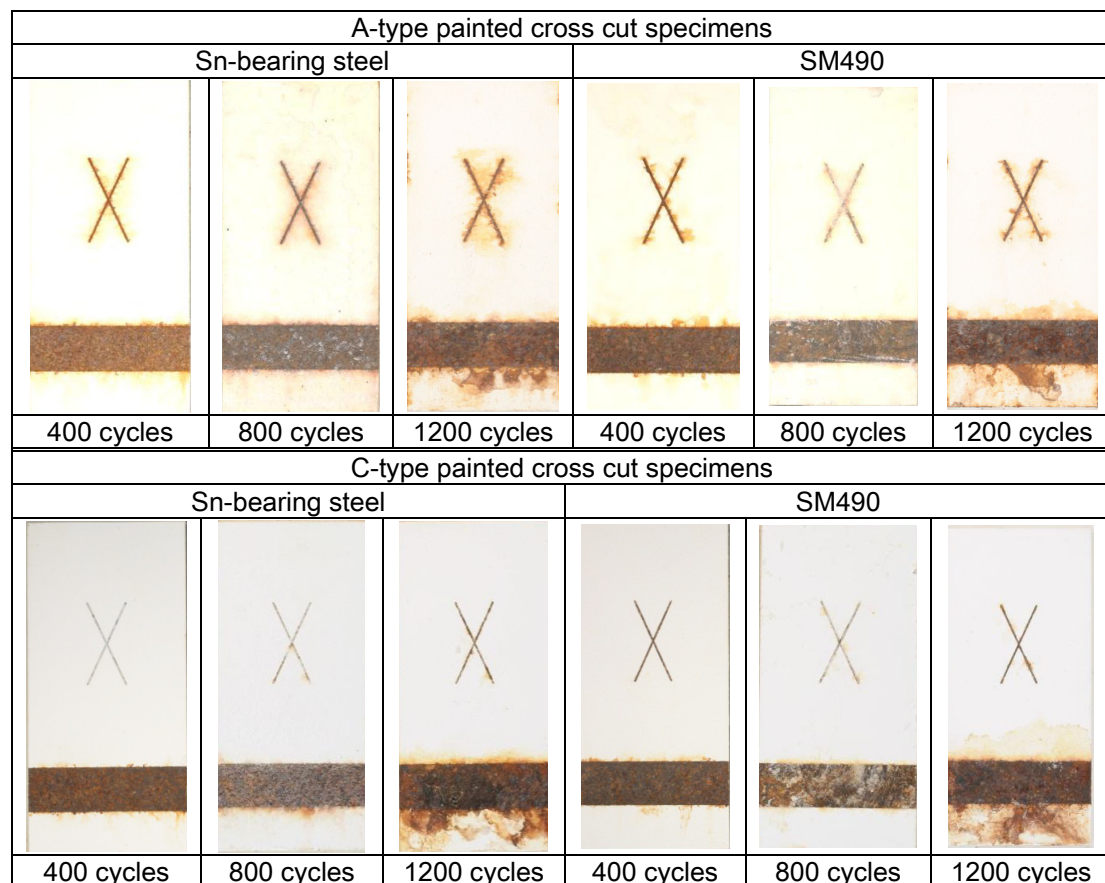
**Figure 3: Appearance of specimens**

Figure 3 shows the appearance of the cross cut specimens taken out from the test chamber by every 400 cycle. In the cases of the A-type painted specimens, the rust was formed around the cross scribe lines and the substrate region from 400 cycles in both the Sn-bearing steel and the SM490 steel. The amount of the rust increased with the test cycles. In the cases of the C-type painted specimens, the rust was scarcely formed around the cross scribe lines in both the Sn-bearing steel and the SM490 steel even after 1200 cycles. However, the amount of the rust around the substrate region spread with the test cycles. It could be seen that the rust under the substrate region of the Sn-bearing steel was fewer than that of the SM490 steel in both the A-type and the C-type painted specimens at 1200 cycles.

In the case of the circular substrate specimens, the degree of the rust was less than those of the cross cut specimens. Especially, almost no rust was observed in the C-type painted specimen regardless of the difference of the substrate steel.

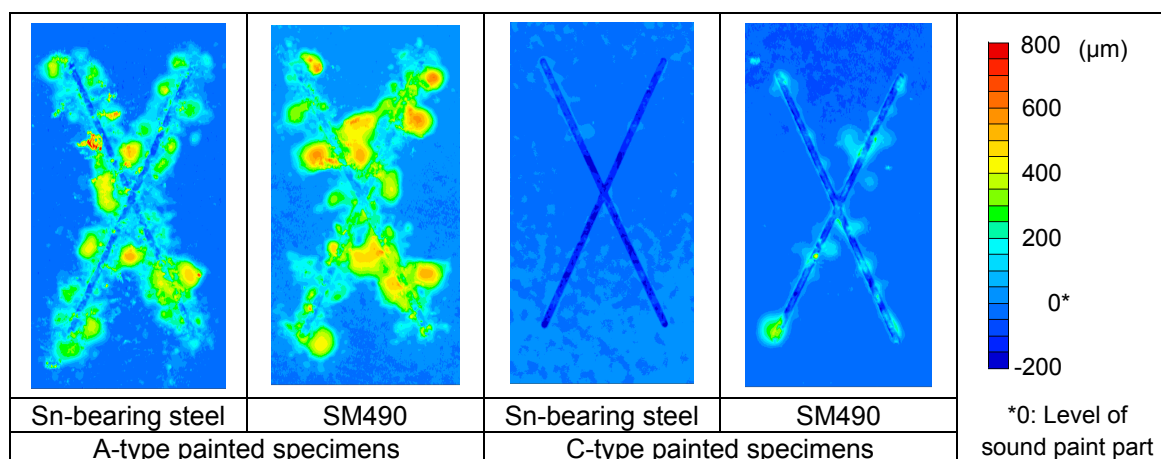
**Figure 4: Blister around cross scribe regions (after the test of 1200 cycles)**

The surface shape of the specimens after the accelerated exposure tests were measured by the laser displacement meter. The measured pitch was 0.3 mm in both the longitudinal and the transverse directions. Figure 4 shows examples of the measured results around the cross scribe regions in the specimens after the test of 1200 cycles. The area in which the height of blister of painting was over 50  $\mu\text{m}$  from the level of sound painting region was determined as the blister area in this study.

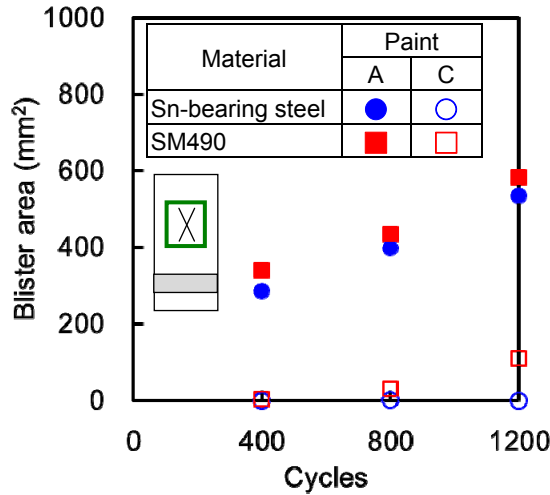
(a) Cross scribe region

Figure 5(a) shows the relationships between the blister areas from the cross scribe regions and the test cycles. The blister areas of the A-type painted specimens were larger than those of the C-type painted specimens. In the A-type painted specimens, the blister area of the Sn-bearing steel was smaller than that of the SM490 steel. The blister area of the Sn-bearing steel was around 92 % of that of the SM490 steel after 1200 cycles. In the C-type painted specimens, the blister areas of both the Sn-bearing steel and the SM490 steel were almost zero until 800 cycles. Although the blister area of the SM490 was increased, that of the Sn-bearing steel was not generated even after 1200 cycles.

- (1) In the A-type painted specimens, the blister area from the cross scribe paint defect of the Sn-bearing steel was around 92 % of that of the SM490 steel at 1200 cycles. In the C-type painted specimens, the blister areas from the cross scribe paint defect of both the Sn-bearing steel and the SM490 steel were not almost observed until 800 cycles. Although the blister of the SM490 was increased, that of the Sn-bearing steel was not generated even after 1200 cycles.

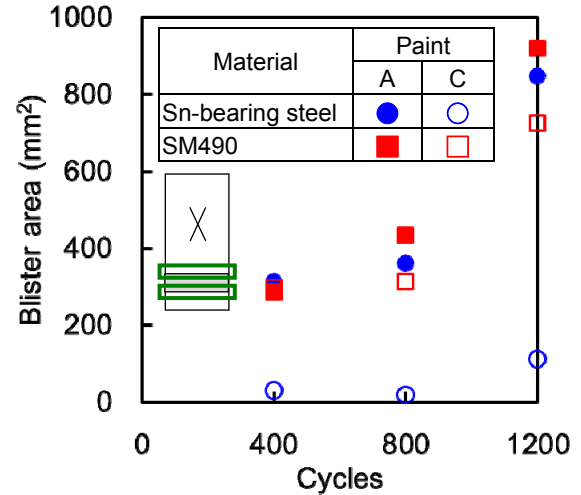
(b) Substrate region

Figure 5(b) shows the sum of the blister areas of the upper and lower parts of the substrate regions. In the A-type painted specimens, the blister area of the Sn-bearing steel was around 92 % of that of the SM490 steel at 1200 cycles as well as the cross scribe region. However, in the C-type painted specimens, a clear difference of the blister areas between the Sn-bearing steel and the SM490 steel could be confirmed. The difference of the blister areas between the Sn-bearing steel and the SM490 steel became larger with an increase of the test cycle. The blister area of the Sn-bearing steel was around 16 % of that of the SM490 steel after 1200 cycles.

- (2) In the A-type painted specimens, the blister area from the boundary between the painted and not painted regions of the Sn-bearing steel was around 92 % of that of the SM490 steel at 1200 cycles. In the C-type painted specimens, the difference of blister areas between the Sn-bearing steel and the SM490 steel became larger with increase of the test cycle. The blister area from the boundary region of the Sn-bearing steel was around 16 % of that of the SM490 steel at 1200 cycles.

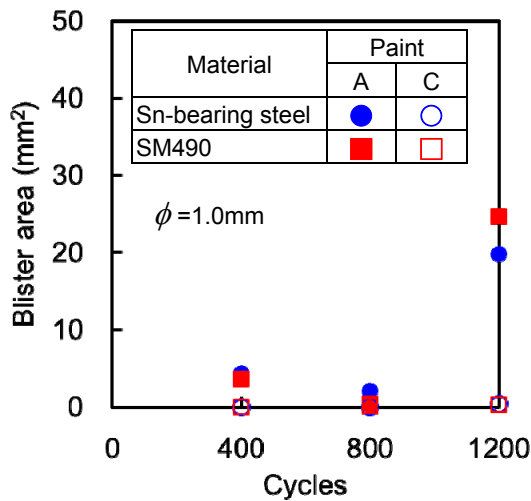
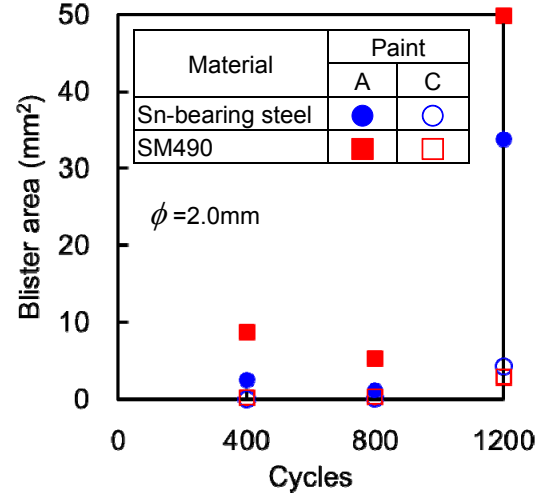
**Figure 5: Relationships between blister area and test cycles**

Figures 5(c) and (d) show the relationships between the blister areas from the circular substrates regions with diameters of 1.0 mm and 2.0 mm and the test cycles respectively. The scarce blister could be observed around the circular substrate region with diameters of 0.2 mm.

In the A-type painted specimens, the blister areas of the Sn-bearing steel around the circular substrates with diameters of 1.0 mm and 2.0 mm were around 80 % and 68 % of those of the SM490 steel at 1200 cycles respectively. In the C-type painted specimens, the blister hardly occurred even though the diameter of the circular defect was 2.0 mm at the 1200 cycles

- (3) In the A-type painted specimens, the blister areas of the Sn-bearing steel around the circular substrates with diameters of 1.0 mm and 2.0 mm were around 80 % and 68 % of those of the SM490 steels at 1200 cycles respectively. The scarce blister could be observed around the circular substrate region with diameters of 0.2 mm. In the C-type painted specimens, the blister hardly occurred even though the diameter of the circular defect was 2.0 mm at the 1200 cycles.
