| Description | The Thirteenth East Asia-Pacific Conference on Structural Engineering and Construction (EASEC-13), September 11-13, 2013, Sapporo, Japan. |

# EVALUATION OF TSUNAMI FORCE ACTING ON BRIDGE GIRDERS

## ABSTRACT

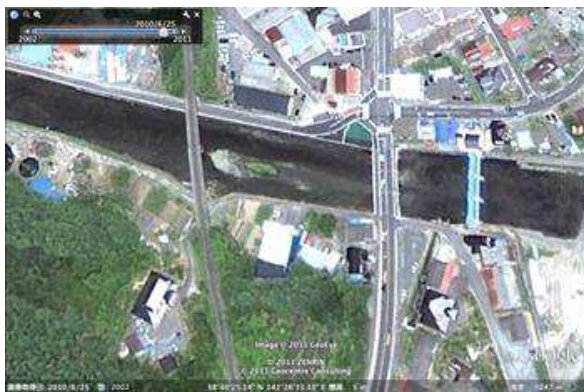
**Figure 1: Satellite images**

At the first stage any data of bridges which located in the inundation area from Aomori prefecture in the north to Chiba prefecture in the south were collected by both internet media and on site survey. Fig.1 shows satellite images taken before and after the earthquake.

(a) Before Earthquake (25<sup>th</sup> June, 2010)

(b) After Earthquake (6<sup>th</sup> April, 2011)

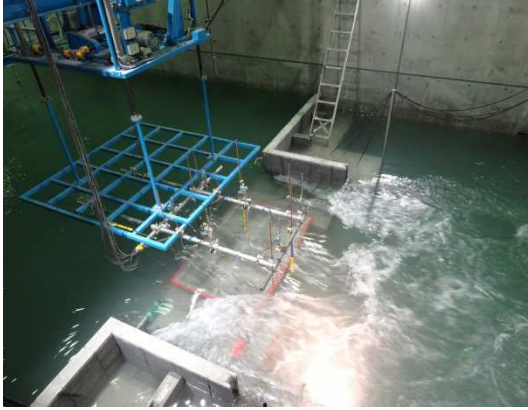
**Figure 11: Girder under uniform flow**

Figs. 11 and 12 show pictures of girder in the experiment. Uniform flow could not move a girder even at a large velocity while solitary wave could lift and move a girder.
