| Citation | Coastal Engineering Journal, 57(03), 1550014<br><a href="https://doi.org/10.1142/S057856341550014X">https://doi.org/10.1142/S057856341550014X</a> |

## Report on the 2014 Winter Cyclone Storm Surge in Nemuro, Japan

From Tuesday, December 16, 2014, until Thursday, December 18, Hokkaido was battered by strong winds and high sea waves caused by a passing low pressure system intensified to typhoon levels. In the city of Nemuro, a rise in sea level influenced by the storm surge which exceeded quay height in port areas was observed from predawn Wednesday, December 17, 2014. Flooding was experienced in areas of central Nemuro, the Nemuro Port and estuaries of rivers. This technical note provides a comprehensive meteorological analysis and the results of a local flood survey carried out by the authors from December 19 to 21, 2014, and summarizes the characteristics of the 2014 Nemuro storm surge disaster.

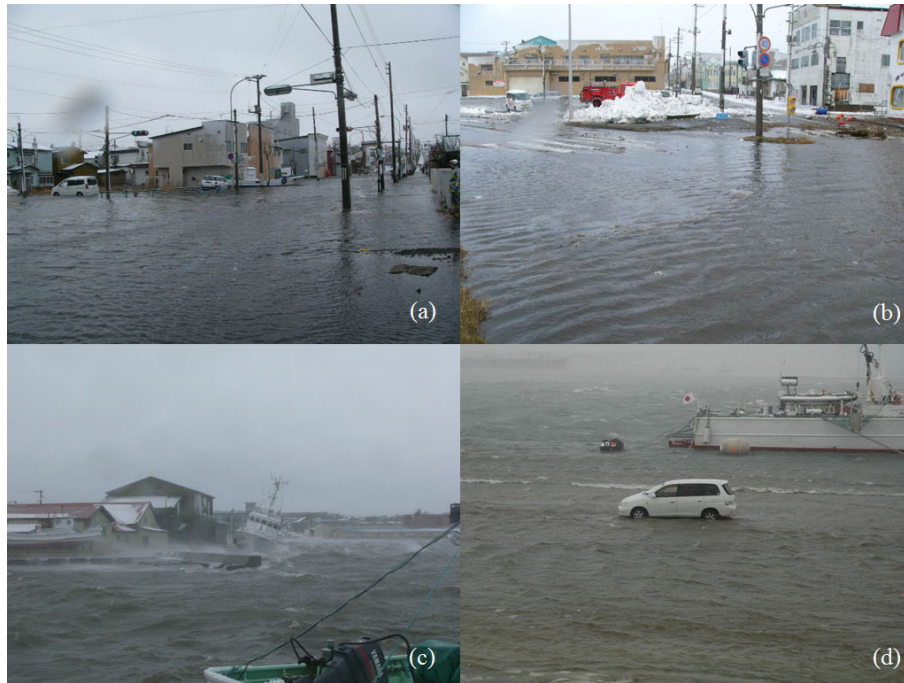
Fig. 2. Photographs of (a)–(b) inundated streets in central Nemuro (locations indicated in Fig. 10), and (c)–(d) inundated quays in the Nemuro Port (locations indicated in Fig. 9). Fishing boats and cars were drifted by the flood. All photos were taken by the Hokkaido Regional Development Bureau during the flood event on December 17, 2014.

towns), causing about \$20 million damage to ports and harbors, fishery facilities, commercial buildings, fishing boats, residences and vehicles (Fig. 2). An overview of the flood damages was reported by the Hokkaido Regional Development Bureau [Hokkaido Regional Development Bureau, 2015].

Fig. 10 shows the runup area and inundation heights in urban areas of Nemuro (Yayoi and Midori towns) where significant flood damage to houses and shops occurred. Seawater flew and spread through sloping streets (see Fig. 2 a and b), causing

above floor and underground inundation, damage to fishing boats and equipment (Fig. 2), and sewage blockage. We estimated a 1.8-2.1 m deep (T.P.) flood covering approximately 7 ha over streets with a relatively low ground level (Fig. 10).

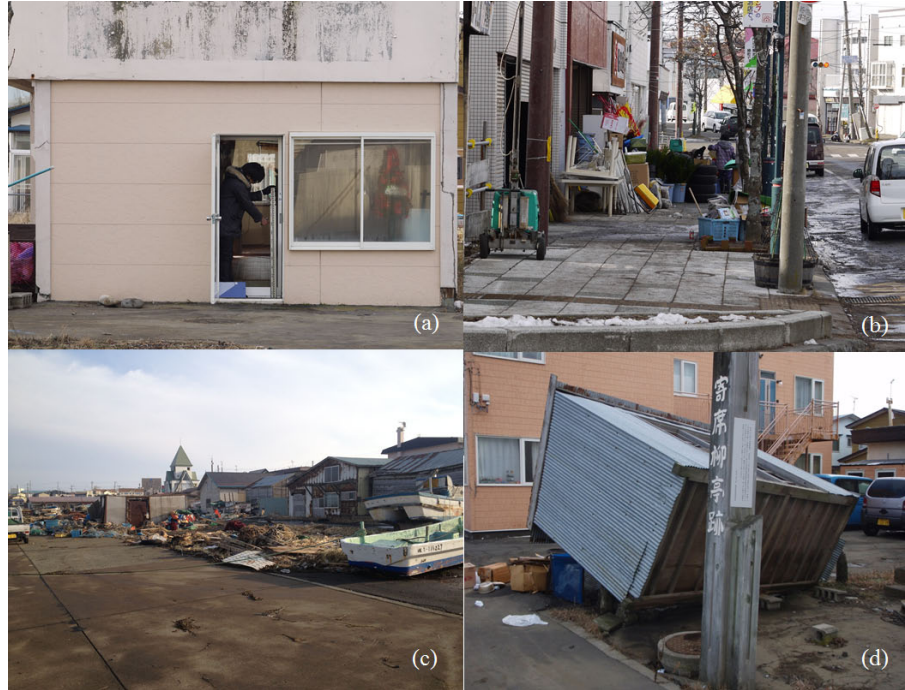
Fig. 7. Photographs of streets in central Nemuro after the disaster: (a)–(b) inundated houses and shops, (c) debris and a fishing boat brought ashore, (d) fallen shed (locations shown in the photos in Fig. 10). All photos were taken during the survey on December 20, 2014.

because the cleaning works of the affected areas were not sufficiently advanced, large amounts of debris carried inland by the storm surge remained untouched (see Fig. 7 and Fig. 8). Additionally, watermarks in buildings, indicated by locals who witnessed the event, were still visible (Fig. 7 a). There were, thus, a number of traces of flooding. For instance, lines of debris from which no debris were observed further upstream were clear vestiges of the extent of the runup (Fig. 8 a and b).

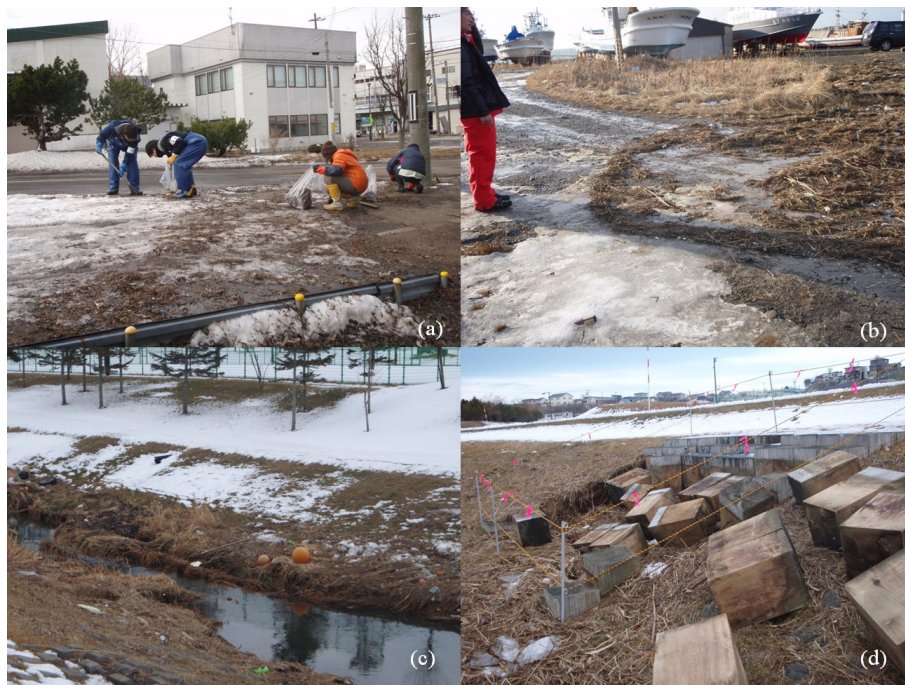
Fig. 8. Debris brought ashore by (a) high tide at Site 4 (see map in Fig. 9) and (b) by wave overtopping at Site 8 (see map in Fig. 10), (c) debris and buoys transported through Hattari River and (d) wooden river-side benches plucked out due to buoyancy (see map in Fig. 11). All photos were taken during the survey on December 20, 2014.

Flooding was also observed around the mouth and downstream areas of Hattari River, which flows through Misaki and Nishihama towns (Fig. 8 c and d). Since the hourly precipitation (snowfall) during the storm surge was less than 1.5 mm, river swelling was not significant. Increased seawater level due to the storm surge spread upstream (Fig. 11) and caused the flood. The inland runup possibly reached approximately 1 km. As in general tropical cyclones accompany heavy rain and cause river flood ([Dietrich et al., 2010; Fritz et al., 2010]), river propagation of the tide had yet to be explicitly observed. A storm tide propagation in the river, which potentially extends the flood area inland away from the coast, is a disaster scenario which should be taken into account for warning and evacuation in future storm surge events.

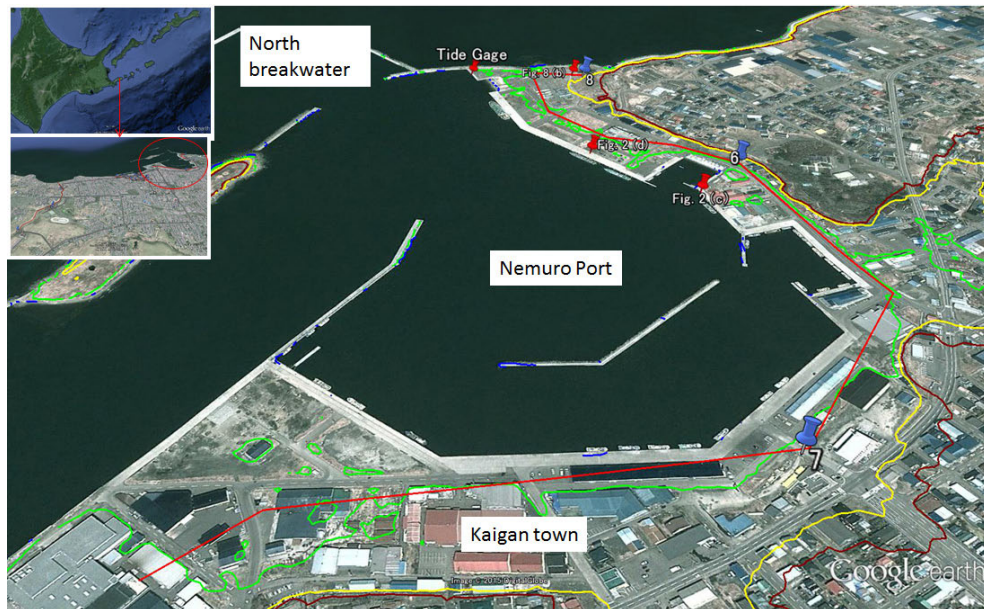
Fig. 9. Estimated runup limits (indicated by a red line) and surveyed sites at Nemuro Port. Flood heights at Sites 6–8 are listed in Table 1. The locations where the photographs of Fig. 2 (c–d) and Fig. 8 (b) were taken and the location of the tide gage (Fig. 3) are indicated in the map. The ground elevation estimated from 5-m topographic data of the Geospatial Information Authority of Japan (GSI) is indicated by the blue (1 m), green (2 m), yellow (4 m) and brown (6 m) contours.

component of approximately 1.8 m (T.P.), Fig. 9) covering approximately 15 ha took place in the pier and other areas surrounding the Nemuro Port, which is located at the lowest ground level of the city. In the present survey, debris from the flood were found at T.P. 3.55 m at site 8, which is located behind the north seawall of the Nemuro Port (Fig. 9 and also Fig. 8 b). Since the traces at site 8 were more than 1 m higher than the highest inundation level of TP 2.24 m observed among the other surveyed sites at Nemuro Port (sites 6 and 7 in Table 1), the flooding at site 8 is attributed to high overtopping waves which developed outside of the port. Seawater influx overtopping the seawall crest (height of 3.13 m) above the sea level rise during the storm surge was found to have inundated areas adjacent to the seawall. No other place affected by overtopping was observed, as the multiple breakwaters surrounding the port, shown in Fig. 9, intercepted the northerly ocean waves from propagating to the affected areas. Thus overtopping waves were effectively reduced and extra damage may have been minimized.

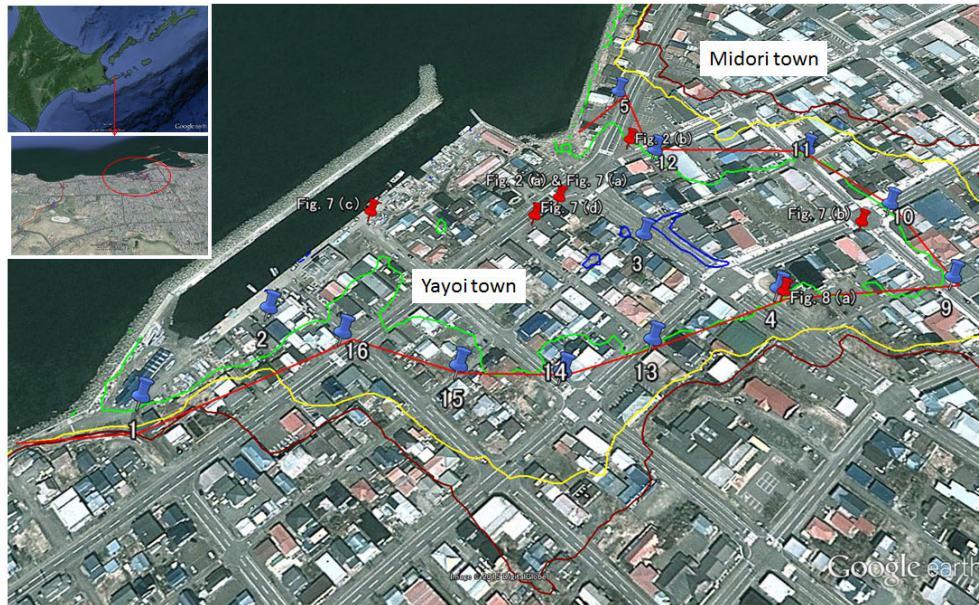
Fig. 10. Estimated runup limits (indicated by a red line) and surveyed sites at central Nemuro. Flood heights at sites 1 - 5 are listed in Table 1, and the locations of the runup limit sites are shown in Table 2. The locations where the photographs were taken (Fig. 2 a, b, Fig. 7 and Fig. 8 a) are indicated in the map. The ground elevation estimated from 5-m topographic data of GSI is indicated by the blue (1 m), green (2 m), yellow (4 m) and brown (6 m) contours.

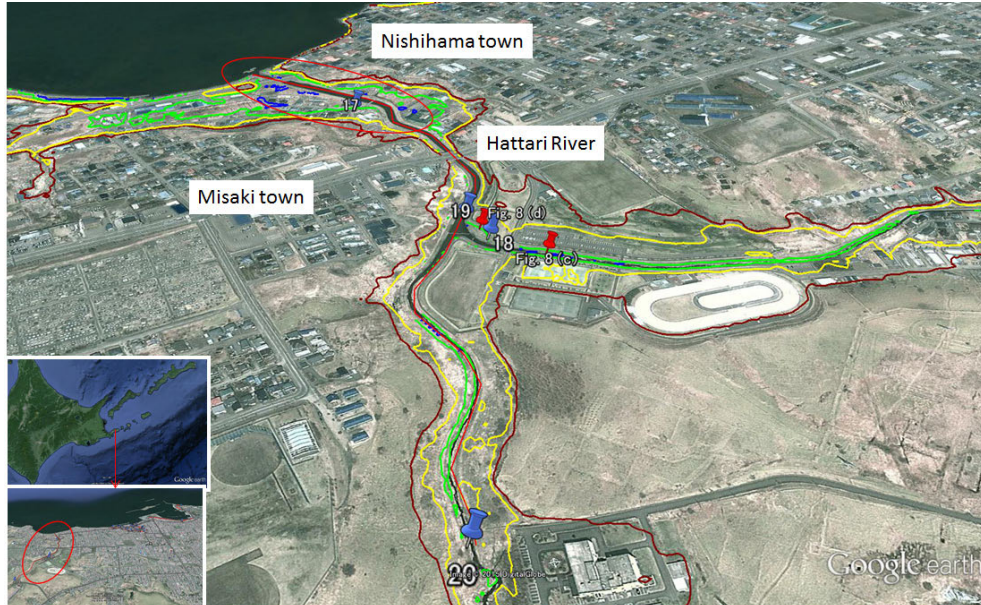
Fig. 11. Location of the survey (red line) and survey sites along Hattari River. The inundated area is marked by a circle. Site locations where debris were observed are shown in Table 2. The locations where the photographs were taken (Fig. 8 c, d) are indicated in the map. The ground elevation estimated from 5-m topographic data of GSI is indicated by the blue (1 m), green (2 m), yellow (4 m) and brown (6 m) contours.
