| Title | Rehabilitation of corrosion damaged reinforced concrete beams with recycled nylon fiber reinforced sprayed polymer cement mortar |

**REHABILITATION OF CORROSION DAMAGED REINFORCED  
CONCRETE BEAMS WITH RECYCLED NYLON FIBER  
REINFORCED SPRAYED POLYMER CEMENT MORTAR**

A THESIS SUBMITTED IN PARTIAL FULFILLMENT OF THE REQUIREMENTS FOR  
THE DEGREE OF DOCTOR OF PHILOSOPHY

**DIVISION OF ENGINEERING AND POLICY FOR SUSTAINABLE  
ENVIRONMENT  
GRADUATE SCHOOL OF ENGINEERING  
HOKKAIDO UNIVERSITY**

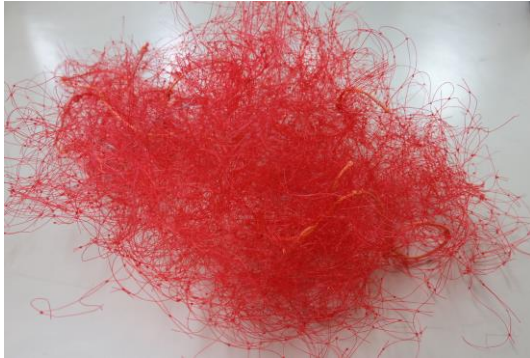
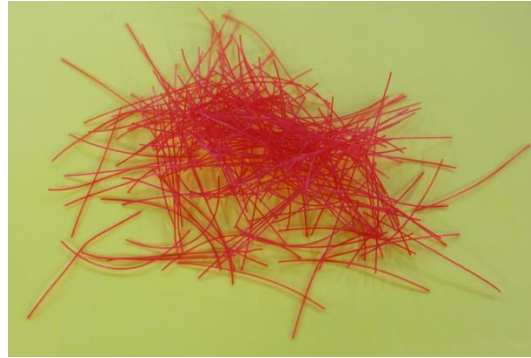
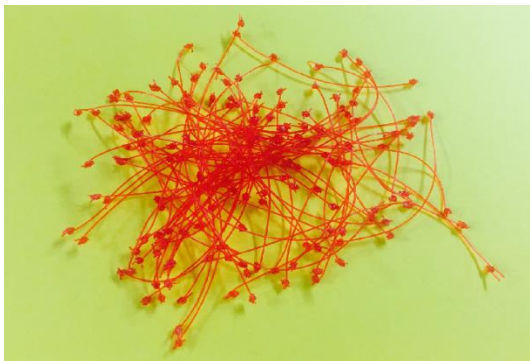
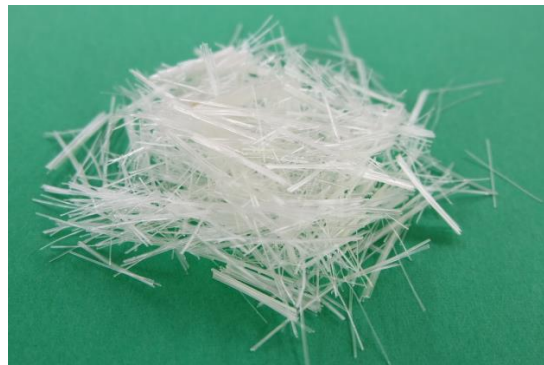
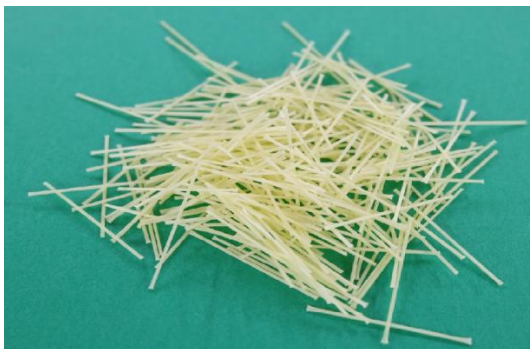
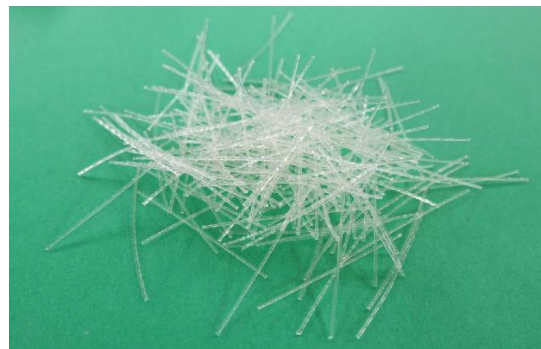
Figure 2.1: Types of fibers

The recycled nylon fiber examined in this study was prepared by manually cutting waste fishing nets collected by fishermen in Hokkaido, see Figure 2.1(a). The cutting was started after washing the net by tap water. The two fiber types were made; that is, straight fiber and knotted fiber, see Figures 2.1(b) and 2.1(c), respectively. The straight fiber was 20 mm, 30 mm or 40 mm long, and was mixed in mortar at the volume fractions of 1.0%, 1.5% and 2.0%. The knotted fiber was 40 mm long, and was mixed in mortar at the volume fractions of 0.5%, 0.75% and 1.0%. The volume fractions of the knotted fiber are less than those of the straight fiber because the knotted fiber tends to form tenacious balls easily. PVA and R-PET fibers were supplied by Kuraray Company and Sango Company, respectively. They were mixed in mortar at the volume fractions of 1.0% and 1.5%. In this study, the uniaxial tensile tests according to ASTM C1557-03 [1] were carried out to determine Young's modulus and tensile strength of recycled nylon fiber, as shown Figure 2.2. The appearances and properties of all the fibers are summarized in Figure 2.1 and Table 2.1, respectively.

(a) Waste fishing net

(b) Straight R-Nylon fiber

(c) Knotted R-Nylon fiber

(d) PVA fiber (18 mm)

(e) PVA fiber (30 mm)

(f) R-PET fiber

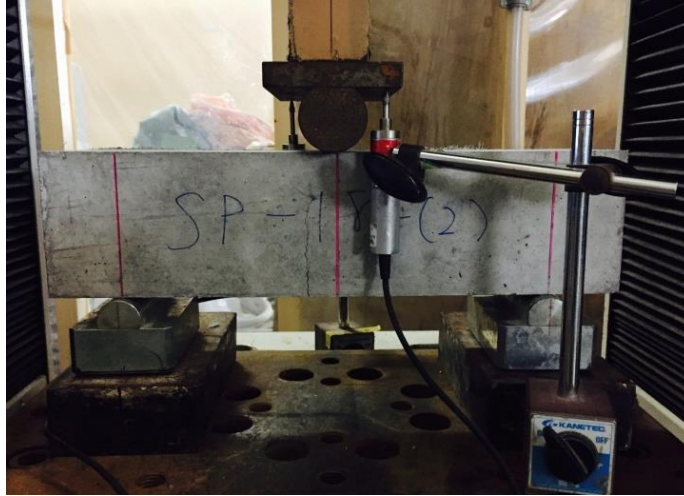
Figure 2.3: Three point bending test setup

The mortar flow test was conducted in accordance with ASTM C 1437 [2]. Compressive strength was determined in compliance with ASTM C 39 [3]. Flexural strength tests were conducted in accordance with ASTM C 1018 [4]. The authors performed three-point bending tests, and measured the peak load, first crack strength, toughness indices and residual strength factors. Two Linear Variable Differential Transformer (LVDT) were used to measure deflection, and were installed each side of the specimen at midspan, as shown in Figure 2.3. For each mix design, the mortar was cast in cylinders of 50 mm diameter  $\times$  100 mm in height for the compressive test and in prism molds of 40 mm  $\times$  40 mm  $\times$  160 mm for the bending test. For each mix, three and two specimens were tested for compressive and flexural strengths, respectively, after curing for 28 days.

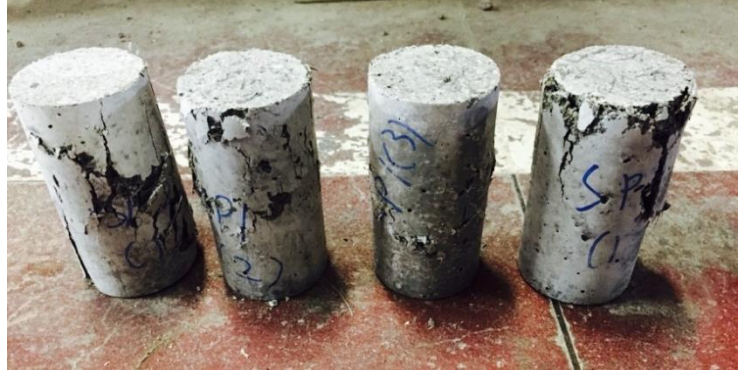
(b) R-nylon fiber reinforced mortar

Figure 2.4: Failure modes of non-reinforced and reinforced mortar by compressive test

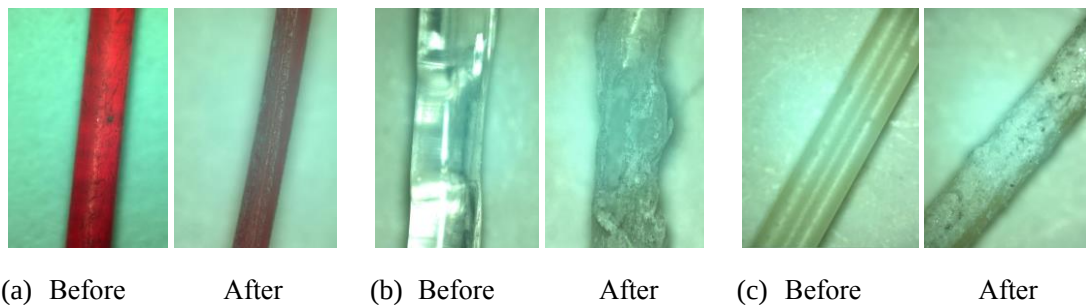
Figure 2.11: The fiber surface before and after the flexural test. (a) R-Nylon fiber; (b) R-PET fiber; (c) PVA fiber (30 mm)

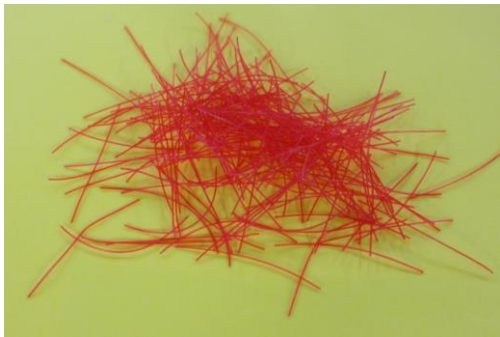
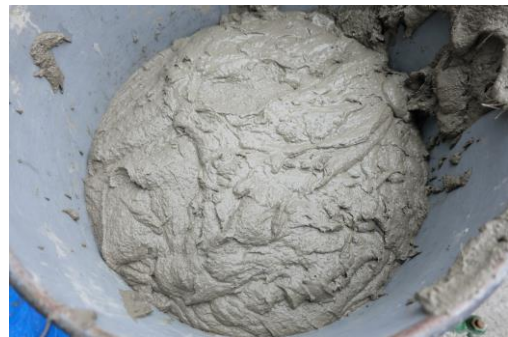
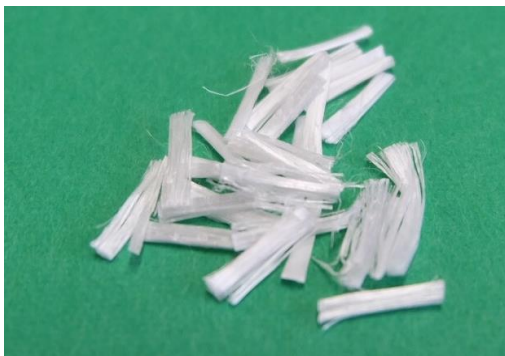
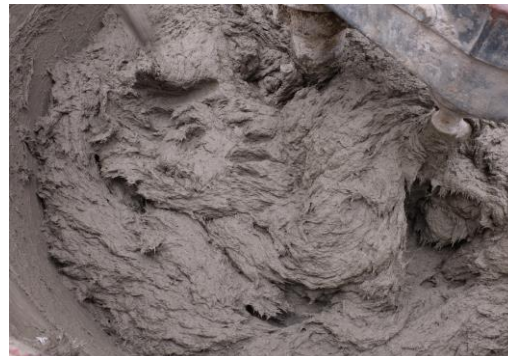
Figure 3.1: Fiber mixed with polymer cement mortar: (a) SPCM containing R-nylon fiber;  
(b) SPCM containing PE fiber

(a) R-nylon fiber

resulting mixture

(b) PE fiber

In this study, recycled (R)-nylon fiber that was manually cut from waste fishing nets was added to the mixture (Figure 3.1 (a)). Orasutthikul et al. and Spadea et al. [12, 13] found that using R-nylon fiber not only improves the structural performance of fiber-reinforced mortar but also affords ecological and economic benefits. To compare the improvement in structural performance afforded by R-nylon fiber SPCM and two common types of SPCM (polyethylene (PE) fiber SPCM (see Figure 3.1 (b)) and non-fiber SPCM), four-point bending tests were conducted on a series of corrosion-damaged RC beams repaired with SPCM. Three work specifications were address: the removal of damaged concrete to a depth of 10 mm from the surface, the removal of all the cover concrete (26 mm deep), and the removal of concrete to a depth of 20 mm over the tensile reinforcements. Flexural behavior was investigated in terms of load carrying capacity, flexural stiffness and ductility as well as crack formation with bending tests that focused on the following test parameters: repair method, SPCM type and level of flexural reinforcement corrosion.

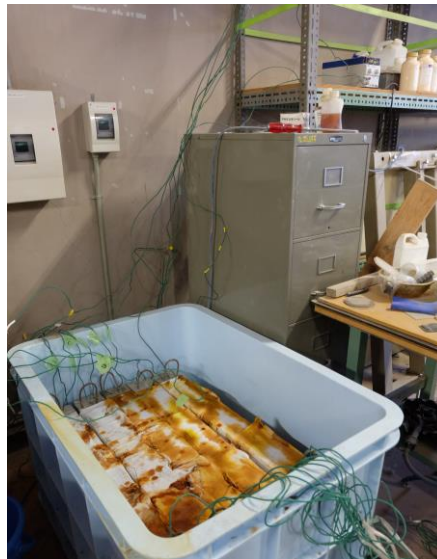
Figure 3.3: Accelerated corrosion system

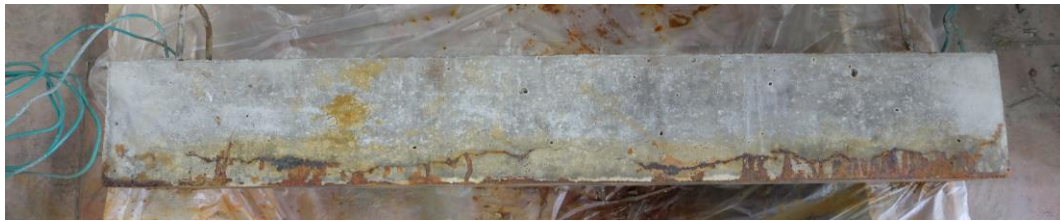
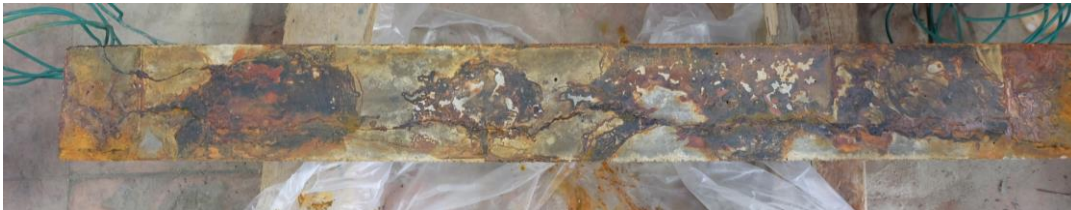
Figure 3.4: Beams after finishing accelerated corrosion: (a) side of the beam; (b) bottom of the beam

After finishing accelerated corrosion, splitting cracks were observed in concrete cover along the alignment of the tensile steel, as shown in Figure 3.4.

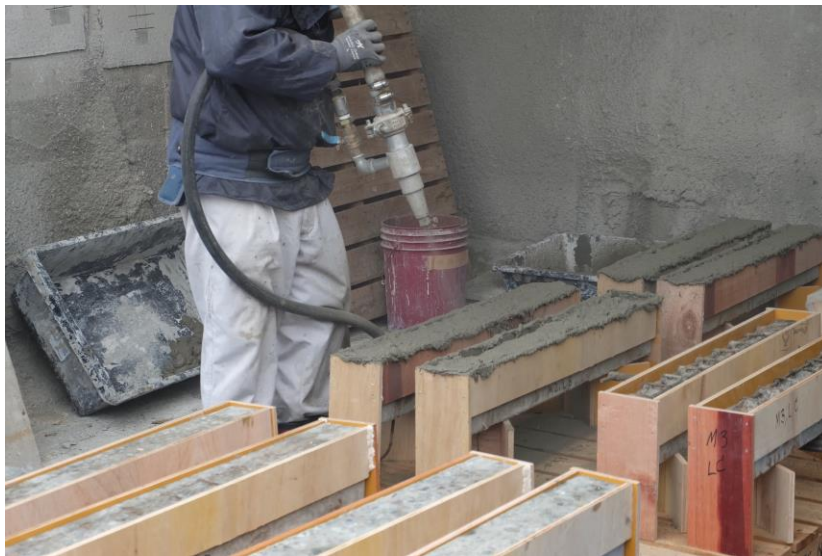
Figure 3.5: Spraying polymer cement mortar

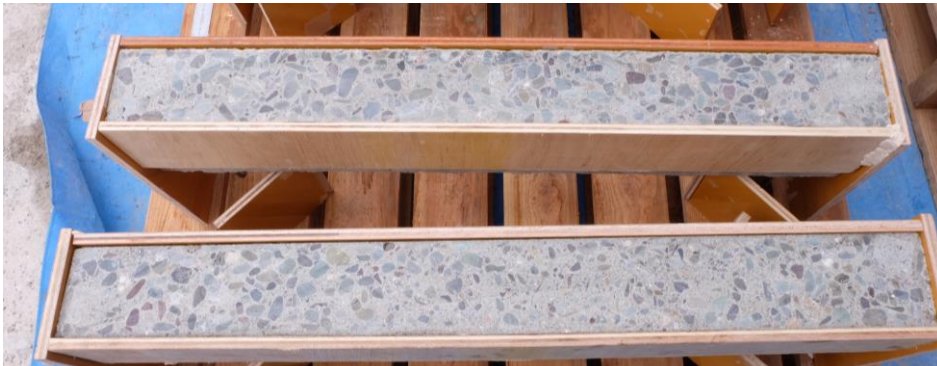
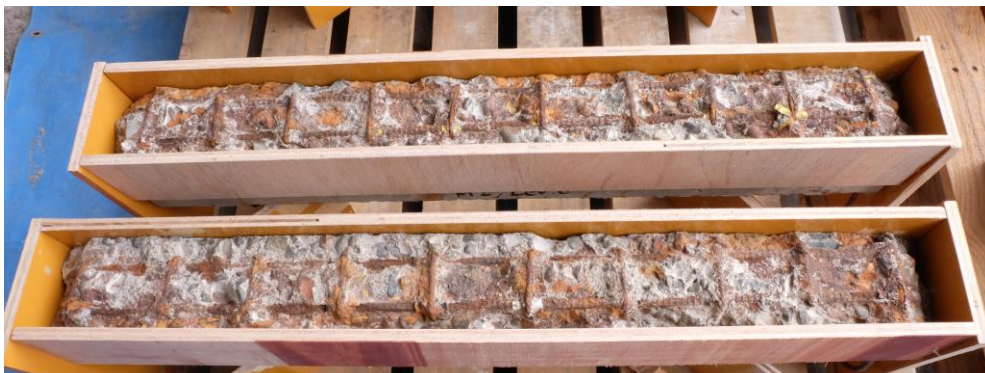
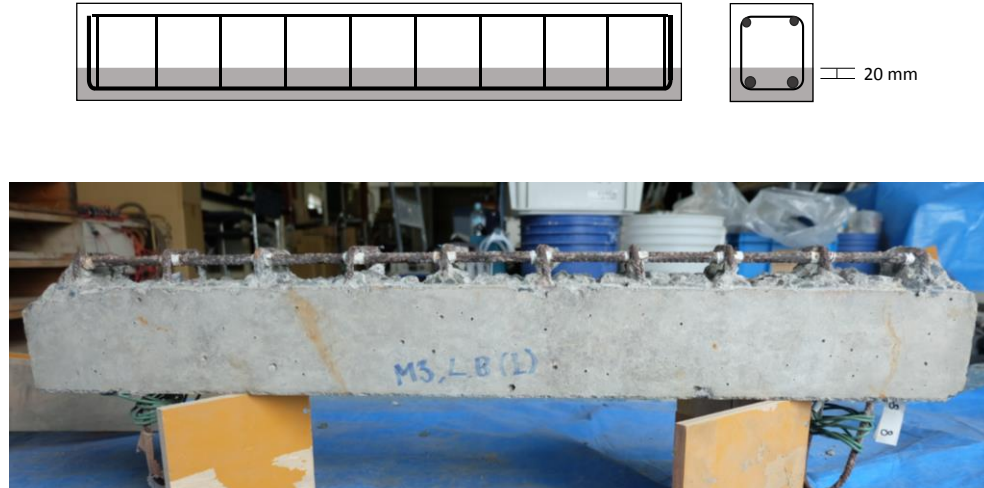
(a) Repair method 1

(b) Repair method 2

(C) Repair method 3

Figure 3.6: Repair methods

In all the repair methods, the corroded tensile reinforcement was not replaced. Of the three methods, method 1 is the most economical; however, because the concrete was removed only to a depth of 10, there were leftover corrosive agents as well as corrosion cracks, and the bond between the concrete and the steel bars that had been lost as a result of rusting was not restored. In method 2, the damaged concrete was removed to whole covering thickness. Such removal can prevent the ingress of corrosive agents; however, some chemical agents remain in the concrete over the tensile reinforcement, and the lost bond is not fully restored. Because it overcomes the main shortcomings of the above two methods, repair method 3 is the best choice for protecting steel against further corrosion. However, it is more costly; therefore, this method is usually used only for beams with severe corrosion.

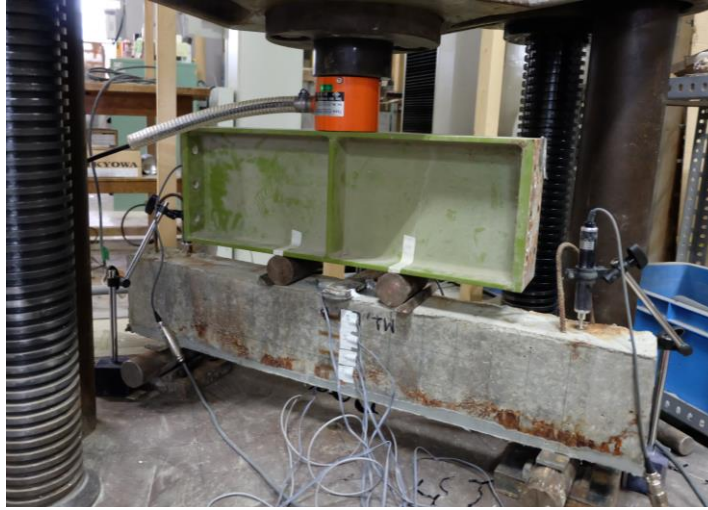
Figure 3.7: Four point bending test setup

In this study, four-point bending tests were conducted, as shown in Figure 3.7. Four linear variable differential transformers (LVDTs) were used to measure deflection; two were installed at the midspan and the other two were installed at each support. A total of 6 strain gauges were glued at the mid-span, with 4 installed along the side of the beam and 2 installed at the top and bottom of the beam, respectively, to measure the strain.

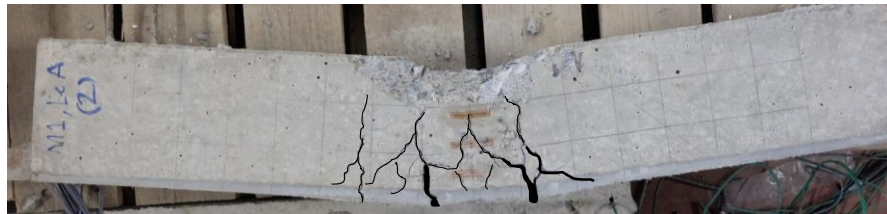
Figure 3.12. Crack formation of non-damaged beam strengthened with method 1 in combination with SPCM\_PE

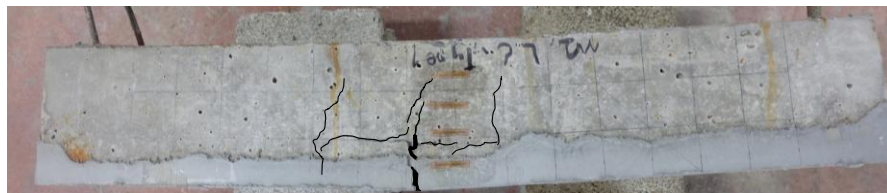
Figure 3.14. Crack formation of the beam repaired with method 2: (a) Typical central peeling of the beam repaired with method 2; (b) Peeling of SPCM or concrete at the midspan; and (c) Primary cracks formation of the beams repaired with method 2

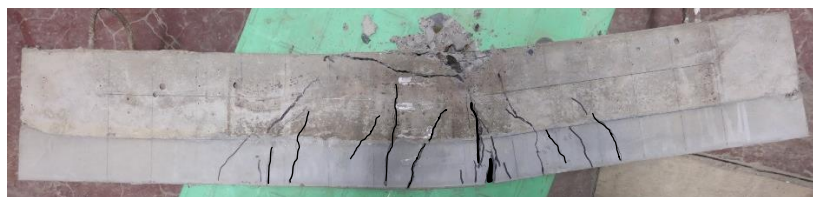
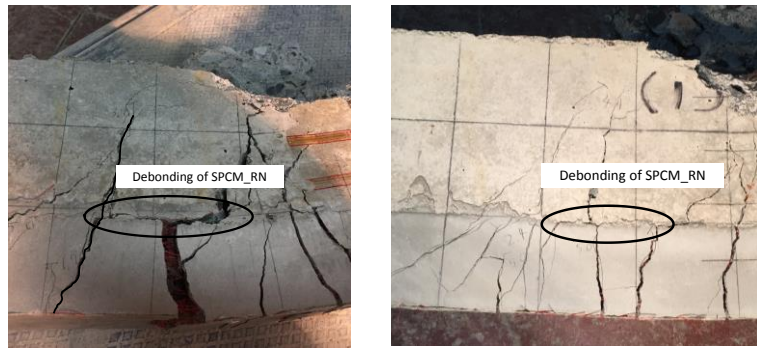
Figure 3.15. Crack formation of the beams repaired with method 3: (a) The beam repaired with SPCM containing PE fiber; (b) The beam repaired with non-fiber containing SPCM; and (c) Peeling of SPCM containing R-nylon fiber

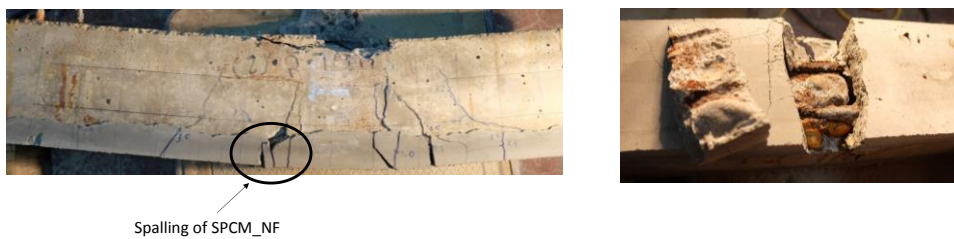
Figure 3.17. Spalling of non-fiber containing SPCM

It was found that the beams repaired with non-fiber containing SPCM showed a rapid growth of cracks as brittle manner, and spalling of SPCM was observed, as shown in Figure 3.17. Moreover, number of severe cracks were observed to be higher, and total number of cracks were observed to be lower than those repaired with SPCM containing fibers because the fibers dispersed severe cracks as much smaller cracks.

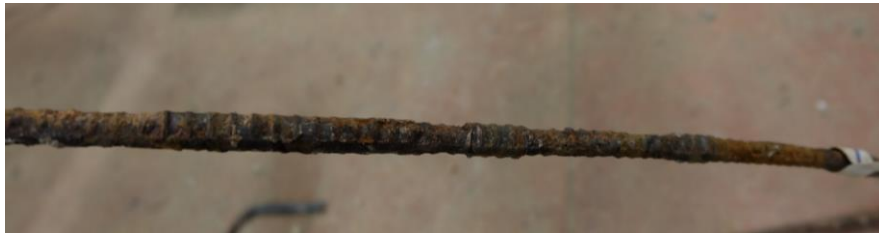
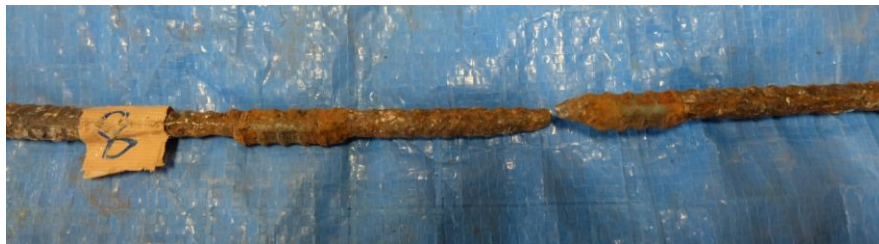
(a) Steel bar corrosion for the beams in group 1

(b) Steel bar corrosion for the beams in group 2

Figure 4.4: Corrosion of steel bars

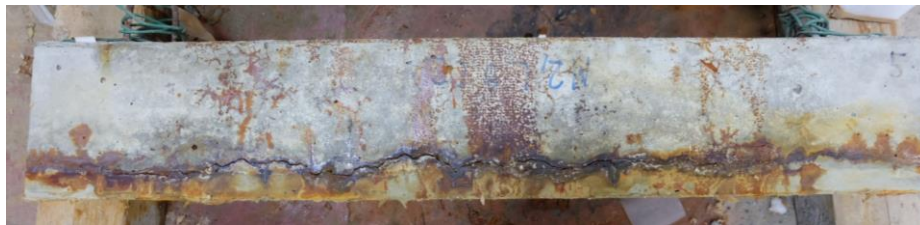
(a) After finish corrosion for the first time and then the beams were repaired with method 2

(b) Splitting crack was not fully stored

(c) After finish corrosion for the second time

Figure 4.8: Crack formation of the beams repaired with method 2

Figure 4.8 – 4.9 present corrosion crack formation of the beams in group 1 after repair and after finish second time accelerated corrosion. For the beams repaired with method 2, large splitting cracks were observed after finish second accelerated corrosion, as shown in Figure 4.8. In this method, the splitting cracks were not fully restored, therefore, corrosion product easily exerted large pressure on these existing cracks, thus these cracks were enlarged (Figure 4.8 (c)). In contrast, for the beams repaired with method 3, splitting cracks were restored and rarely observed on the beam surface after second accelerated corrosion, as shown in Figure 4.9.

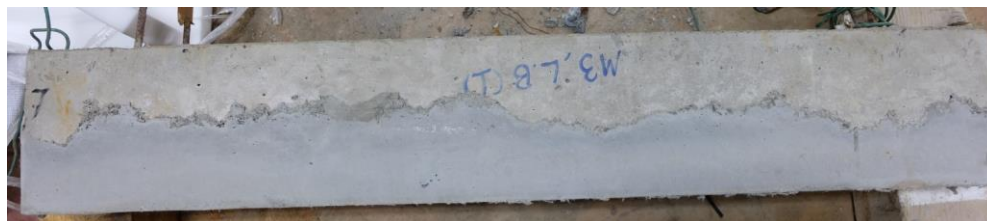
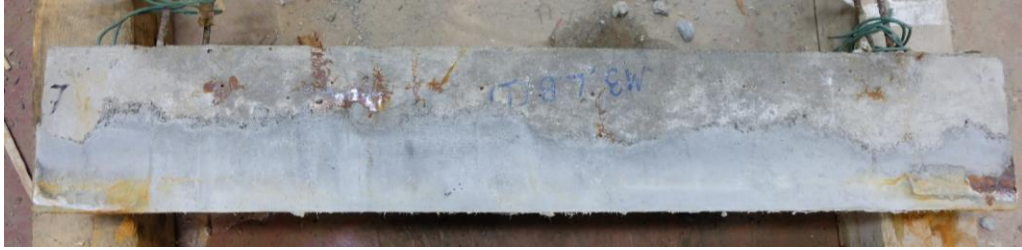
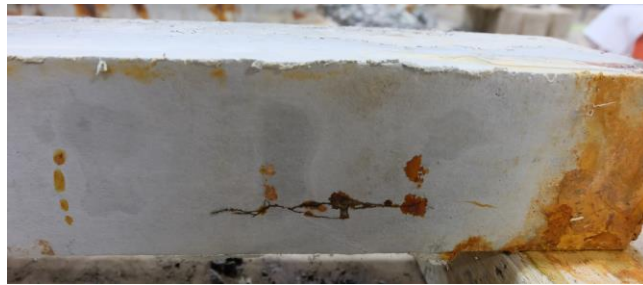
(a) After finish corrosion for the first time and then the beams were repaired with method 3

(b) After finish corrosion for the second time

(c) Corrosion crack after finish second accelerated corrosion

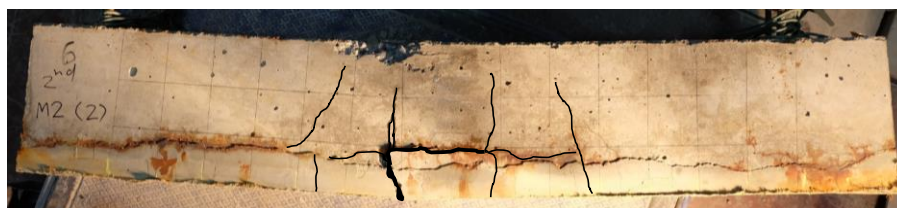
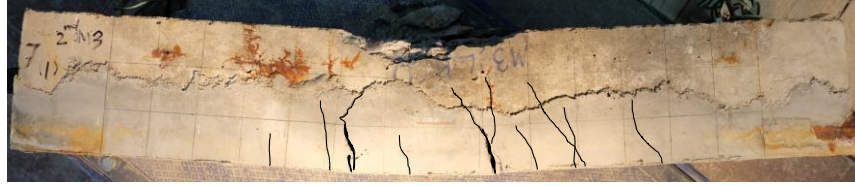
Figure 4.10 (a) and (b) present crack formation of the corroded beams in group 1 repaired with method 2 and 3, respectively, when conducting four point bending tests. Crack formation of the beams in group 1 are similar to the beams in group 2 as presented in Chapter 3. For the beams repaired with method 2, first the flexure cracks formed followed by concrete or SPCM peeling at the mid-span area, as shown in Figure 4.10 (a), the details of this kind of crack formation are explained in Chapter 3. In case of the beams repaired with method 3, flexural cracks were observed accompanied by concrete crushing in the compression zone (Figure 4.10 (b)).

(a) The beam repaired with method 2

(b) The beam repaired with method 3
