| Title | Mechanical behavior of reinforced concrete beams with locally corroded shear reinforcement |

# **Mechanical Behavior of Reinforced Concrete Beams with Locally Corroded Shear Reinforcement**

A dissertation submitted to Hokkaido University in partial fulfillment  
of the requirements for the Doctoral Degree of Engineering

September 2017

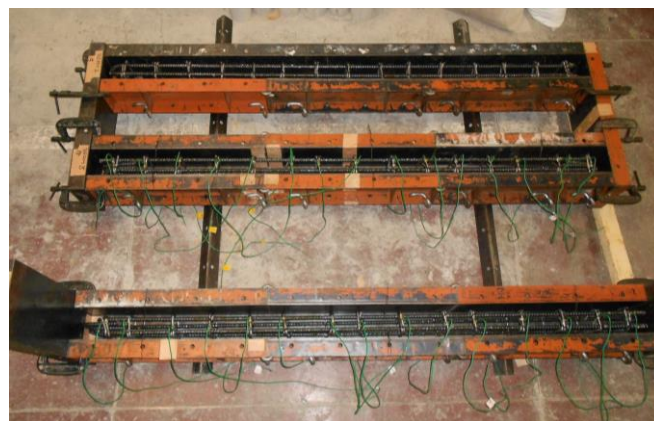
The longitudinal reinforcement, both compression and tension rebars were insulated at the stirrup location by using the insulation plastic tape to prevent any transmission of electrical current and to avoid corrosion of the longitudinal reinforcement. After attaching the wire at the top of each stirrup, the steel cage of the reinforcement was fixed and formwork was prepared. Figure 2.7 shows formwork arrangement and preparations for casting of the beams.

**Figure 2.7 Formwork and other preparations for casting of concrete beams**

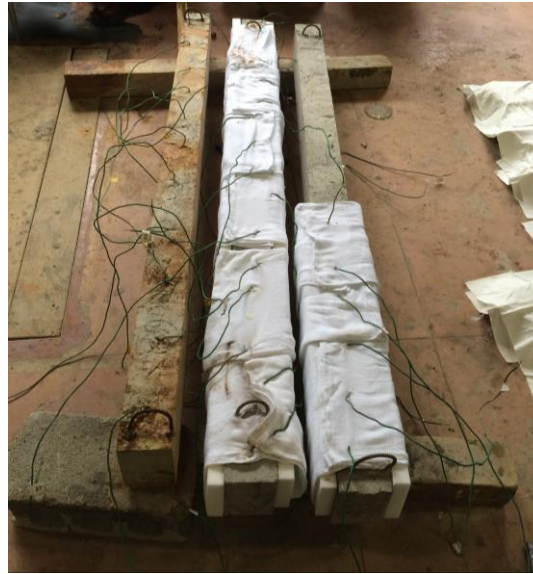
After 14 days of curing, the beams were prepared for the accelerated corrosion exposure to corrode the stirrup. A sponge was placed on both sides of the beam and wrapped with towels all around. The sponge will facilitate the chloride ion penetration in the concrete from side surfaces which is the intended location of corrosion and towels will provide moist conditions. Major contribution of shear strength of stirrup is provided by the vertical sides of the stirrup in a cross-section, which is the reason why the sponges were attached on the sides of the beam. Figure 2.8 shows the prepared beams which are ready for the application of electric current for stirrup corrosion.

**Figure 2.8 Beams attached with sponge and prepared for corrosion exposure**

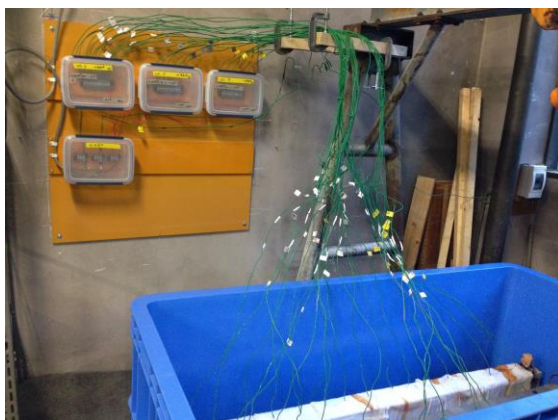
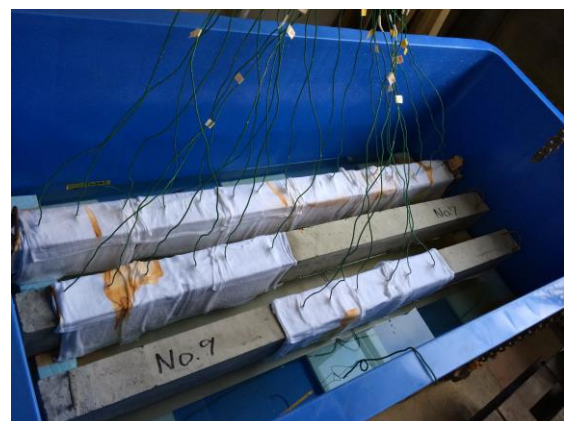
The beams were placed in a pool with 3% NaCl solution on one of its side. The height of solution was upto the mid of sponge level so that chloride ion can pass through the sponge and reach to the side of the concrete surface. The wires of the stirrups were connected to three sources of power supply called Supply A, B and C which was further connected to main DC controller power supply. This DC controller was the main control of the electric current and the amount of current can be adjusted through this device. Figure 2.9 shows the arrangement for electric current and beams in pool with 3% NaCl solution.

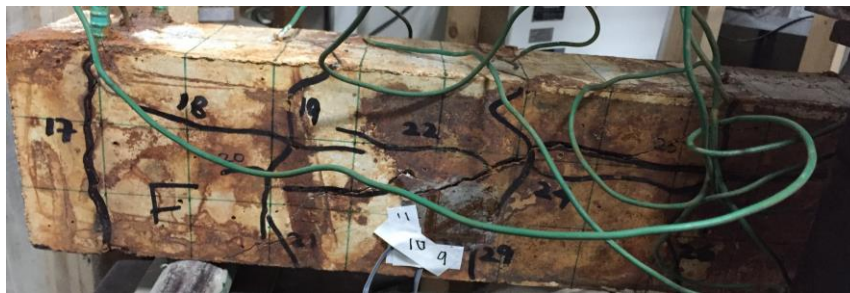
**Figure 3.39 Formation of shear crack during bending test of B11S-FS-10/120**

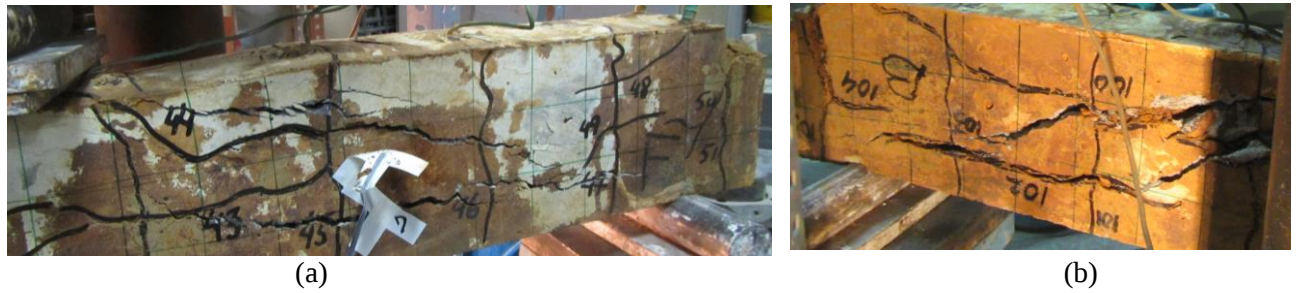
**Figure 3.42 Formation of shear cracks during bending test of B24S-FS-13/120**

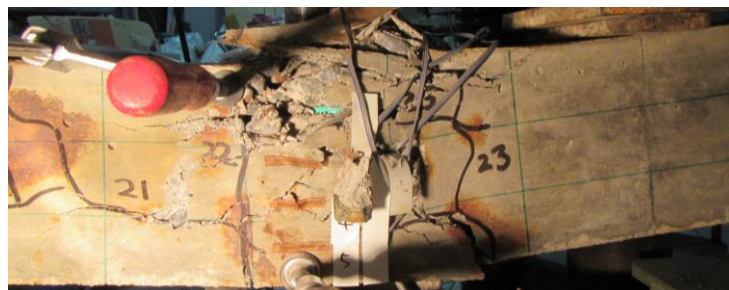
**Figure 3.46 Formation of cracks during bending test of B38M-FS-16/160**
