| Title | Influences of Water Vapor on Roof Fall Accidents in Selected Underground Coal Mines in Malawi |

# Influences of Water Vapor on Roof Fall Accidents in Selected Underground Coal Mines in Malawi

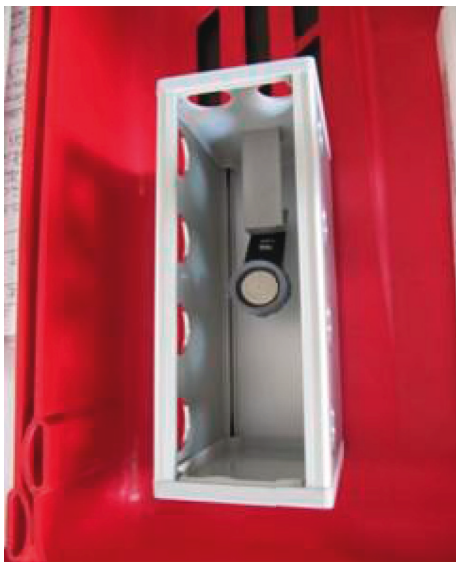
FIGURE 4: Coin-type data logger.

**2.4. Humidity Measurement.** Seven, coin-type data loggers (Figure 4) were installed at varying levels in and close to the working face with an average depth of 130 m from the ground surface (Figure 5) in mine adits of Mchenga Coal Mine. The instruments were fixed in matt packs not to be damaged or stolen. Hence, there was not enough airflow. Therefore, the recorded humidity may be higher than the surrounding atmosphere. In addition, one data logger was installed at the mine office at the ground surface.

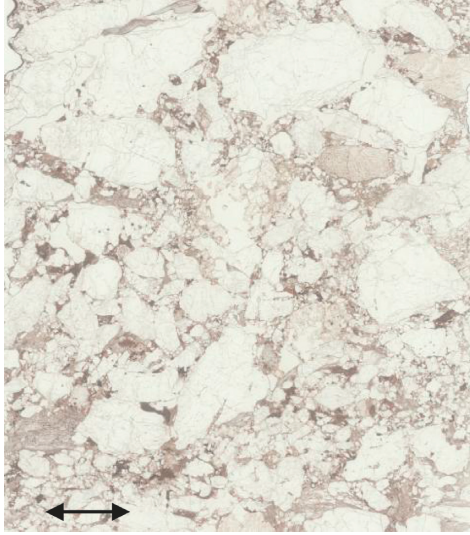
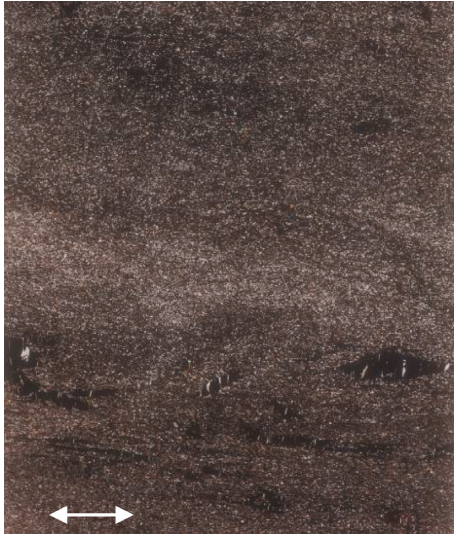
FIGURE 10: Scanned thin section images. The arrow length is 2.5 mm. (a) Kaziwiziwi conglomerate. (b) Kaziwiziwi carbonaceous sandstone.

**3.2. Kaziwiziwi Rocks.** Conglomerate and carbonaceous sandstone samples from Kaziwiziwi Coal Mine were also observed. The scanned image of the thin section of the conglomerate showed irregularities of minerals which indicates obvious open pore spaces (Figure 10(a)), while that of Kaziwiziwi carbonaceous sandstone exhibited a uniform color and texture (Figure 10(b)). The effective porosity for the conglomerate and the carbonaceous sandstone was 11.2% and 9.3%, respectively.
