### 2.4.1 国際学会INTERPRAEVENT2018への参加

# Prompt Report on Landslides Triggered by the 2018 Hokkaido Eastern Iburi Earthquake on September 6, 2018

Prompt Disaster Survey Team on landslide disasters triggered by the 2018 Hokkaido Eastern Iburi Earthquake

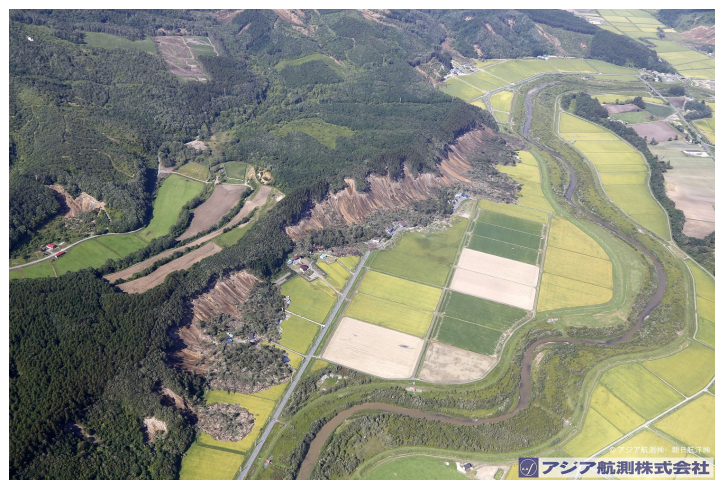
Photo 1 Yoshino area

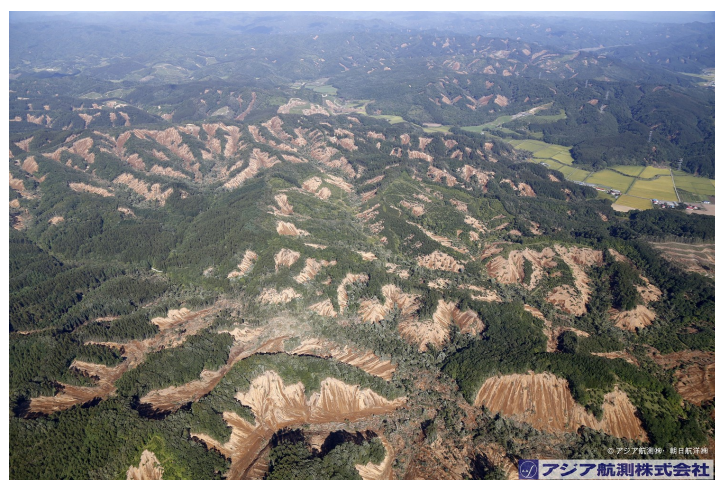
Photo 2 Upstream areas of Chikaeppu and Yachise River

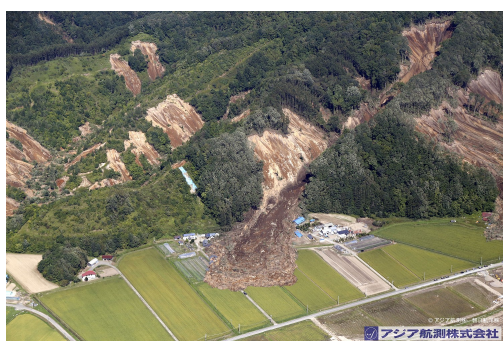
Photo 3 Tomisato area

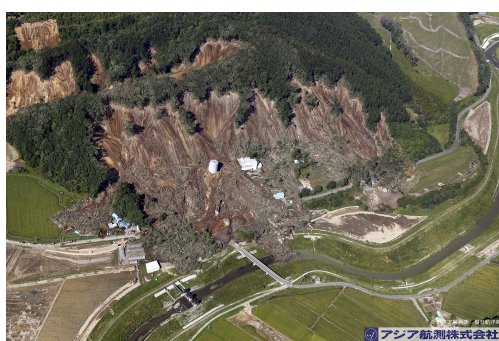
Photo 4 Tomisato area

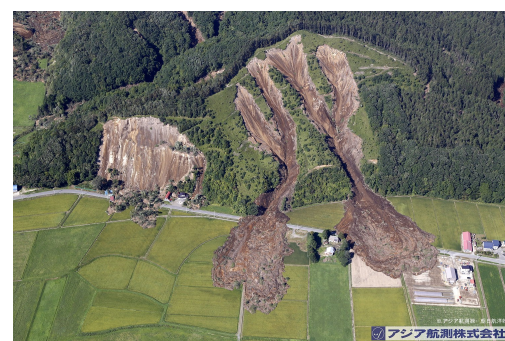
Photo 5 Horonai area

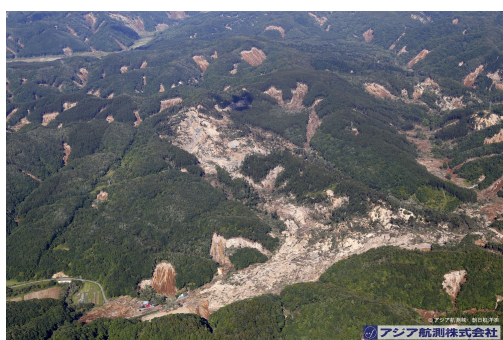
Photo 6 Upstream area of Hidaka-Horonai River

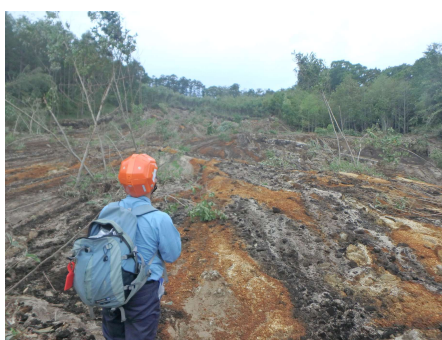
Photo 7

Landslide at Sakuraoka area and outcrop observed at the side of the landslide scar

- Slided materials consisted of less solidified pyroclastic fall deposits (derived from Tarumae Volcano etc.) containing almost no boulders, and were not disturbed and deposited remaining the original layers.
