**MULTI-STAGE FATIGUE ANALYSIS OF AN
ORTHOTROPIC STEEL BRIDGE DECK REINFORCED
WITH UHPFRC OVERLAY CONSIDERING CRACK
BRIDGING AND INTERFACIAL BOND STIFFNESS
DEGRADATIONS**

Chi Hieu Ma

Laboratory of Bridge and Structural Design Engineering
Division of Engineering and Policy for Sustainable Environment
Graduate School of Engineering
Hokkaido University

March 2022

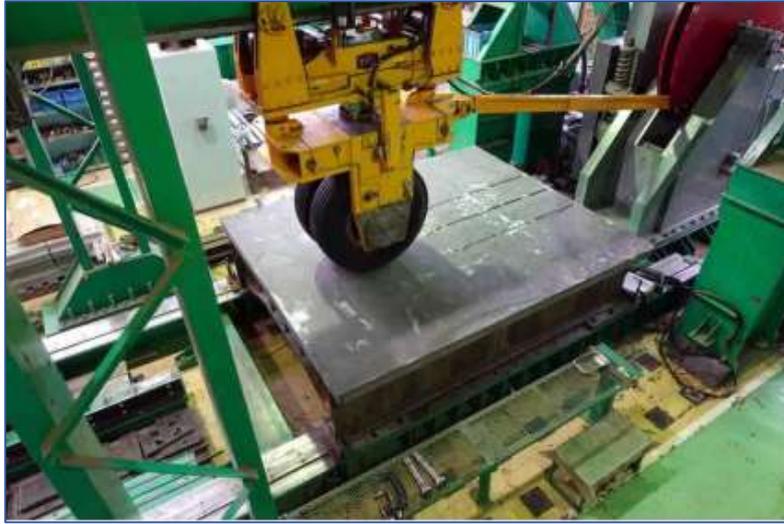
Figure 1.1 Fatigue test of full-scale OSD reinforced with UHPFRC overlay [9]

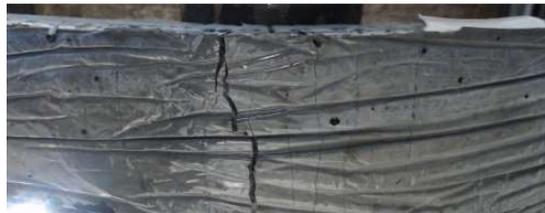
Figure 2.16 Static 3-point bending test of a small-scale UHPFRC-steel plate [25]

(c) Crack localization under the bottom of UHPFRC layer at final failure

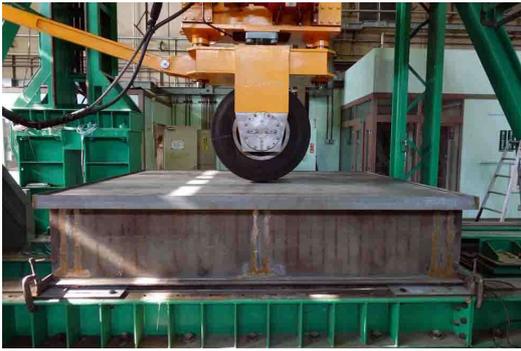
Figure 3.4 Rubber tire under static loading: (a) Static wheel load at Center location, (b) contact footprint of rubber tire [9]

(a)

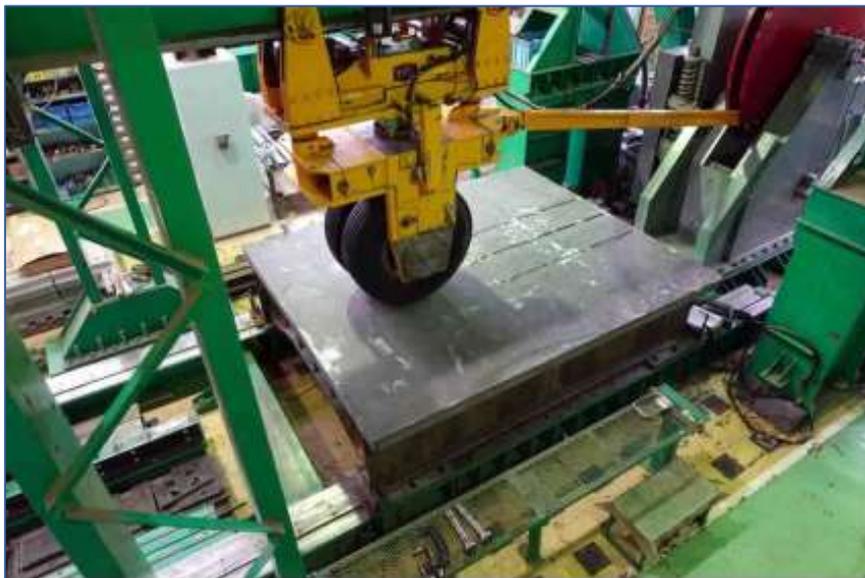
Figure 4.1 Fatigue test of full-scale UHPFRC-steel composite bridge deck in stage 1 subjected to a moving wheel loading with rubber tire under dry condition. [9]

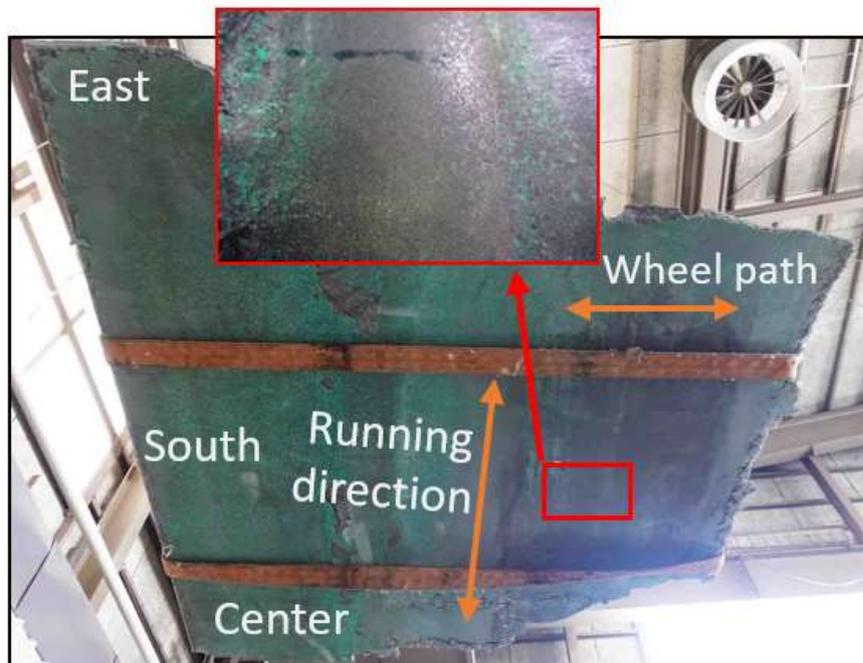
Figure 4.6 Interfacial bond layer under bottom surface of removed UHPFRC overlay at the end of stage 3 from fatigue test.

It is known in the analysis that due to the high contact shear stress induced by the wheel load (as illustrated in Figure 4.5), the region below the tire contact patch is susceptible to the fatigue action of the load moving, which may lead to the interfacial delamination at this region, i.e., the dark region under UHPFRC layer as seen in Figure 4.6. The picture of bottom surface of the removed UHPFRC overlay shown in Figure 4.6 is taken at the end of stage 3 from the fatigue test of the composite bridge deck. It is also noticed that the dark region in Figure 4.6 is composed of the iron oxide particles caused by the surface treatment process using shot-blasting before UHPFRC was overlaid on the steel plate.

(longitudinal) for matching the experimental tendencies at strain gauges SEL1, SEL2 and SEL3 in steel deck plate. The middle gap of 11 mm is applied above longitudinal Rib 4 for the degradation area S_I . The reason is that the contact shear stresses are nearly zero in the region above the middle stiffener (Rib 4), as shown in Figure 4.5. The existence of the middle gap of the bond stiffness degradation can also be confirmed in Figure 4.6.

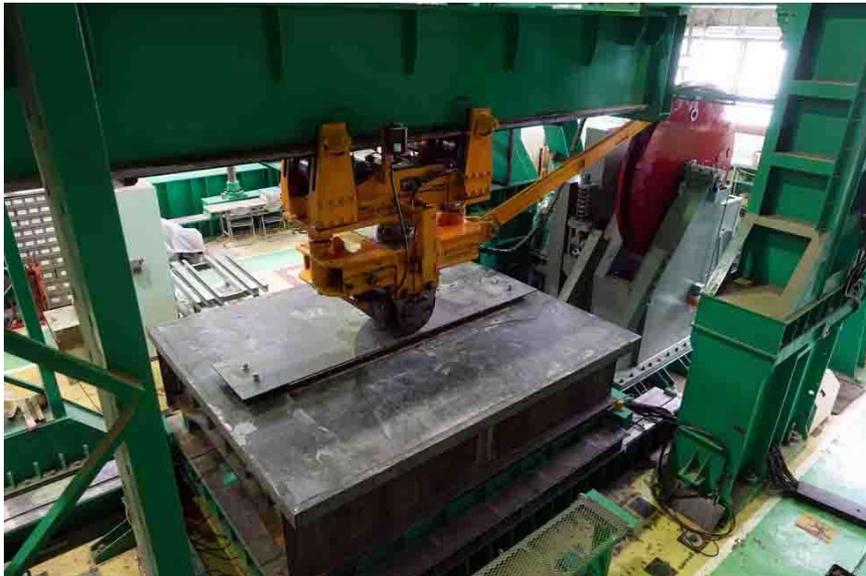
Figure 6.1 Fatigue test of UHPFRC-steel composite bridge deck in stage 3 subjected to a moving loading with steel wheel under dry condition. [9]
