1 Fatigue analysis of orthotropic steel-UHPFRC composite deck
2 considering accelerated deterioration and self-healing of fractured
3 UHPFRC in surface water condition

4 Chi Hieu Ma^{a,*}, Pengru Deng^c and Takashi Matsumoto^b

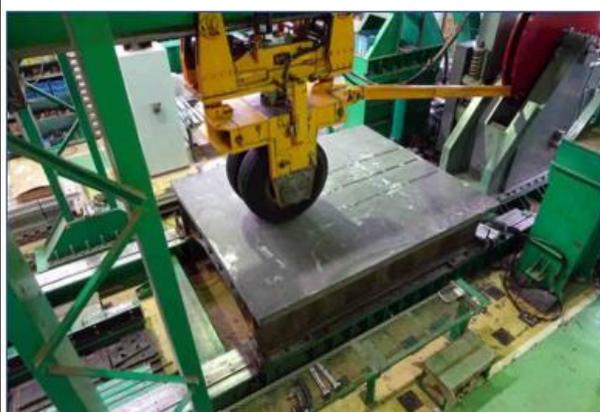
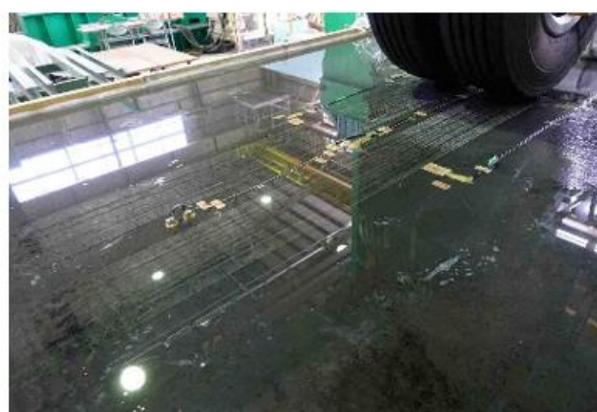
(a) Stage 1 (dry condition)

(b) Stage 2 (surface water condition)

106 The loading and environmental conditions adopted during the fatigue test for the composite bridge
107 deck, and the fatigue test images of Stages 1 and 2 are depicted in Fig. 2. In the current study, fatigue
108 analysis was conducted for Stage 2. After Stage 1, which included 1,100,000 cycles subjected to a
109 moving wheel loaded with a rubber tire under dry conditions, the damaged composite deck with
110 evident fine cracks on the top surface of the UHPFRC was subsequently tested for 60,000 cycles
111 under the surface water condition in 1 day. For one night before the execution of Stage 2 of the fatigue
112 test, a thin layer of water was deposited on the overlayer top surface. In the current fatigue analysis,
113 two phases were considered for the material model of cracked UHPFRC.

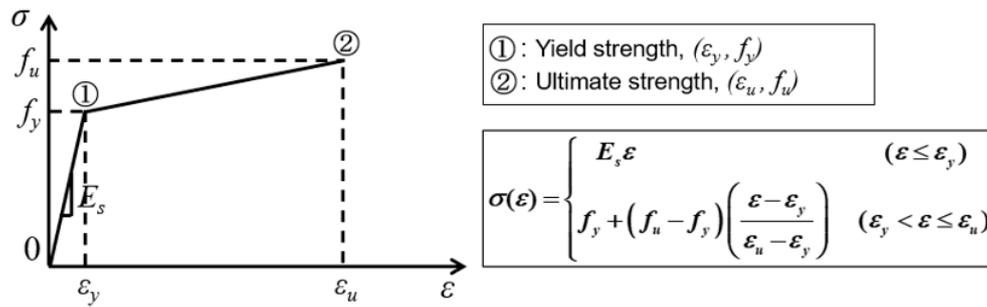
Material properties of steel	Steel members		Cross beam	Longitudinal rib	Steel plate
	Parameter				
Yield strength	f_y (MPa)		245	365	365
Tensile strength	f_u (MPa)		400	490	490
Ultimate tensile strain	ϵ_u		0.22	0.23	0.23

150 The stress–strain relationship of the steel material, and the primary material properties of the steel
 151 members are presented in Fig. 3. Notably, a Poisson’s ratio of 0.3 and Young’s modulus of 200 GPa
 152 are considered in the current model. The von Mises criterion is used as the yield criterion of steel. In

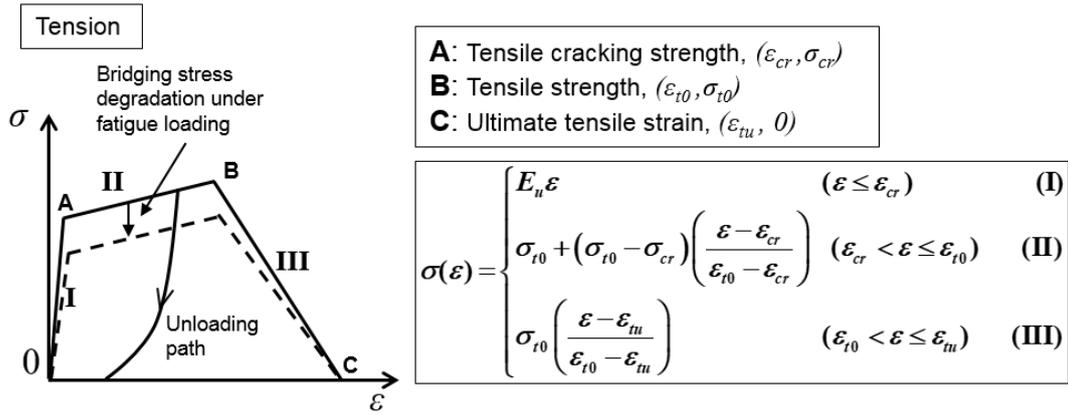
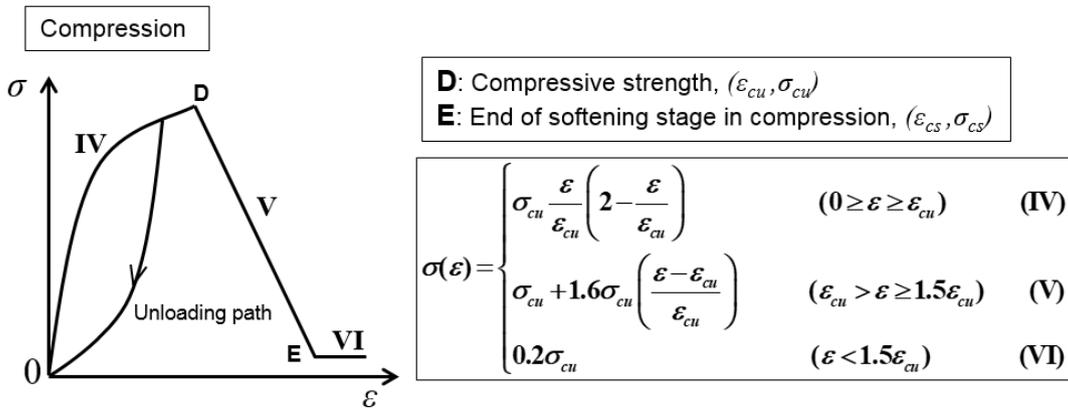
162 A user subroutine in Marc program is coded to define the constitutive law of UHPFRC. According
 163 to JSCE Recommendations (2008), the nonlinear stress–strain relationships of UHPFRC are
 164 presented in Fig. 4. The constitutive law of UHPFRC under tension can be defined by a trilinear
 165 relation, i.e., (I) elastic, (II) strain-hardening, and (III) strain-softening domains. After the elastic
 166 domain, the tensile stress increases with the formation and propagation of microcracks in the second
 167 domain, i.e., the strain-hardening domain. Following this, localized macrocracks initiate and develop
 168 in the third domain after achieving the tensile strength.

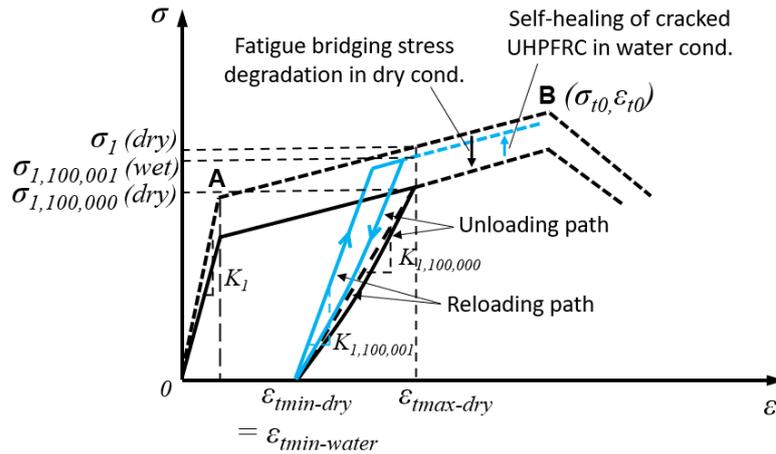
197 Fig. 5 Tensile stress–strain relation of the cracked UHPFRC under the surface water condition

185 Based on the studies conducted by Herbert and Li (2012, 2013), the mechanical recoveries of
 186 tensile strength and reloading stiffness of the UHPFRC surface cracks are considered in the current
 187 analysis, from the end stage of the dry condition (1,100,000th cycle) to the beginning stage of the
 188 surface water condition (1,100,001st cycle) in Phase 1 (Fig. 5).

198 The mechanical recoveries, especially for tensile strength, of the cracked UHPFRC under surface
 199 water condition are meaningful for the current fatigue test of Stage 2. By reducing the maximum
 200 tensile strain ε_{max} of UHPFRC cracks after self-healing, the bridging stress degradation can thus be
 201 decelerated during fatigue loading, as referred to the Eqs. (5) - (6) in the next section.

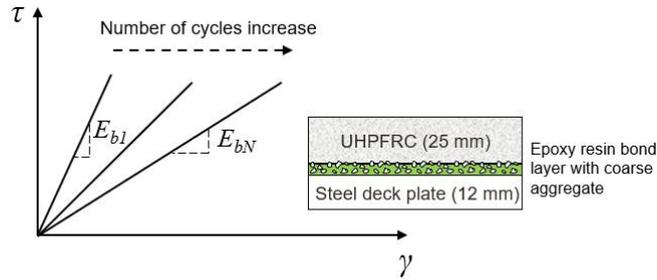
259 (a) Bond stiffness degradation model at steel/UHPFRC interface (Ma et al., 2021).

234 strain relationship is assumed in the current analysis (Fig. 6(a)). The shear elastic stiffness of the bond
 235 material, i.e., E_{b1} , is 2.66 GPa, is used following properties reported by Mitamura et al. (2011). In
 236 fatigue analysis of Stage 1, the interfacial bond stiffness degradation between steel plate and overlayer
 237 caused by repetitive moving-wheel load (see Fig. 6(a)) was considered by Ma et al. (2021). According
 238 to this study, by comparing the experimental observations (i.e., steel strain and hammer tapping test
 239 results) with the analysis results, the bond stiffness degradation speed was determined, as follows:

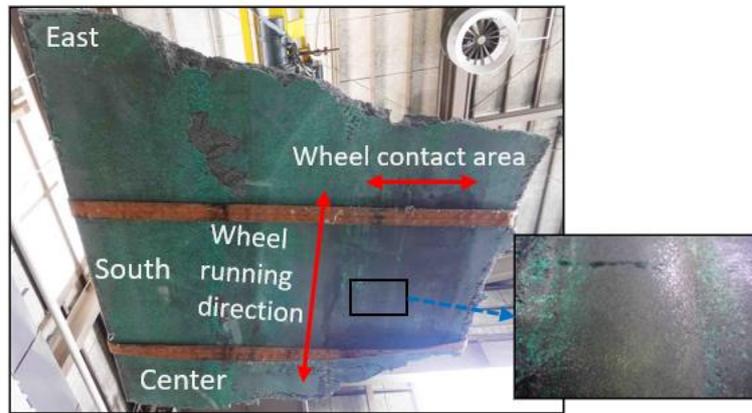
261 (b) Interfacial bond layer at the end of fatigue test (Makino et al., 2021).

243 Subsequently, the delamination area at the interface was considered for the FEM model from the
 244 700,000th cycle when the interfacial bond stiffness under wheel load region was zero (Ma et al.,
 245 2021). Fig. 6(b) shows the bonding layer at the UHPFRC/steel interface at the end of the experiment.
 246 The dark region under the wheel contact area, which comprised iron oxide particles obtained from
 247 shot-blasting process for the steel plate before applying the UHPFRC overlayer, could be observed
 248 after the fatigue test. This denoted the fatigue failure of bonding layer at wheel load region. In addition,
 249 based on acoustic inspections, i.e., a hammer test, in Stage 1 (see Fig. 6(c)), the abnormal noise range
 250 was detected at the 760,000th cycle, indicating the occurrence of interfacial delamination. Thereafter,
 251 the delamination area found by the hammer test gradually expanded in the local region above Rib 5.

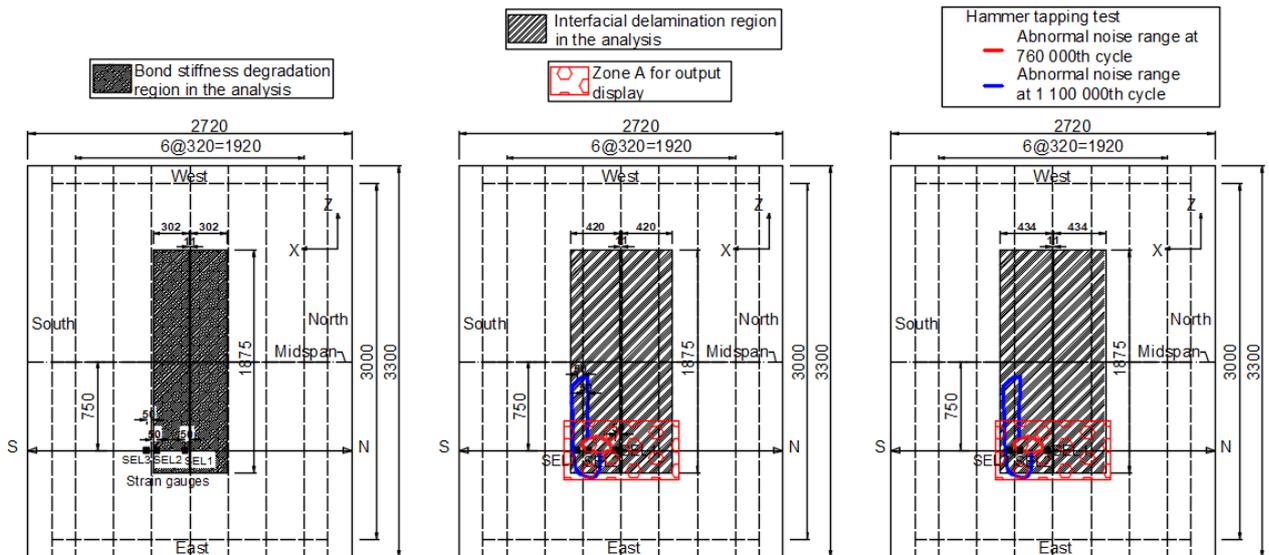
263 (c.I) Before 700,000 cycle

264 (c) Interfacial degradation areas for fatigue analysis of Stage 2 (All dimensions are in mm)

241 where E_{bN}/E_{b1} denotes the ratio of the interfacial stiffness from N th to 1st cycles. The region being
 242 applied the bond stiffness degradation, $S = 2 \times 302 \times 1875 \text{ mm}^2$, is shown in Fig. 6(c.I).

256 previous cycles in Stage 1 (from the 940,000th to the 1,100,000th cycles). The transverse dimension
 257 of the debonded area are then gradually increased from 840 to 868 mm (Fig. 6(c.III)).

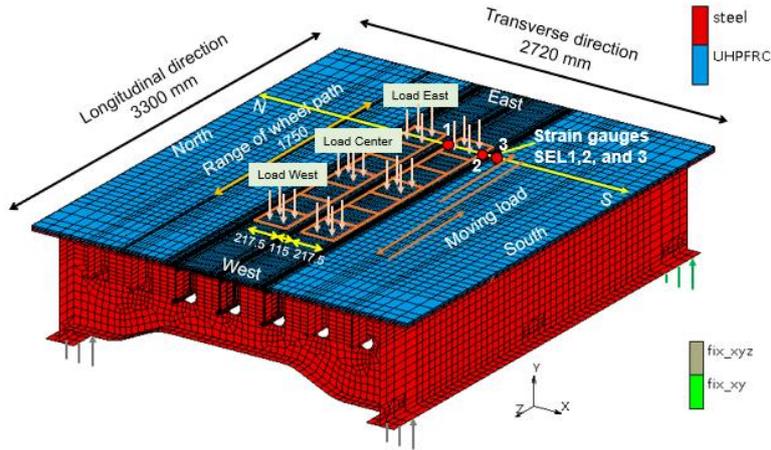
(a) Boundary conditions

267 The boundary conditions and mesh pattern in the FEM model of the composite deck are shown in
268 Fig. 7(a). Notably, a fine mesh with a minimum transverse size of 2.5 mm was employed for the
269 overlayer and steel plate at regions above the three central longitudinal ribs. The UHPFRC-reinforced
270 layer was vertically segregated into three layers in the current FEM model. In order to minimize
271 computational cost, the 4-node thick shell elements are utilized instead of the 8-node solid elements
272 to model the steel members such as cross beams, main girders, and the 4 outer bulb ribs (which are
273 located far away from the critical region at wheel loading lane, as shown in Fig. 7(b)). It was found
274 that, in comparison the model using only solid elements, the analysis time of the current model
275 reduced about 40%, while the differences between numerical results at critical locations in steel deck

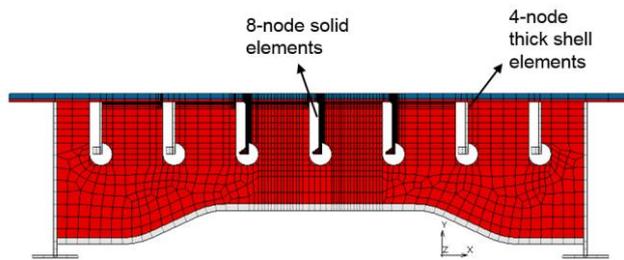
(b) Front view of FEM model

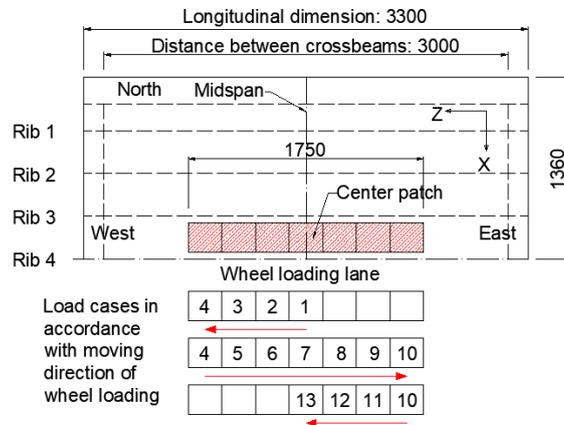
(c) Moving direction and load cases used in a single cycle

302 the peak value (100 kN) is reached from load case 1. In load case 2, this location is unloaded with the
303 loading of the adjacent elements at the same increasing rate. Herein, each load case includes 30
304 loading steps with a total running time of 2190s. This procedure is continuously repeated along the
305 loading lane, reproducing the movement of the rubber tire wheel. During this process, the bridging
306 stress degradation equation (i.e., Eq. (6)) and unloading behaviors at each integration point of the
307 UHPFRC elements are modified and determined based on the maximum value of tensile strain, which
308 is recorded from the previous cycle of the fatigue analysis. The obtained bridging stress degradation
309 value at each node is then applied directly to the nonlinear constitutive law of UHPFRC after cracking
310 which is defined in the multi-fixed smeared crack model for each cycle. The current analysis of Stage

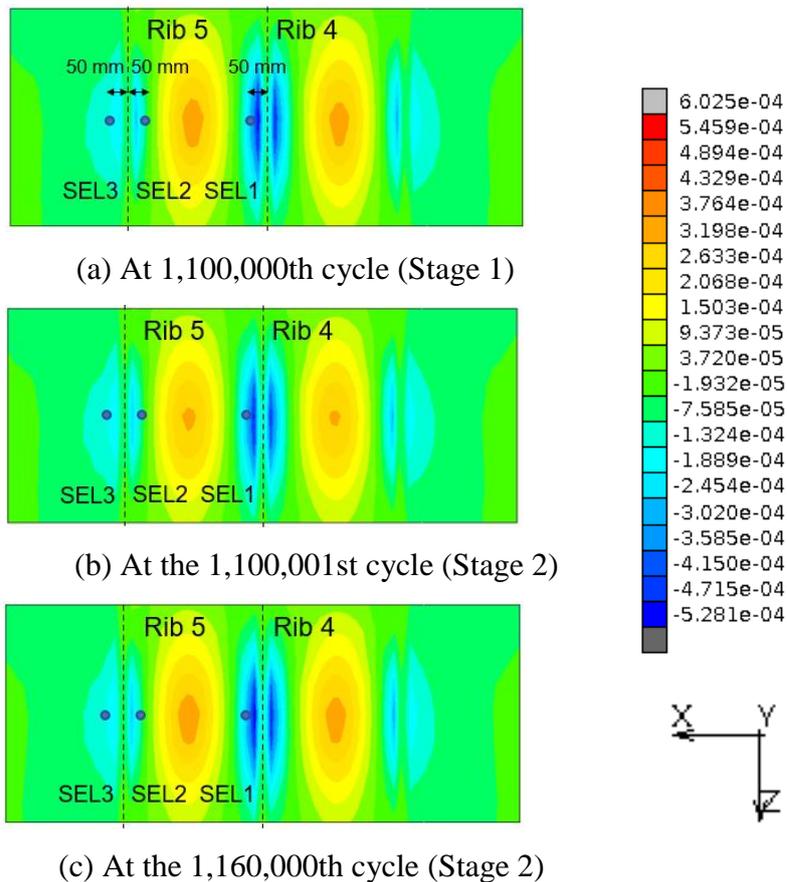
341 Fig. 8 Distributions of the steel transverse strain under bottom surface of the deck plate for different
 342 cycles in load case 10 (displayed at zone A).

345 In contrast to the first cycle of Stage 2, the increase in transverse strain magnitudes can be observed
 346 at the 1,160,000th cycle (see Fig. 8(c)), and this is owing to fatigue bridging stress degradation of
 347 cracked UHPFRC under moving-wheel loading in Phase 2. After the formation of a tensile crack,
 348 owing to the continuous reduction in tensile strength resulting from the degradation in the bridging
 349 stress between crack surfaces, a stress concentration can be induced in the region of the crack tip.
 350 Thereafter, the fatigue crack propagates in the overlayer with a newly formed crack length at the
 351 crack tip. Consequently, the deformation of the bridge deck is increased, leading to strain
 352 redistribution in the UHPFRC and steel plate. Moreover, stiffness reduction of the bridge deck is as

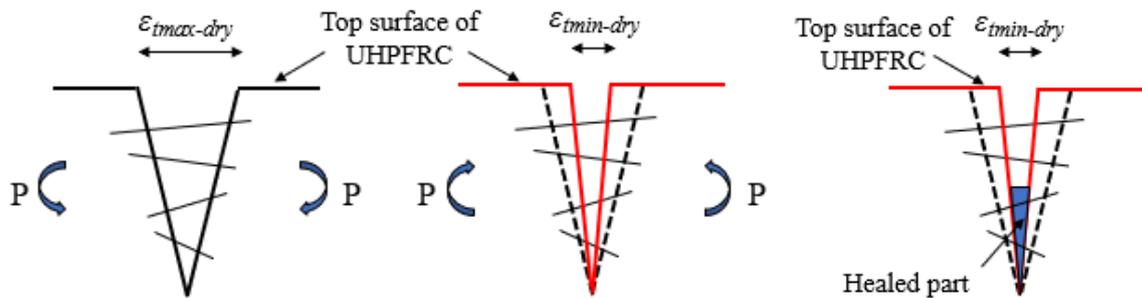
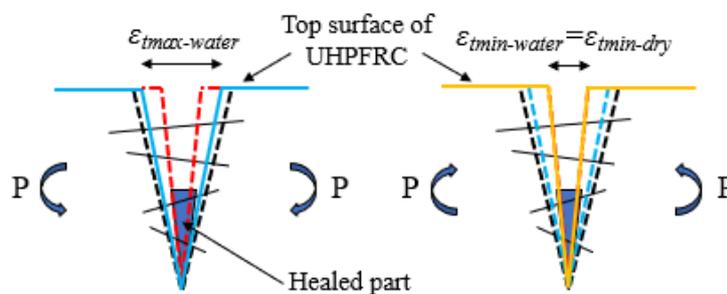
353
 354 (a) Loading under dry condition (b) Unloading under dry condition (c) Healed part formed inside
 355 crack

356
 357 (d) Reloading under water condition (e) Unloading under water condition

358 Fig. 9 Opening–closing behaviors of a UHPFRC crack before (a and b) and after (d and e) self-
 359 healing.

324 the steel deck plate during this loading cycle. Further, the mechanical recoveries of the cracked
325 UHPFRC in Phase 1 can be interpreted based on the opening–closing actions of a single crack (Fig.

326 9) on the top layer of the overlayer before and after self-healing. It is noted that the UHPFRC tensile
 327 cracks at East patch above Ribs 3, 4 and 5 are under the process from opening to closing when the
 328 wheel load moves from East to West load patches; and vice versa. In the presence of the healed part
 329 inside the UHPFRC crack, the stress transfer between pulled-out or ruptured fibers is restored,
 330 causing an increase in the bridging stress between the crack surfaces. Thus, the reloaded maximum
 331 strain or crack opening displacement decreases after the self-healing of UHPFRC cracks (Fig. 9(d)).
 332 The autogenous healing process of the UHPFRC cracks is assumed to terminate at the beginning of
 333 the 1,100,001st cycle (Fig. 9(c)), and the healed parts undergo cracking and degradation under
 334 repetitive wheel loading without further self-healing throughout Stage 2. Therefore, the unloading

343 minimum strain under the water condition ($\epsilon_{tmin-water}$) is maintained equal to that under the dry
 344 condition ($\epsilon_{tmin-dry}$) (Fig. 9(e)).

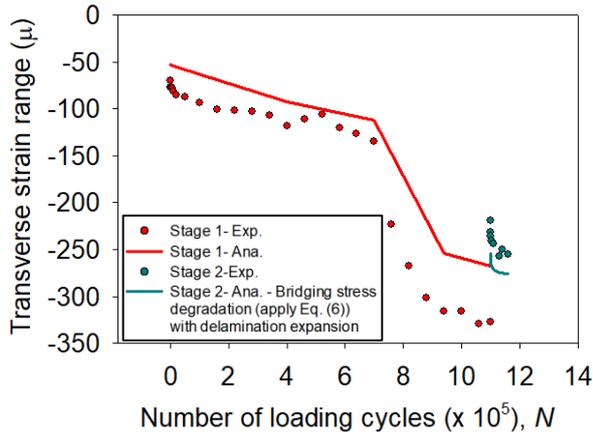
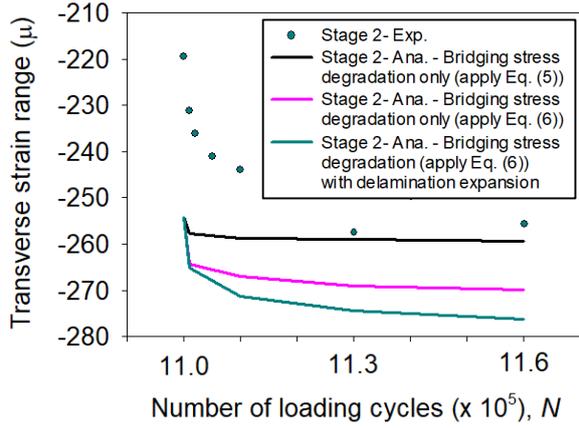
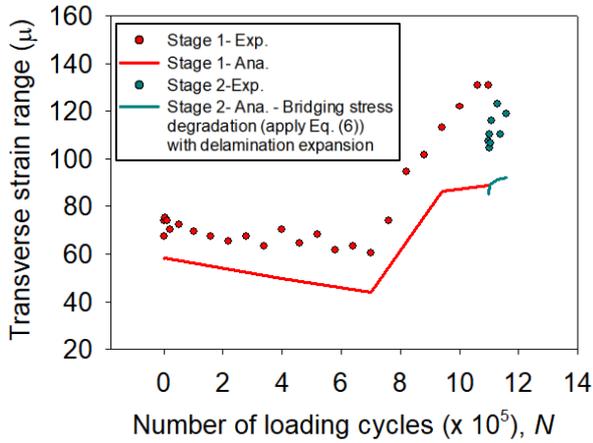
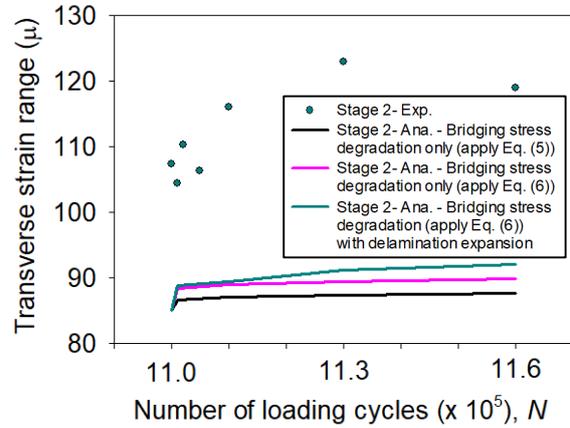
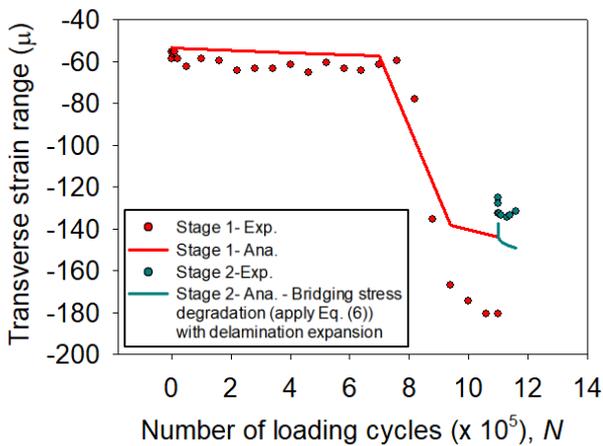
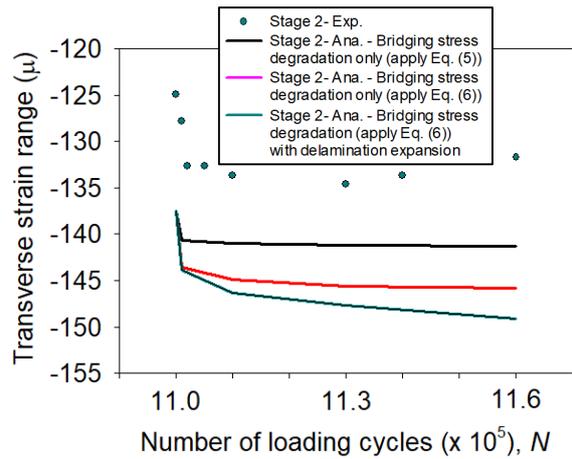
Fig. 10 Transverse strain range vs. the number of cycles at SEL strain gauges

367 In Fig. 10, the transverse strain range evolutions in load case 10 at the locations of the SEL strain
368 gauges (Fig. 1(a)) under steel-plate bottom are plotted in comparison with the experimental data, with
369 the chosen recovery ratios for tensile strength and reloading stiffness of 70%. As reported by Ma et
370 al. (2021), in Stage 1, owing to continuous deterioration of the interfacial bond stiffness before the
371 700,000th cycle, the strain range of the steel deck plate gradually decreases with an increase of the
372 number of cycles. Subsequently, a delamination area formed at the UHPFRC/steel interface and
373 expands along the transverse direction, leading to considerable variations in the transverse strain
374 range levels of the steel deck plate from 700,000th to 1,100,000th cycles. From Fig. 10, it is apparent
375 that the experimental strain range magnitudes at the SEL strain gauges from the end of Stage 1

376 (1,100,000th cycle) to the beginning of Stage 2 (1,100,001st cycle) have decreased after one-night
377 exposure in surface water condition. Possible cause of this behavior is the self-healing of surface
378 cracks in the overlayer, as introduced above. To assess the effect of this mechanism on the structural
379 responses of the composite deck, a parametric study is conducted and presented in the following
380 section.

446 From Fig. 10, it is obvious that the contribution of bridging stress degradation to the increase in
447 the strain range is more dominant during the early stages of the fatigue analysis under the surface
448 water condition based on a comparison between numerical models with and without interfacial
449 delamination expansion. The reason for this is that the expansion of the debonded zone is quite
450 minimal at the beginning cycles of Phase 2. With an increase in the number of cycles, the strain ranges
451 of the steel plate increase, as the UHPFRC–steel composite undergoes continuous degradation when
452 the delamination area is expanded along the transverse direction.

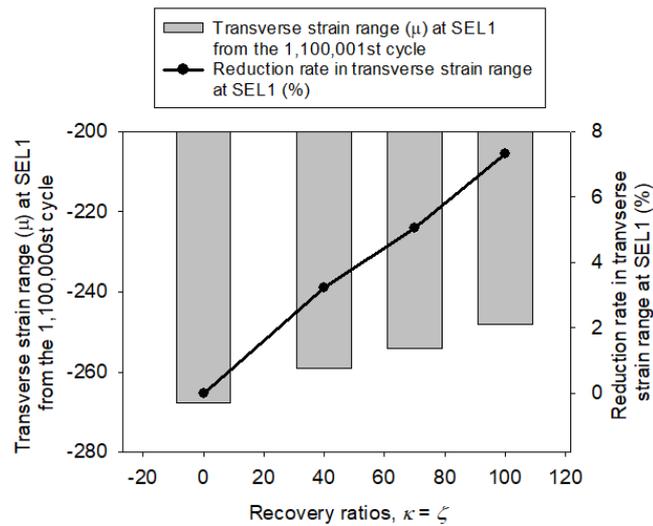
418
 419 Fig. 11 Effect of the self-healing recovery ratio on the transverse strain range at SEL1

382 Based on the current analysis under surface water condition in Phase 1, Fig. 11 shows the
383 relationships between the recovery ratios of tensile strength and reloading stiffness caused by self-

384 healing, along with the results of the transverse strain range considering the reduction rates from the
 385 1,100,001st cycle at strain gauge SEL1, i.e., steel plate's critical location. When the recovery ratios
 386 after the self-healing of UHPFRC cracks increase, the transverse strain range levels at SEL1 decrease,
 387 along with an increase in the reduction rates of the strain range. In the current model, with recovery
 388 ratios of 100% for the UHPFRC surface cracks, the reduction in the transverse strain range at SEL1
 389 can reach 7.32% (reduced from -267.7 μ to -248.1 μ). Based on the Japan Society of Steel Construction
 390 (JSSC) code (1993), the prediction analysis of the fatigue life at the critical point of SEL1 is
 391 conducted using the obtained transverse strain ranges. The fatigue life (in years) (N) is calculated as
 392 follows:

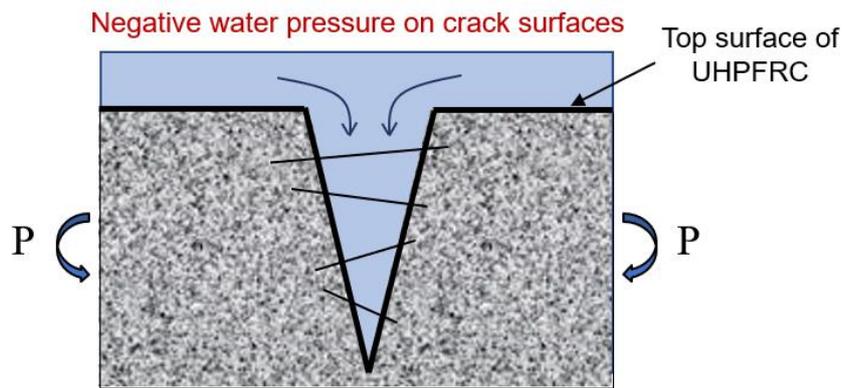
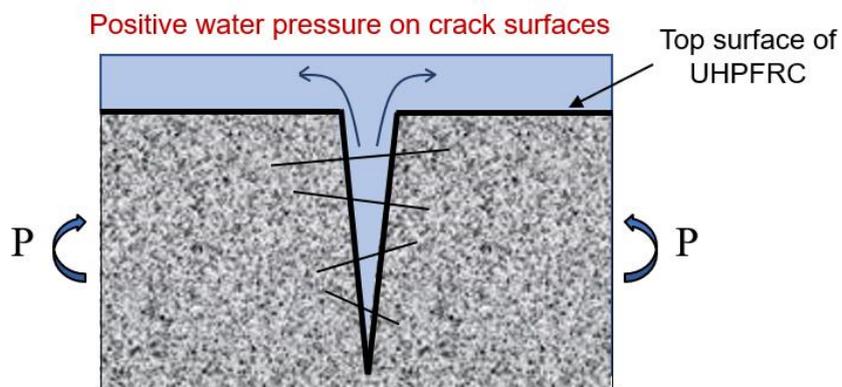
(a) Crack opening in water

(b) Crack closure in water

Fig. 12 Water pressure generated inside a UHPFRC crack under cyclic loading

438 and surface water condition. This mechanism can be explained based on the generated water pressure
439 inside the cracks under repetitive cyclic loading (Fig. 12). Under cyclic loading, the water pressure
440 acting on the crack surfaces becomes negative with the opening of the UHPFRC crack. By contrast,
441 a positive water pressure can be obtained during the closure of the UHPFRC crack in the presence of
442 water. Hence, under the repetitive moving-wheel load, additional forces resulting from stagnant water
443 could accelerate fatigue fiber deterioration (i.e., fiber pullout) in the fractured zone, which may result
444 in an increase in the bridging stress degradation speed of UHPFRC cracks considered for Phase 2 of
445 the material model of the UHPFRC.

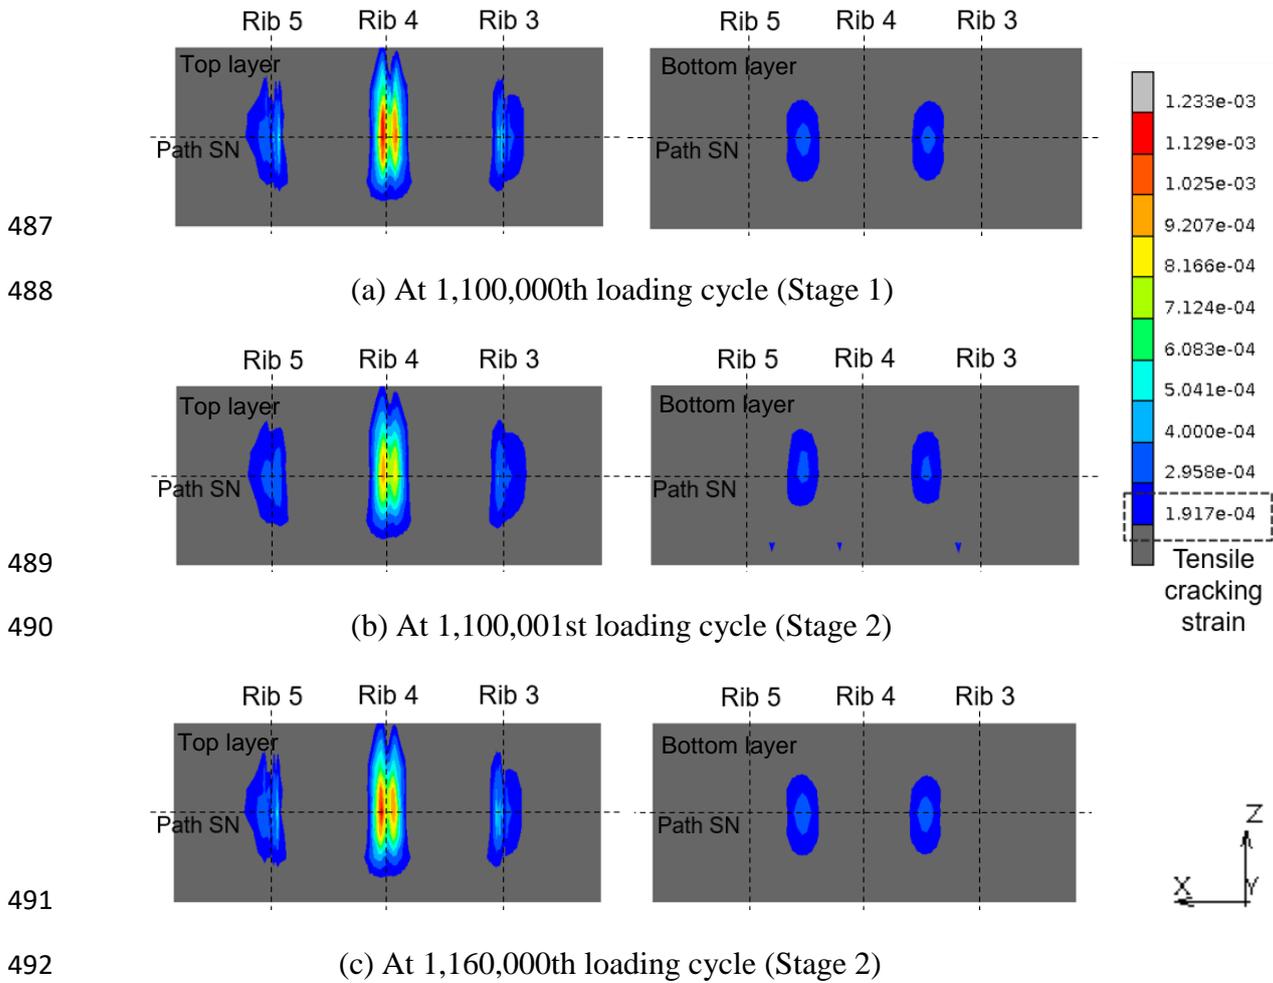
493 Fig. 13 Distributions of maximum principal strain for cracked areas on top and bottom layers of
494 UHPFRC overlay (displayed at zone A)

478 The maximum strain distributions for the cracked elements during Stages 1 and 2 at zone A
479 (presented in Fig. 6(c)) are shown in Fig. 13 for the bottom and top layers of the reinforced overlayer,
480 respectively. The blue-to-red color band represents the cracked regions on the overlayer surface. For
481 the OSD, an overall downward movement of the steel deck plate is achieved under wheel loading,
482 which induces positive bending at the tire contact region. However, owing to the stiffening effect of
483 the longitudinal rib, negative bending at these local regions is produced via wheel loading. Therefore,
484 cracks emerge on the top surface of the overlayer and propagate at local zones above Ribs 3, 4, and
485 5; whereas tensile cracks at the bottom layer of the UHPFRC overlayer are created at the rubber-tire
486 contact regions. At the beginning cycle of Stage 2, owing to an increase in the tensile strength caused

495 by the self-healing of the cracks on the top layer of the UHPFRC, the maximum tensile strain levels
496 from the top and bottom layers of the UHPFRC overlayer, as shown in Fig. 13(b), decrease compared
497 to those under the dry condition (Fig. 13(a)). This is accompanied by a narrower crack region from
498 the bottom layer of the overlayer. On the contrary, the maximum tensile strain level of UHPFRC
499 increases at the end of this stage owing to a significant increase in the bridging stress degradation
500 speed of the healed UHPFRC in stagnant water, as shown in Fig. 13(c).

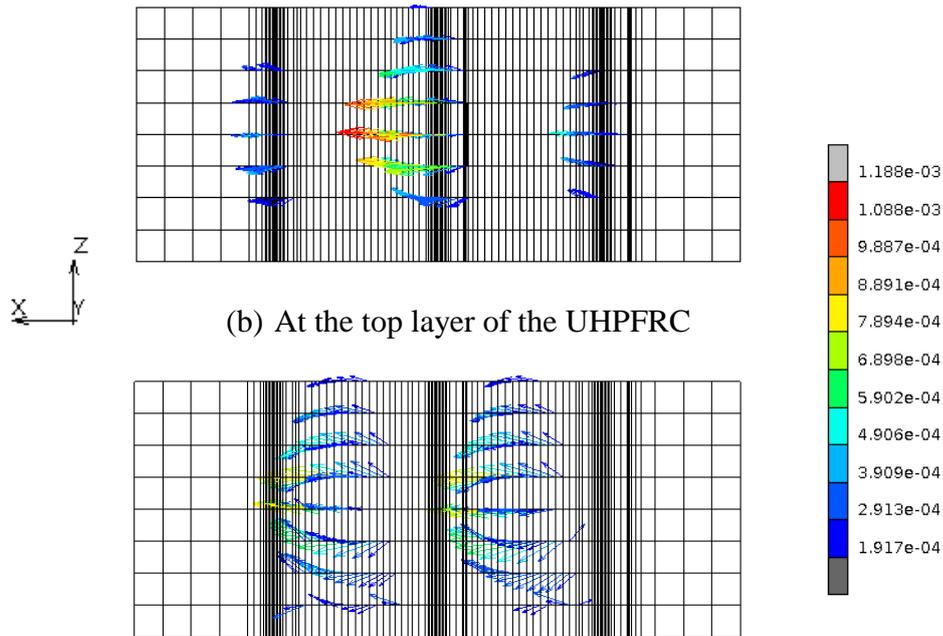
Fig. 14 Maximum principal strain directions of UHPFRC cracks at 1,160,000th loading cycle

501 The maximum principal strain directions obtained from the crack elements in the UHPFRC
502 overlayer under load case 10 of the 1,160,000th cycle are depicted in Fig. 14. It is obvious that the
503 maximum principal strain directions obtained from the crack elements on the UHPFRC top surface

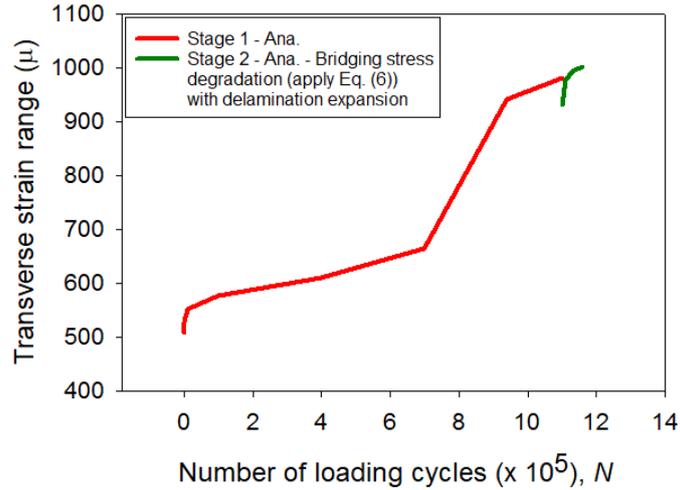
522
523 Fig. 15 Transverse strain evolution at the middle point of path SN

The transverse strain range evolution at the critical location on UHPFRC top surface (i.e., middle point of path SN) is plotted in Fig. 15, with the mechanical recovery ratio of 70%. Since the strain gauges separated from the UHPFRC top surface after 20,000 cycle, the discussion in this section is focused on the numerical results.

524 In Stage 1, the transverse strain range of the UHPFRC overlayer gradually increase until 700,000th
525 cycle, due to the combination of the degradations of cracked bridging stress and interfacial bond
526 stiffness. After that, from 700,000th to 1,100,000th cycles, a considerable increase in strain range
527 results are obtained after the formation and development of the interfacial delamination area.

528 In Phase 1 of Stage 2, it can be observed that there is a reduction in transverse strain range at the
529 middle point of path SN in UHPFRC overlayer after applying the mechanical recovery ratios of 70%
530 to the UHPFRC surface cracks to reproduce the self-healing behavior. Herein, the reduction
531 percentage is approximately 5.09% (reduced from 981 μ to 932 μ). Subsequently, under fatigue
532 loading process (Phase 2), by applying the increased speed of crack bridging stress degradation in Eq.
533 (6), the transverse strain results in UHPFRC overlayer continuously increase, especially from the
534 initial 5,000 cycles of Phase 2. These results are similar to the observation of the steel strain results
535 represented in Fig. 10.

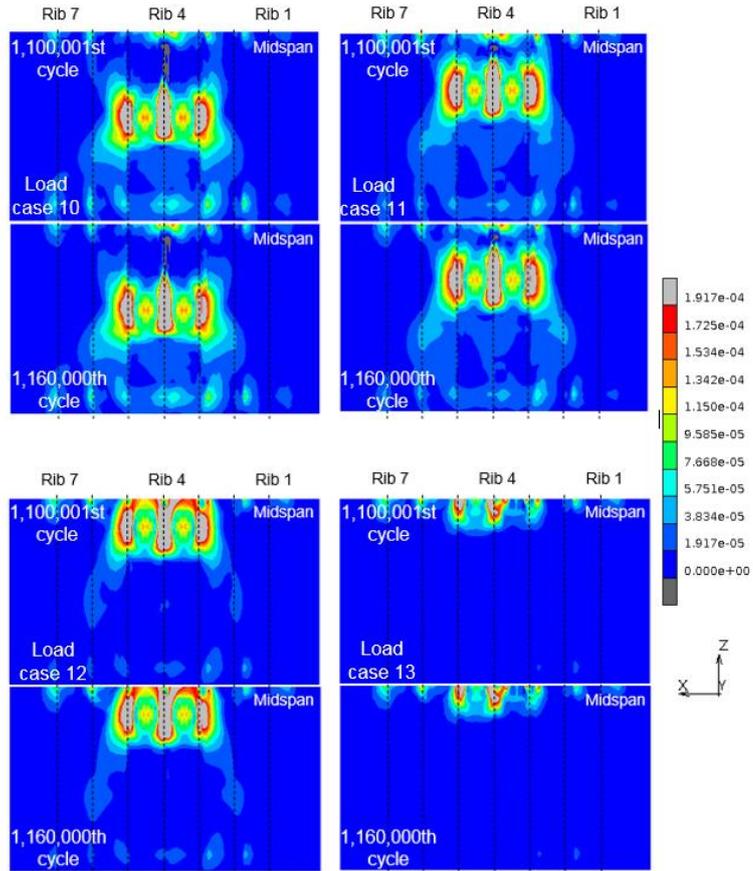
(a) Distributions of maximum principal strain on the UHPFRC top layer obtained from the fatigue analysis (Gray color: the crack region)
