| Title | Morphological responses in drainage basins affected by coseismic landslides triggered by the 2018 Eastern Iburī Earthquake, Hokkaido, Japan |

Morphological responses in drainage basins affected by coseismic  
landslides triggered by the 2018 Eastern Iburi Earthquake, Hokkaido, Japan

Graduate School of Environmental Science, Hokkaido University

LO Lap Wing

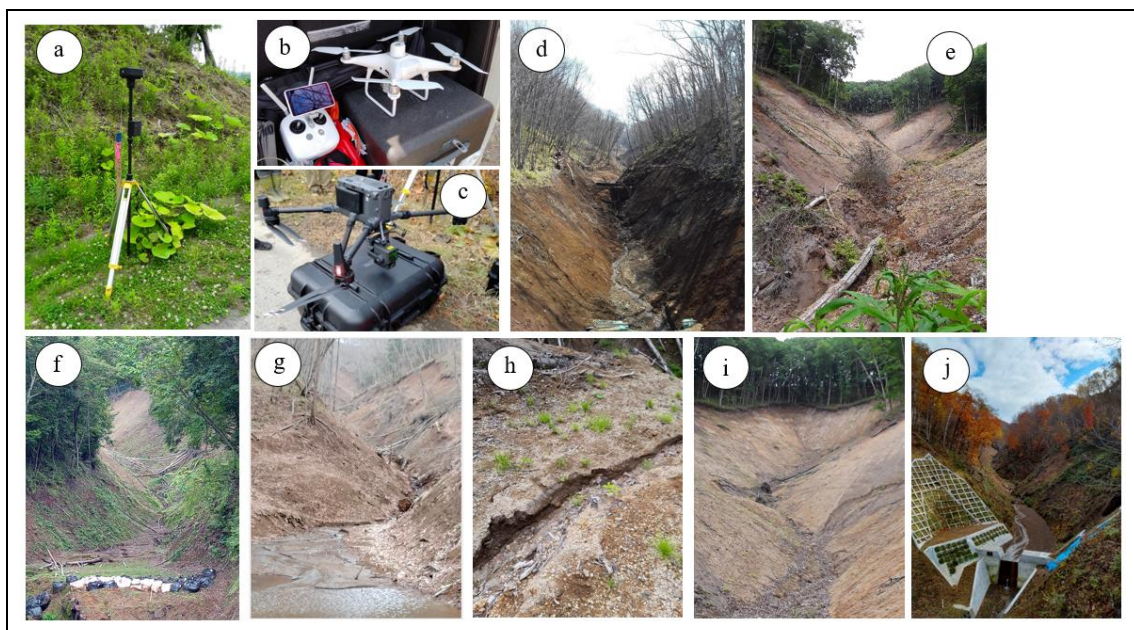
Figure 3.1.1: Field surveys: (a) A base station of global navigation satellite system (GNSS) receiver (DJI D-RTK2), (b) UAV of DJI Phantom 4 RTK, (c) Matrice 300 RTK with Lidar sensor, (d) Field survey April 23, 2020, (e) Field survey June 25, 2020, (f) Field survey September 14, 2020 (g) Field survey April 13, 2021, (h) Field survey June 21, 2021, (i) Field survey August 27, 2021, (j) Field survey October 29, 2021

For data and information collection, 8 field surveys were conducted from April 2020 to October 2021 (Period 2 to 9) which were indicated in Table 1. Weather condition was considered to ensure stable and safe autonomous UAV flight. A UAV of DJI Phantom 4 RTK, equipped with an RGB camera (20 M sensor and pre-calibrated lens) (Figure 3.1.1 b), and Matrice 300 RTK with Lidar sensor (Figure 3.1.1 c) were used with the terrain following mode to keep the relative flight height of approximately 100 m from the ground. A base station of global navigation satellite system (GNSS) receiver (DJI D-RTK2) (Figure 3.1.1 a) was used to perform the real-time kinematic (RTK) correction of the GNSS-derived aircraft positions during the flight, providing the geographic coordinates of each camera image at a centimeter-level accuracy. Aerial photos taken by the UAV were used for processing dense point clouds, DEMs and high resolution orthorectified images (Figure 3.1.2 a-c). We also performed field observations of the study sites by walking along the drainage valleys on study site B and D (Figure 3.1.1 d-j) until the upslope of drainage basin to identify morphological changes such as stream-bed deposition, gully erosion and stream network development (Figure 3.1.1 d-j).

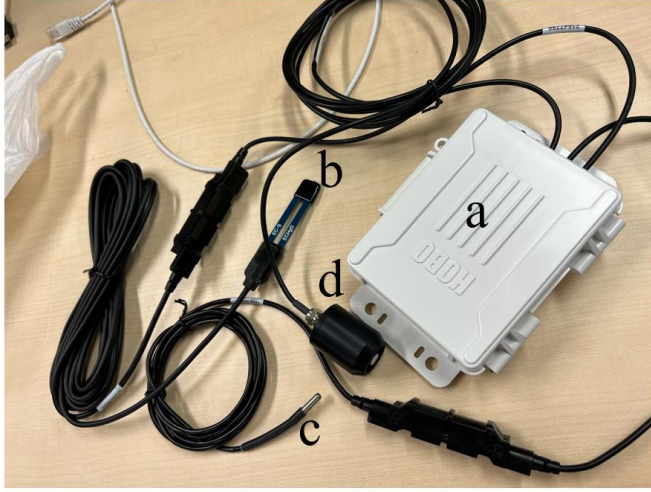
Figure 3.1.4.1: Equipment: (a) Data micro station loggers (HOBO H21-USB), (b) 5cm fork-shaped soil moisture sensors (S-SMC-M005), (c) Soil temperature sensors (S-TMB-M002) and (d) Photosynthetic active radiation (PAR) sensors (SLIA-M003).

On March 15, 2023, four sets (Set A, B, D and E) of USB Data micro station loggers (HOBO H21-USB), 5cm fork-shaped soil moisture sensors (S-SMC-M005), Soil temperature sensors (S-TMB-M002) and Photosynthetic active radiation (PAR) sensors (SLIA-M003) (Figure 3.1.4.1) were set on 4 target slide slopes caused by coseismic landslides after the 2018 Hokkaido Eastern Iwate Earthquake (two sets near stream outlet and two sets at middle course of stream in Study site B with north-facing and south-facing aspects (Figure 3.1.4.2) to measure the daily and seasonal variations on top soil moisture ( $\text{m}^3/\text{m}^3$ ), soil temperature ( $^{\circ}\text{C}$ ) and Photosynthetic active radiation (PAR) ( $\mu\text{mol m}^{-2} \text{s}^{-1}$ ).

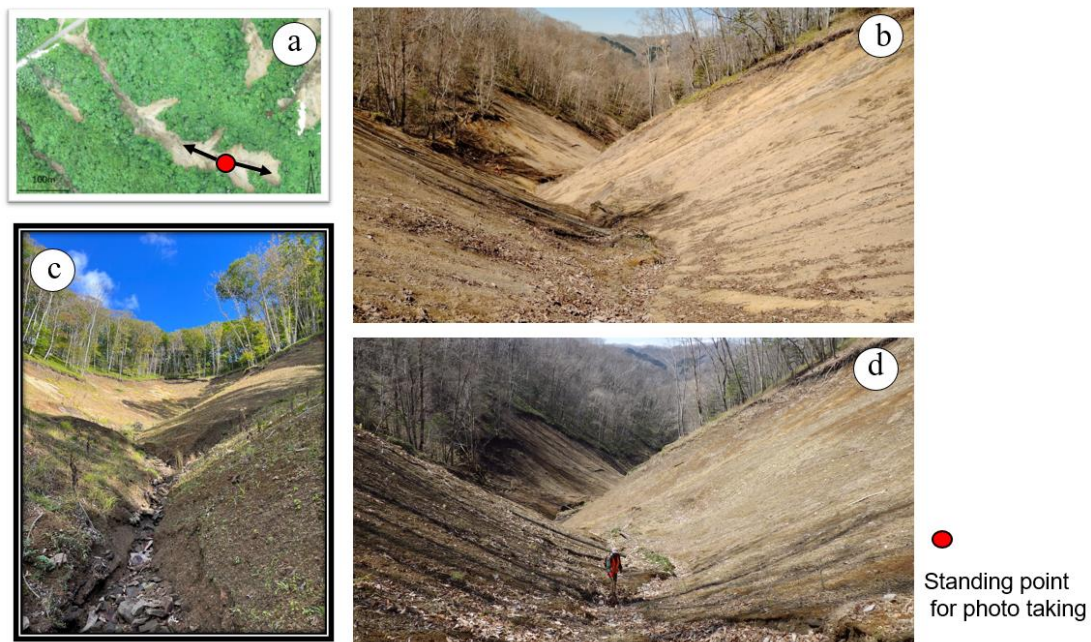
Figure 5.4.1.2: Vegetation recovery (a) Overview of the Study site B (Orthorectified mosaic image), (b) Photo taken on April 25, 2022, (c) Photo taken on September 22, 2022 and (d) Photo taken on April 18, 2023.
